WHAT NEEDS TO BE DONE TO REACH BEAM ENERGY ABOVE 3.5TeV? COMMISSIONING OF ESSENTIAL MAGNET POWERING AND MACHINE PROTECTION SYSTEMS.

N. Catalan Lasheras CERN, Geneva, Switzerland.

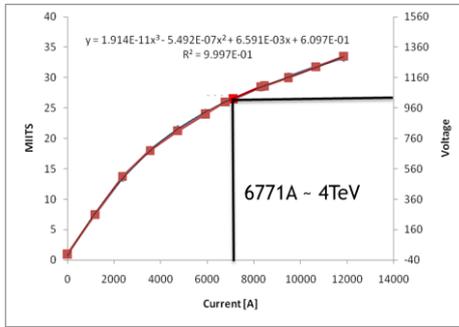
B30R7 insulation weakness [4]. During the qualification of the RB.A78 circuit, a breakdown appeared around 1.6 kV instead of the nominal qualification voltage of 1.9 kV. The insulation breakdown was localized inside the B30R7 dipole (MB1007) by the use of oscilloscopes [5]. The fault being inside the cold mass, there is no possibility to repair in-situ.

The qualification voltage is defined as the maximum operating voltage that the circuit might experience and has, for the case of the dipole circuit, two components. The first part (600 V) comes from the energy extraction resistance and the common mode voltage in the converter in case of short. This contribution is not energy dependent and cannot be reduced. Only a change in the energy extraction resistors and thus in the decay time for the RB circuit during a fast power abort will decrease the maximum voltage. This solution is however not considered safe until the splice consolidation has been done. The second part (1300 V) comes from the quench

development inside the coil and scales down with current and beam energy.

Figure 1: Simulated MIITS (A. Verweij) for the main arc dipole in LHC against current and the equivalent voltage developed in the coil.

Extrapolating from MIITS measurements in the main dipole (see Figure 1), a reduction of 300V in the voltage developed during a quench will mean a reduction of 3TeV. The maximum beam energy for which the use of this magnet is still safe is 4 TeV. Above that energy, the magnet should be replaced.

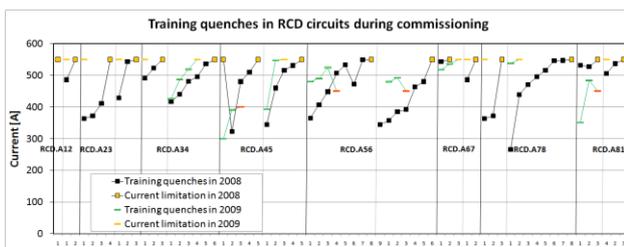
Training non-conformities. A number of circuits have experienced quenches during hardware commissioning. At the time of commissioning in 2009/2010, the training was stopped and the nominal current decreased to save time. There is however no reason why the circuits will not go to higher currents. Figure 2 shows the training of RCD circuits both in 2008 and 2009. In this particular case, every circuit containing 77 magnets experienced one to seven training quenches before reaching 550A. Still all of them reached nominal during the 2008 campaign.

Figure 2 Quench history of all RCD circuits during the hardware campaigns 2008 and 2009. (S. Le Naour)

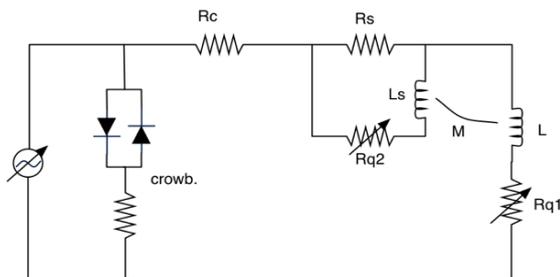
A possible explanation for this observation is a resistive short circuit between two layers in the coil. Figure 3 shows the schematic shorted circuit. Simulations with such model seem to confirm the observed behaviour. A test using a modified magnet with a set of extended instrumentation is scheduled for April in the new SM18 vertical cryostat facility. This will allow verifying this hypothesis.

Figure 3: Electrical schematic of a dipole corrector in which one group of coils will be short-circuited. The final configuration would include two independent coils with a mutual inductance.

Unfortunately, the current in these circuits cannot be raised. If stronger correction is needed at any beam energy, new cryo-magnets should be put in the machine or additional warm correctors should be added. Both solutions will only be possible during a long shut-down period.
