***Chamonix 2011 LHC Performance Workshop,
Session 04: Beam Energy***

**Consequences of a hypothetical
incident for different sectors
(with beam energy up to 5 TeV)**

Laurent Tavian

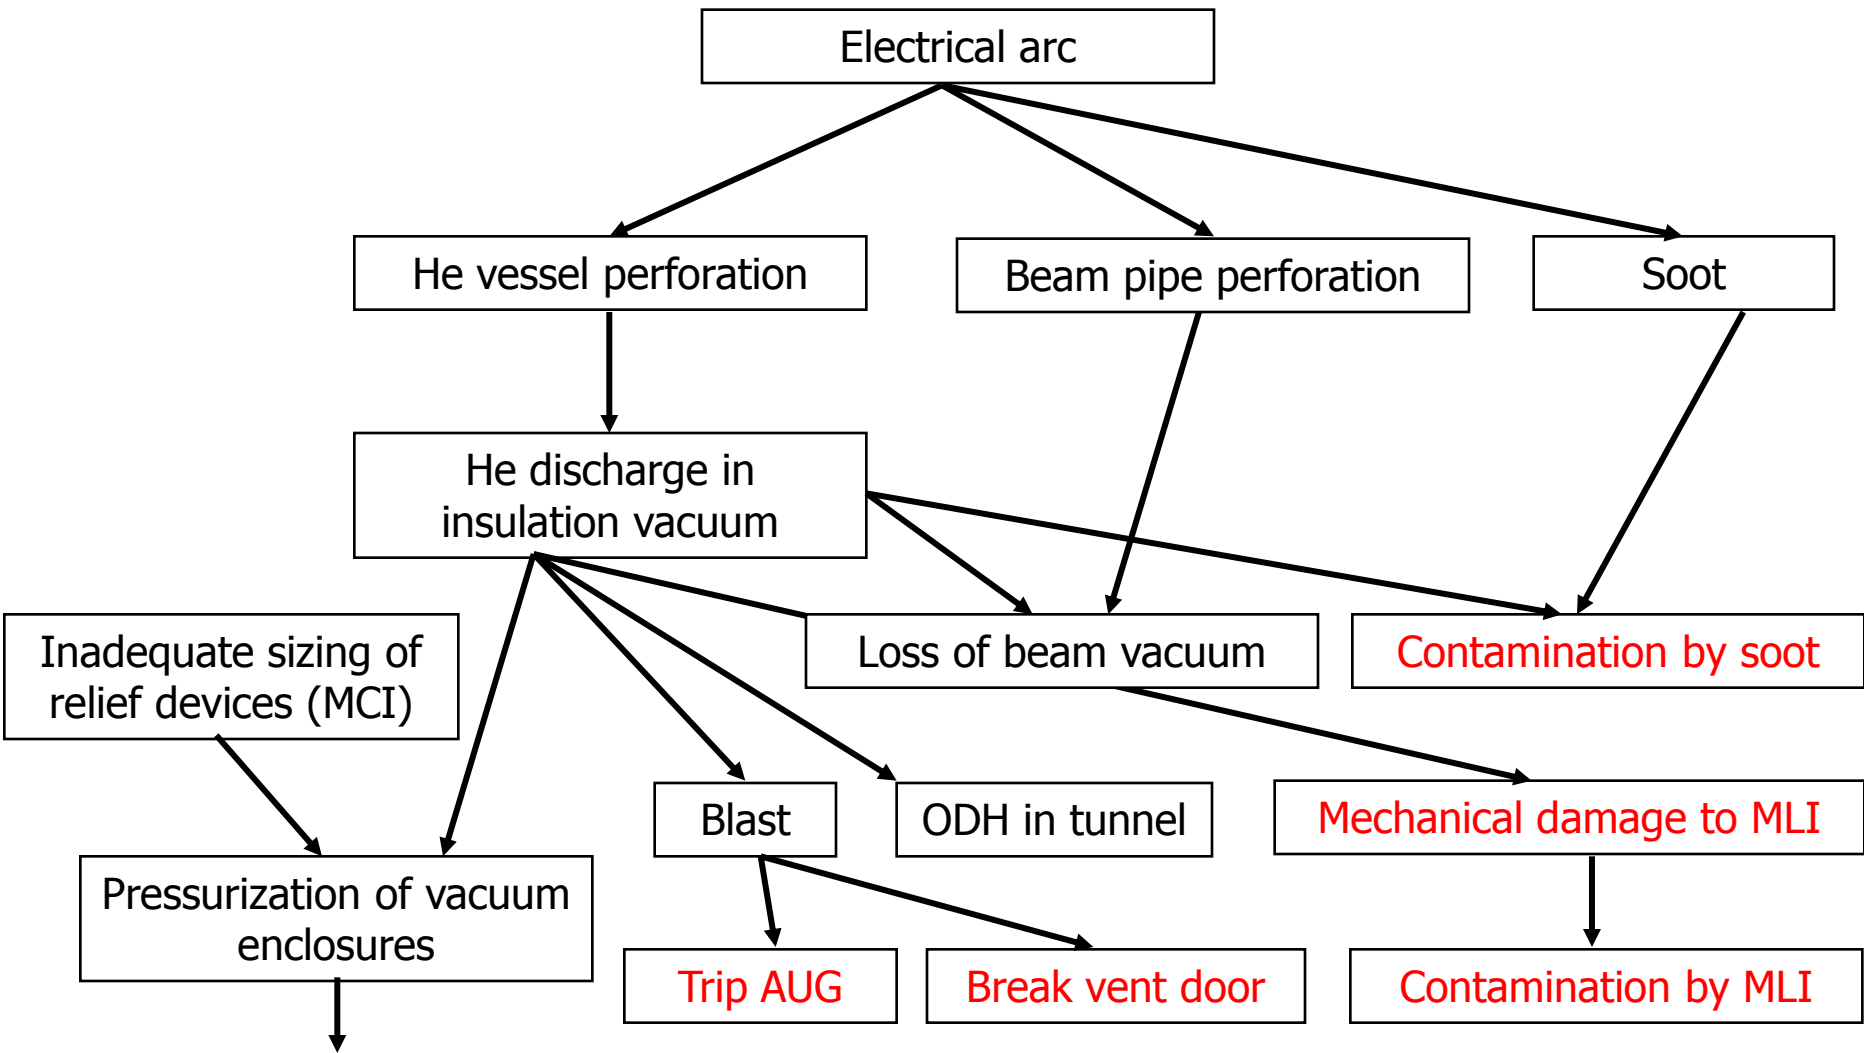
Cryogenic effects [1/2]

Fault tree of 19 Sept 2008 incident at the LHC

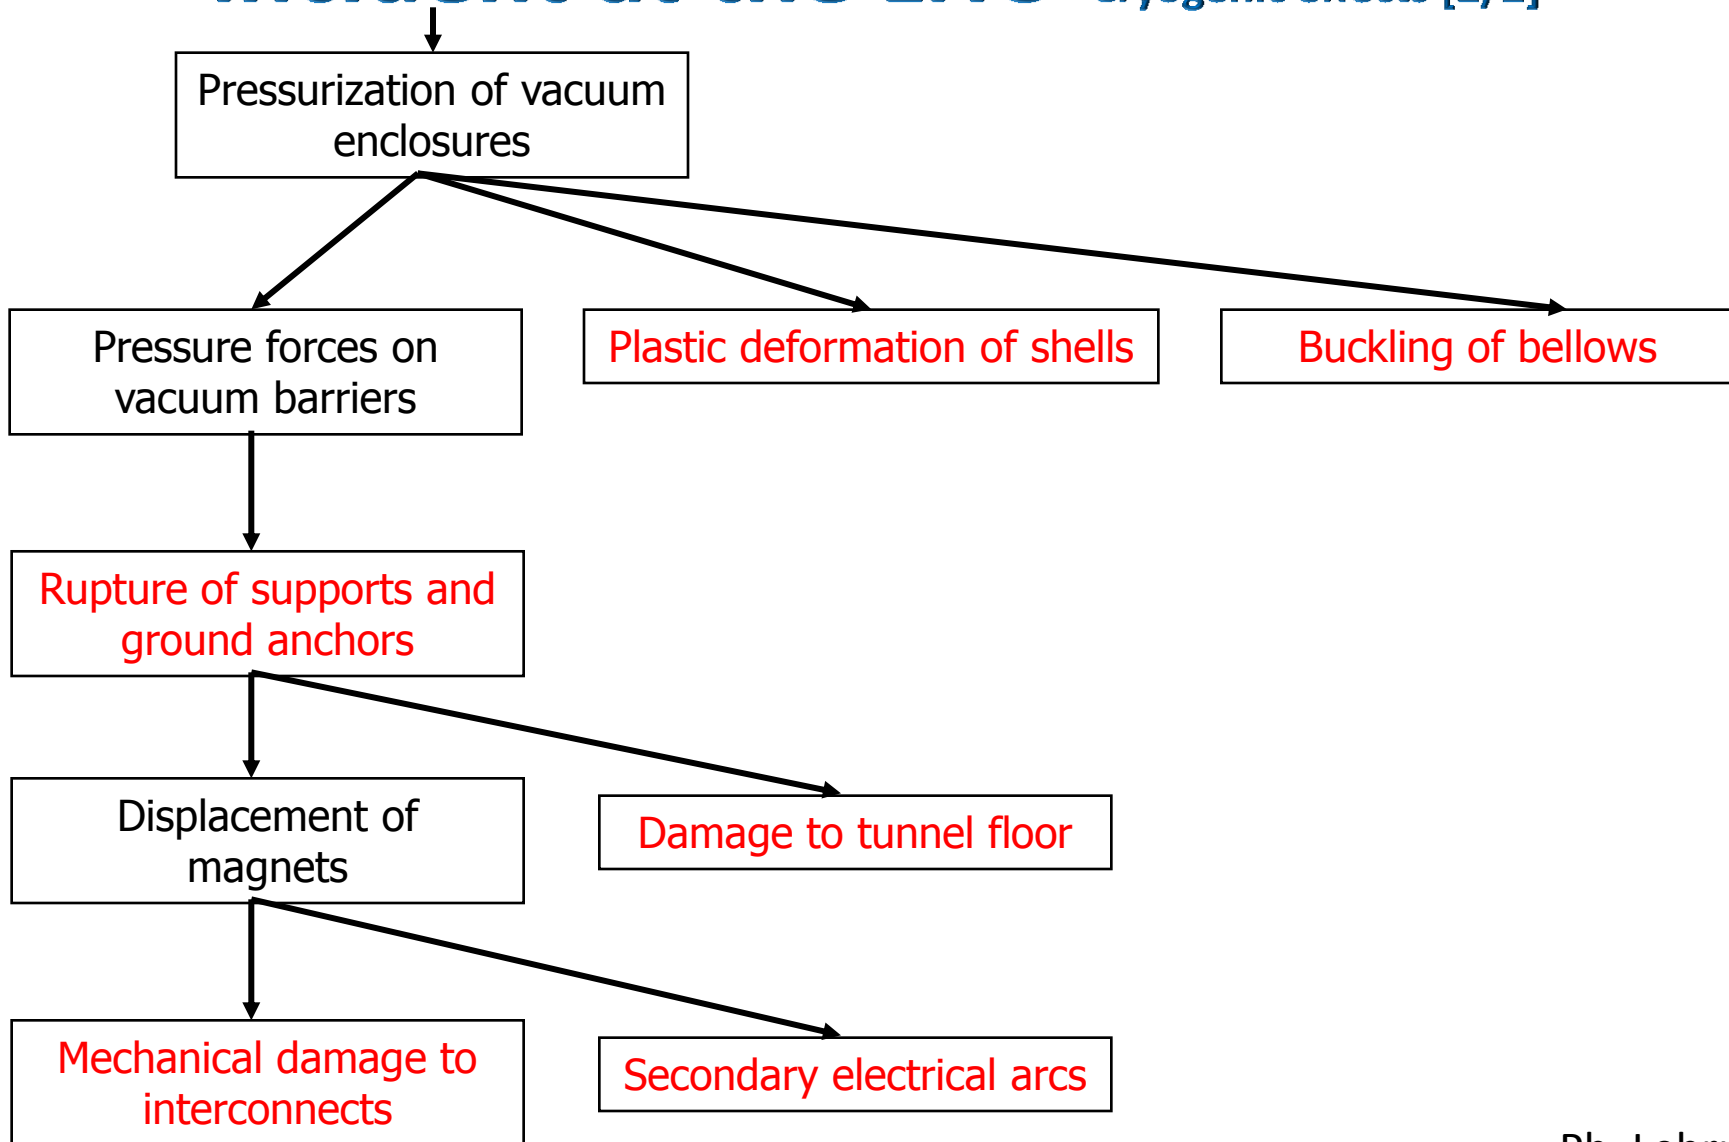
Cryogenic effects [2/2]

Fault tree of 19 Sept 2008 incident at the LHC

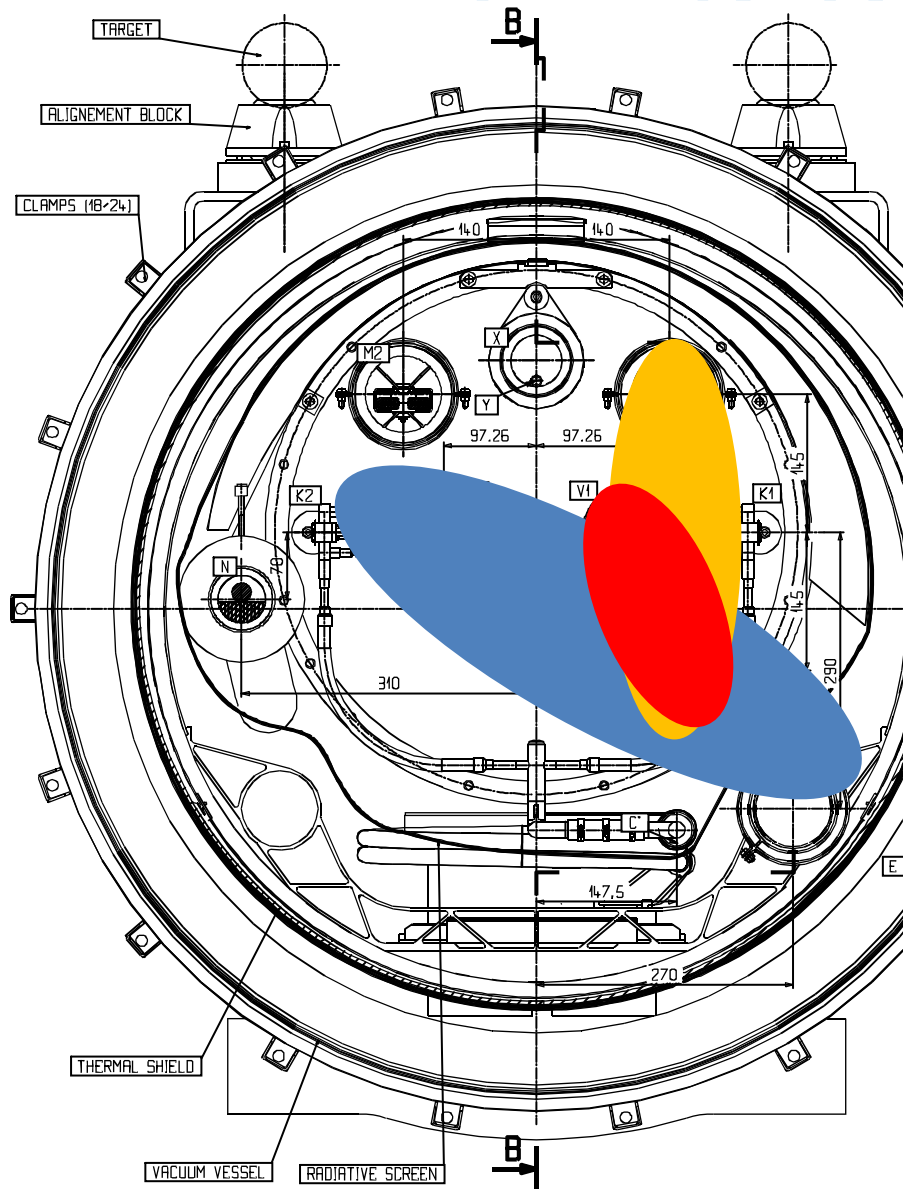
MCI in case of electrical arc in an interconnect

With “smaller” electrical arc (i.e. lower magnetic stored energy and/or lower discharge time constant), perforation of the beam pipe can not be excluded with the present consolidation status. (Electrical insulation of the beam pipe interconnect foreseen in 2013/12)

080919 accident
 (~ 5 TeV)

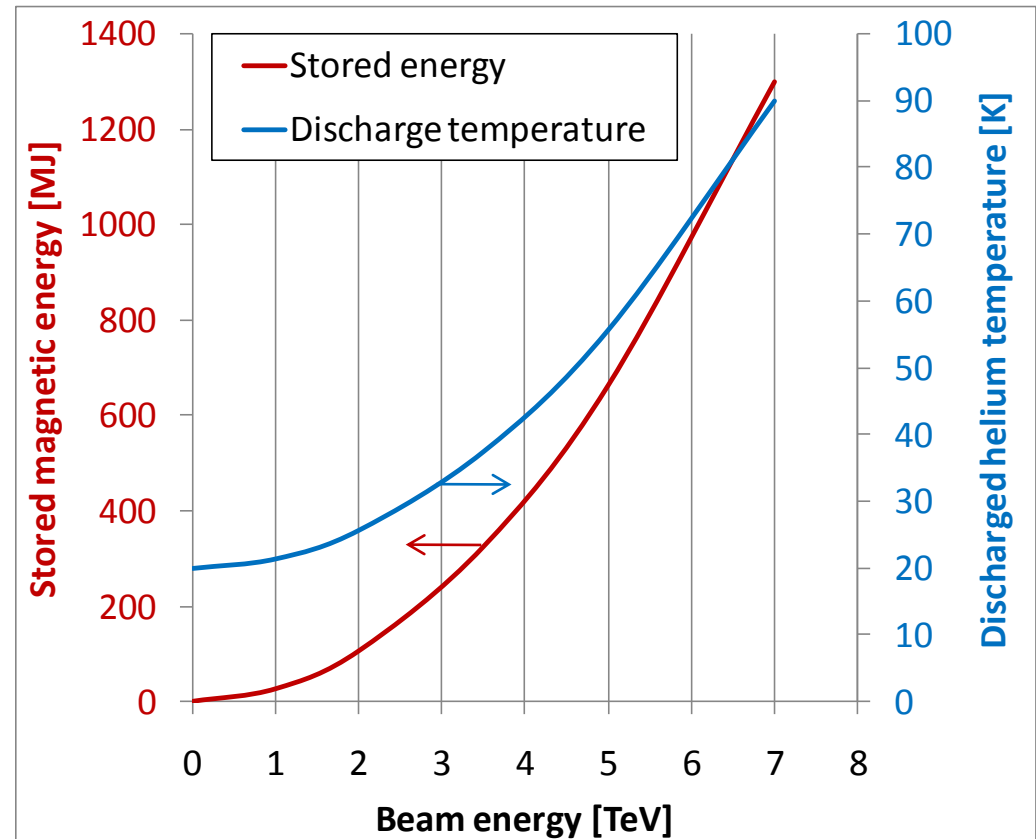
Discharge conditions through safety devices vs beam energy

- Mass flow \rightarrow MCI flow (already at 3.5 TeV, an electrical arc is able to create the MCI breaches ($2 \times 60 \text{ cm}^2$)), e.g. 30 kg/s in the continuous cryostat.
- Temperature of helium heated by the electrical arc power and discharged through the safety devices depends on:
 - the stored magnetic energy
 - The current discharge time constant
 - The heat transferred by convection from the environment.

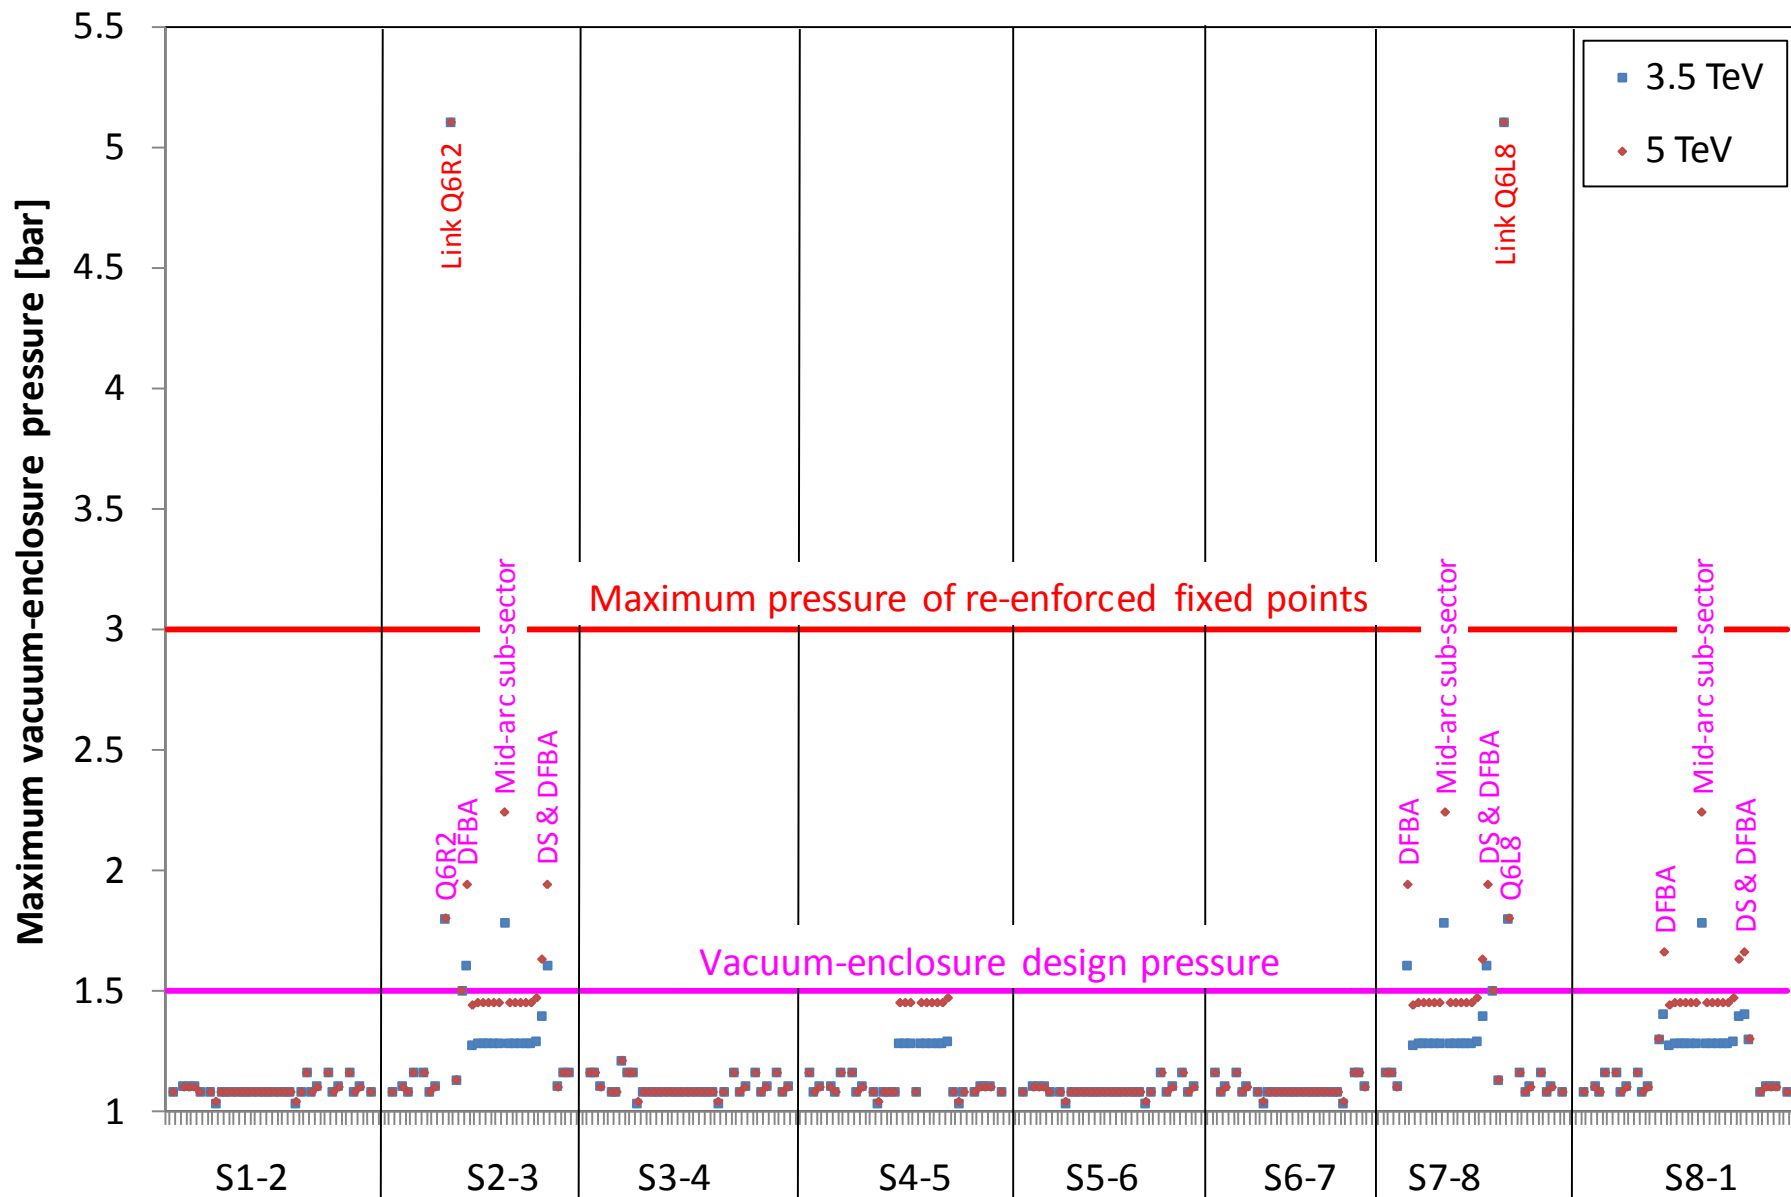
Maximum pressure build-up in vacuum enclosure

Vacuum sub-sector	P max [bar]		Remarks
	3.5 TeV	5 TeV	
Link Q6R2 & Q6L8	5.1	5.1	Compatible with vacuum enclosure design margin (DN200 link)
Q6R2 & Q6L8	1.8	1.8	Compatible with vacuum enclosure design margin
Mid-arc S2-3, S7-8 & S8-1	1.8	2.3*	Compatible with vacuum enclosure design margin and re-enforced fixed points on SSS
DFBA HCM R2, L3, R7 & L8	1.6	2.0	Compatible with vacuum enclosure design margin and re-enforced fixed points on DFBA
DFBA HCM R8 & L1	1.4	1.7	Compatible with vacuum enclosure design margin and re-enforced fixed points on DFBA
DS L3, L8 & L1	1.4	1.6	Compatible with vacuum enclosure design margin and re-enforced fixed points on SSS and DFBA

*: Above 1.9 bar, plastic deformation of SSS vacuum barrier could occur (pressure test under preparation)

Conclusion: Up to 5 TeV, no longer mechanical collateral damages in adjacent sub-sectors!

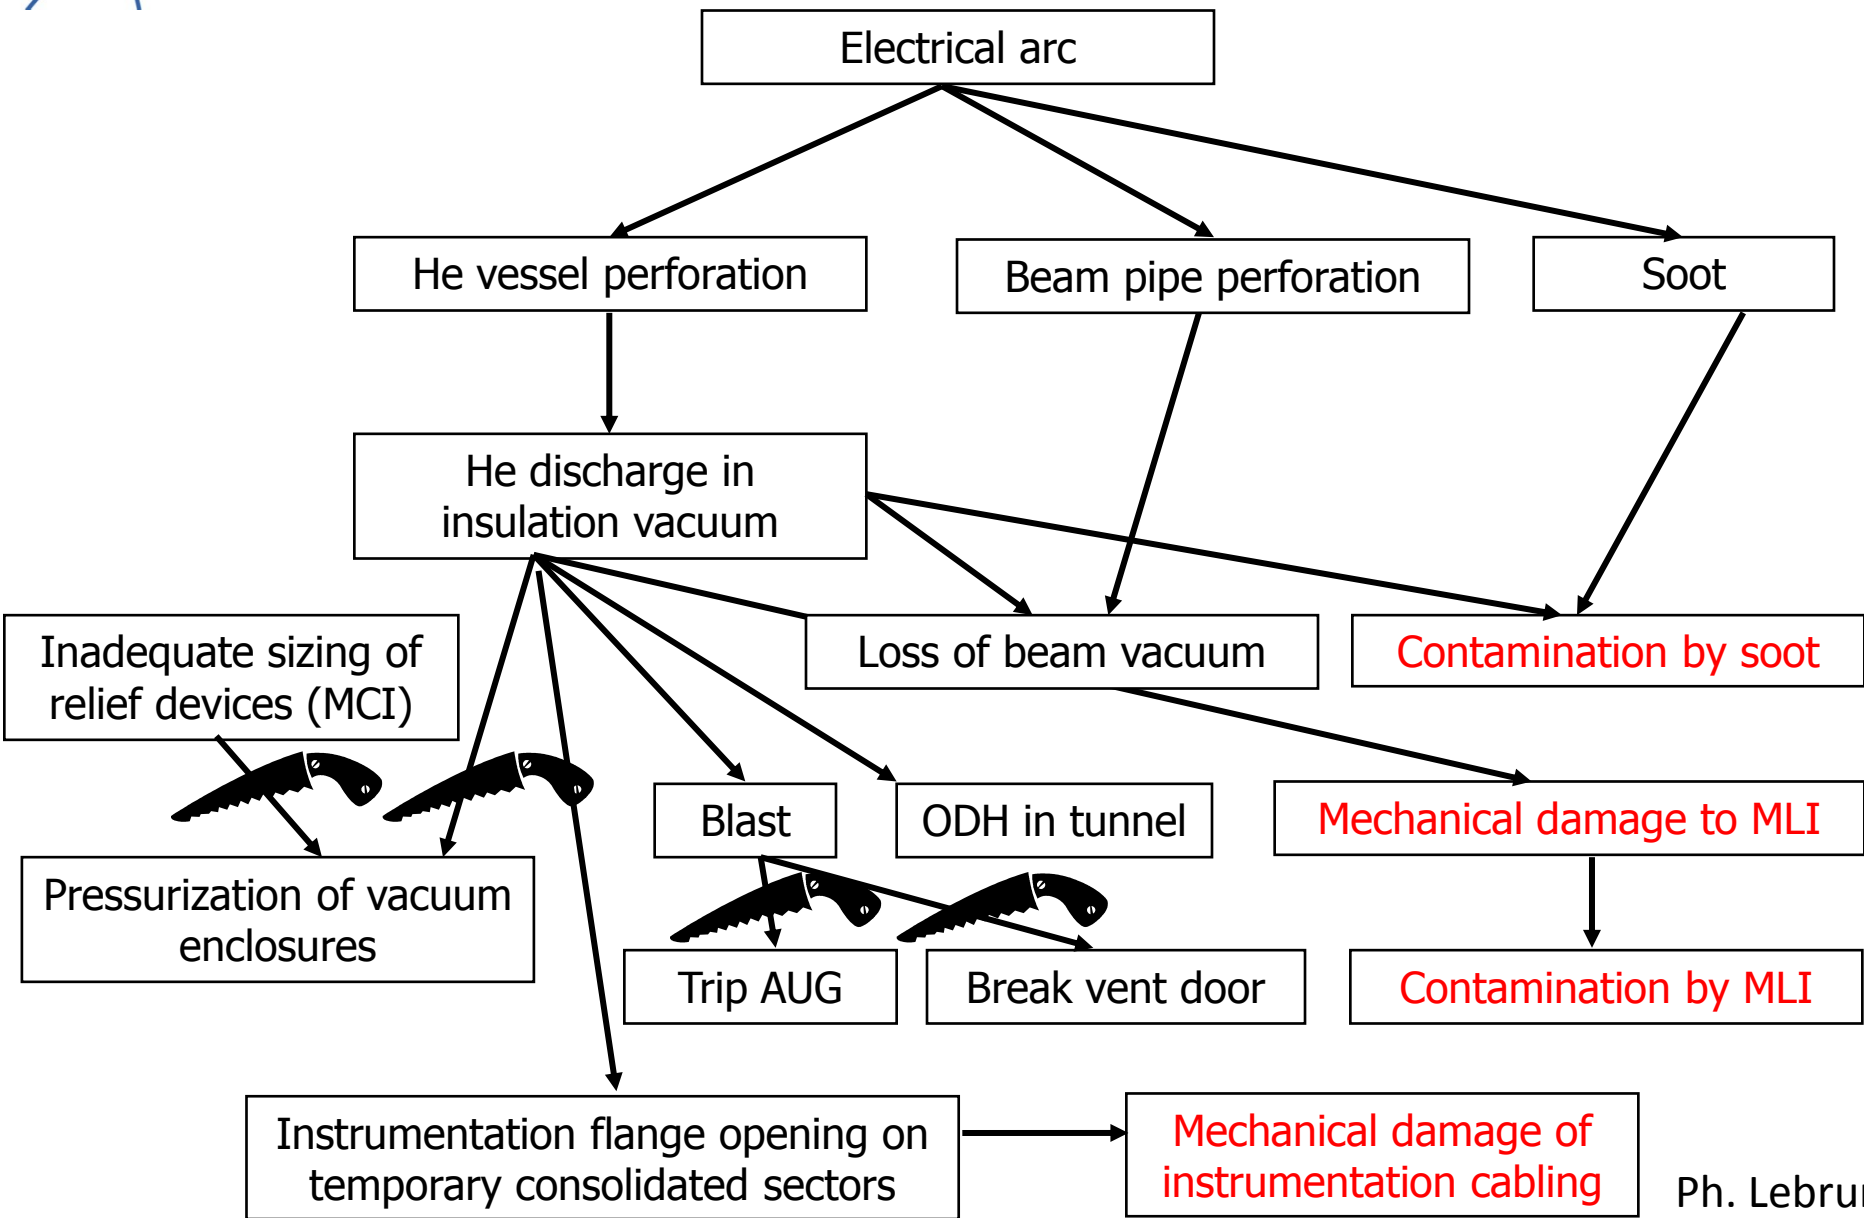
Updated fault tree up to 5 TeV

- Sept'08 damages which are mitigated by the 2009 consolidations:
 - Plastic deformation of shells
 - Buckling of bellows
 - Rupture of supports and ground anchors
 - Damage to tunnel floor
 - Mechanical damage to interconnects
 - Secondary electrical arcs
- Damages still present up to 5 TeV
 - He vessel and beam pipe perforation
 - Mechanical damage of MLI
 - Contamination by soot of MLI and beam pipes
 - Contamination by MLI of vacuum enclosure and beam pipes
 - Mechanical damage of BPM cabling

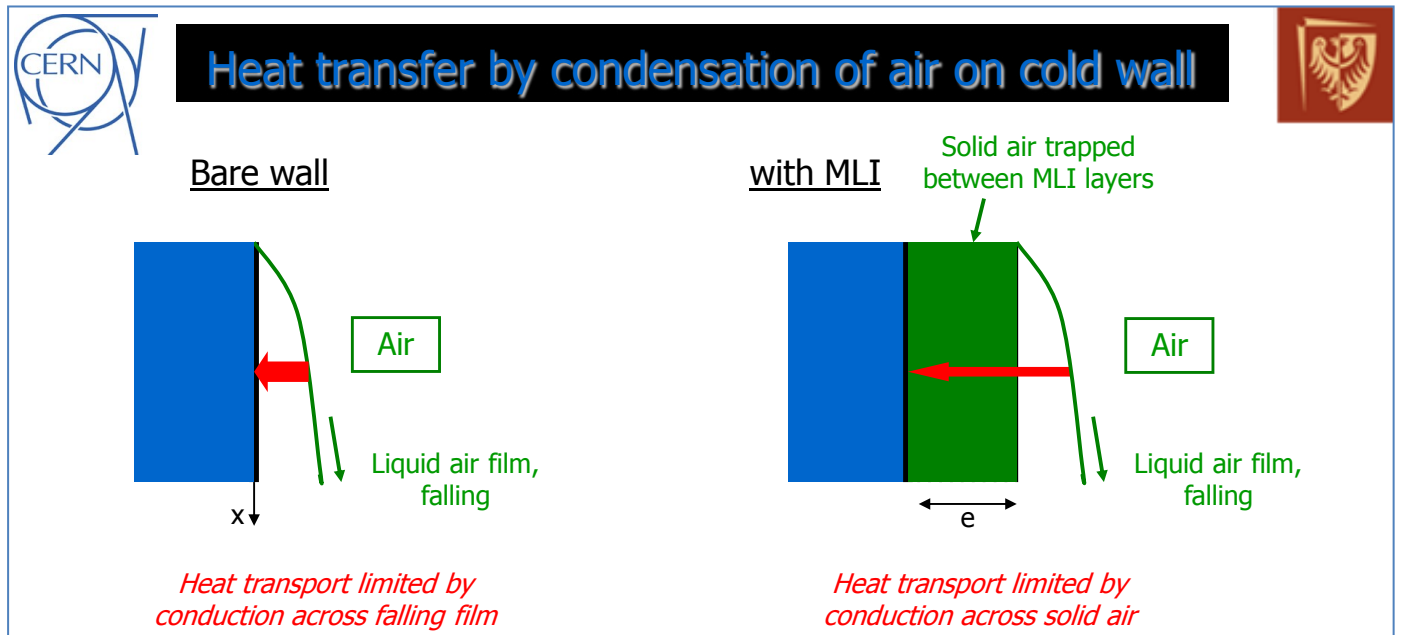
Mechanical damage of MLI (1)

- Without MLI, cold mass enclosure are not protected against pressure build-up in case of break of the insulation vacuum with air.

Not compatible with the cold-mass pressure relief system !

- From a calculation by Nusselt
 - $h \approx 0.943 (\rho^2 g k^3 L_v / \eta \times \Delta T)^{0.25}$
- Assimilating air to nitrogen
 - $h \approx 680 \text{ W/m}^2 \text{ K}$
 - heat flux $h \Delta T \approx 50'000 \text{ W/m}^2$
 - average thickness of film $\approx 0.2 \text{ mm}$
- Multi-layer insulation
 - take $e = 10 \text{ mm}$
- Conduction in solid nitrogen
 - conductivity integral from 77 to 4 K $\approx 50 \text{ W/m}$
 - Heat flux $h \Delta T \approx 5'000 \text{ W/m}^2$

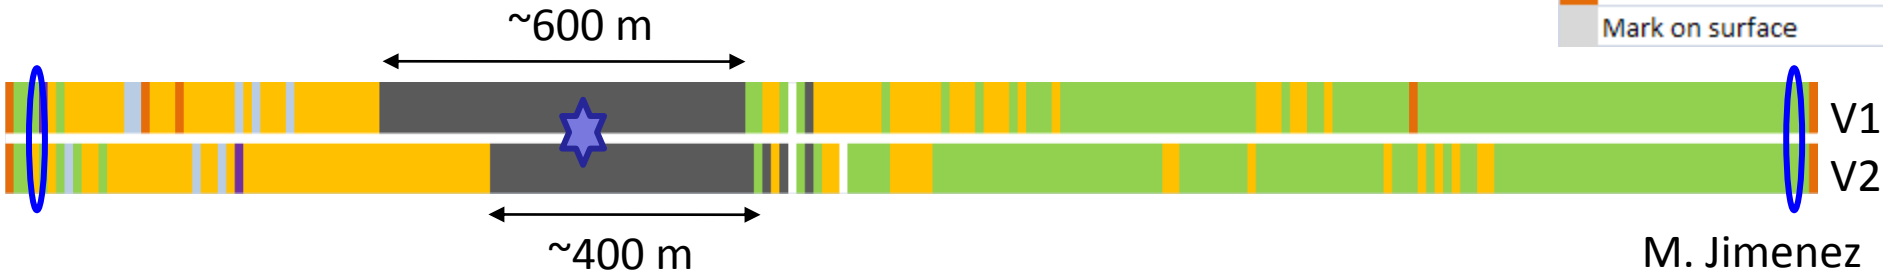
Contamination by soot of beam pipes: Affected length?

- Experience return from S3-4
 - V1 more representative (not burst disk opening)
 - In V1 about 600 m contaminated with soot
 - Pressurization: up to 3.5 bar

- New incident expectation: Affected length is assumed to be proportional to the quantity of soot introduced:
 - For most sub-sectors, pressurization limited to 1.1-1.5 bar:
 - quantity of soot introduced in the beam pipes divided by 2.3 to 3
 - **250 to 200 m of magnet could be affected**
 - For the specific mid-arc subsectors (3/8), pressurization limited to 1.8 -2.3 bar:
 - quantity of soot introduced in the beam pipe divided by 2 to 1.5
 - **300 to 400 m of magnet could be affected**

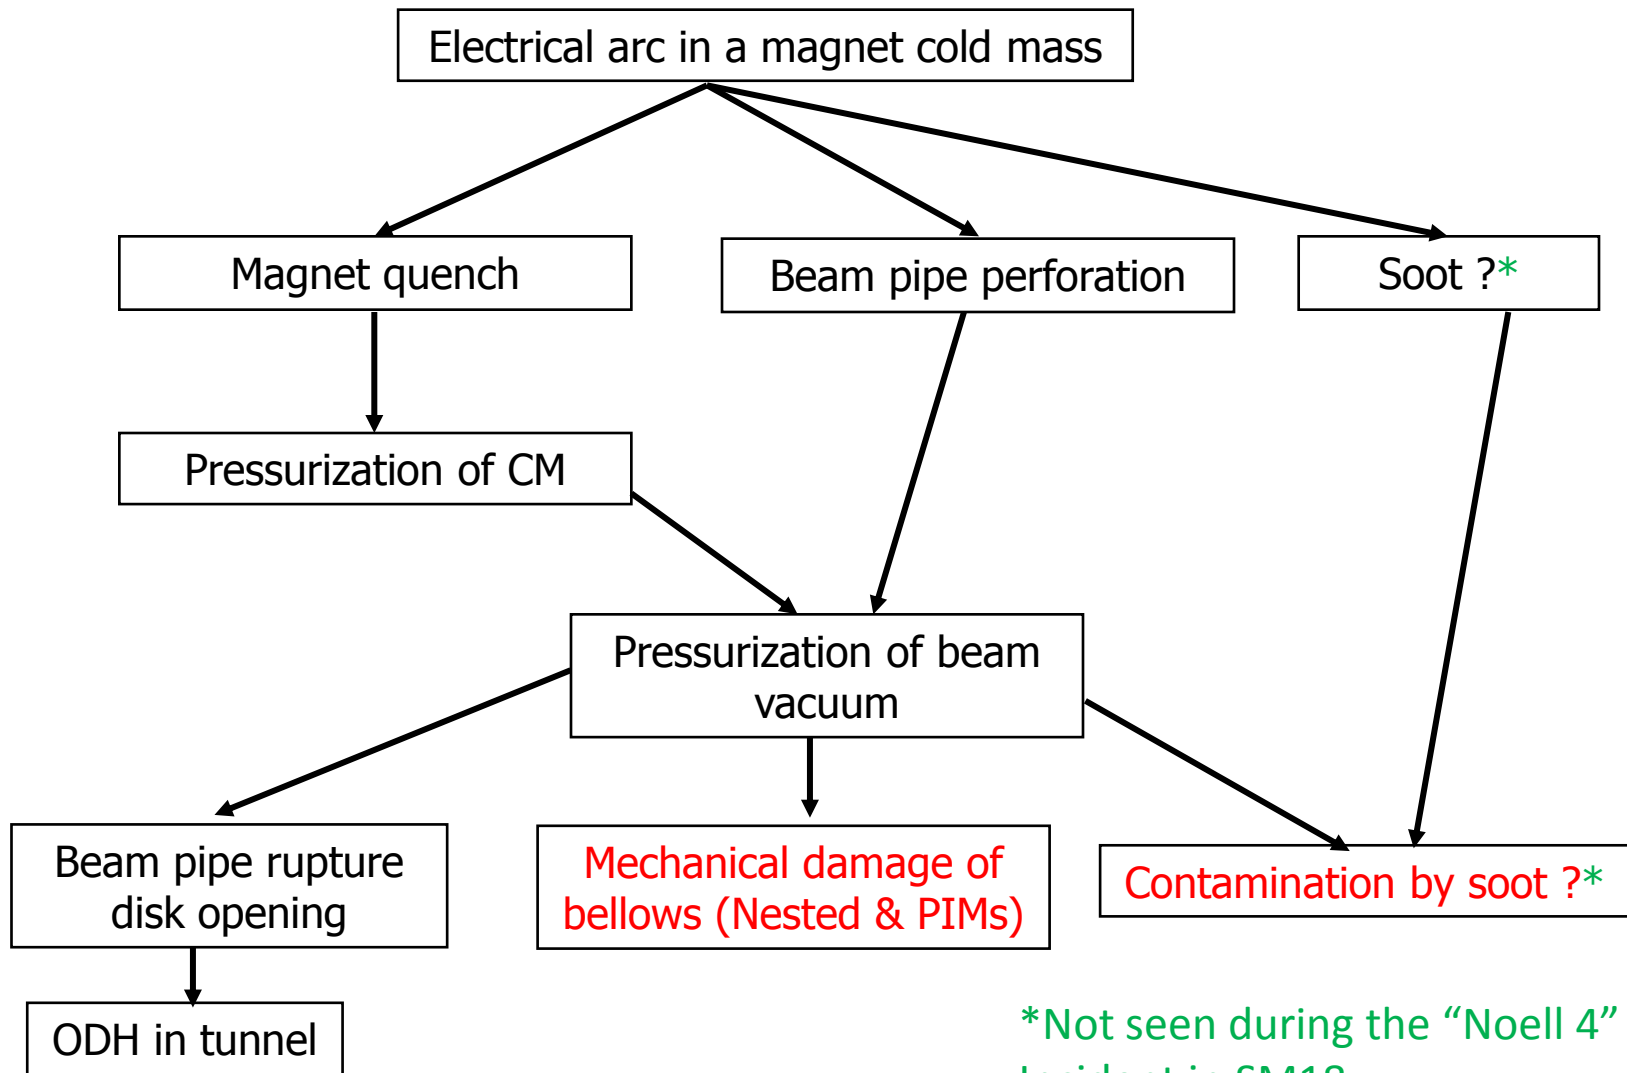
Fault tree of an electrical arc in magnet coil

(caused by a short circuit or by a catastrophic beam loss)

*Not seen during the "Noell 4" Incident in SM18

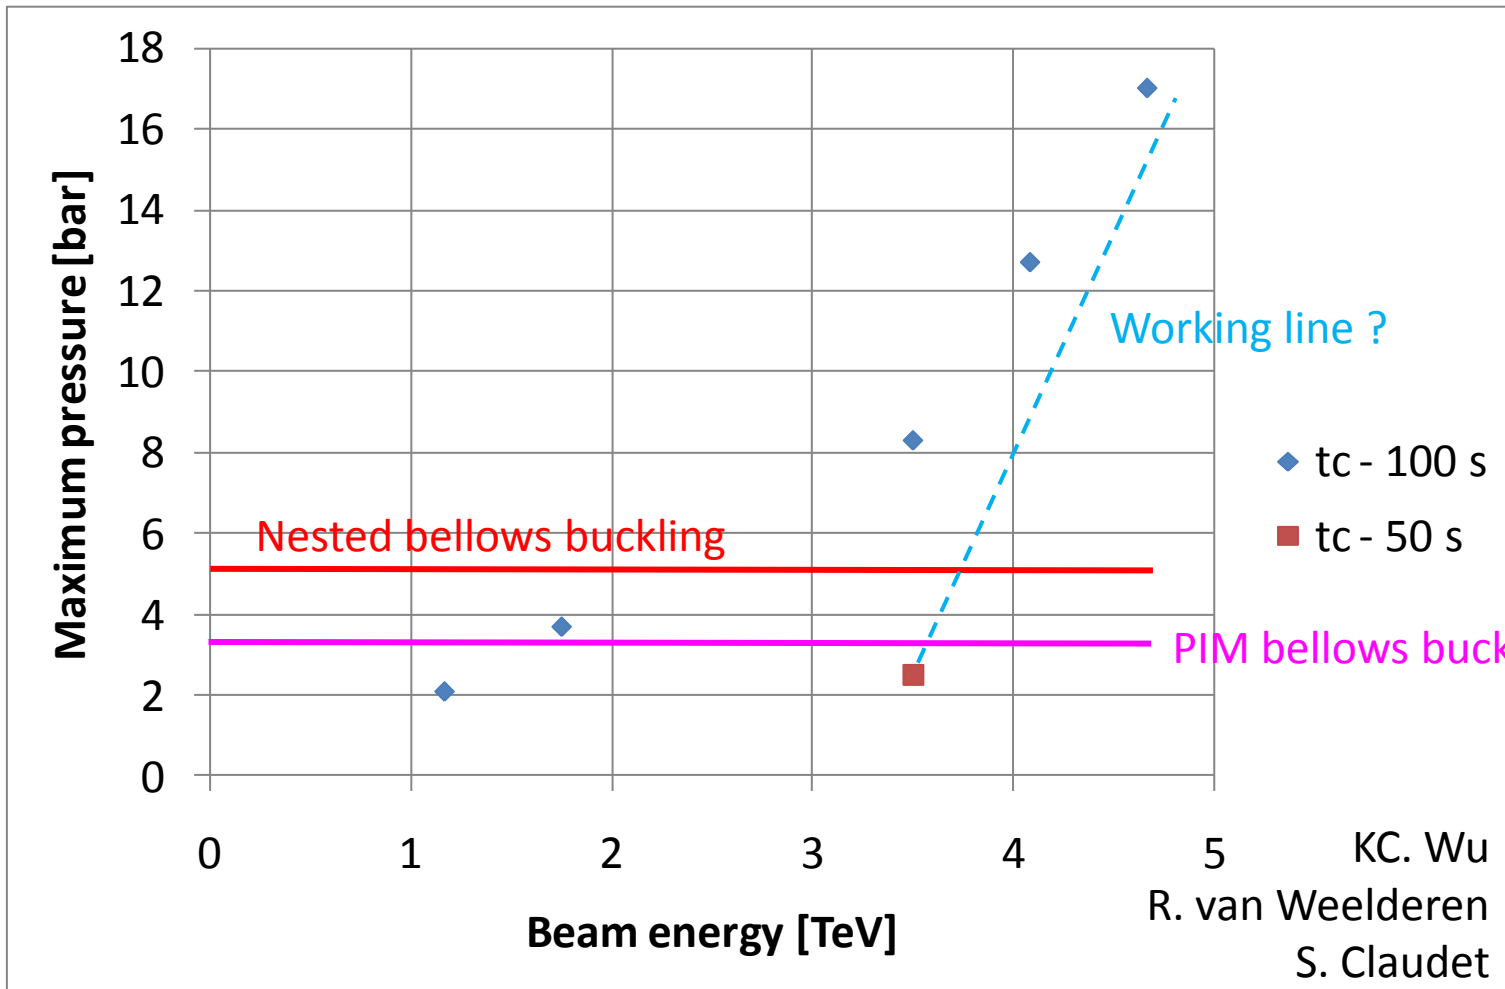
Maximum pressure following a dipole quench (measurements)

- Beam pipe perforation of a single magnet (Reminder: the downtime for a single dipole exchange is about 4 months)
- Plastic deformation (rupture ?) of nested & PIM bellows:
 - No damage at 3.5 TeV (with 50 s time constant)
 - Could become critical above 3.5 TeV especially if we increase the discharge time constant.
 - PIMs can be repaired in-situ
 - Nested bellow repair requires magnet removal.
