# **QPS - analysis of main problems, areas to target, possible improvements**

R. Denz, TE-MPE-CP

Evian 2011

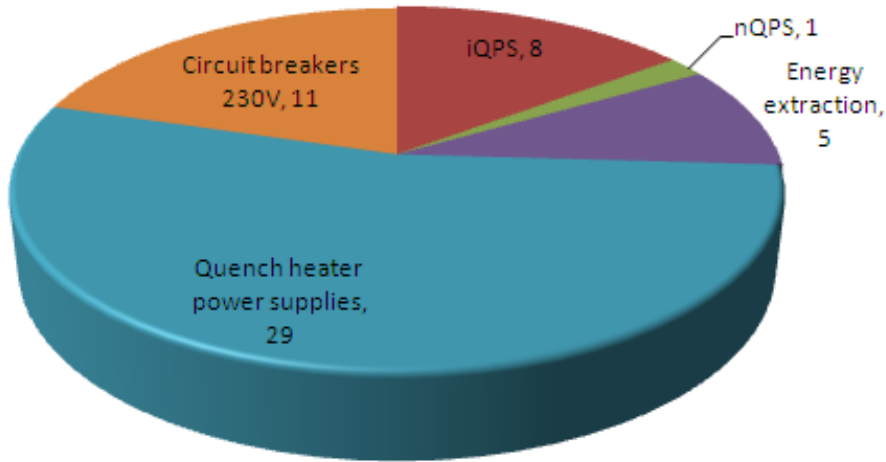
QPS and QPS related hardware faults causing interventions (54 outside TS).

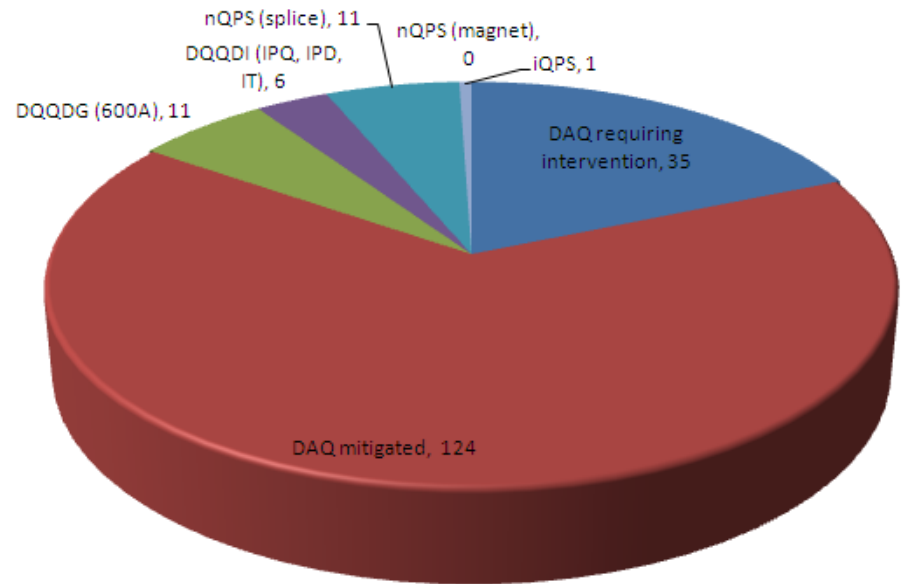
QPS radiation induced faults (190).

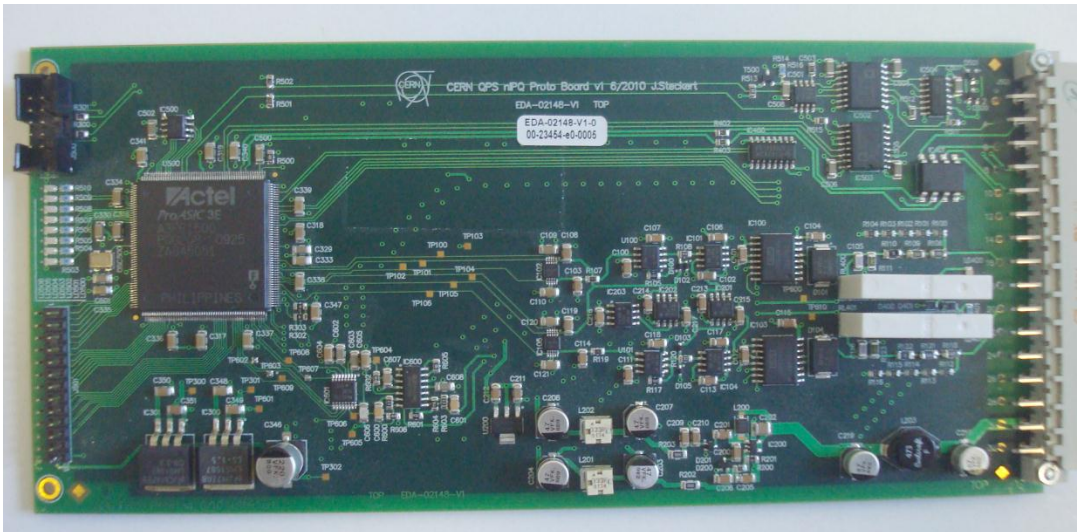
- ➔ New digital quench detection systems type nDQQDI
  - Similar to symmetric quench detection board developed for nQPS
    - Core is flash based FPGA ProAsic™ A3PE1500
  - Board design and firmware development by J. Steckert
  - New board is (of course) not fully compatible with previous version
    - Some specialist work required to integrate it into QPS supervision
  - 200 boards including spares required for consolidation (starting 2012)
    - UJ14,16,56, RR13,17,53,57

Prototypes are currently under test and the series production will be launched early 2012.
