# QPS - ANALYSIS OF MAIN PROBLEMS, AREAS TO TARGET, POSSIBLE IMPROVEMENTS

R. Denz on behalf of the QPS team, CERN, Geneva, Switzerland

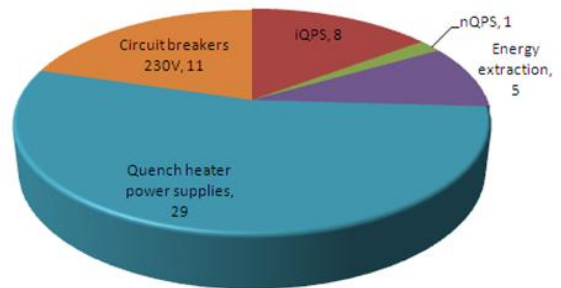
The hardware failures were mostly related to a malfunction of the quench heater discharge power supplies.

Figure 1: Hardware failures of QPS and energy extraction systems reported during LHC operation in 2011.

The principal cause of failure of the quench heater discharge power supplies is related to a malfunction of the mains switch. The fault is provoked by the mechanical breakdown of one of the plastic materials used for the construction of the switch, most likely due to an excess of hardener in its composition. A repair campaign has been launched in 2010 with the objective to replace all 6076 faulty switches during technical stops of the LHC until spring 2012. At the time of writing this mission has been accomplished [4].

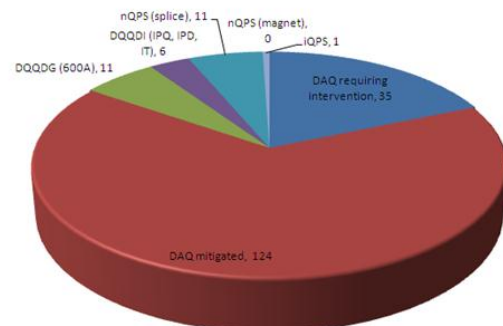
Figure 1 and 2 summarize the basic fault statistics focussing on hardware failures and radiation induced faults; the latter ones basically determining the fault rate in the 2<sup>nd</sup> half of year 2011.

Figure 2: Radiation induced faults during the 2011 LHC proton run.

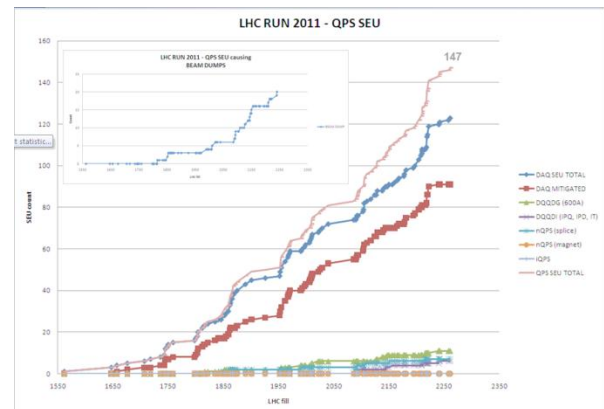
Figure 3: Radiation induced fault statistics for the LHC proton run 2011.

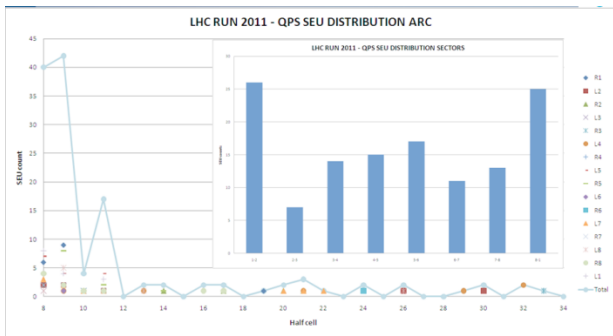
Figure 4: SEU distribution in the regular arc during the LHC proton run 2011.

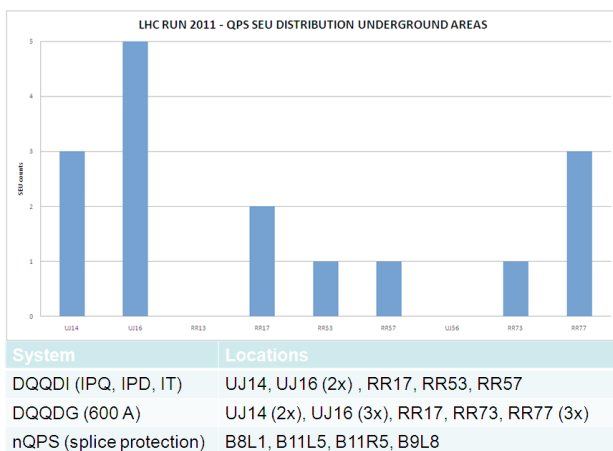
Figure 5: SEU distribution in the LHC underground areas during the LHC proton run 2011.

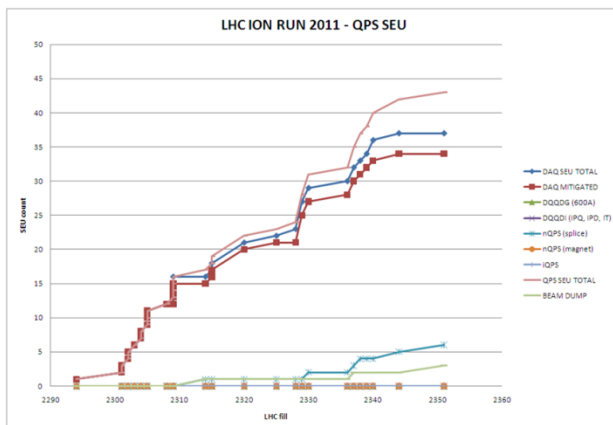
Figure 6: Radiation induced fault statistics for the LHC ion run 2011.

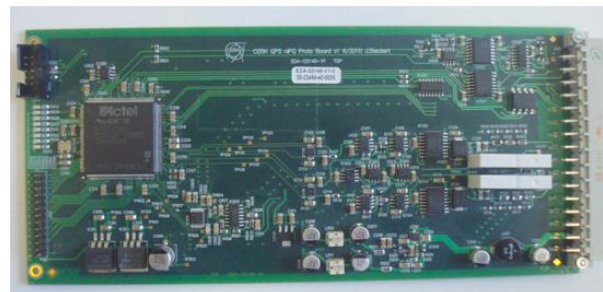
Figure 7: Radiation tolerant FPGA based quench detection board for the protection of insertion region magnets.

The radiation exposed quench detection systems for the insertion region magnets will be upgraded to a radiation tolerant design using flash based FPGA ProAsicA3PE1500™ (see figure 7). The new systems are similar to the symmetric quench detection board type already successfully being exploited in the LHC. The production of 200 boards will be launched in February 2012 and the installation in the LHC underground areas UJ14, 16, 56 and RR13, 17, 53, 57 is foreseen to be completed by June 2012 (technical stop 2).

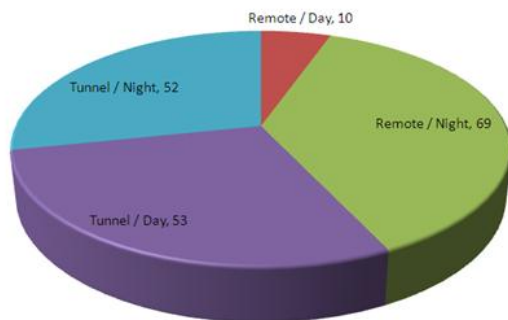
Intensive training and growing experience of the team members allowed reducing the average time for an intervention in the LHC from 2.3 hours in 2010 to 1.3 hours in 2011[8].

Figure 8: Interventions of the TE-MPE standby service during the LHC run 2011.
