LHC Beam Operation workshop - Evian 2011

Injection and Dump System

W. Bartmann, M.J. Barnes, C. Bracco, E. Carlier, B. Goddard,
V. Kain, M. Meddahi, V. Mertens, J. Uythoven, L. Drosdal

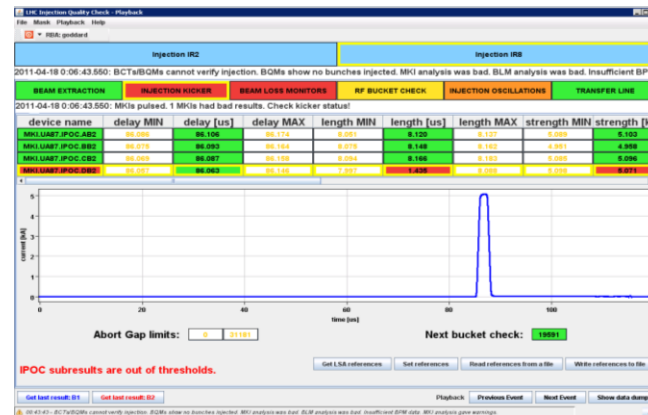
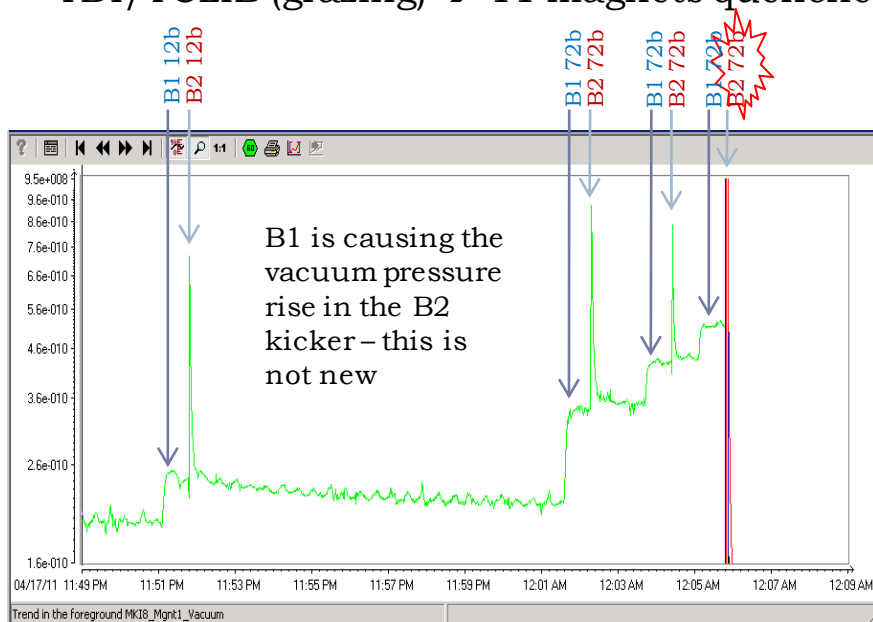
MKI Flashover 18/04/2011

- Injection of 2×36 bunches spaced by $2.2 \mu\text{s}$
 \rightarrow Breakdown after $\sim 2 \mu\text{s}$ \rightarrow All 36b of 2nd batch were kicked with 110-125% nominal MKI deflection
- Beam was on LOWER TDI jaw and over-kicked, i.e. breakdown in second half of magnet (LHCb signals support this)
- Nearly all p+ of the 36b impacted on the TDI/TCLIB (grazing) \rightarrow 11 magnets quenched

- MKI HW vacuum interlock** reduced from $5\text{e-}8$ mbar to **$2\text{e-}8$ mbar**
- New **SIS** to **prevent injection** if **MKI pressure** **$>2\text{e-}9$ mbar** for 50 ns beam (temporary **$>2.5\text{e-}9$ mbar** for scrubbing with 25 ns beam)
- Checked carefully **TDI angular alignments** in IR2 and IR8

- TCLI openings** \rightarrow **TCLIB to 8.3σ**
- New Fixed Display in CCC with MKI pressures
- Solenoids between MKI and Q4/A5 switched ON

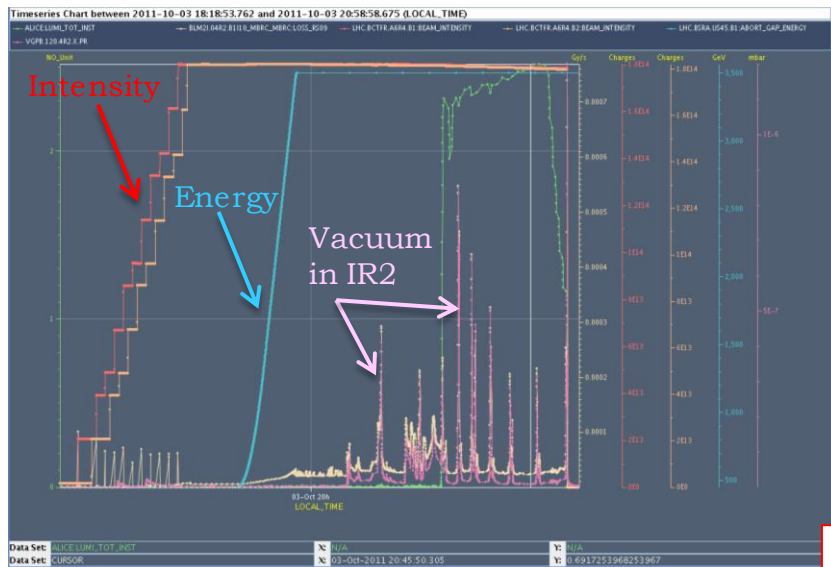
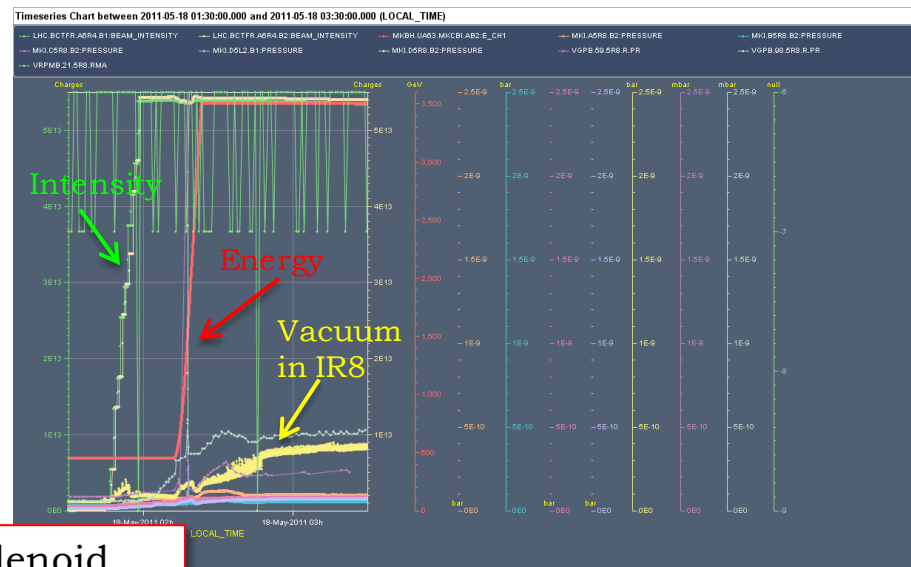
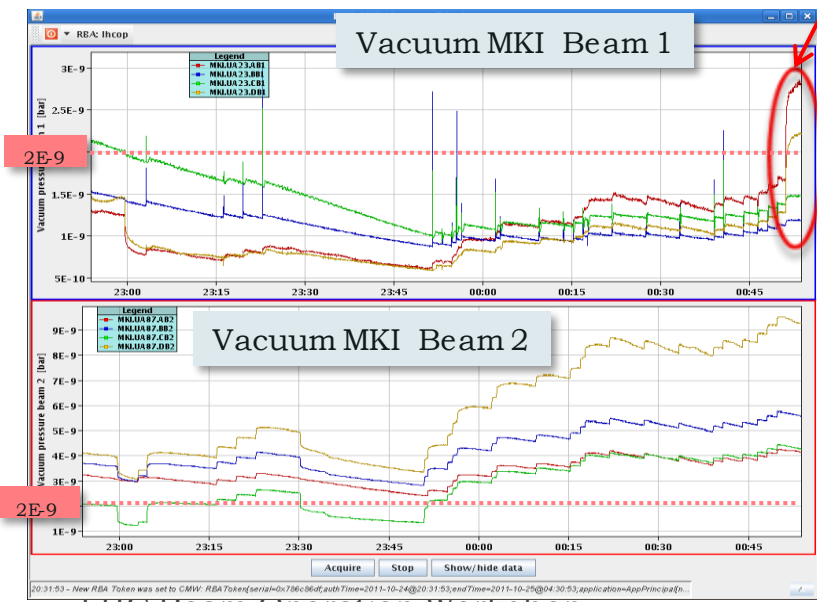
MKI Vacuum Activity

Solenoid switched off

To avoid possible vacuum/breakdown problems with the MKIs, solenoids:

- ▶ ON during normal operation
- ▶ OFF during scrubbing provided pressure does not become too high (respect SIS injection interlock)
- ▶ In future, possible to include a $\int P \cdot dt$ interlock (under study)

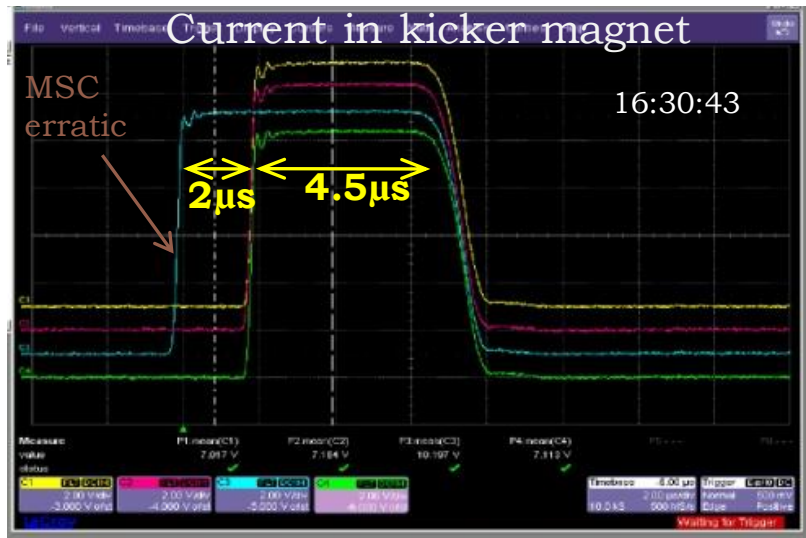
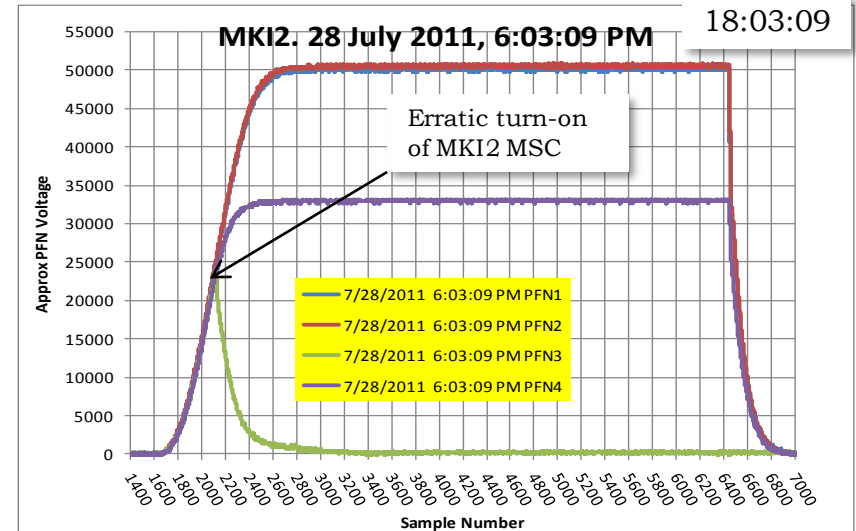
MKI Erratics on 28/7/2011

- Interlocks detected an MSC erratic and correctly triggered MS's and DS's of system (within $2\mu\text{s}$), emptying PFN via both ends.
- Hence **kicker-C** pulsed for **$6.5\mu\text{s}$** and **3 other kicker magnets pulsed** for up to **$4.5\mu\text{s}$** , emptying PFNs of energy.
- **Circulating beam was not in IP2** and therefore not disturbed.
- **Batch was extracted from SPS** but saw no kick at MKI2 (current already back to zero in all magnets) and went **straight into the TDI upper jaw**.

- Erratic of MKI2 MSC at 33kV **during resonant charging** – sending current to one of the four kicker magnets
- **Interlocks did NOT detect erratic** of MS3: hence no immediate action was taken to turn-on other thyratrons → **full $9\mu\text{s}$ PFN pulse length to kicker C**.
- Failure $\sim 500\mu\text{s}$ into charging process: **extraction from SPS correctly inhibited**;
- Circulating beam was swept over aperture and grazed TDI (**$\sim 17\%$ of normal kick**) for **$\sim 8-9\mu\text{s}$** → **150-190 bunches**

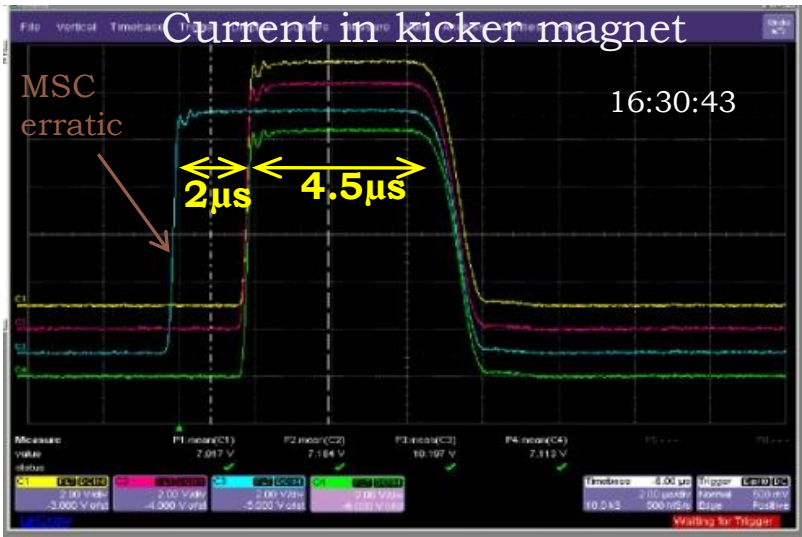
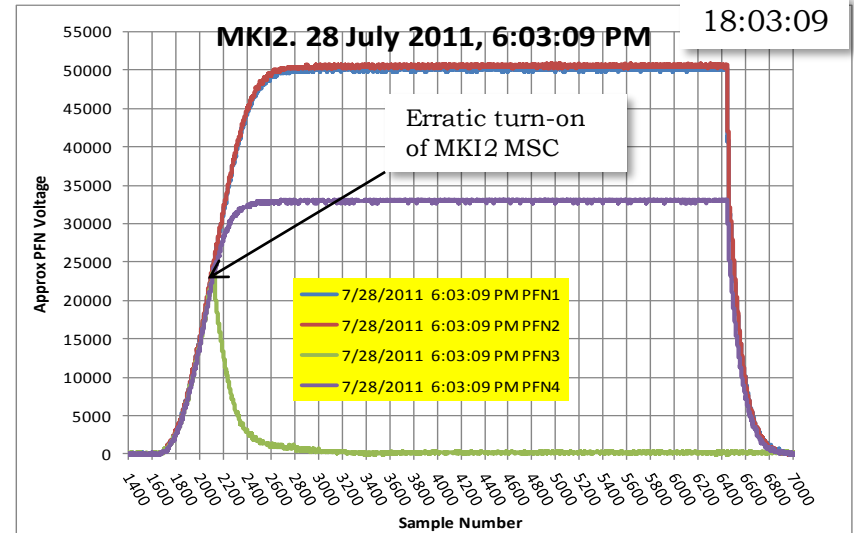
MKI Erratics on 28/7/2011

- Interlocks detected an MSC erratic and triggered MS's and DS's of system (with emptying PFN via both ends.
- Hence **kicker-C** pulsed for **6.5µs** and **kicker magnets pulsed** for up to **4.5µs** of energy.
- **Circulating beam was not in IP2** and therefore not disturbed.
- **Batch was extracted from SPS** but saw no kick at MKI2 (current already back to zero in all magnets) and went **straight into the TDI upper jaw**.

- Erratic of MKI2 MSC at 33kV **during resonant charging** – sending current to one of the four magnets
- **did NOT detect erratic** of MS3: reaction was taken to turn-on **all 9 µs PFN pulse length**
- **SPS correctly inhibited;**
- Circulating beam was swept over aperture and grazed TDI (**~17% of normal kick**) for **~8-9µs → 150-190 bunches**

Hardware problem → faulty components exchanged + additional diagnostic + faster detection electronics with lower voltage threshold

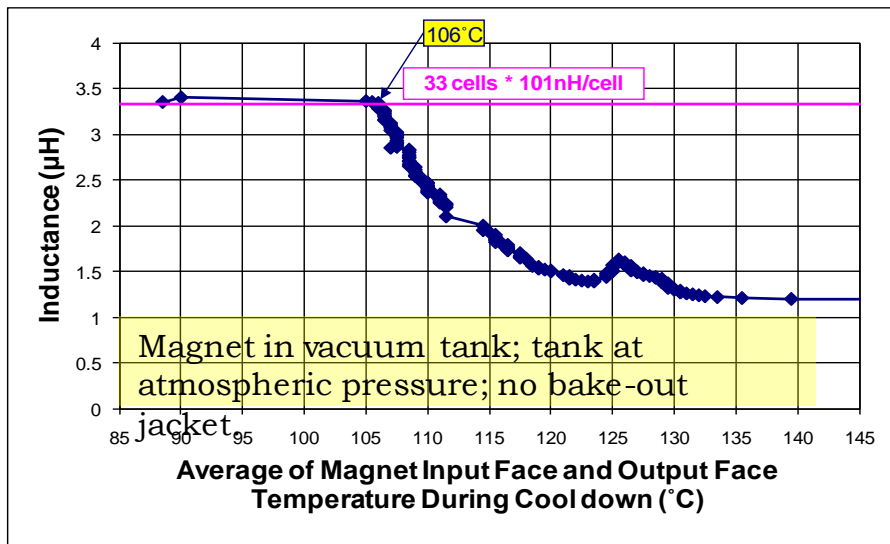
MKI Temperature Interlock

Ferrite Heating Measurements in Clean Room:
Curie point of ferrite corresponds to 106 $^{\circ}\text{C}$ measured on ground plates

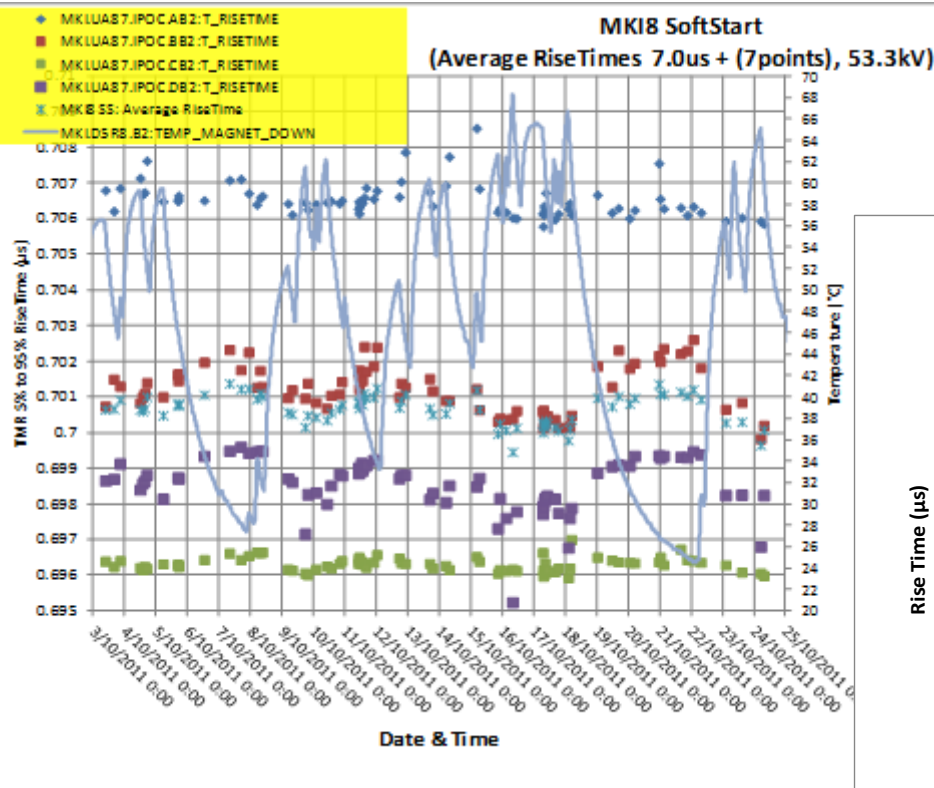
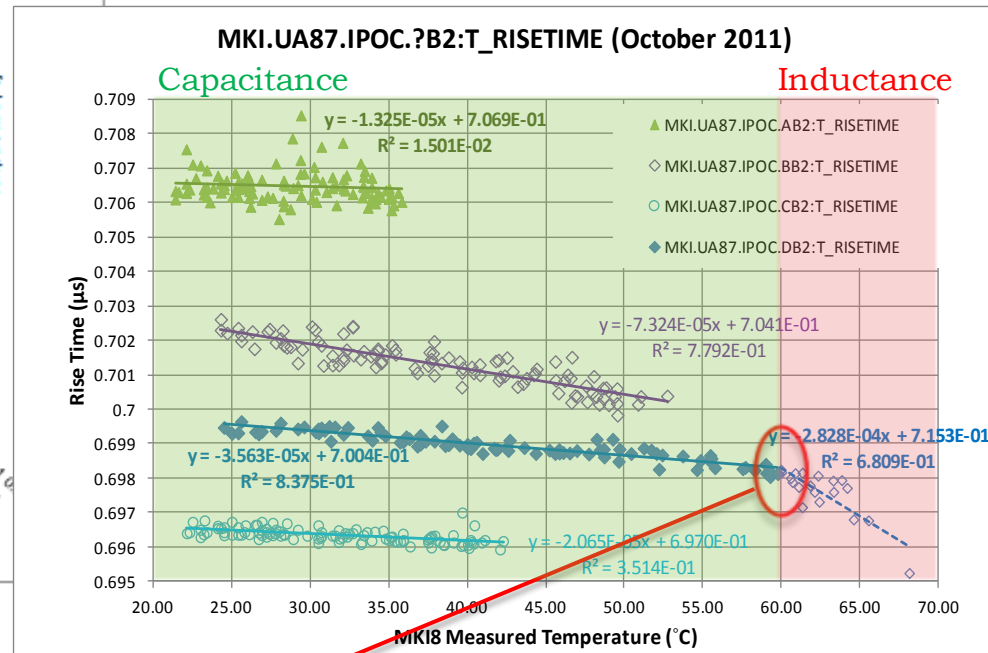
MKI Temperature Interlock

- ✓ **SIS interlock presently 62 °C (originally 55 °C) cannot be further increased !**
- ✓ MKI Temperature is < 68 °C and lags real temperature (ferrite thermal capacity)
- ✓ Softstart: OK → injection
not Ok → wait for MKI cooling

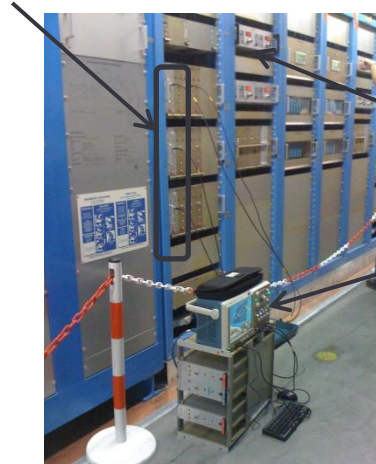
Two More Erratics.....

Two more erratics happened during softstart on 30/07/2011

- Replaced MS3– damaged current regulator on bias board
- Remote current monitoring added
- New G1 trigger cards installed
- Damaged thyatron switch replaced
- Fiber optic read-back to better monitor thyatron and bias-board G1 current ??

Trigger units for MS3 replaced.
