LHC Beam Operation workshop - Evian 2011

Injection and Dump System

W. Bartmann, M.J. Barnes, C. Bracco, E. Carlier, B. Goddard,
V. Kain, M. Meddahi, V. Mertens, J. Uythoven, L. Drosdal

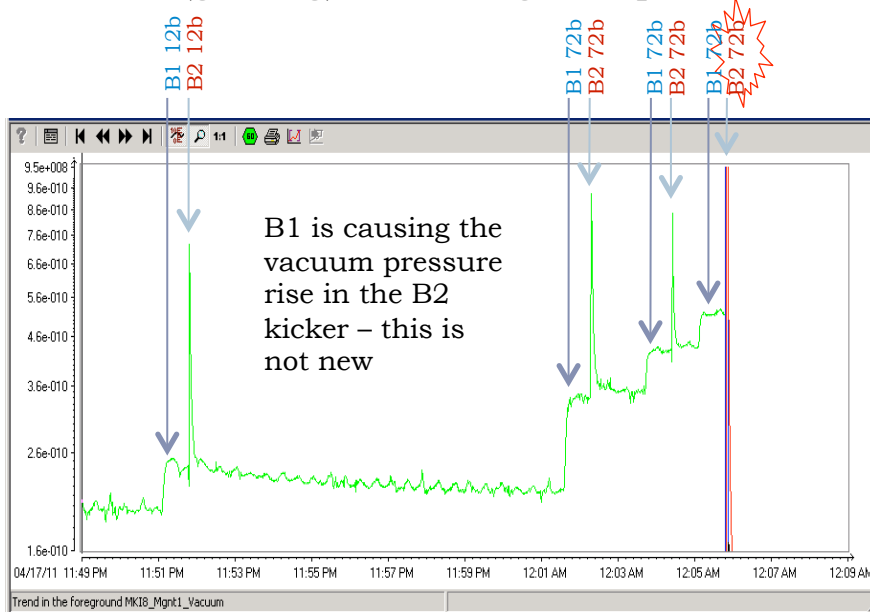
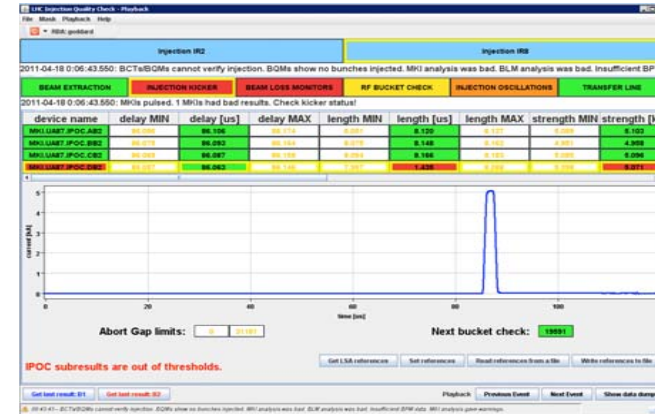
MKI Flashover 18/04/2011

- Injection of 2×36 bunches spaced by $2.2 \mu\text{s}$
 \rightarrow Breakdown after $\sim 2 \mu\text{s}$ \rightarrow All 36b of 2nd batch were kicked with 110-125% nominal MKI deflection
- Beam was on LOWER TDI jaw and over-kicked, i.e. breakdown in second half of magnet (LHCb signals support this)
- Nearly all p+ of the 36b impacted on the TDI/TCLIB (grazing) \rightarrow 11 magnets quenched

- MKI HW vacuum interlock** reduced from $5e-8$ mbar to **$2e-8$ mbar**
- New **SIS to prevent injection** if **MKI pressure $>2e-9$ mbar** for 50 ns beam (temporary **$>2.5e-9$ mbar** for scrubbing with 25 ns beam)
- Checked carefully **TDI angular alignments** in IR2 and IR8

- TCLI openings \rightarrow TCLIB to 8.3σ**
- New Fixed Display in CCC with MKI pressures
- Solenoids between MKI and Q4/A5 switched ON

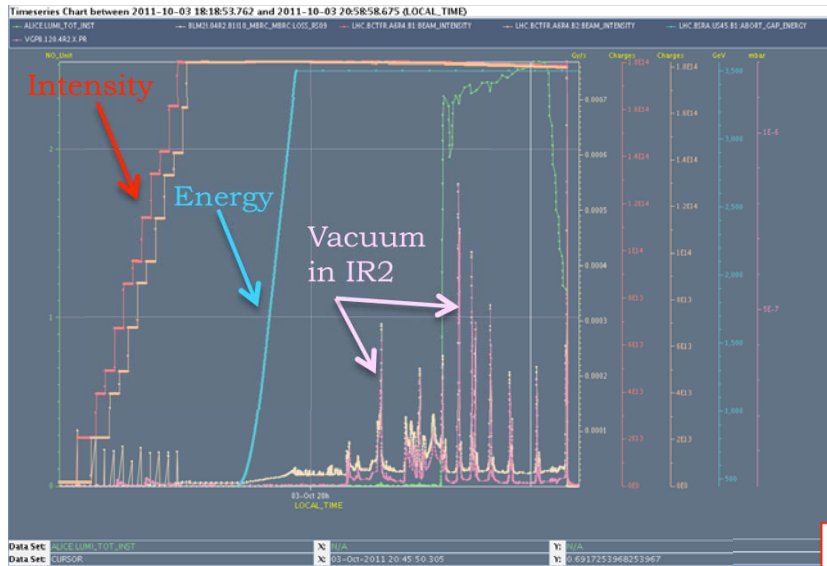
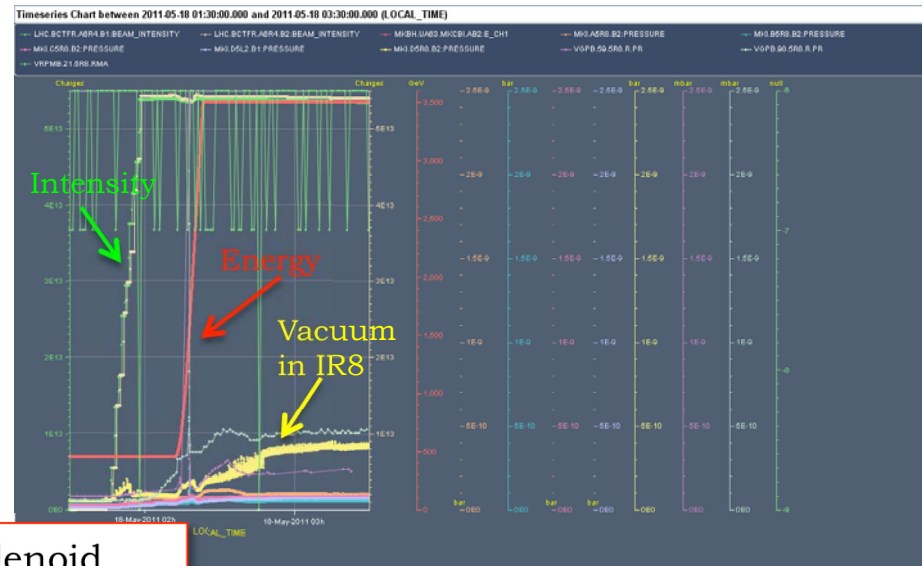
MKI Vacuum Activity

Solenoid switched off

- To avoid possible vacuum/breakdown problems with the MKIs, solenoids:
- ▶ ON during normal operation
 - ▶ OFF during scrubbing provided pressure does not become too high (respect SIS injection interlock)
 - ▶ In future, possible to include a $\int P \cdot dt$ interlock (under study)

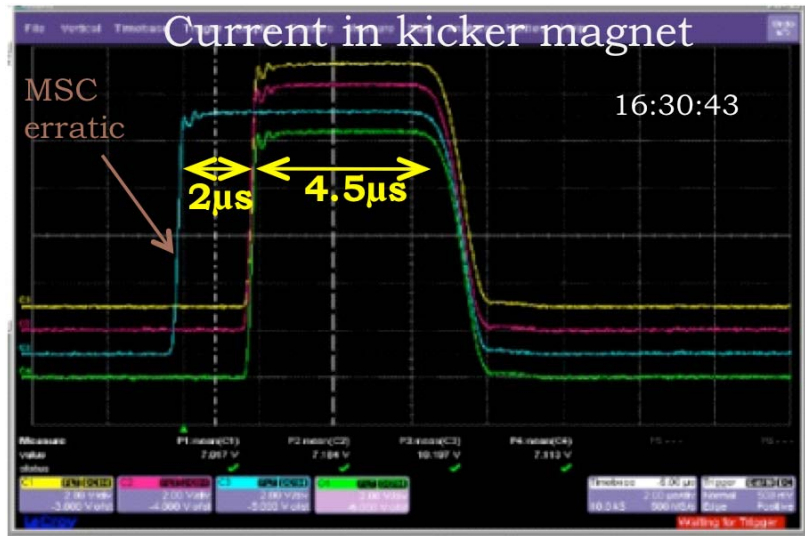
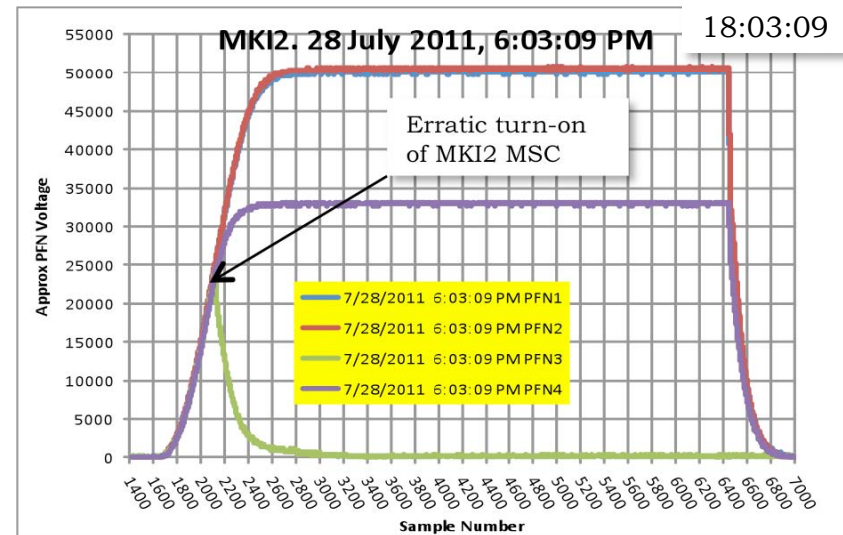
MKI Erratics on 28/7/2011

- Interlocks detected an MSC erratic and correctly triggered MS's and DS's of system (within 2µs), emptying PFN via both ends.
- Hence **kicker-C** pulsed for **6.5µs** and **3 other kicker magnets pulsed** for up to **4.5µs**, emptying PFNs of energy.
- **Circulating beam was not in IP2** and therefore not disturbed.
- **Batch was extracted from SPS** but saw no kick at MKI2 (current already back to zero in all magnets) and went **straight into the TDI upper jaw**.

- Erratic of MKI2 MSC at 33kV **during resonant charging** – sending current to one of the four kicker magnets
- **Interlocks did NOT detect erratic** of MS3: hence no immediate action was taken to turn-on other thyratrons → **full 9 µs PFN pulse length to kicker C**.
- Failure ~500µs into charging process: **extraction from SPS correctly inhibited**;
- Circulating beam was swept over aperture and grazed TDI (**~17% of normal kick**) for **~8-9µs** → **150-190 bunches**

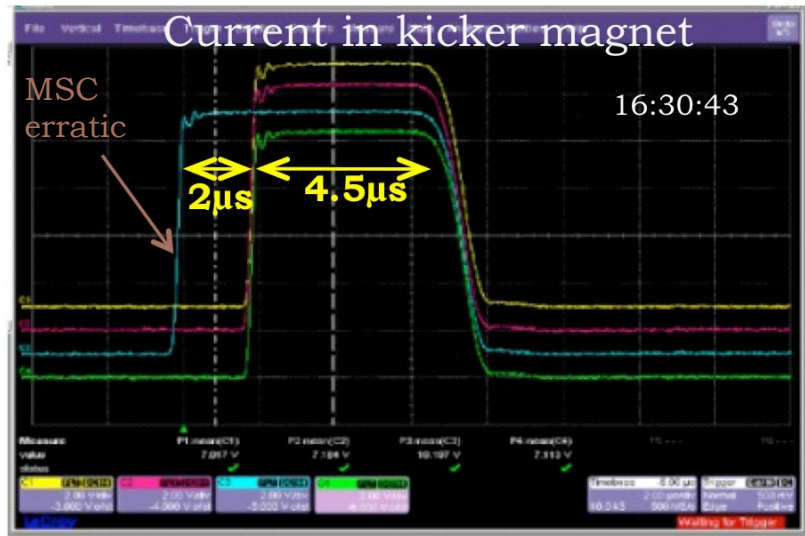
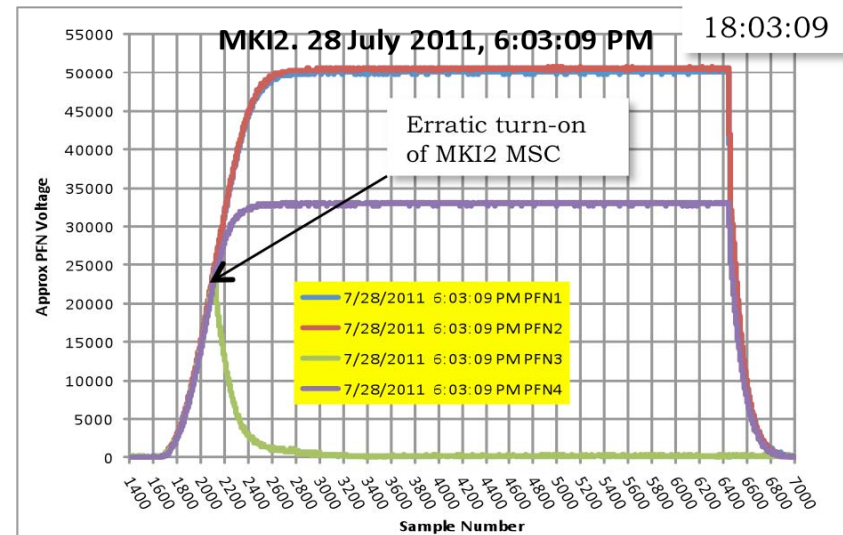
MKI Erratics on 28/7/2011

- Interlocks detected an MSC erratic and triggered MS's and DS's of system (with emptying PFN via both ends).
- Hence **kicker-C** pulsed for **6.5µs** and **kicker magnets pulsed** for up to **4.5µs** of energy.
- **Circulating beam was not in IP2** and therefore not disturbed.
- **Batch was extracted from SPS** but saw no kick at MKI2 (current already back to zero in all magnets) and went **straight into the TDI upper jaw**.

- Erratic of MKI2 MSC at 33kV **during resonant charging** – sending current to one of the four magnets
- **did NOT detect erratic** of MS3: reaction was taken to turn-on **all 9 µs PFN pulse length to**
- **SPS correctly inhibited;**
- **Circulating beam was swept over aperture and grazed TDI (~17% of normal kick) for ~8-9µs → 150-190 bunches**

Hardware problem → faulty components exchanged + additional diagnostic + faster detection electronics with lower voltage threshold

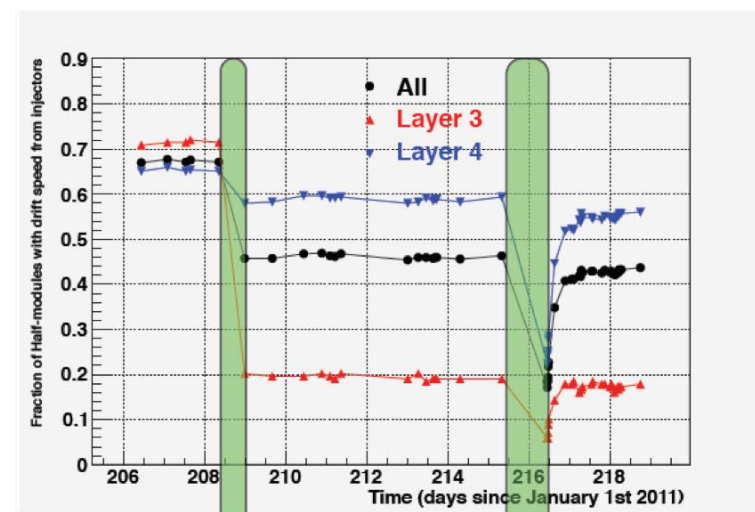
- ▶ 173 bunches - **2.15e13 p+ lost** (not dumped)
- ▶ **3 magnets quenched**
- ▶ **ALICE:**
 - ▶ The values of **BCM threshold for beam background** were exceeded:
 - 16:30 - **80 times**
 - 18:03 - **3559 times**
 - ▶ 9 / 17 sub-detectors were affected during second erratic event
 - ▶ All subsystems **except** Silicon Drift Detector (SDD) recovered using standard procedures
 - ▶ **20% of modules with good drift speed** from injector on layer 3 and 60% on layer 4 (**permanent effect**)

First recovery attempt:
SDD completely off for 24 hours

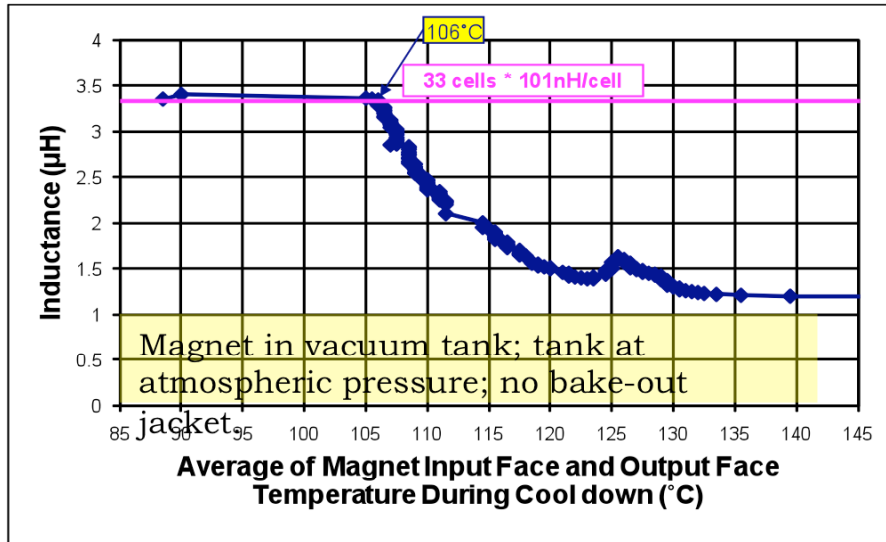
MKI Temperature Interlock

Ferrite Heating Measurements in Clean Room:
Curie point of ferrite corresponds to 106 °C measured on ground plates

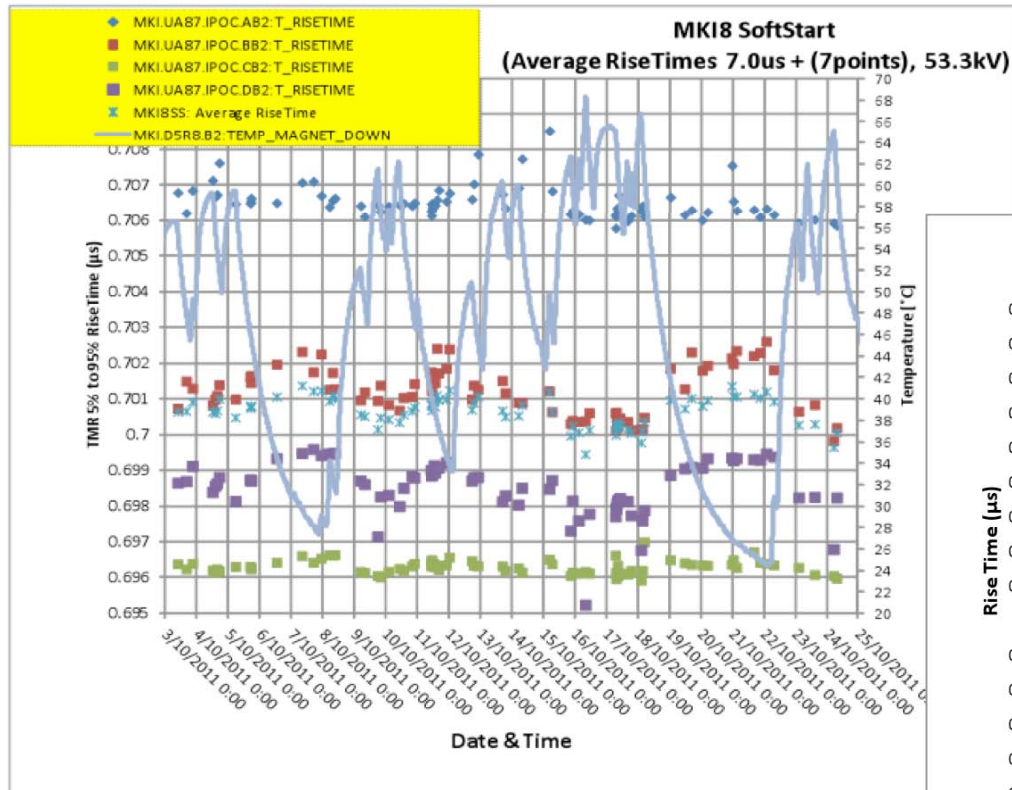
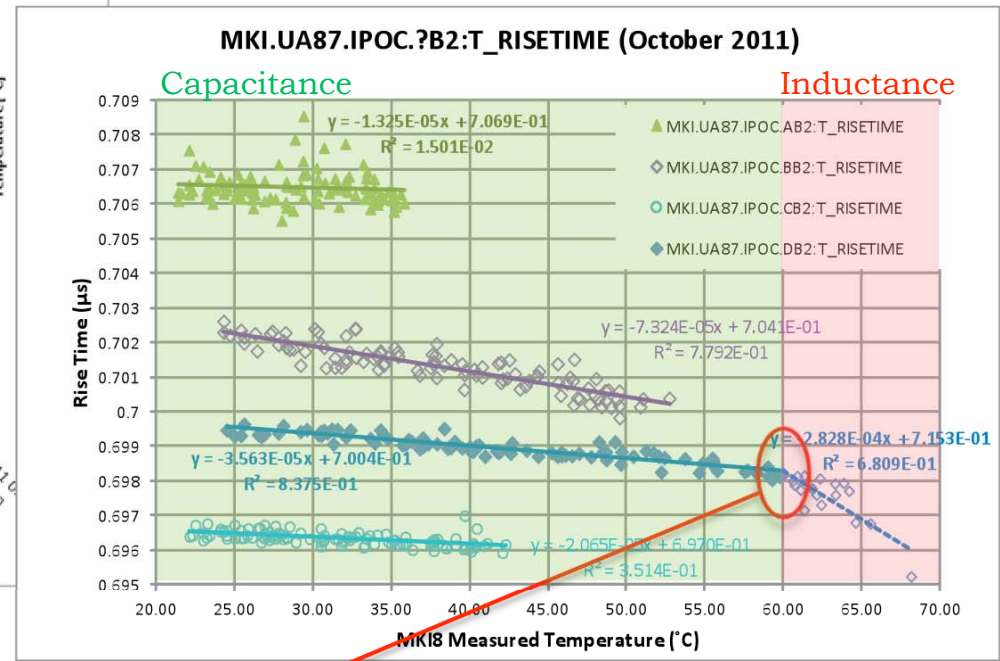
MKI Temperature Interlock

- ✓ **SIS interlock presently 62 °C** (originally 55 °C) **cannot be further increased !**
- ✓ MKI Temperature is < 68 °C and lags real temperature (ferrite thermal capacity)
- ✓ Softstart: OK → injection
not Ok → wait for MKI cooling

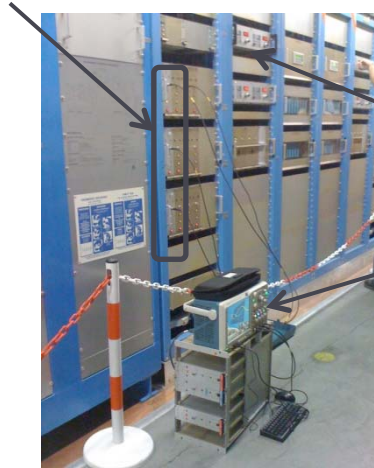
Two more erratics happened during softstart on 30/07/2011

- Replaced MS3- damaged current regulator on bias board
- Remote current monitoring added
- New G1 trigger cards installed
- Damaged thyatron switch replaced
- Fiber optic read-back to better monitor thyatron and bias-board G1 current ??

Trigger units for MS3 replaced.

Power supply and crate for MS3 heater/ reservoir replaced.
