# INJECTION AND DUMP SYSTEM

C. Bracco, W. Bartmann, M.J. Barnes, E. Carlier, L.N. Drosdal, B. Goddard, V. Kain, M. Meddahi, V. Mertens, J. Uythoven, CERN, Geneva, Switzerland

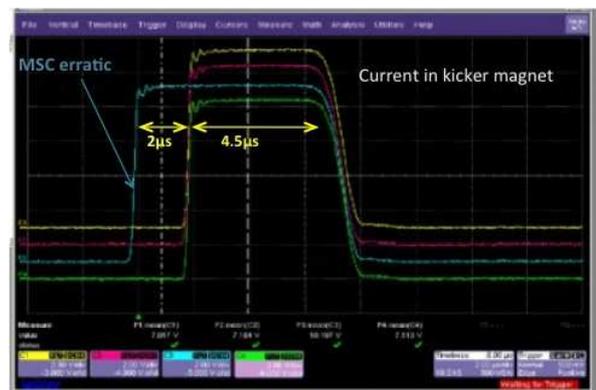
On July 28<sup>th</sup> two erratics happened at the main switch of the MKI-C (MSC) in point 2. In the first case the interlock system detected correctly the erratic and triggered the firing of the remaining kickers within  $2 \mu\text{s}$ . Hence the kicker-C pulsed for  $6.5 \mu\text{s}$  and the 3 other kickers for  $4.5 \mu\text{s}$  emptying the Pulse Forming Network (PFN) of energy (see Fig. 1). No circulating beam was passing through the MKIs at the moment of the pulse. The kicker current was still at zero when a batch of 144 bunches was extracted from the SPS and ended up on the upper TDI jaw. Several soft-starts were repeated after this event to check the status of the system but no failure was observed and a new machine fill was started.

Figure 1: The current in the four injection kicker magnets following the first MSC erratic.

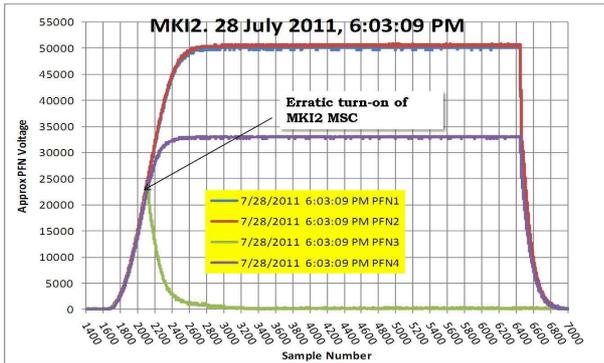
same MSC. This time the failure happened during the resonant charging. The erratic was not detected and the MKI-C pulsed for about  $9 \mu\text{s}$  (17% of nominal injection kick, see Fig. 2). The extraction from the SPS was inhibited but the circulating beam was swept over the aperture and grazed the TDI lower jaw. The XPOC analysis showed that 173 bunches ( $2.15 \times 10^{13}$  protons) were lost in the machine and not dumped. Three magnets quenched and ALICE suffered permanent effects in the silicon detector.

Figure 2: The current in the four injection kicker magnets following the second MSC erratic is presented.

The cause of the erratics was identified as the MSC thyatron itself which was replaced together with other damaged components. Diagnostics were improved and a faster detection system with a lower voltage threshold was implemented.

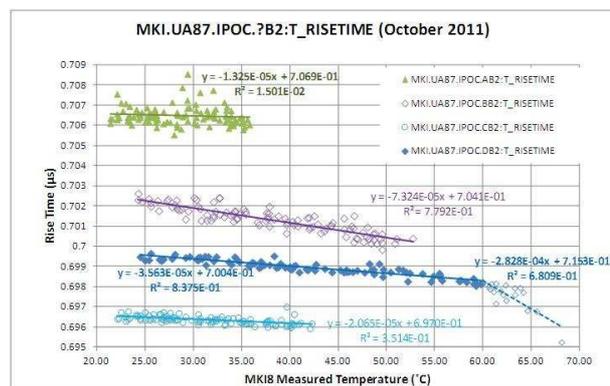
Results of rise time measurements performed on the four MKIs in point 8 are shown in Fig. 4. All the kickers present a slow linear reduction in rise time with the temperature; this effect seems to be mainly due to a capacitance reduction. A clear faster drop can be observed for the MKI-D starting at about  $60 \text{ }^\circ\text{C}$ , indicating a change in the ferrite inductance. Based on these measurements, the interlock limit was set at  $62 \text{ }^\circ\text{C}$  (originally at  $55 \text{ }^\circ\text{C}$ ) and it cannot be further increased. Temperature interlocks for individual magnets will be deployed from the 2011/2012 Christmas stop.

Figure 4: The rise time is measured as a function of the temperature of the 4 MKIs in IR8.
