# Beam systems without failures – what can be done?

Session 07 - 09<sup>th</sup> February 2012

M.Solfaroli/J.Uythoven

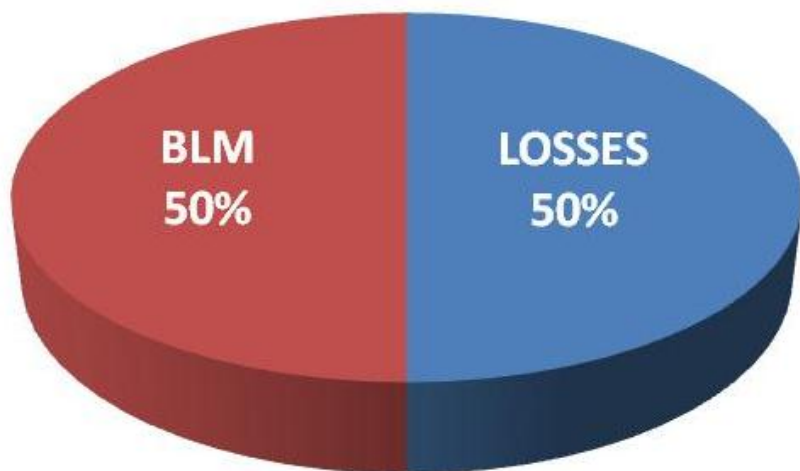
## 2010 (2 events)

Beam dump cause	
LOSSES (injection region)	
BLM (failure of a processing card)

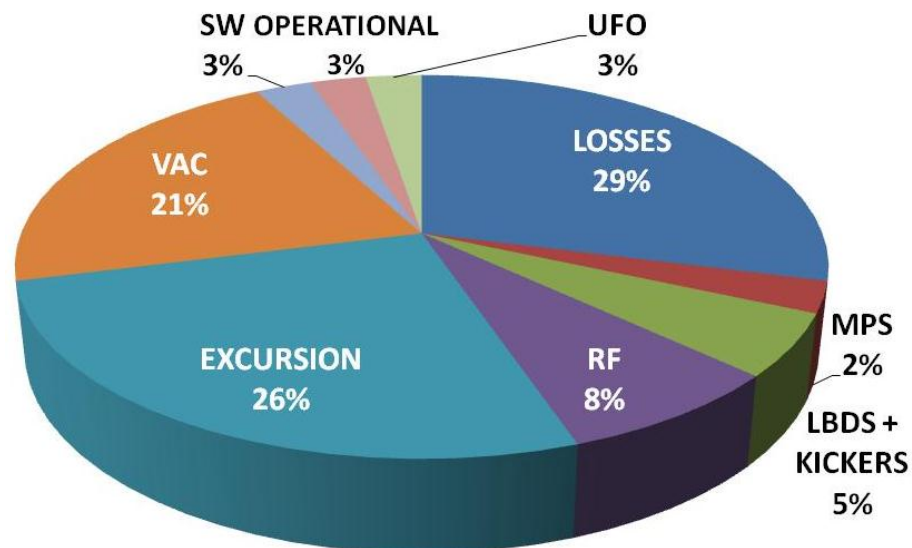
## 2011 (38 events)

Beam dump cause	
LOSSES	11
EXCURSION	10
VAC	8
RF	3
LBDS + KICKERS	2
MPS	1
SW	1
OPERATIONAL	1
UFO	1

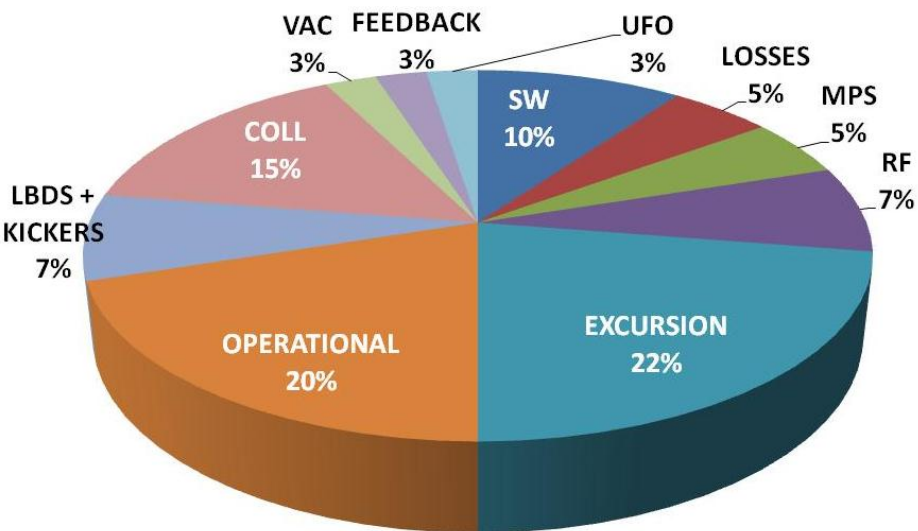
## 2010 (40 events)

Beam dump cause	
EXCURSION	9
OPERATIONAL	8
COLL	6
SW	4
RF	3
LBDS + KICKERS	3
LOSSES	2
MPS	2
VAC	1
FEEDBACK	1
UFO	1

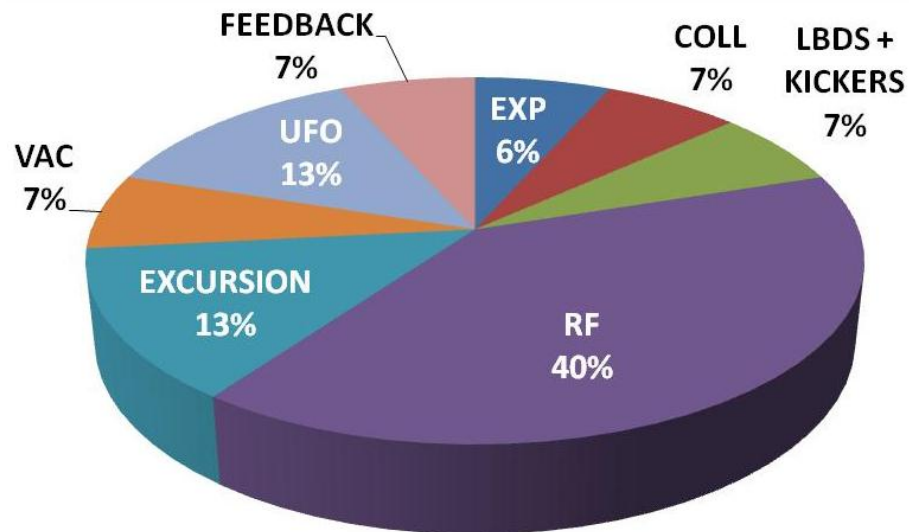
## 2011 (15 events)

Beam dump cause	
RF	6
EXCURSION	2
UFO	2
EXP	1
COLL	1
LBDS + KICKERS	1
VAC	1
FEEDBACK	1

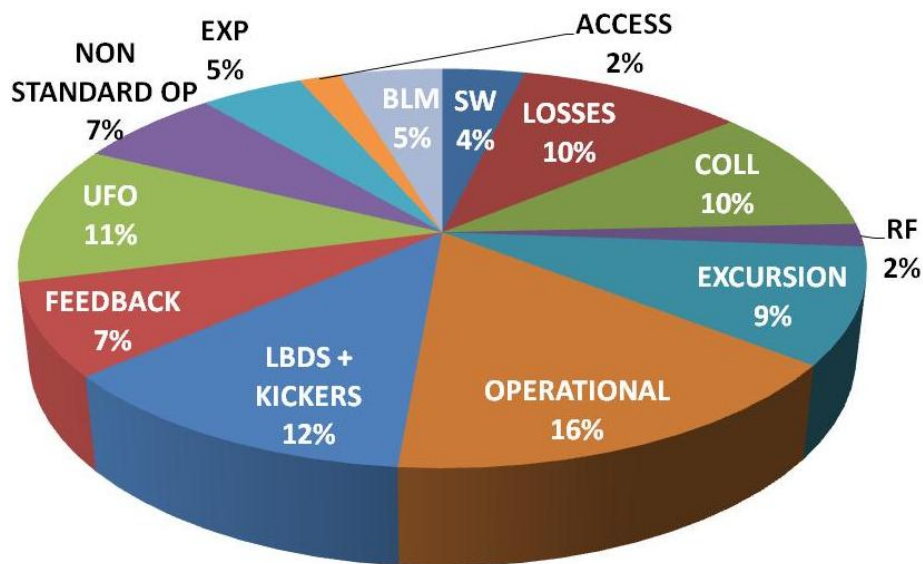
## 2010 (107 events)

Beam dump cause	
OPERATIONAL	17
LBDS+KICKERS	13
UFO	12
LOSSES	11
COLL	11
EXCURSION	10
FEEDBACK	8
NON-STANDARD OP	7
EXP	5
BLM	5
SW	4
ACCESS	2
RF	2

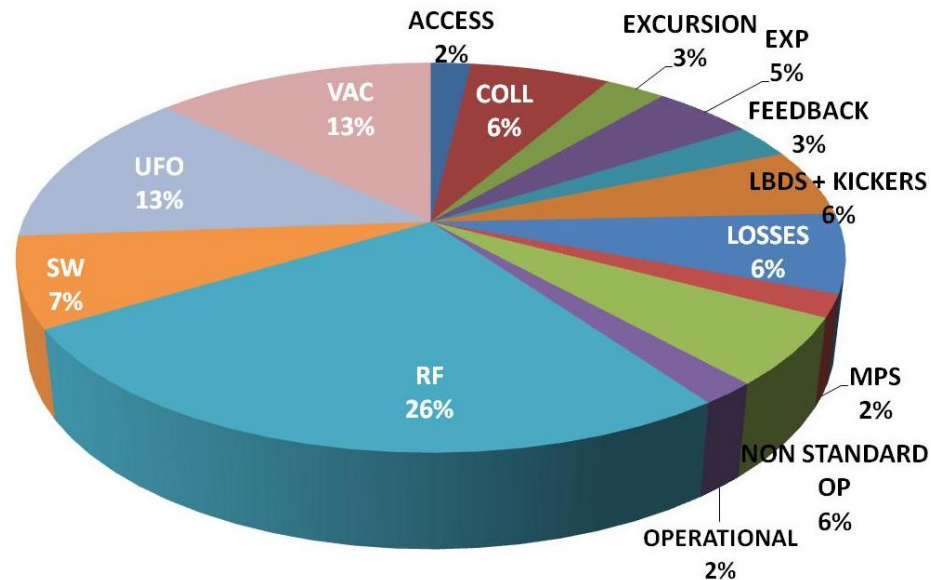
## 2011 (107 events)

Beam dump cause	
RF	28
VAC	14
UFO	14
SW	8
LOSSES	7
COLL	7
LBDS + KICKERS	6
NON STANDARD OP	6
EXP	5
FEEDBACK	3
EXCURSION	3
ACCESS	2
MPS	2
OPERATIONAL	2
