Existing Hardware Machine components

Frank Tecker - AB/OP
for the CTF3 Team

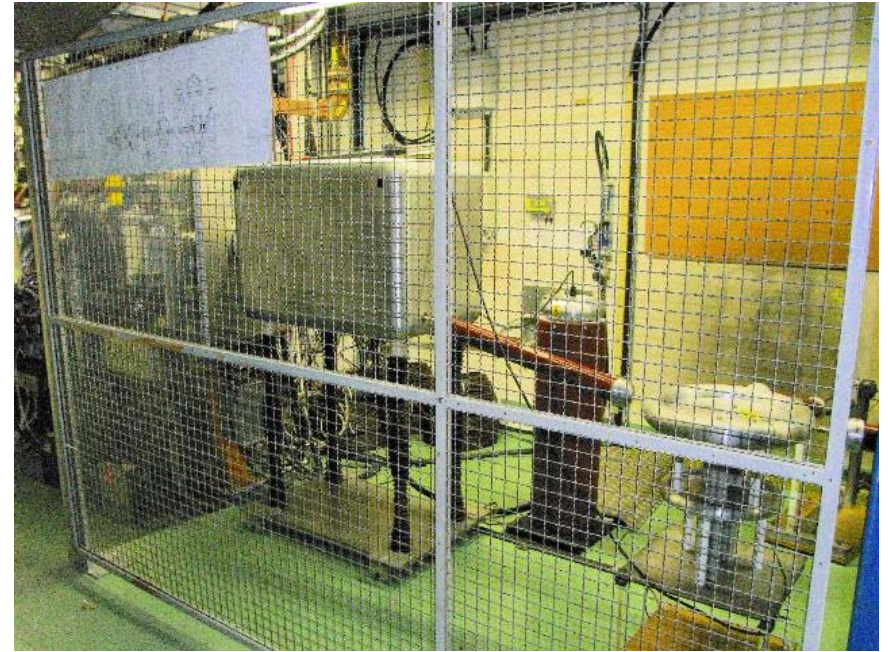
- the source of a lot of down-time and problems this year
 - Heater power supply
 - Bias power supply
 - Bad contacts
 - Gun pulser
 - Cathode
 - Dark current
 - 2 vacuum leaks after solenoids on Oct 9 and Nov 20, caused by gun dark current, 6 and 5 days downtime
 - Stability and jitter

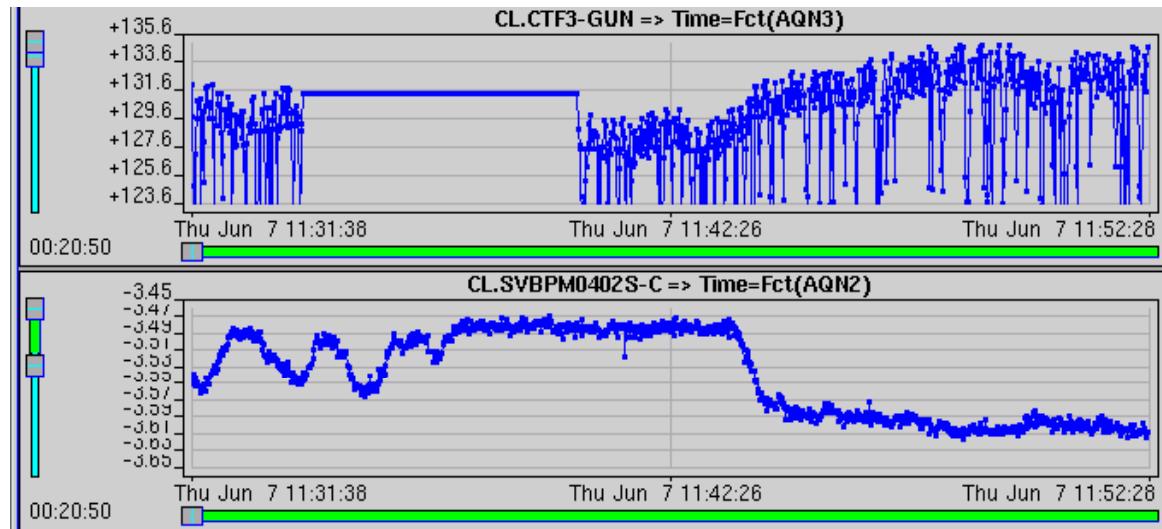
Gun current variation

- We observed current variations caused by **HV change**
 - Small HV variations not obvious since acquisition is noisy
- Could trace them to the **gun regulation**:
for a high dark current
the gun changes from current to voltage regulation and lowers the HV to limit the current
- Could be fixed by increasing the threshold for switching
- But the problem reappeared ...

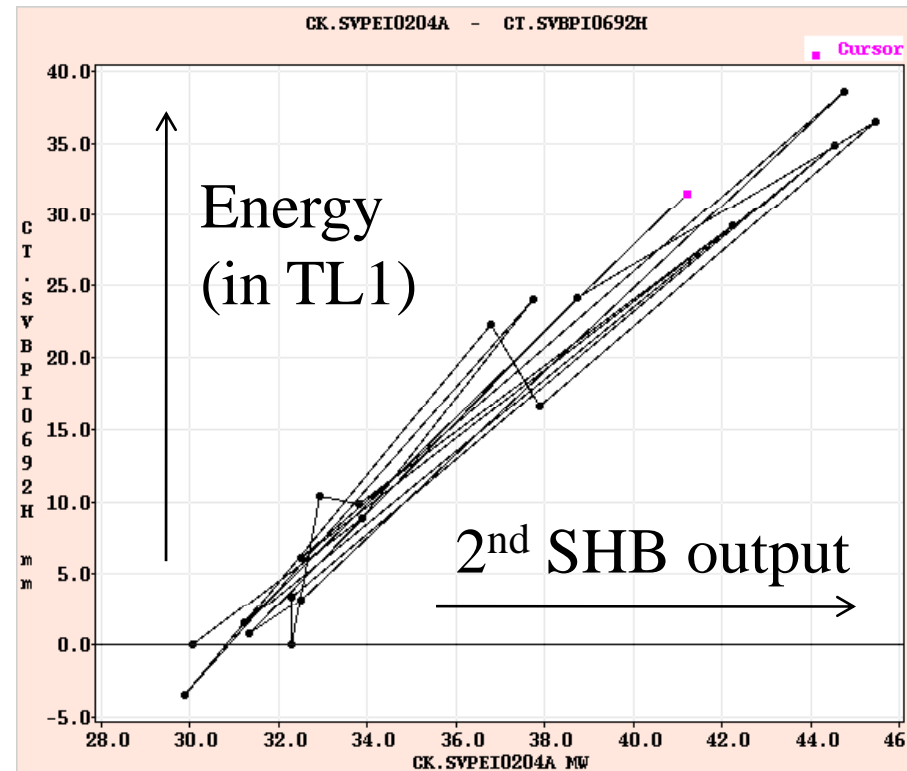
Energy variations and jitter

- Correlation between energy (hor position in dispersive region) and SHB02 loaded signal
- Stable SHB phases measured
- Gun current stable
- => other variation from gun, HV? but we **miss proper diagnostics**

- Periods of better or worse jitter, not understood why
- Jitter variations bigger than tuning variations
- Beam **very difficult** to **set up**
- Lower variations without 1.5 GHz SHBs => used 3 GHz beam

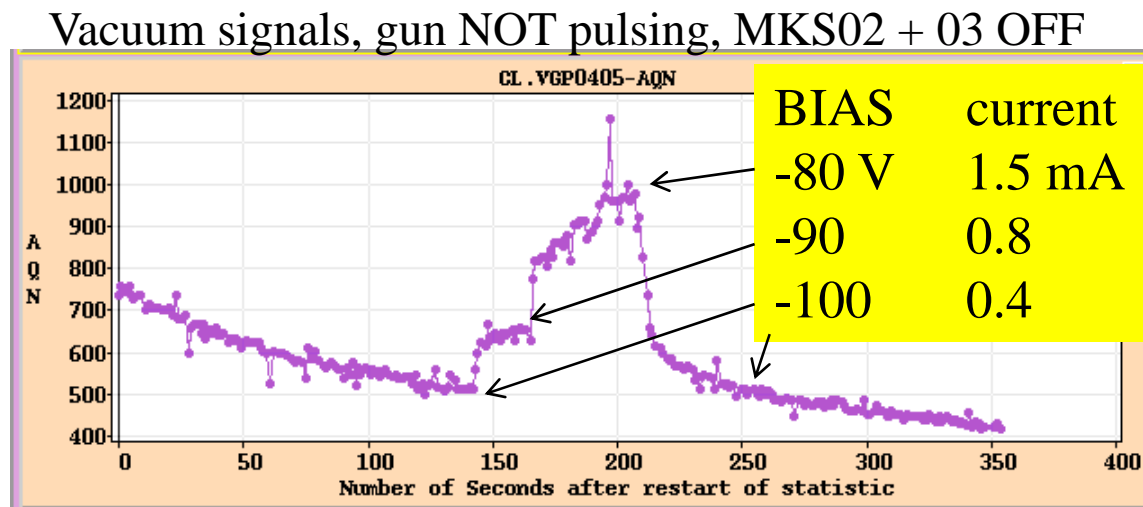
Dark current

- 2 Oct: high dark current after cathode change
- 9 Oct: vacuum leak after solenoid exit (CL.0405)
- 15 Oct: restarting, almost 10 mA dark current, try to fix
- 23 Oct: restarting commissioning
- 20 Nov: new leak at same location
- 25 Nov: restart, temperature probe installed
- **Conclusions:** Vacuum activity and local temperature at the leak
 - NOT correlated to
 - beam pulsing or not
 - RF on or off
 - BUT are correlated to
 - gun average current readings
- **Dark current (cw) from gun responsible for leaks**

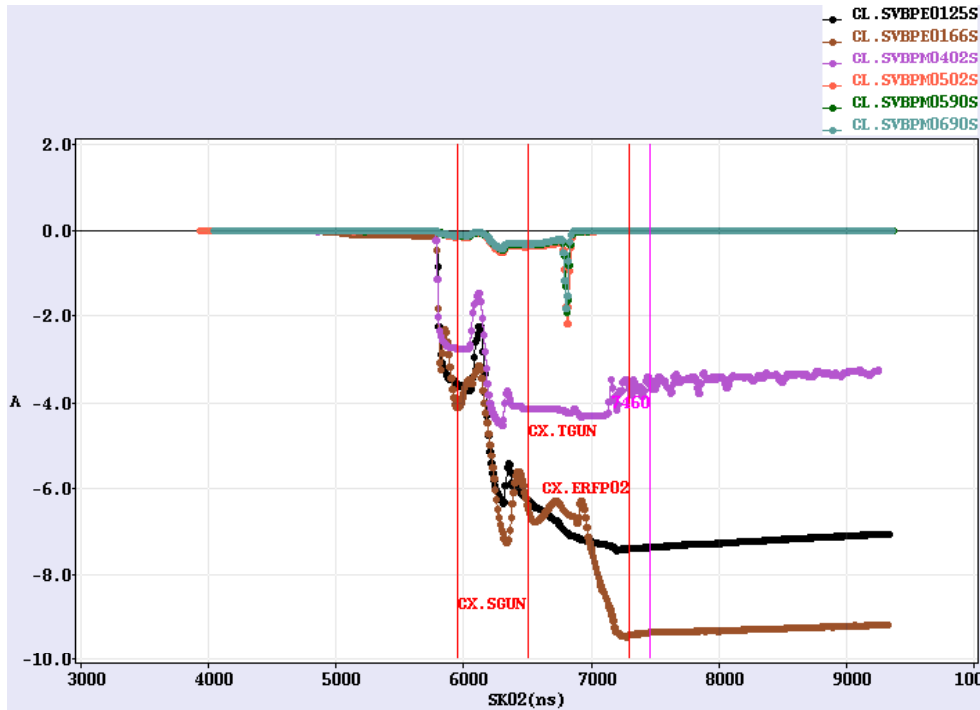
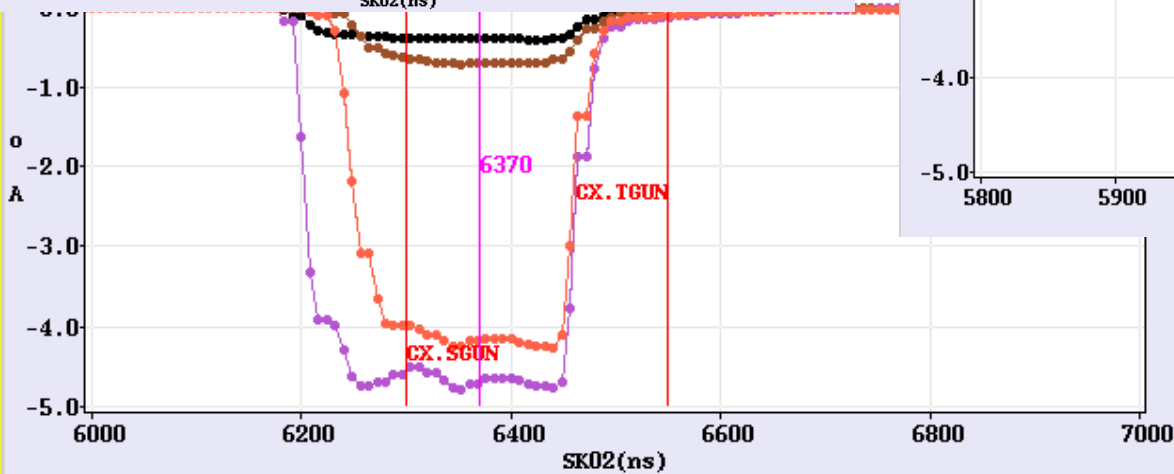
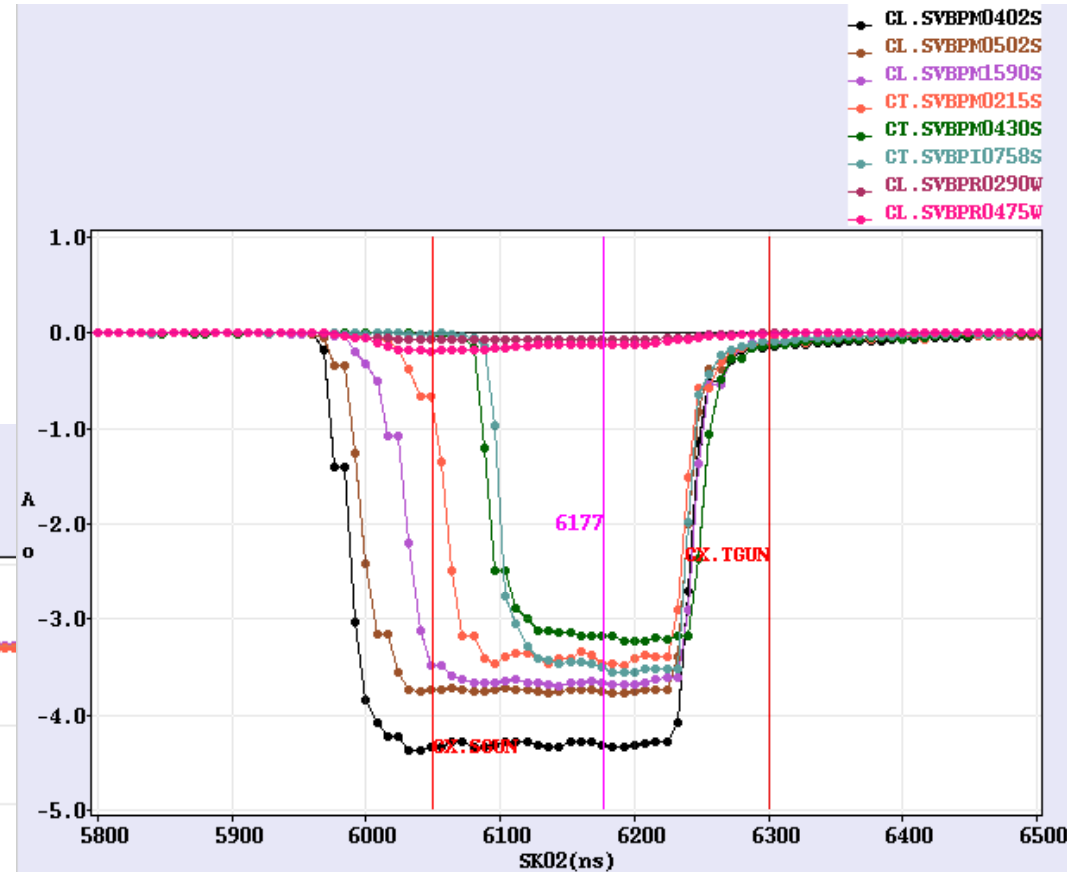
Gun pulse shape

- Current pulse shape shows variations, ringing needs to be optimized

- With the present gun performance
 - It is extremely **difficult** to **set up** combination
 - It will be even more difficult with DL+CR and beam for CLEX!
- We certainly **need** a **consolidation** of the gun !
 - Review different power supplies
 - Add proper measurement signals to allow better diagnostic
 - Review the voltage regulation
 - Implement feedbacks as an upgrade?
 - Activate current modulation feature (in design) to compensate current modulation during SHB phase switch

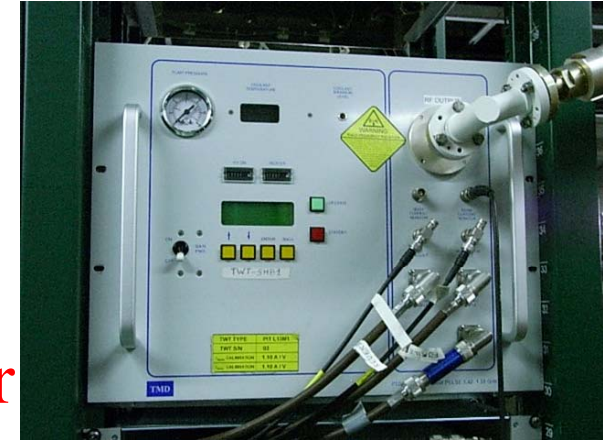
Sub-harmonic bunchers (SHB)

- three 1.5 GHz SHBs fed by Traveling Wave Tubes (TWT)
- Required for DL operation
- 1 tube broke in May
- We have **1 spare tube** but **no spare amplifier**
- => amplifier has to be send to repair
2-3 month delay
- We were left with 2 SHBs for a large fraction of the run
larger satellite bunches
- Other point: no remote indication of status
we had periods of faults, not immediately obvious to operation

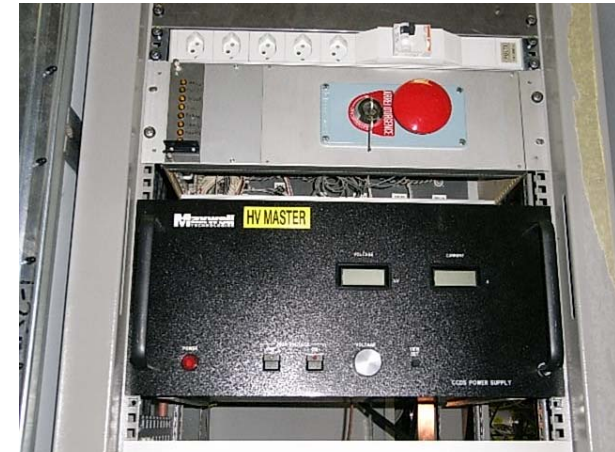
Klystron - Spares

- Two klystrons failed due to charging power supply failures
 - MKS15 End Oct
 - MKS11 27 Nov
- **No spares** available
- Could continue operation but needed a completely new setup of the machine
=> several days time lost each time
- We need spares for these power supplies
- We also need spares for klystron tubes
- => Gerry's talk

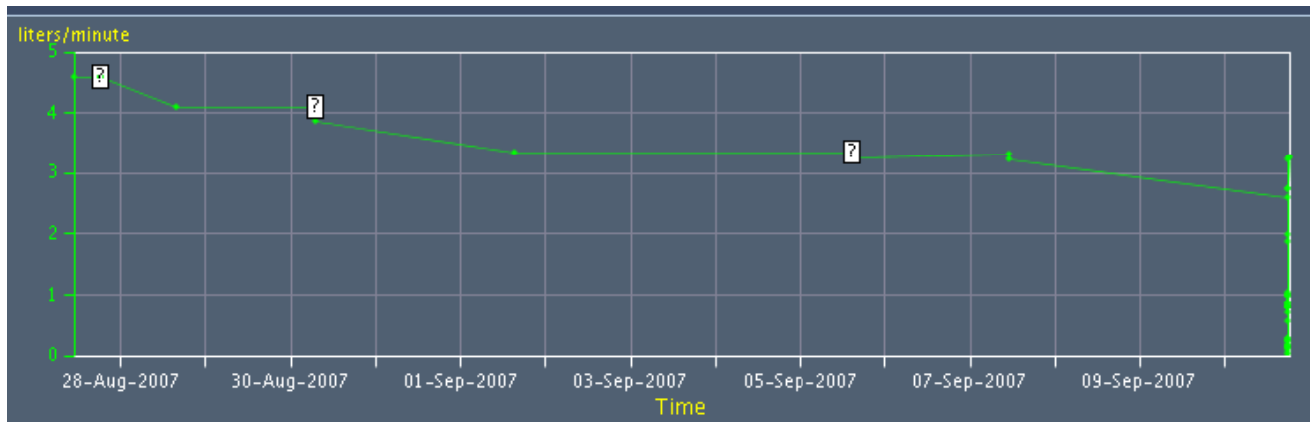
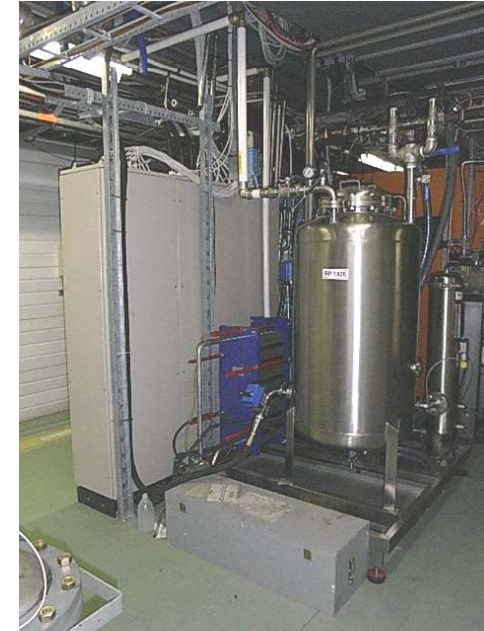
Water station for LIPS/BOC

- Temperature control for RF pulse compression cavities
- Tuning very crucial
- Filter for one device got blocked twice
→ flow rate reduced, cavity detuned

- Regular maintenance + cleaning needed
- Regulation for some devices slower than others
=> needs regulation, evtl. change of feedback to include power dependance

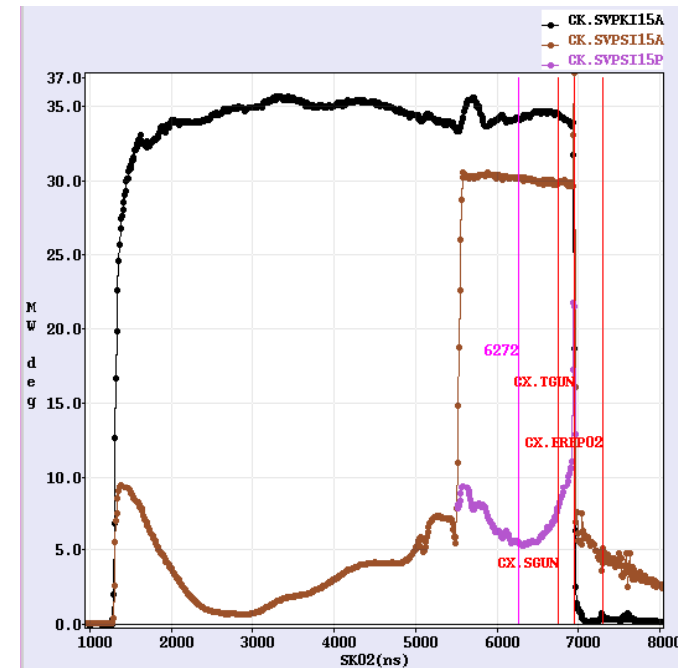
RF pulse compression

- We had frequent problems with the waveform generators on one front-end computer
- Finally fixed by CPU card exchange
- Setting up improved by Hamed's software
- **Slow drifts** in compressed pulse shape
- Should invest time into automatic feedback to keep power constant
- A basic version for this exists but needs testing
- Combination for long beam pulse difficult due to energy variation over the pulse
- Need to review phase sag, eventually lower compression ration

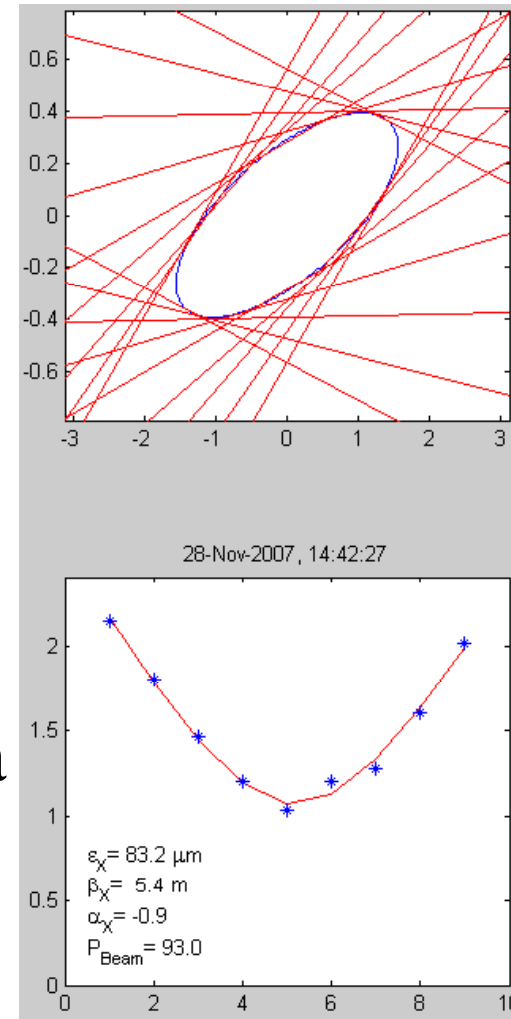
Quad scans + spectrometers

- Quad scans **essential for optics studies** and machine setup
- on girder 10 (for linac matching) during 2nd run
 - Al screen was damaged
 - Carbon screen did not give sufficient light
- Got repaired => widely used for linac matching
- **Screen control** + analysis software not optimum
- Spectrometer 10 screen has radiation hard camera => not enough light for energy measurement
- New segmented dump foreseen (=> Thibaut)
- We would profit from measurement software for energy

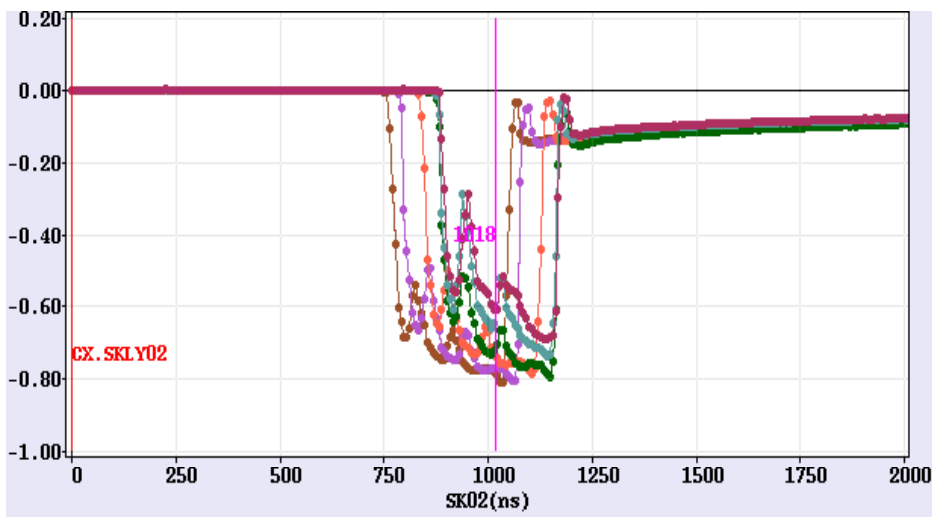
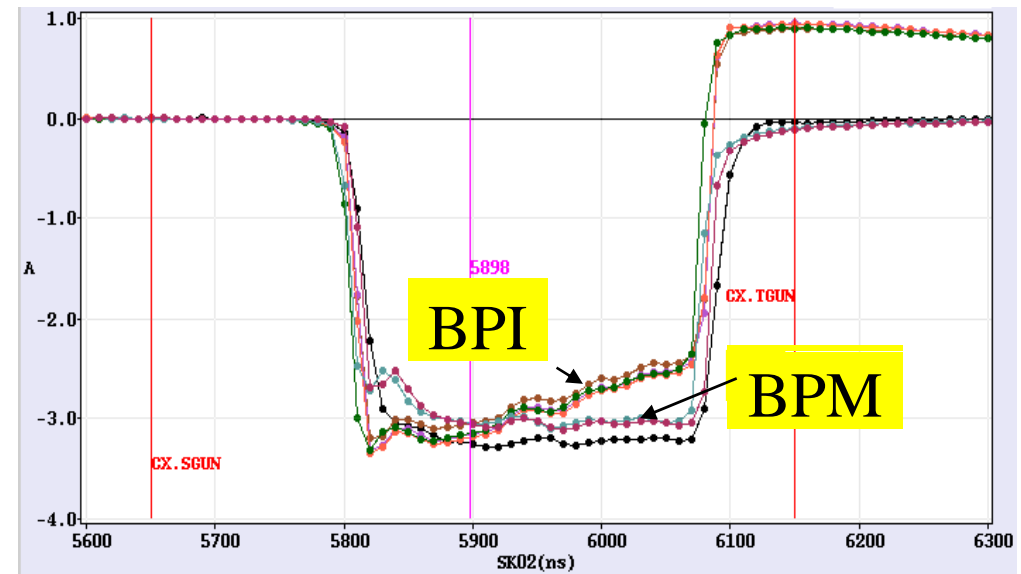
- **BPI**: racetrack, similar to BPM, different electronics
- First version had a signal droop due to different low frequency cut-off
- CR BPMs overcompensated for droop during 1st run 2007

- Finally, also working very well (see next slide)
- But we had only $\sim 2/3$ of all BPIs in the CR until last period

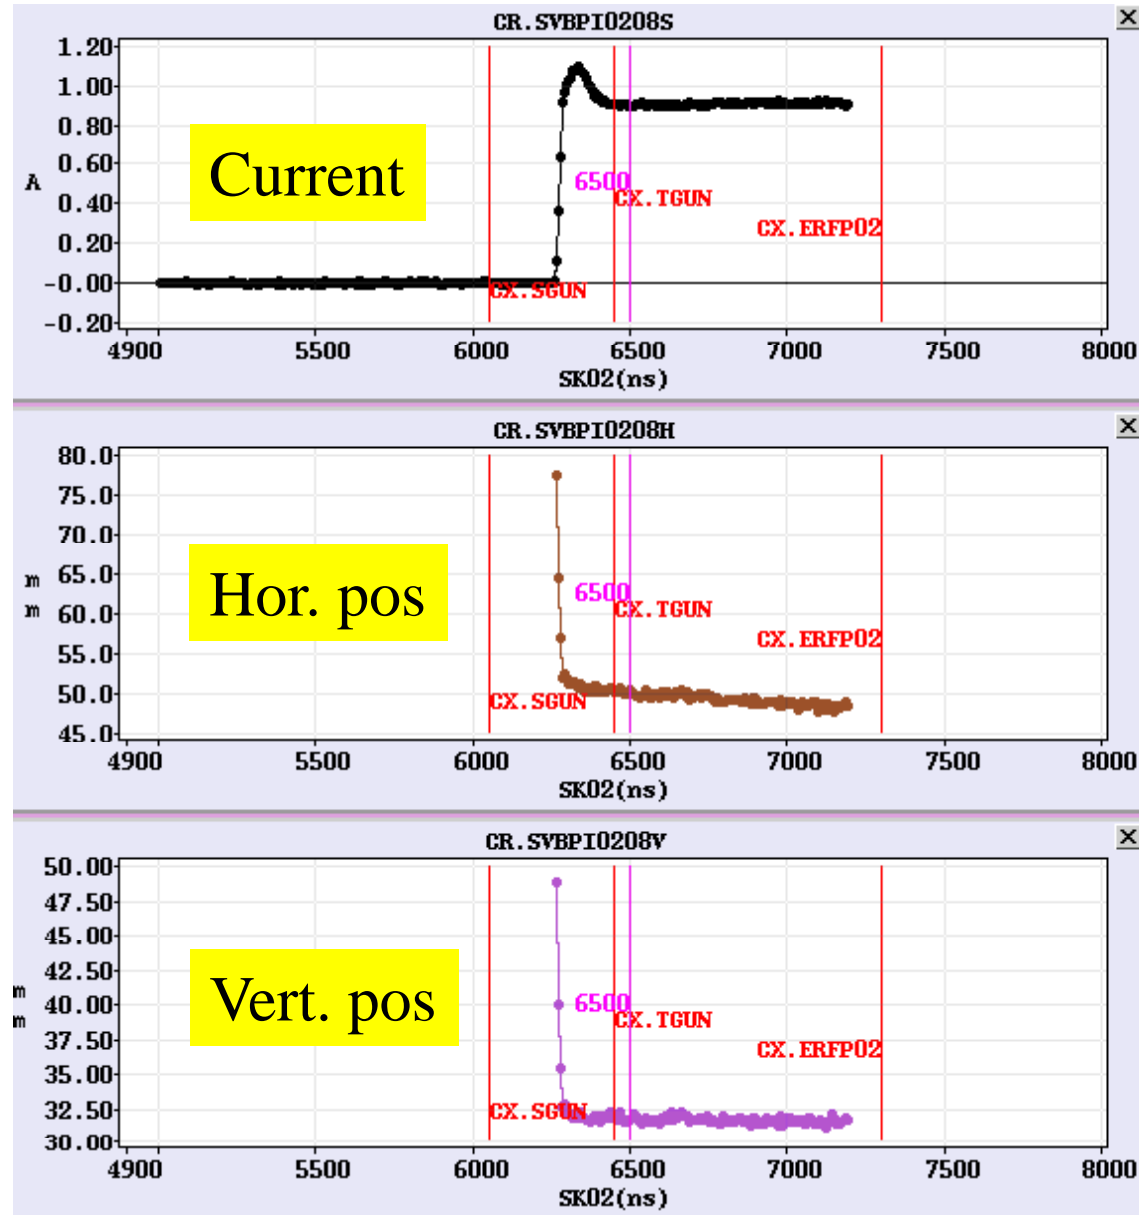
BPI signal droop corrected

- Adjustment of electronics solved droop for current signal
- Still small droop for position signals left

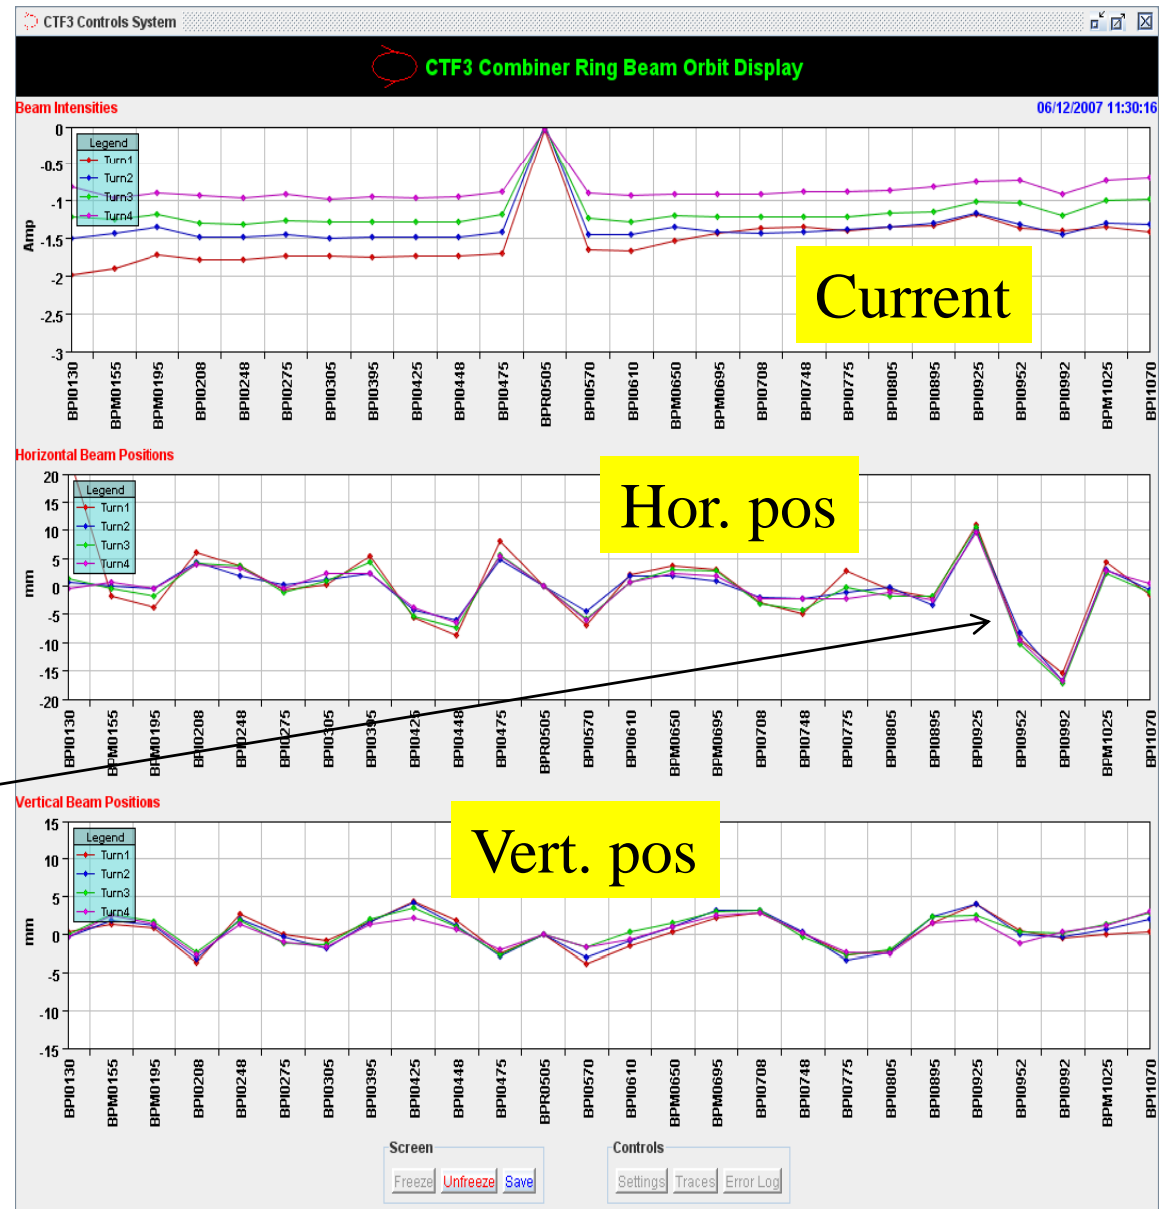
BPM alignment

- DL and CR vacuum chamber has sparse bellows
- Difficult to align
- BPM **offsets** up to **15mm** measured
- Taken into account in software but still questionable
- Will be realigned during shut-down

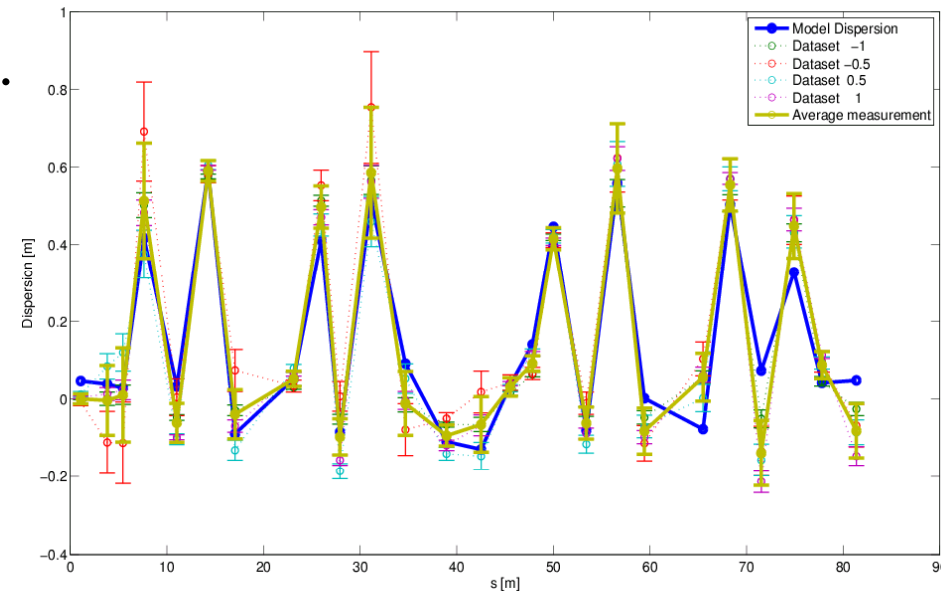
BPM calibration

- We had quite some problems/confusion with the different type of BPIs concerning calibration
 - Different calibration windings
 - Different gain
 - Different signal treatment
- Doubts about position calibration
 - BPMs in CR show smaller position variation than BPI
 - Measurement data to be analyzed ..
- BPMs and BPIs used for many important optics studies
 - Dispersion
 - Corrector kick measurements

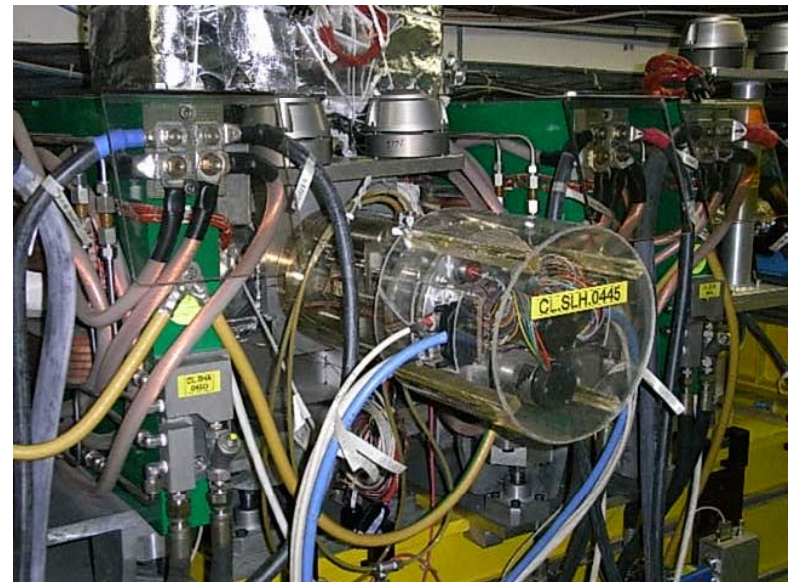
Slits + Stepping motors

- We use stepping motors for collimating slits and RF equipment
- Most have been upgraded to PLC control
- CK.MKS14-PHAS / -ATTN are not working remotely (still on old system, extremely slow – locally OK new system does not yet support this motor)
- Will be upgraded
- Slit calibration needs to be added
