EAR1 Beam Line - Report on the Status

Oliver Aberle, EN/STI

n_TOF Collaboration / Collaboration Board

November 2013

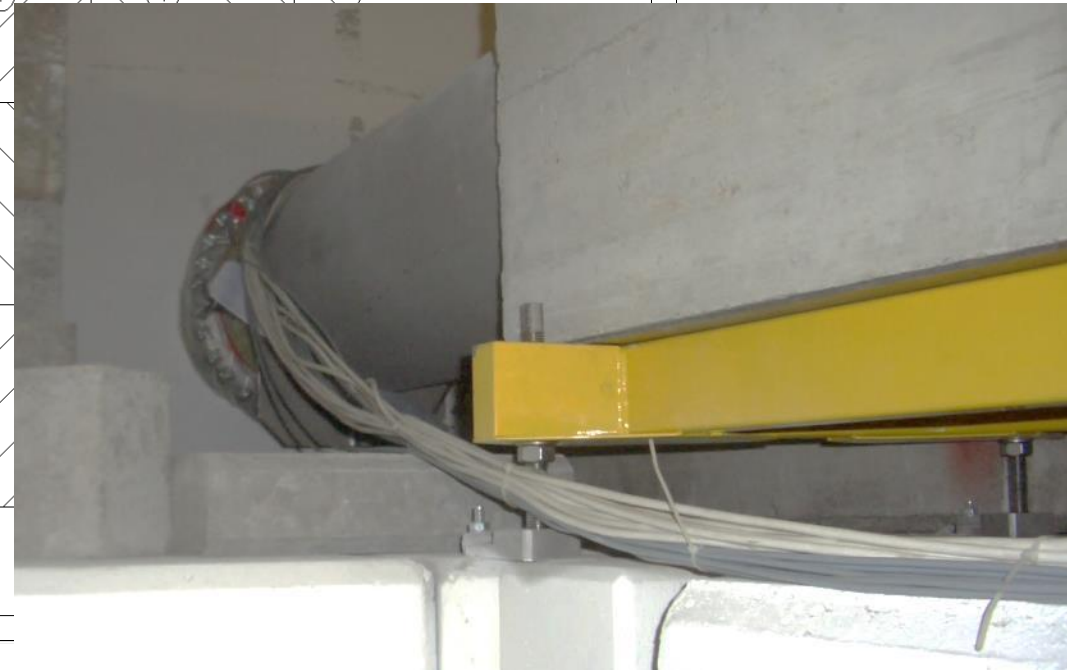
Collimator No. 1

Collimator 1 was found to be misaligned by 1.9 cm H, 0.75 cm V, during the realignment campaign in 2010 (see MC [C.B. April 2010](#))

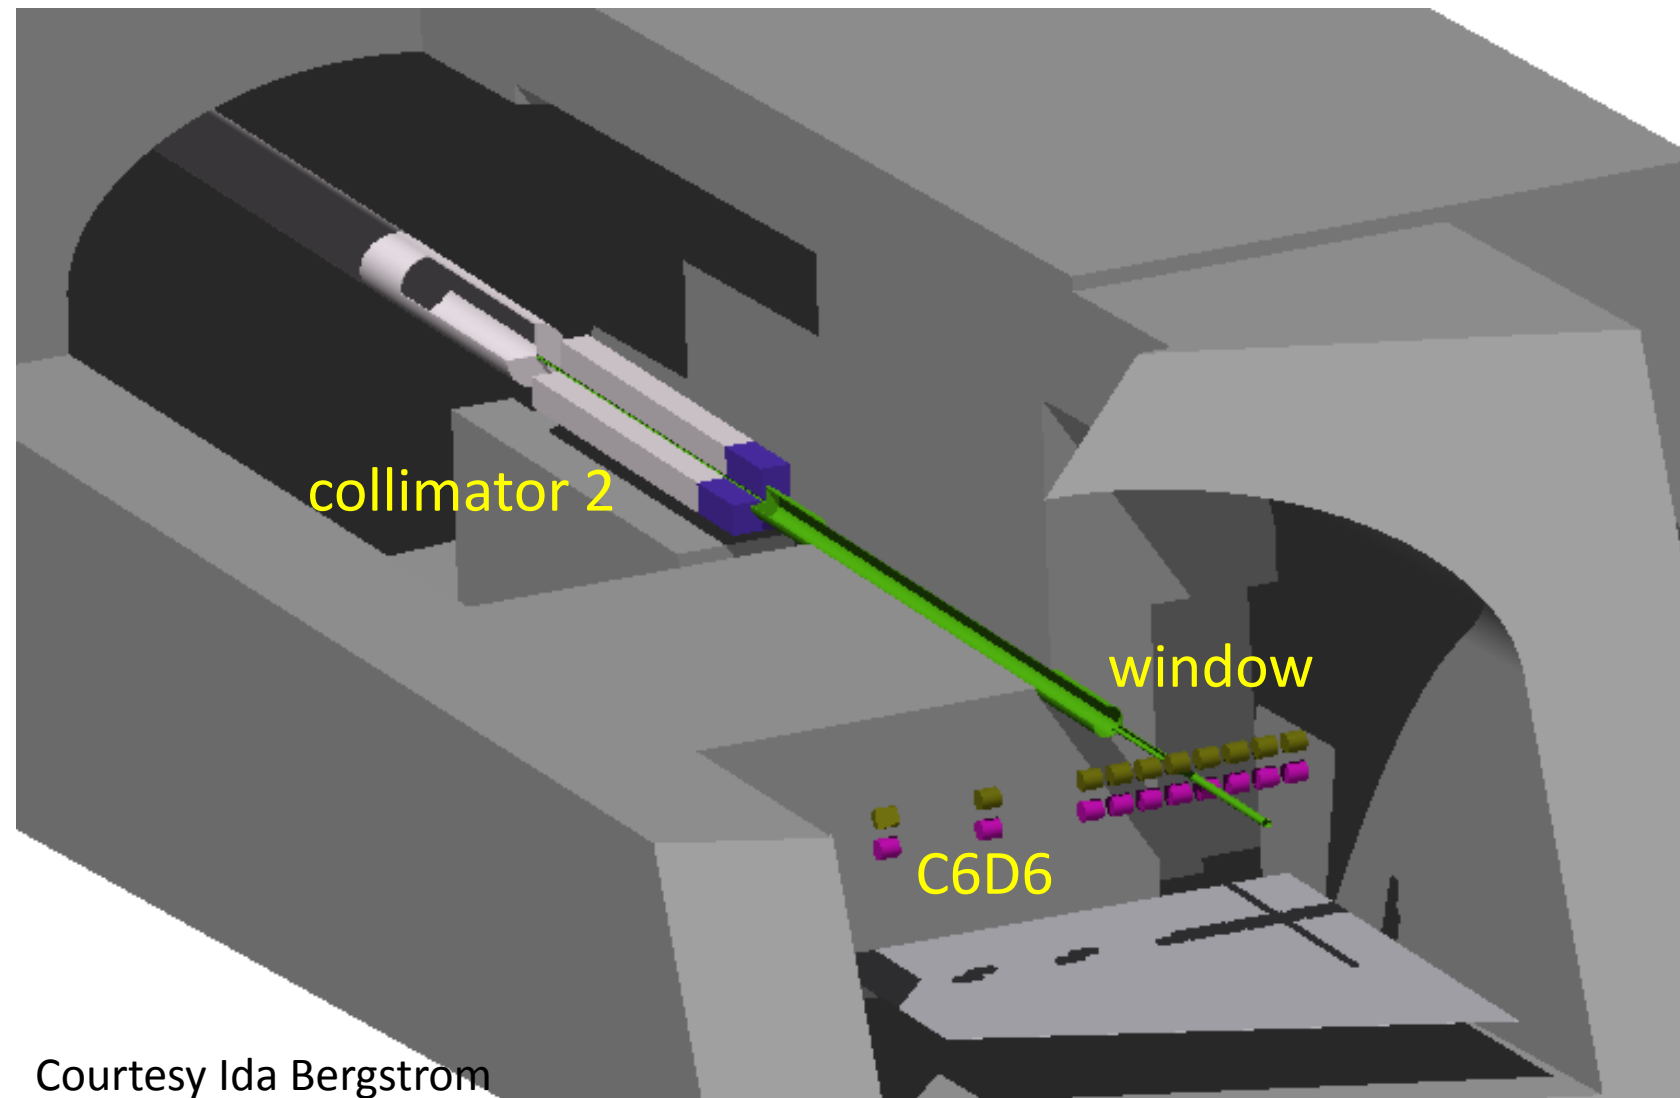
Vacuum window

Background improvement on EAR1

1. Reduce free passage through the wall to ~ 10 cm
2. New window, smaller diameter, upstream of collimator No 2.
3. Kapton Windows in EAR1
4. Smaller valve (shutter) upstream of new window
5. Sample holder?
