CLICpix cross-talk issue

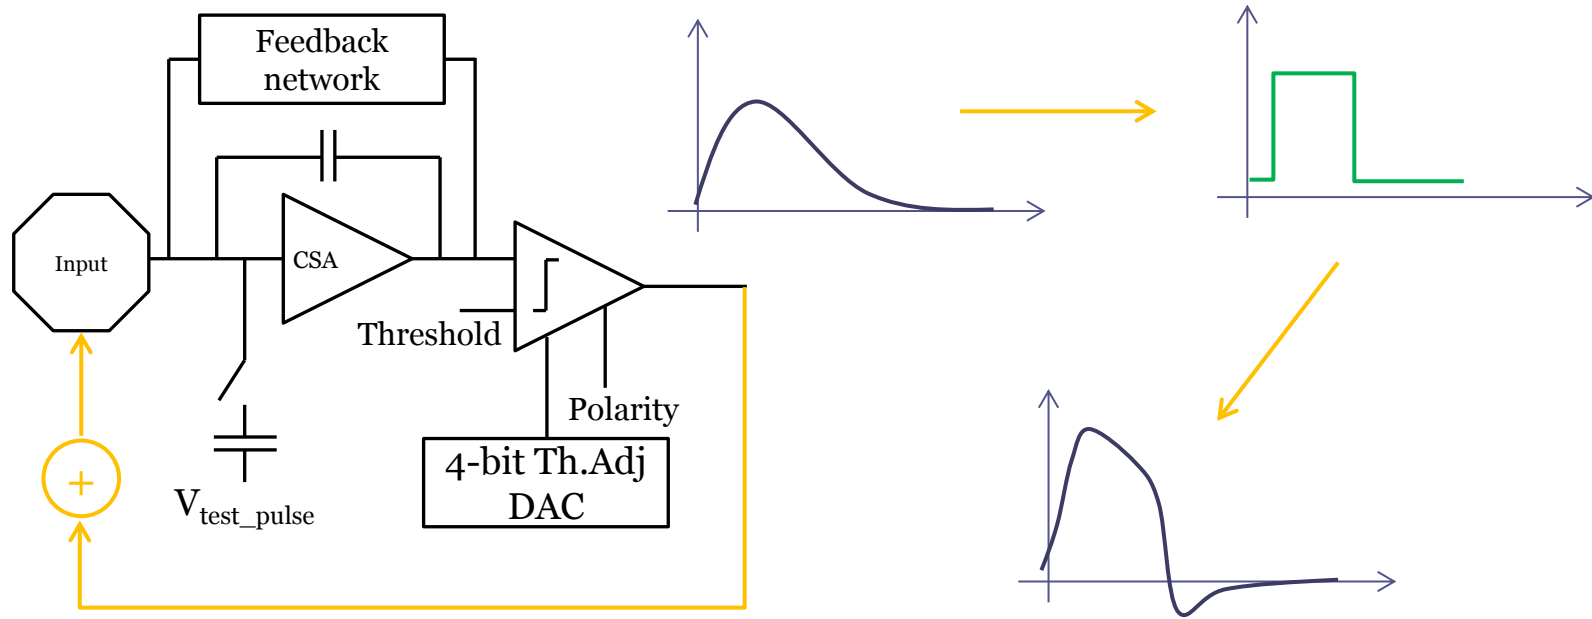
Cross-talk feedback

- While testing different polarities, we noticed that the S-curve measurement for one polarity (holes collection) showed a much larger noise than the other
- Moreover, the noise for pixels on the left of a double column was 3x the noise from pixels on the right
- Despite looking like noise, the counters were not saturating → the front-end was oscillating

- Due to an error in the physical layout of the cell, the output injects charge which feeds back into the input

- Unfortunately I don't think there is any valid workaround, as the effect is largely independent from the biasing conditions of the chip.
- The only solution is to set the threshold far away from the baseline ($>1500 e^-$) so that the front-end can't start oscillating. If the threshold is high enough, the performances of the measurement shouldn't be affected by the issue, apart for a small offset in the TOT count.
- More unfortunately, the HVCMOS sensors we have access to operate mostly in the worst polarity
- The issue is not related to the architecture of the chip or the technology used. It's a layout mistake which can be solved with better routing and shielding.

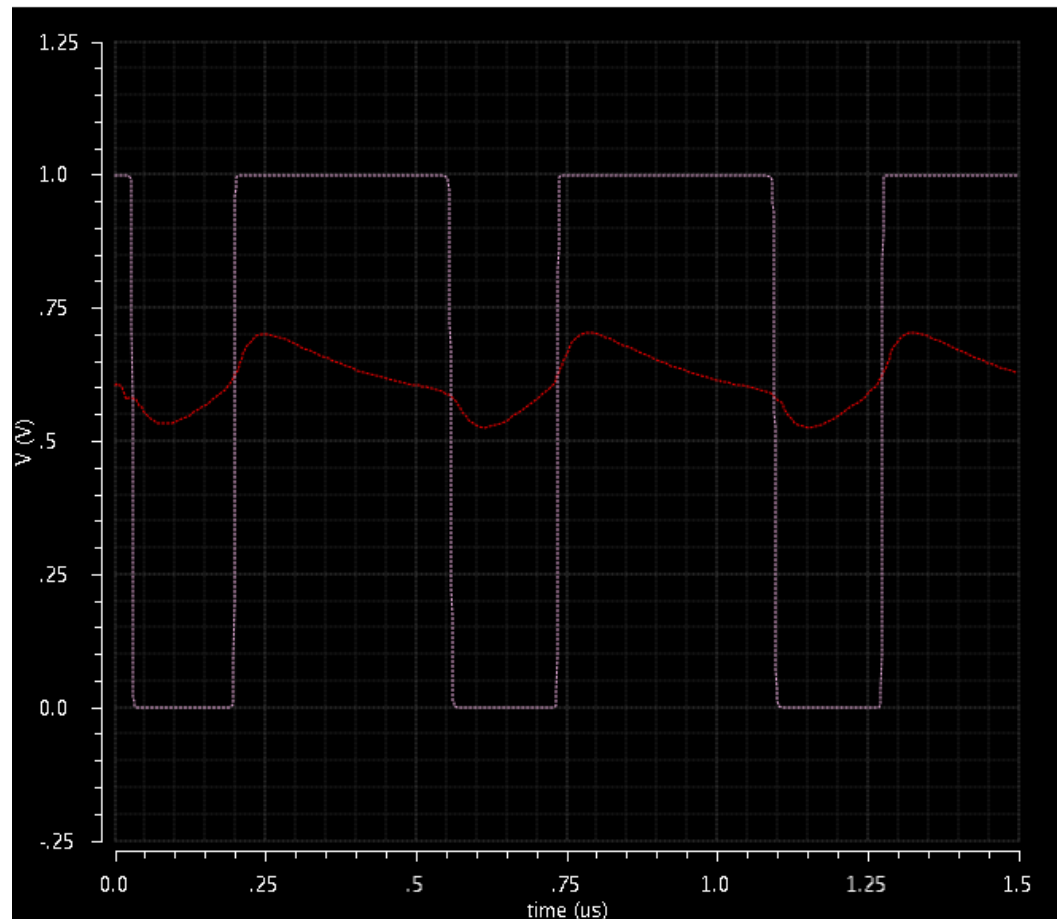
Simulated effect

- In holes collection polarity, if the threshold is close to the baseline, the injection can produce a pulse in the opposite direction, making the front-end oscillate
- The frequency of the oscillation is tied to the I_{krum} value, but otherwise the effect is mostly independent from the working conditions of the chip.

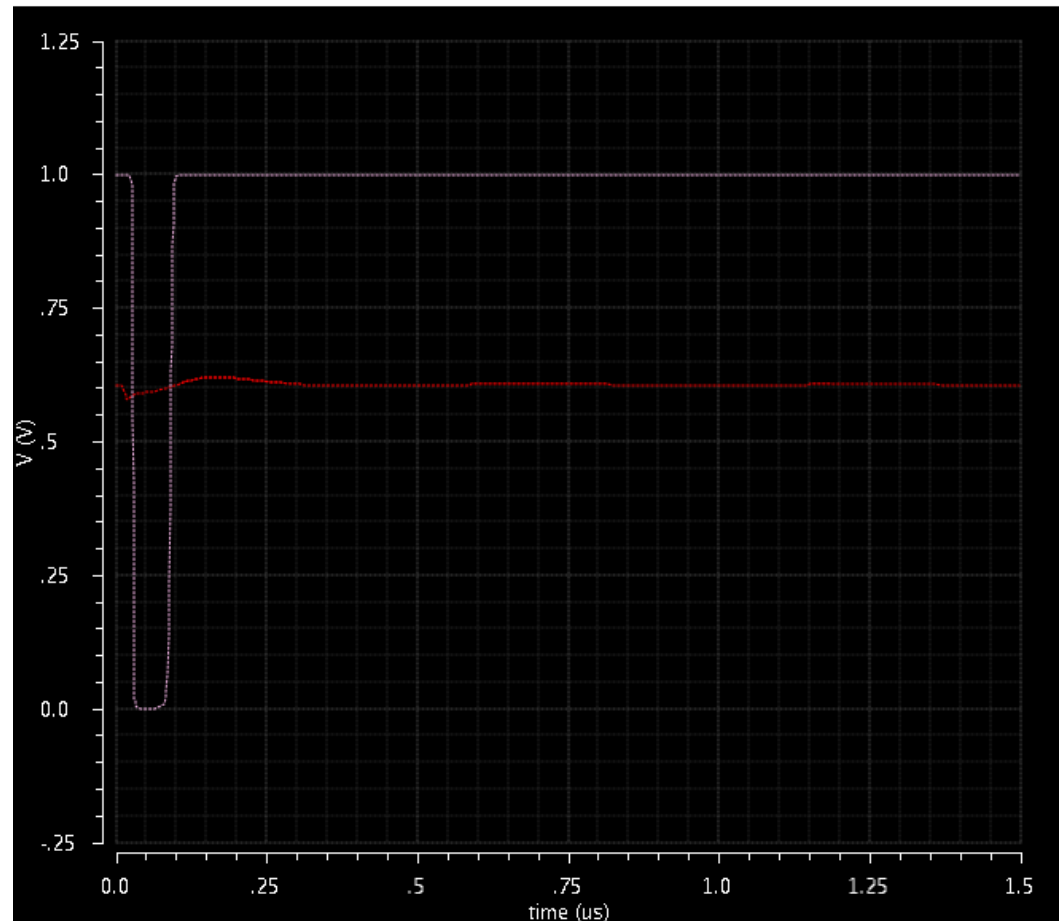
Simulated effect (different pixels)

- For pixels in the right side of double columns, the injection is much smaller, so it increases the measured noise, but it doesn't cause the front-end to oscillate

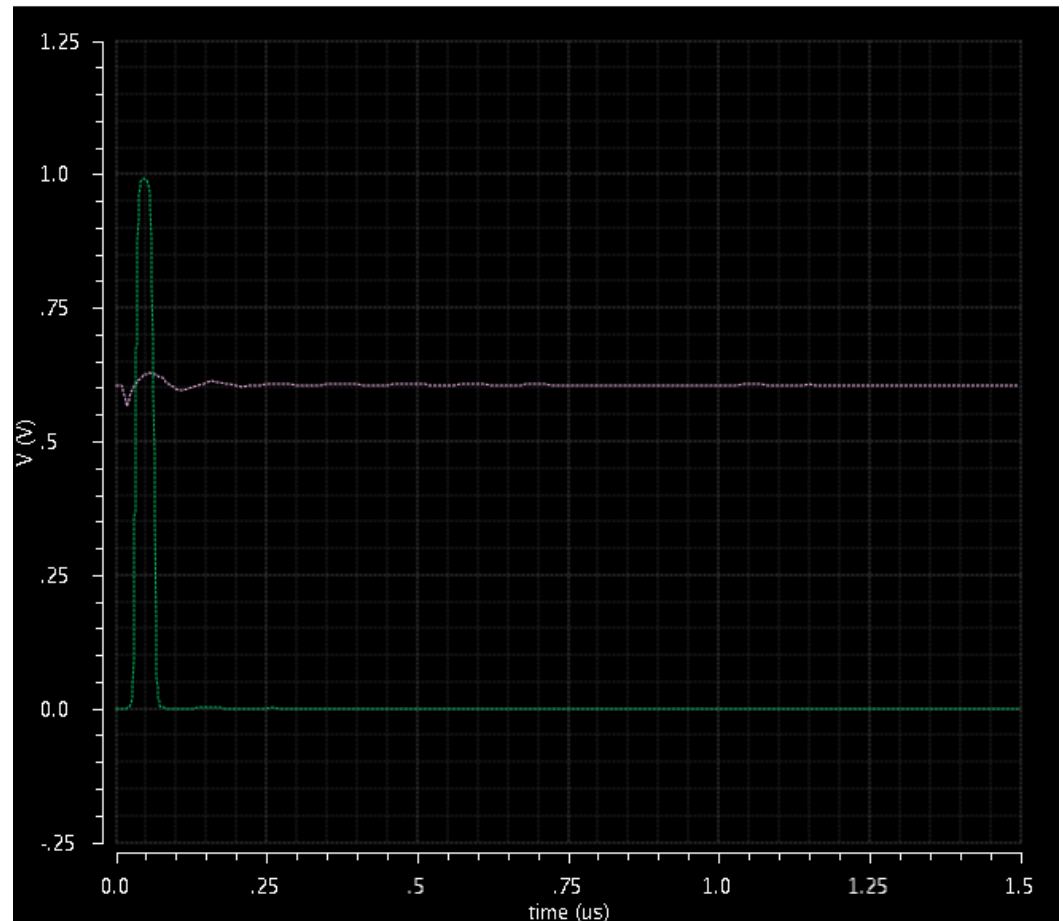
Simulated effect (other polarity)

- For the other polarity, the injection is subtracted from the input charge. It will cause a shift in the TOT measurement, but it doesn't cause the front-end to oscillate
