Science & Technology
Facilities Council

Computer Operations Group Data Centre Facilities

Hitendra Patel
June 2015

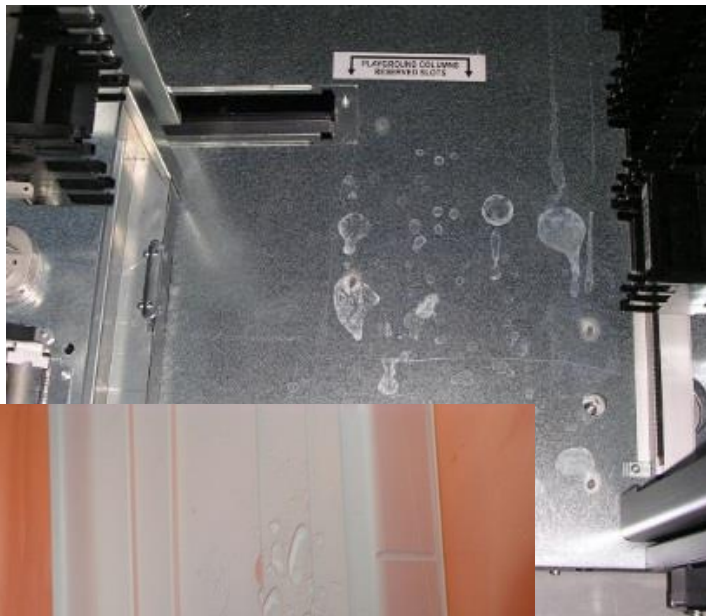
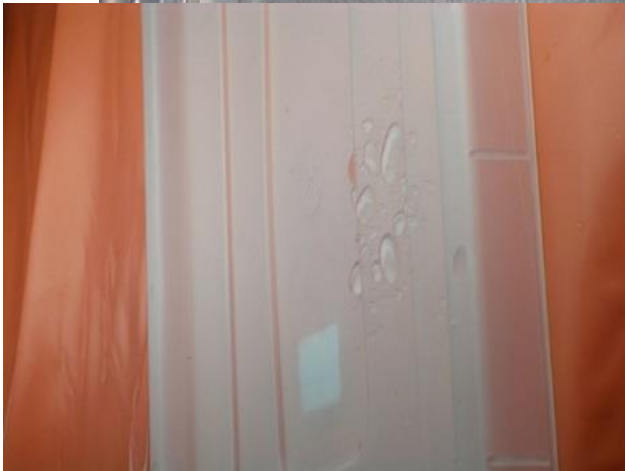
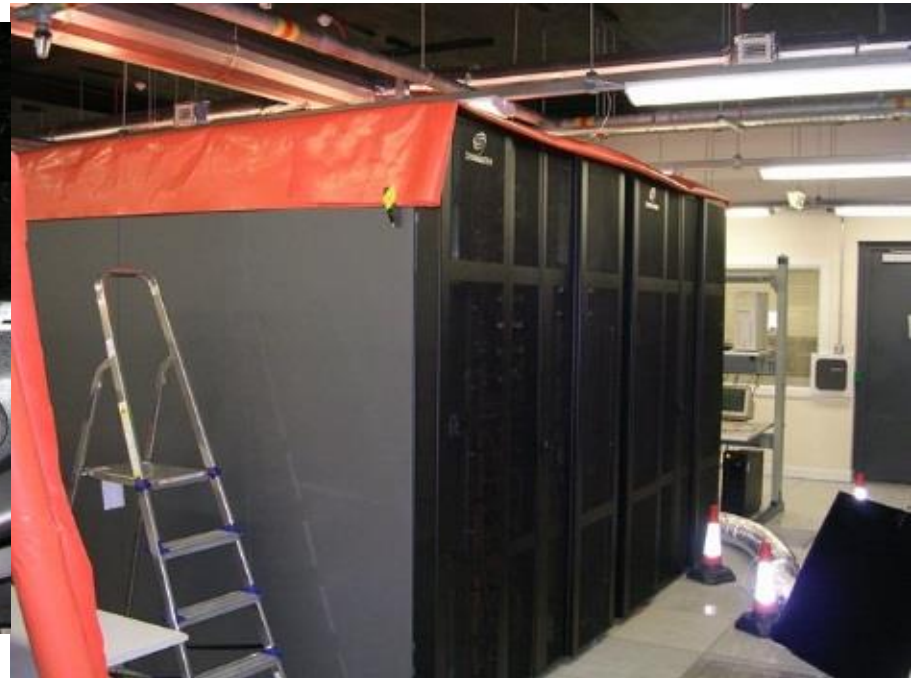
Water Leak

June 2009 Water leak

- Water leakage from AHU on the first floor identified.
- Water leaked into the SL8500 tape robot
- Water leak missed a rack in the HPD computer room

- Modified with overflow drainage
- Installed water detection system linked to the auto shut-off the water on the 1st / 2nd floor.
- Installed bund under the 1st floor kitchen

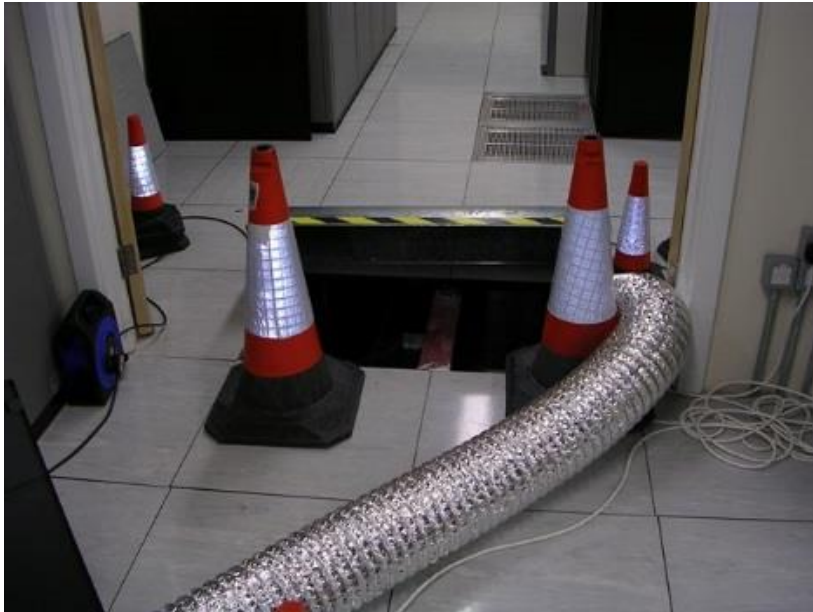
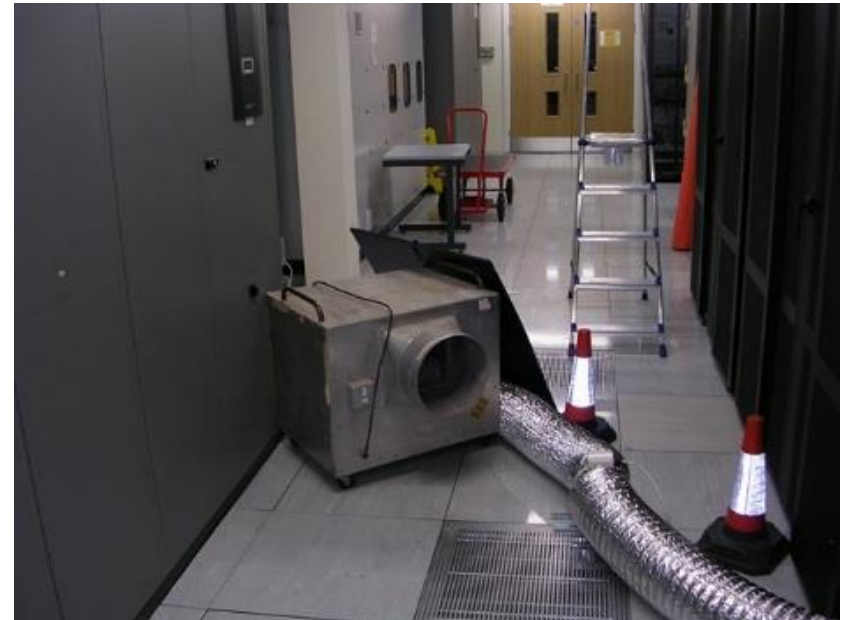
Air Conditioning Failure

August 2009 Air Conditioning failure

- Complete air conditioning auto-shutdown
- All racks in the HPD computer room shutdown
- UPS and LPD computer room survived because of dual CRAC (DX and chilled-water)
- Cause was a faulty sensor
- HVAC system managed by BMS

- BMS reconfigured to act as slave/notification only
- Complete temperature sensors installed and alert notification setup

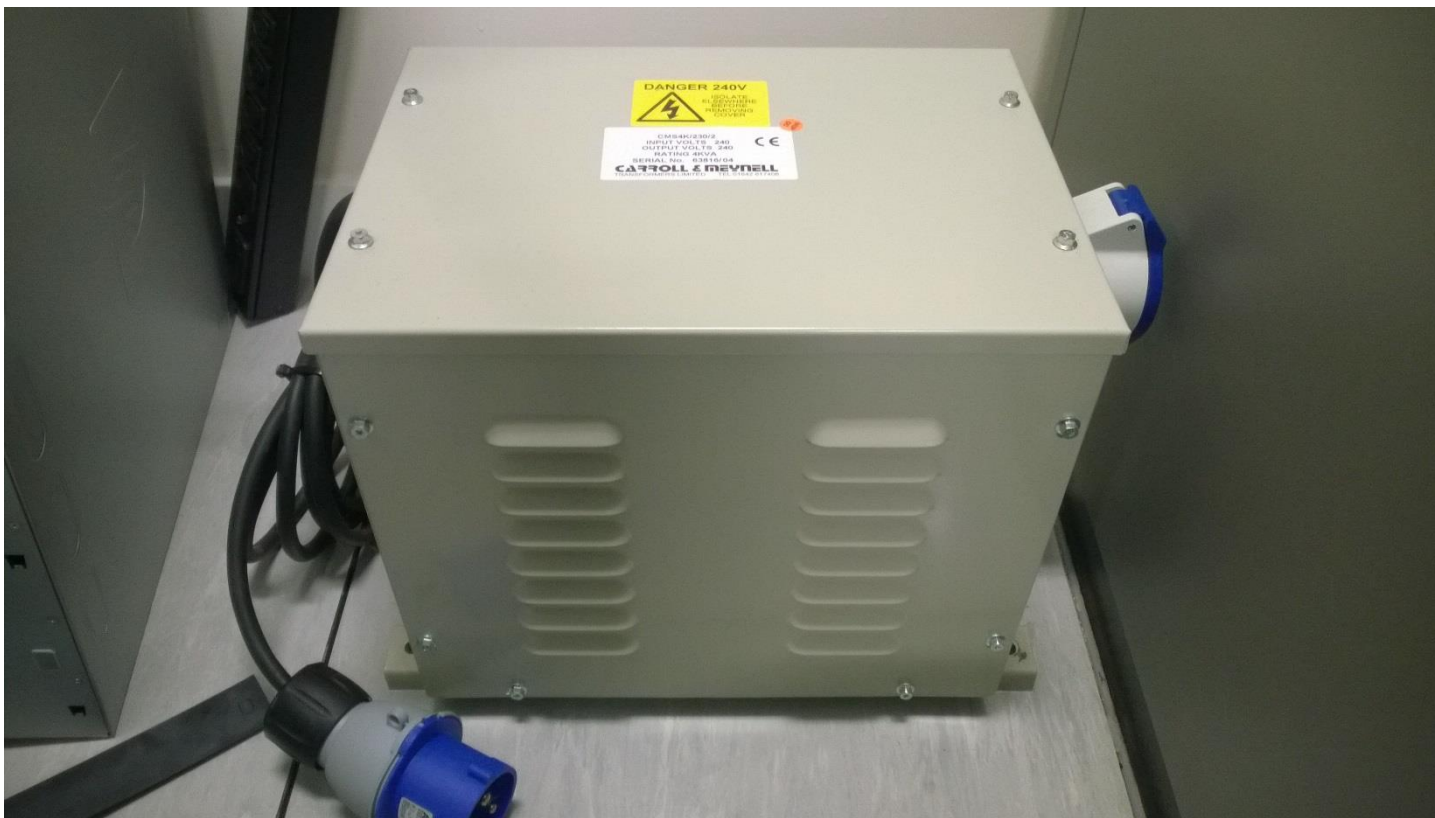
4kVA isolating transformer

Noise in the UPS power supply

- Some EMC power supplies detecting auto-shutdown
- Critical Tier1 database racks affected
- UPS supply under-load 20% usage

- 100m power cable installed to reduced noise ***DID NOT WORK***
- Purchased 4kVA isolating transformers for each supply to the rack.
WORKED

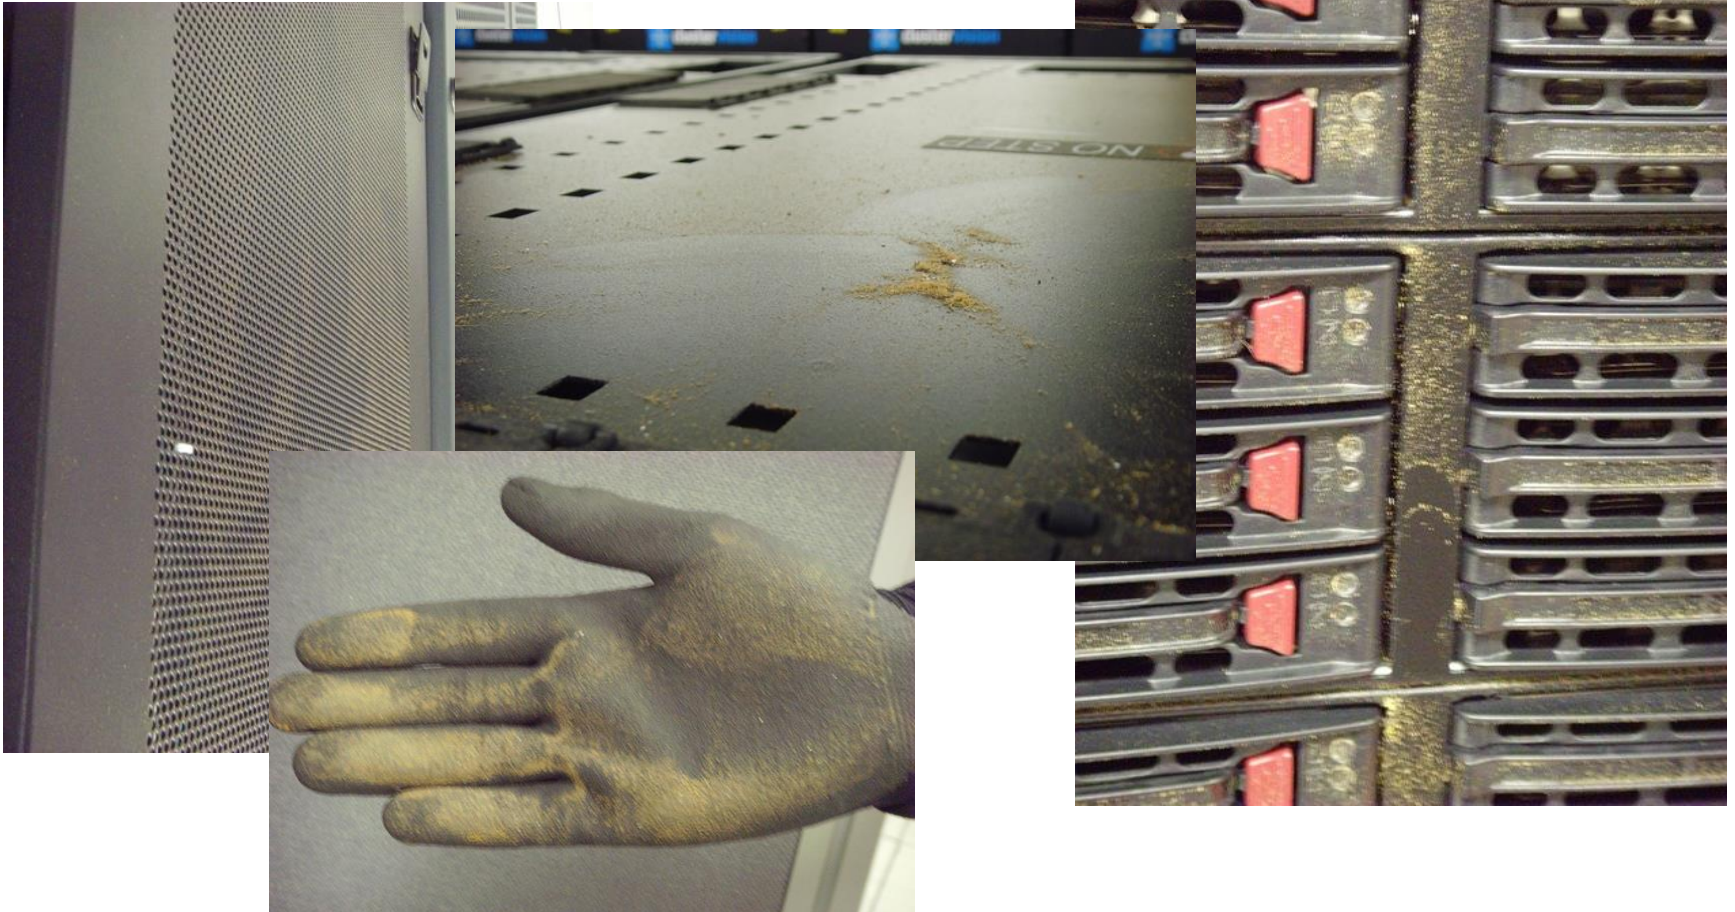
HPD Dust Contamination

Dust contamination in the HPD Computer Room

- Pipe lagging on the chiller water ring mains coming off
- Orange dust contamination in the room
- Health & Safety issues

- Access limited to HPD. Masks must be worn
- Replaced ALL the lagging
- Underfloor/overhead cleaning implemented and CRAC filters replaced
- Routine checks on the lagging

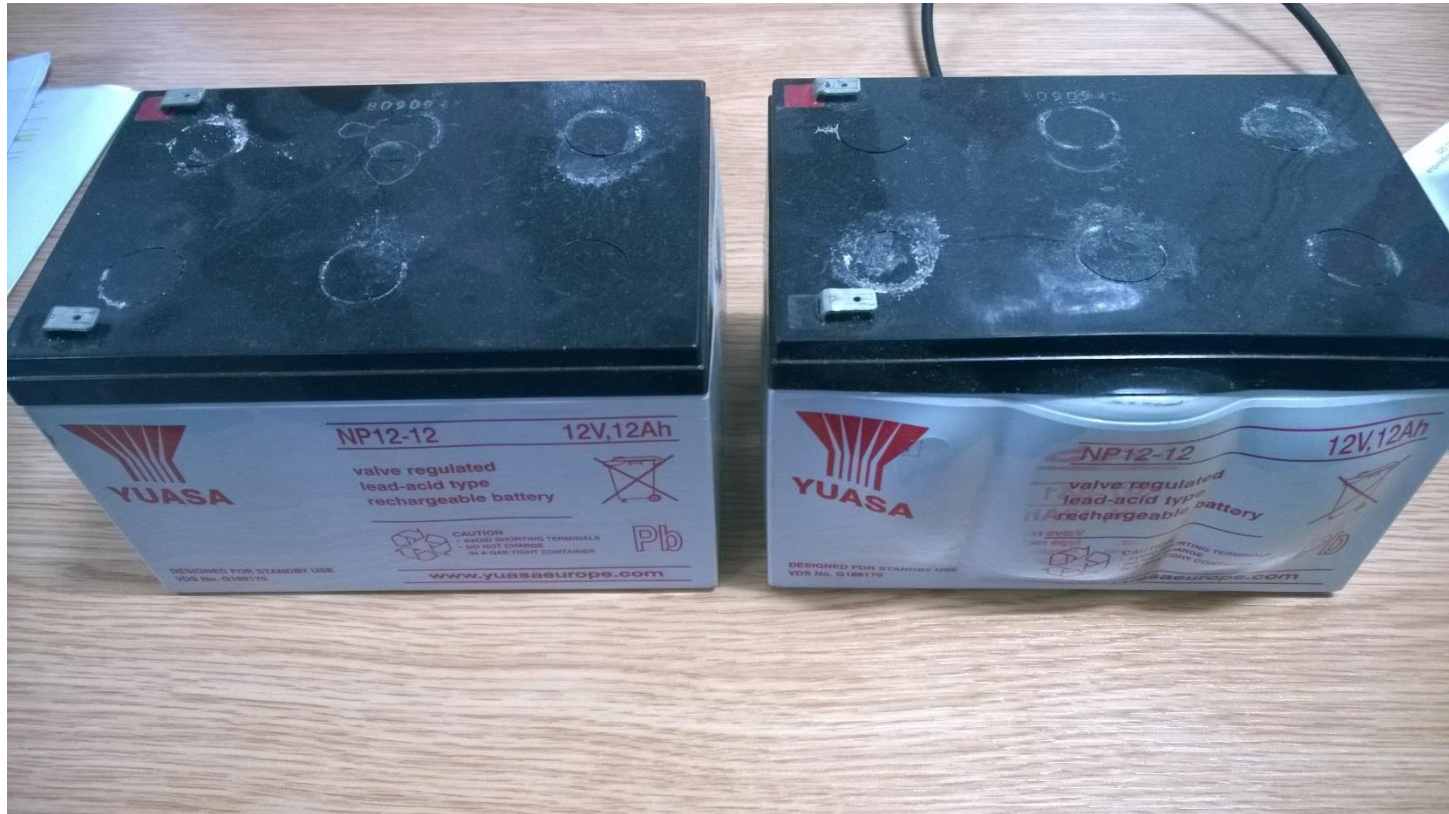
Faulty Transformer batteries

November 2012 Generator Test

- Generator failed to start
- UPS Computer room on UPS feed with NO power!
- Bus-coupler failed to close when fuse put back in

- Bus-coupler manually switched in and normal power restored
- Fault identified to faulty battery in the transformer. Could have been as a result of the power cut in early November
- All internal batteries removed from the transformers and now powered from central source. All batteries now monitored
- Generator Testing regularly – On-load every quarterly and Off-load monthly
