# ngCCM Update

Joseph Mariano

27-08-2015

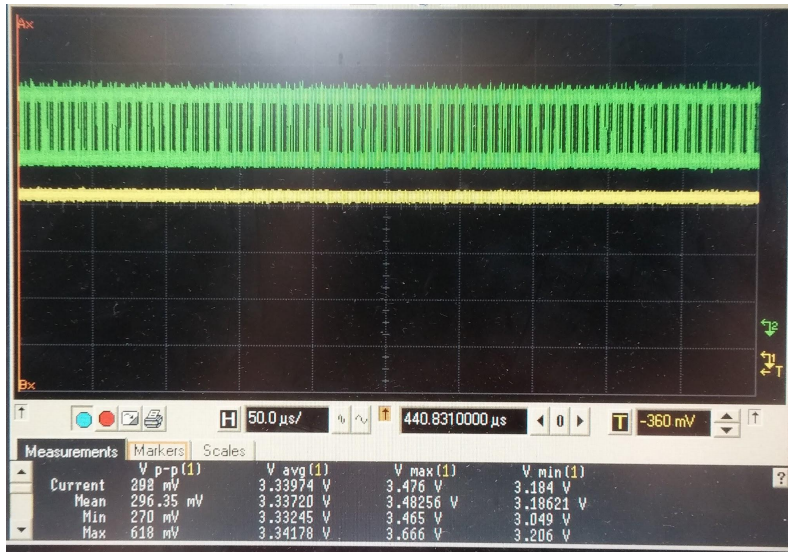
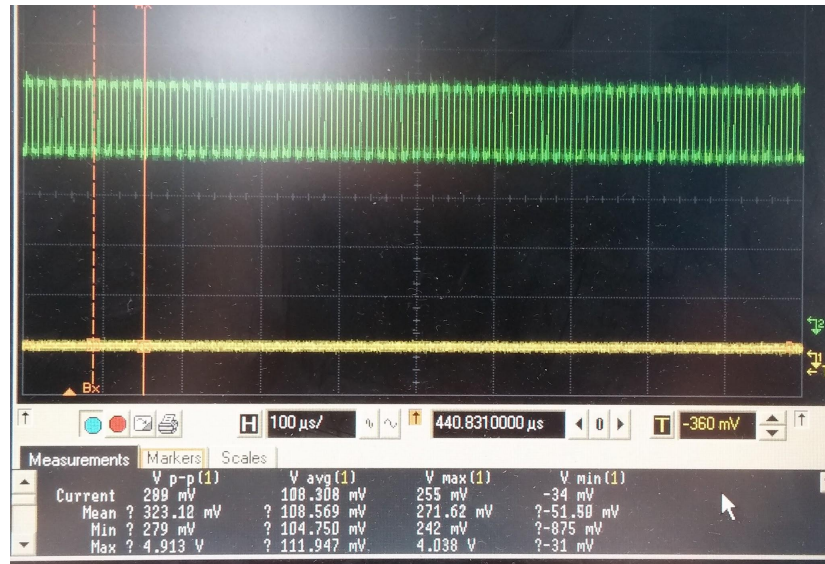
# ngCCM 03-04/002 continued...

- 03-04/002
  - Intermittent communications with QIEs
    - Does not depend on QIE chip number or slot position
  - I2C data line should be  $\sim 3.3V$  when no signal is on the line and be pulled low for data
  - I2C data was found to be stuck low ( $\sim 0.1V$ ) for slots investigated (between 1 and 7)
  - Signals 1-7 are handled by one FPGA (Slow1) and signals 8-14 by another (Slow2)

- But, when I tried to probe slots 9-14, the problem had disappeared (on all slots!)
  - I'm monitoring to see if the issue comes back
