## The Sector 3-4 incident

Ph. Lebrun *on behalf of the*  
Task Force on the Analysis of the 19 September 2008 Incident

LHC Performance Workshop 2009  
Chamonix, 2-6 February 2009

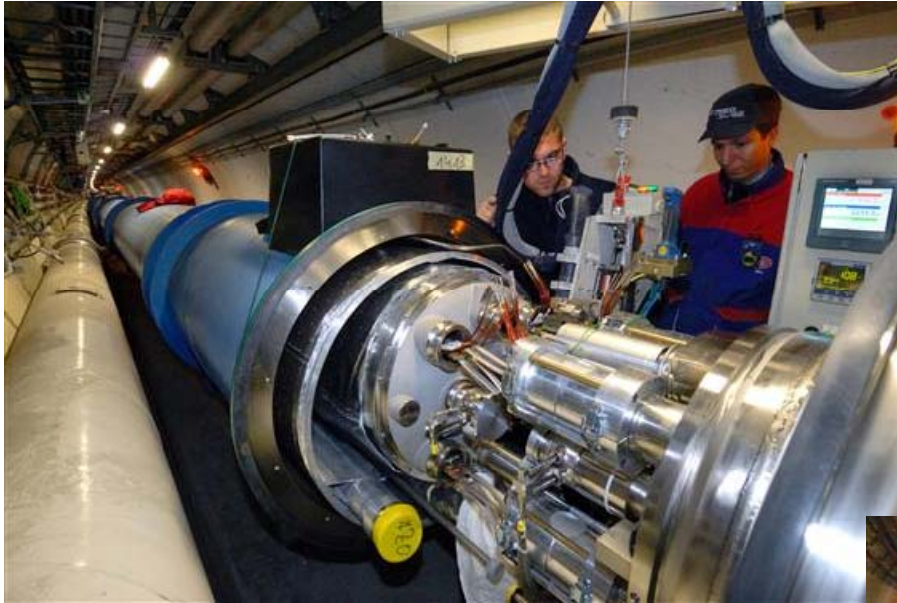
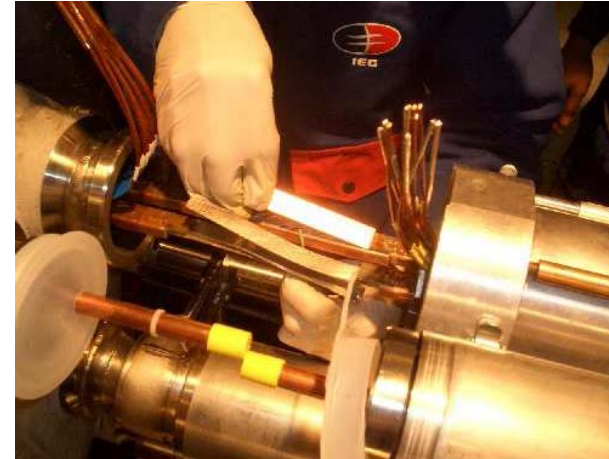
## Electrical joints on 12 kA bus bars

History of interconnections in sector 3-4 (Oct 2006-July 2007) shows no particular cause of defect, but worst working conditions of all machine:

- low temperature and humidity in tunnel
- low productivity of industrial staff (Jan 2007) following contract policy of company

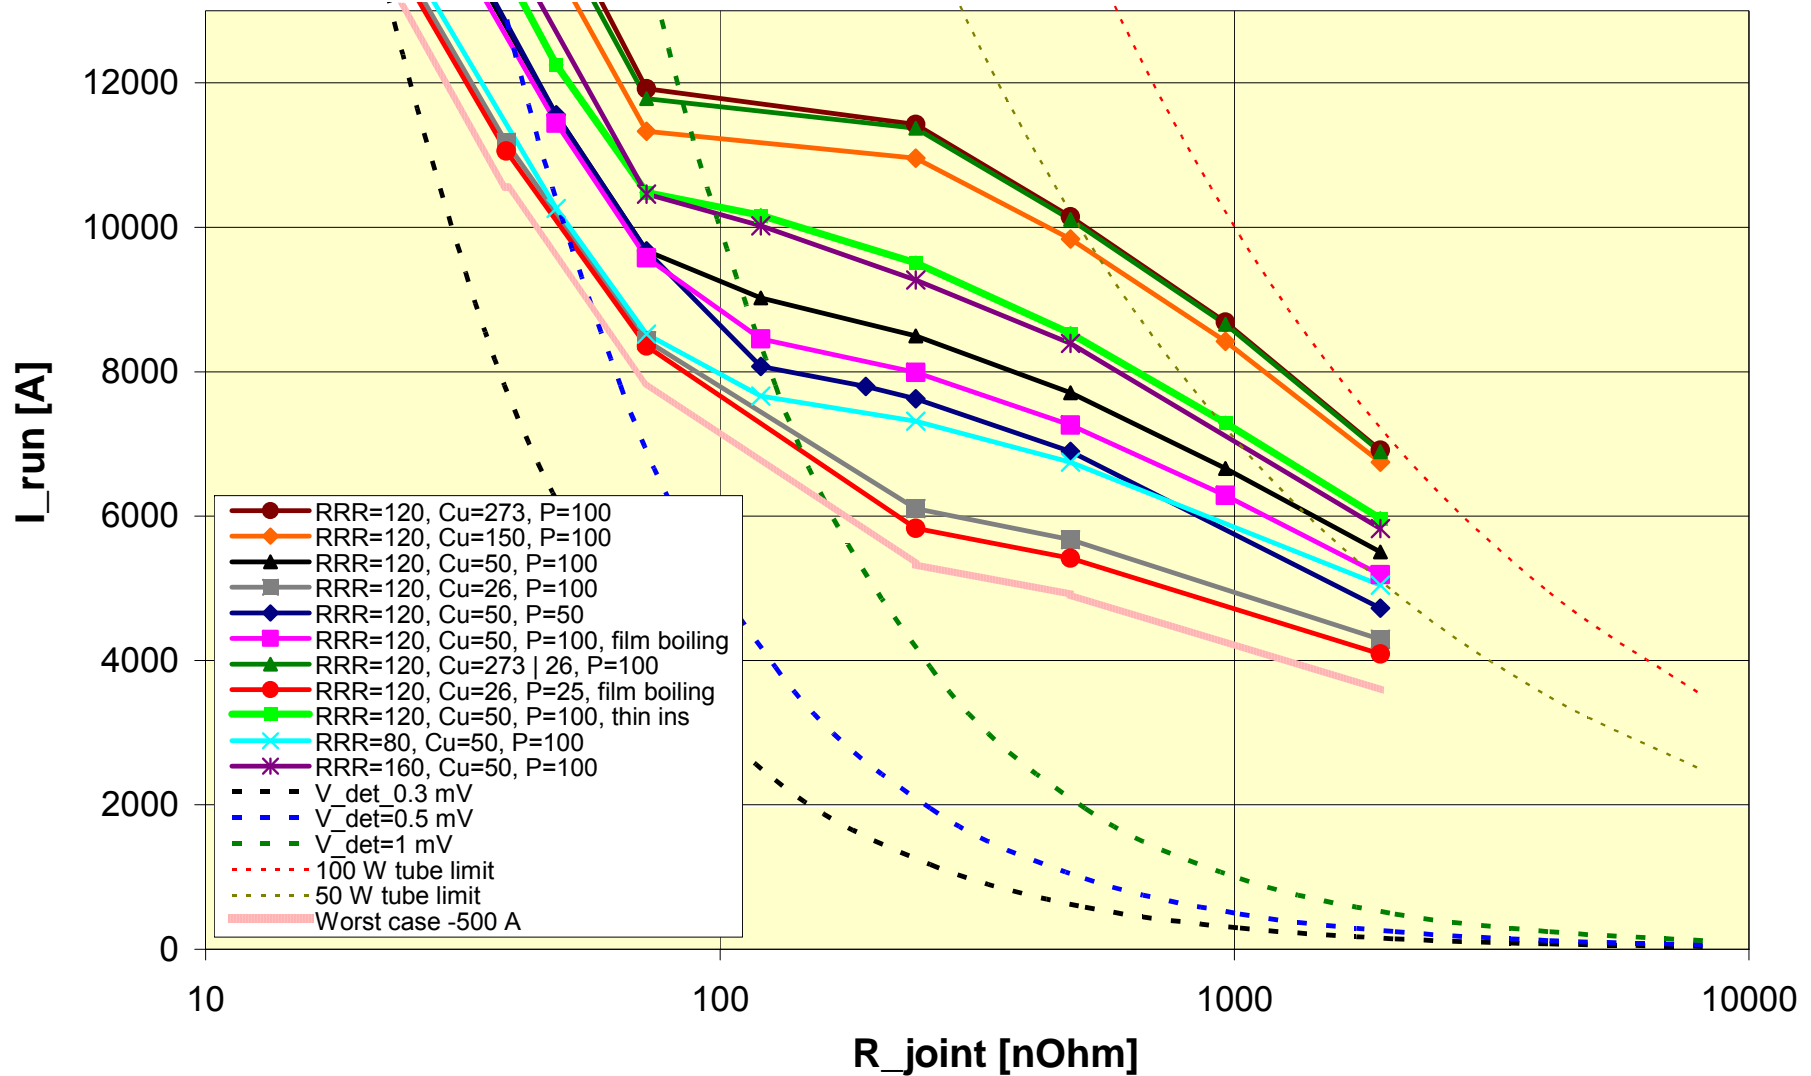
# Simulated thermal runaway threshold of electrical interconnect

A resistive joint of about  $220 \text{ n}\Omega$  with bad electrical and thermal contacts with the stabilizer

No electrical contact between wedge and U-profile with the bus on at least 1 side of the joint

No bonding at joint with the U-profile and the wedge

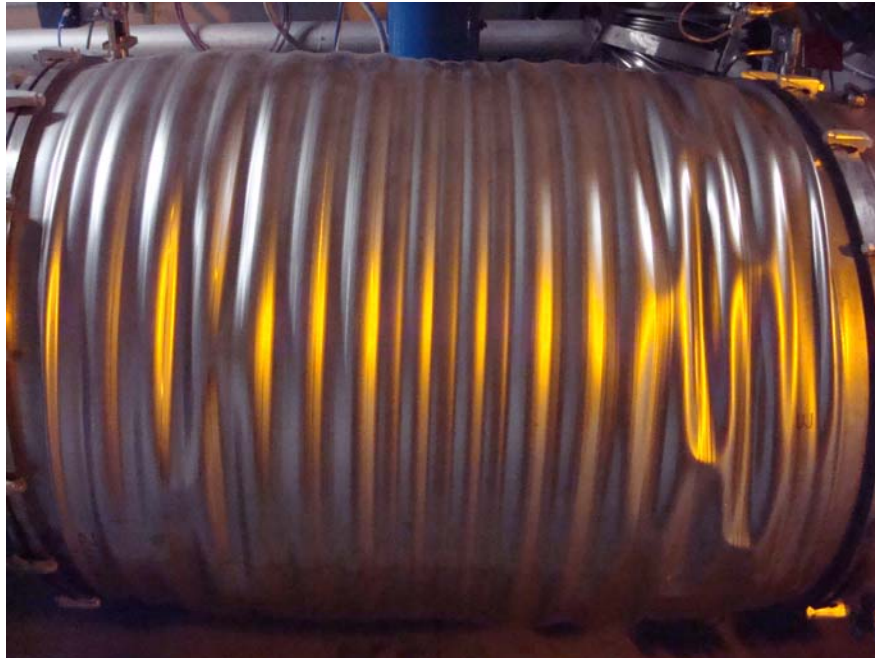
# Assessment of maximum pressure in insulation vacuum enclosure from deformation of W sleeve

Corrugated sleeve of 1 mm thick AISI 316 L

Yield stress 275 MPa

Nominal diameter 1016 mm

Maximum diameter 1055 mm

FE calculation in large displacement case (iterative geometry) gives 7 bar overpressure

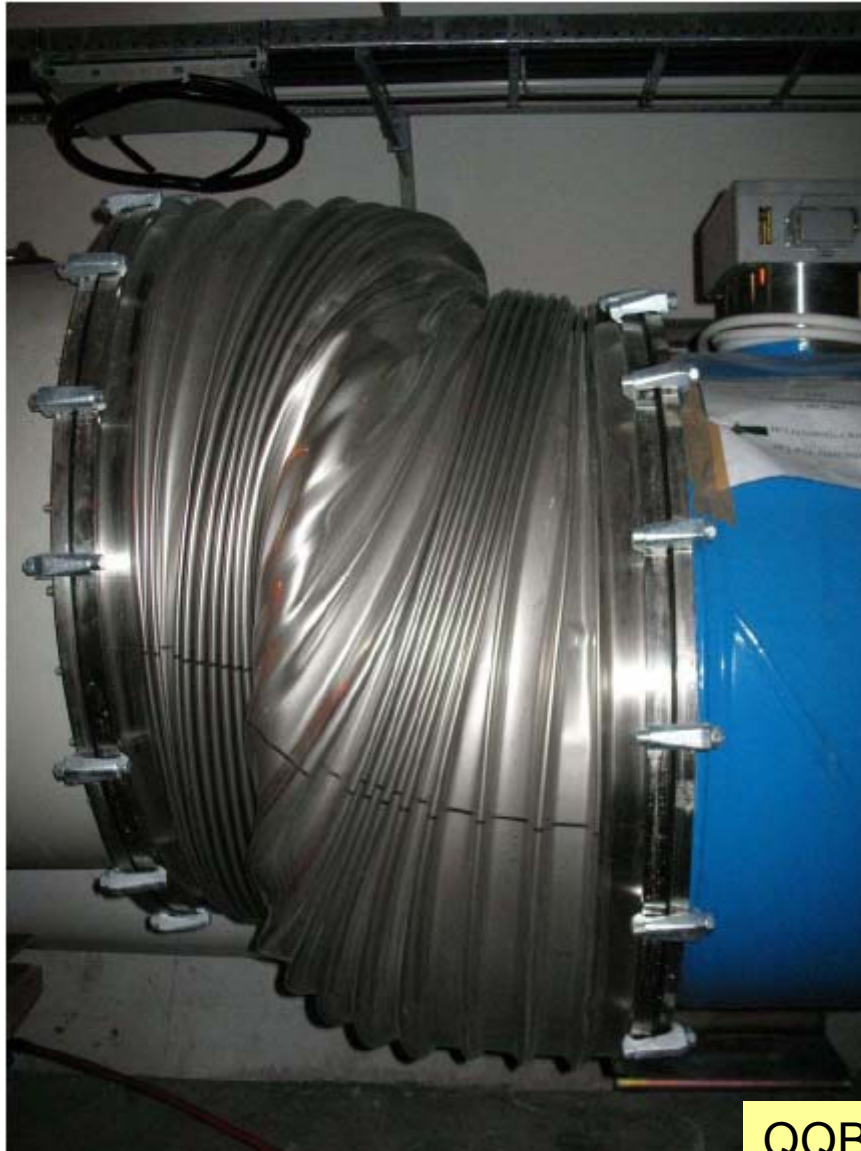
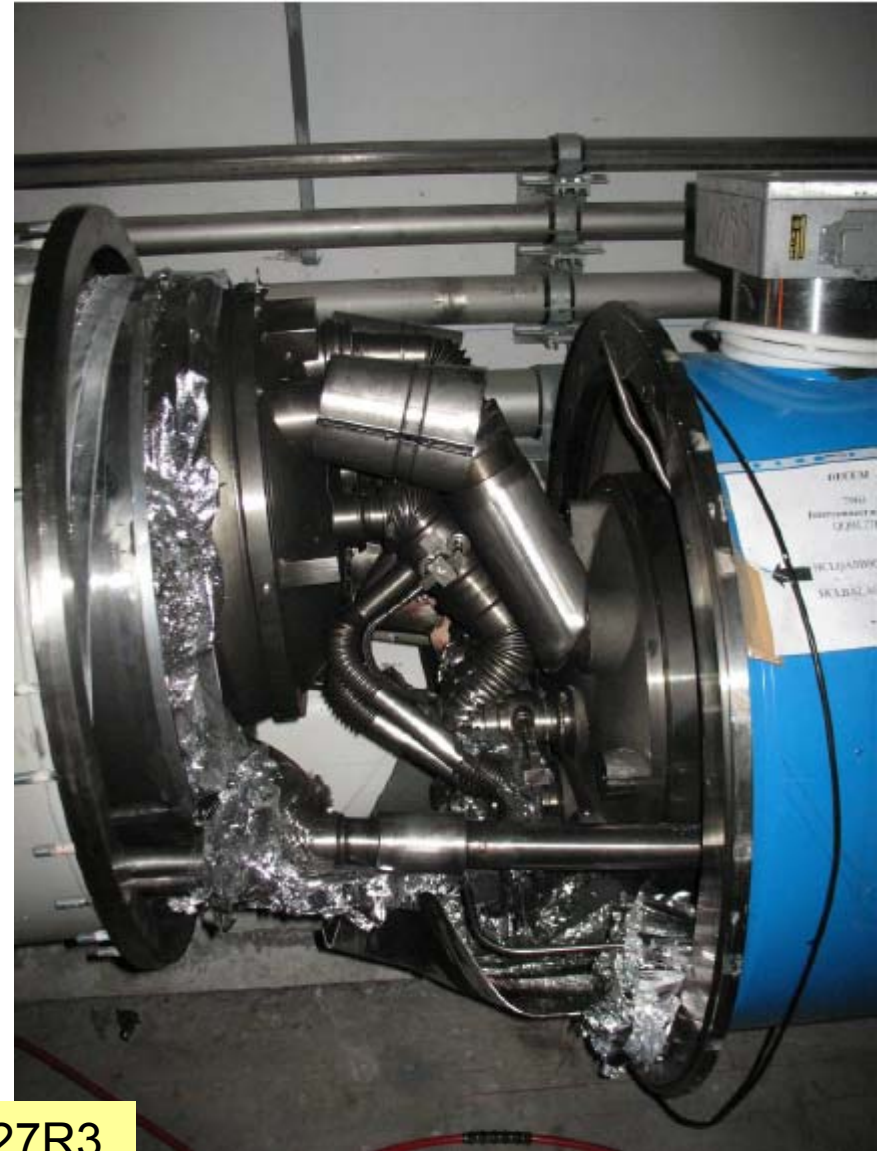
QQBI.27R3

# Collateral damage: magnet displacements

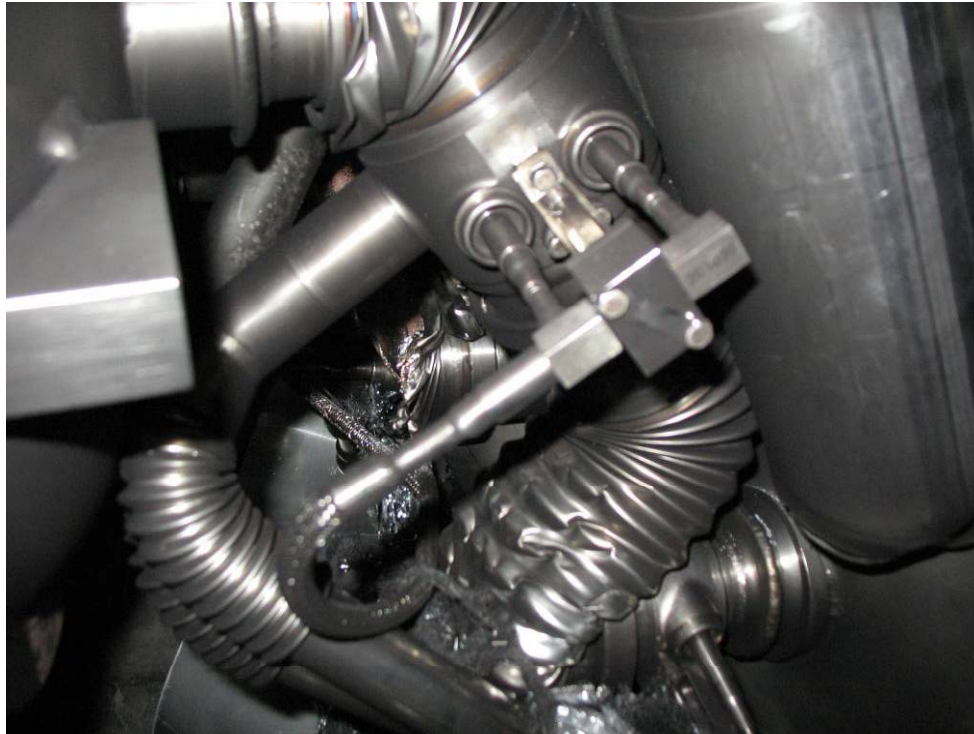
QQBI.27R3  
N line

# Collateral damage: magnet displacements

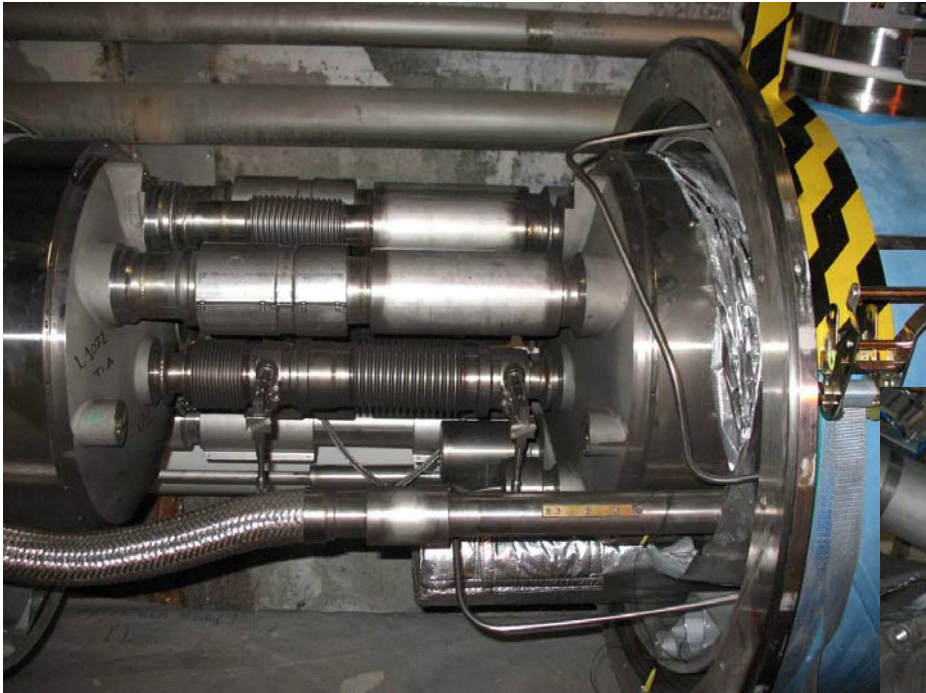
**QBBI.B31R3**  
Extension by 73 mm

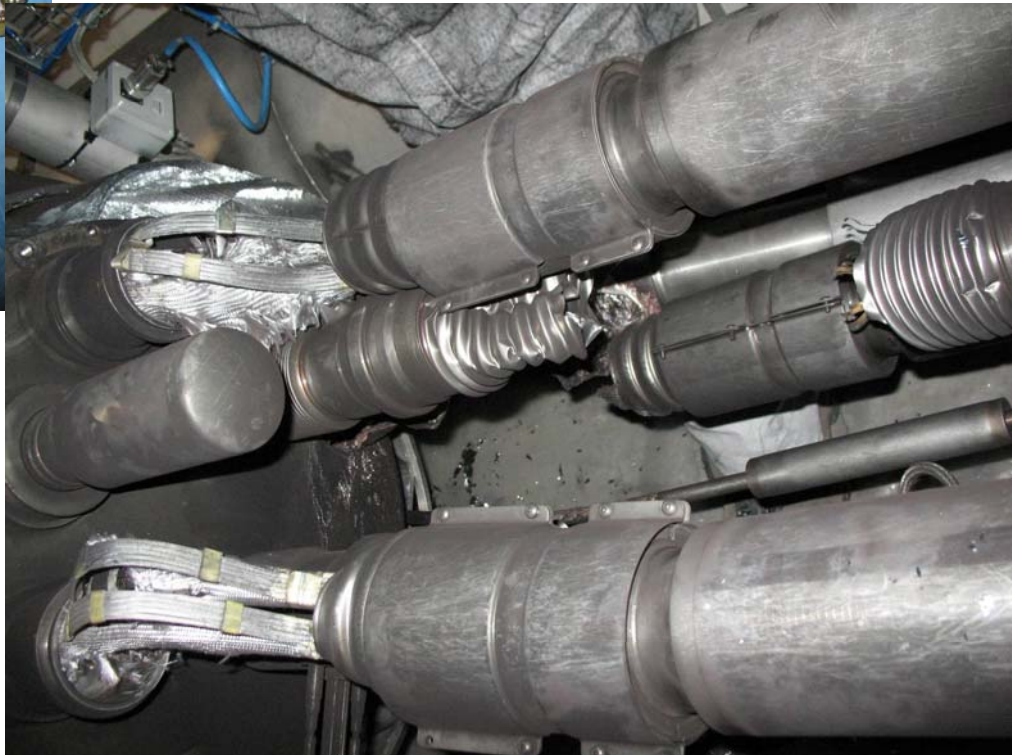
**QBQI.27R3**  
Bellows torn open

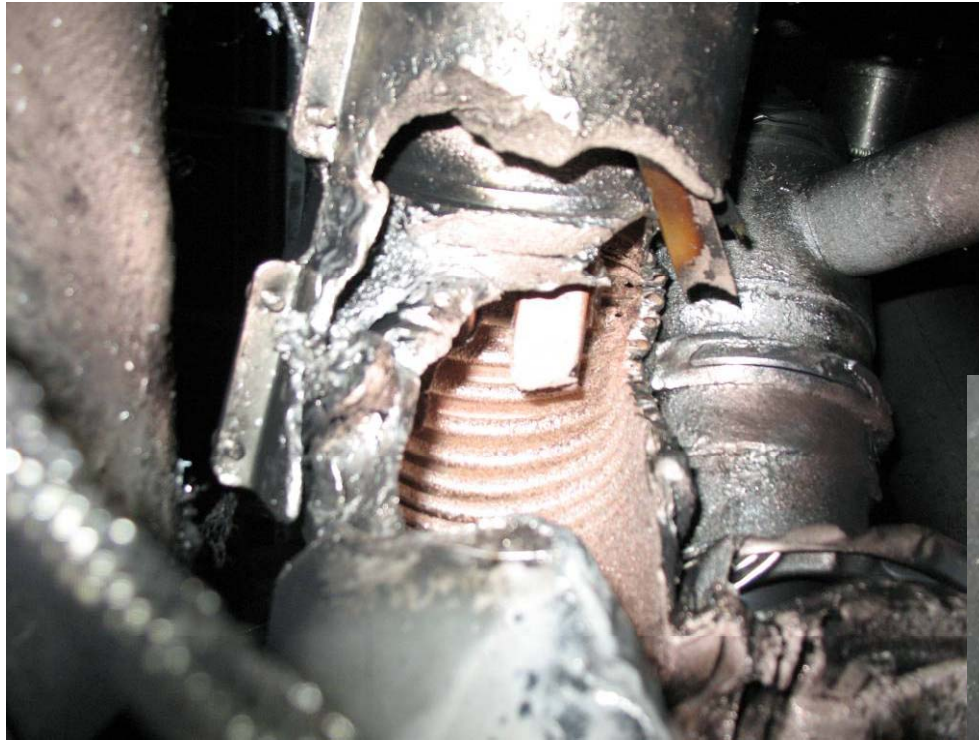
QQBI.27R3 Dipole bus line

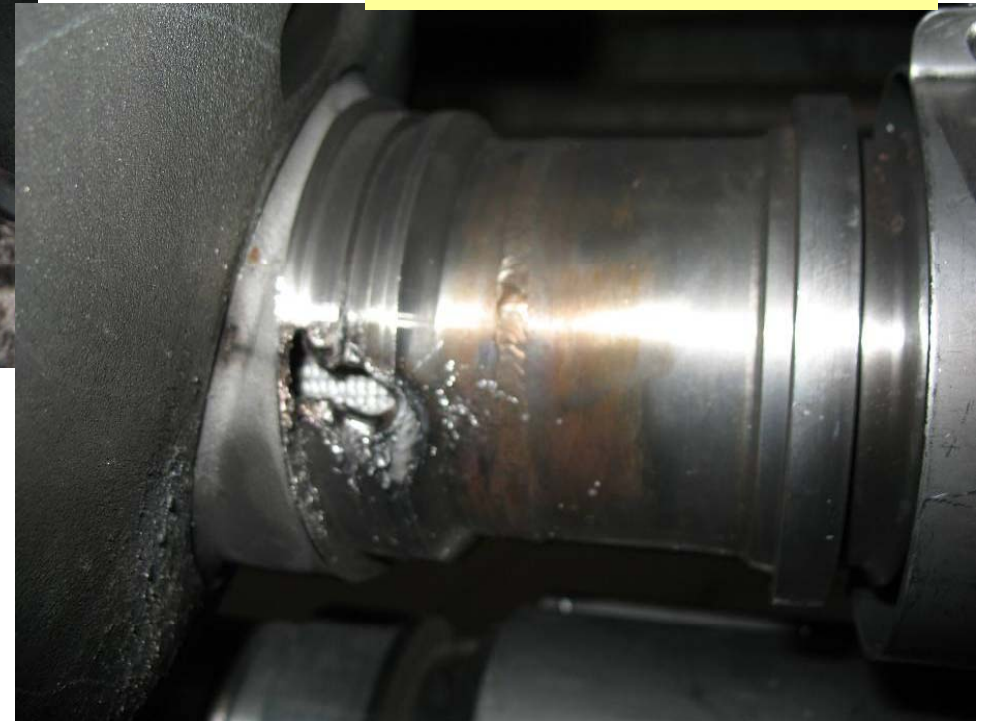
QBBI.B31R3 M3 bus line

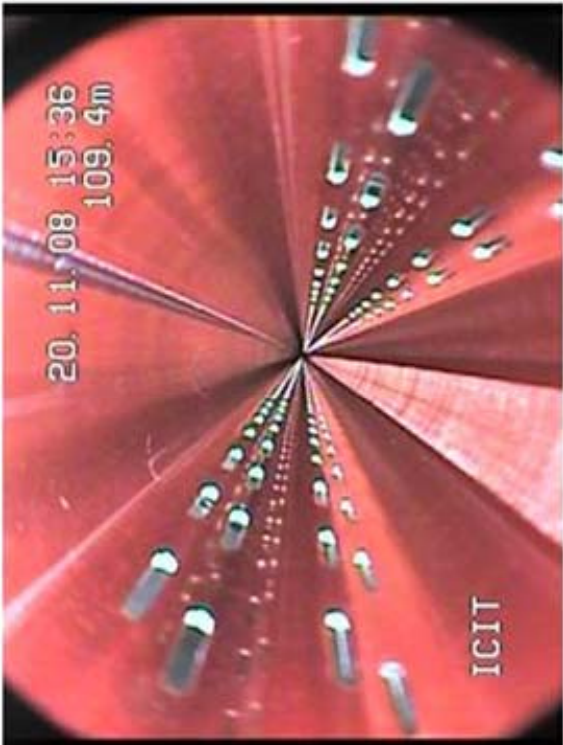
| <p>Beam Screen (BS) : The red color is characteristic of a clean copper surface</p> | <p>BS with some contamination by super-isolation (MLI multi layer insulation)</p> | <p>BS with soot contamination. The grey color varies depending on the thickness of the soot, from grey to dark.</p> |
