Fracture Failure Analysis for MQXF Magnet Aluminum Shells

Mon-Mo-Po1.03-02

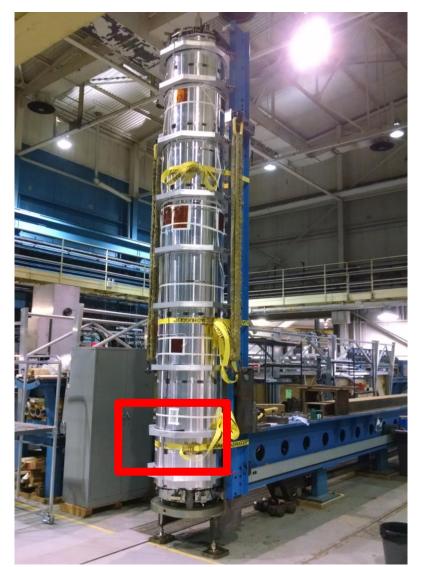
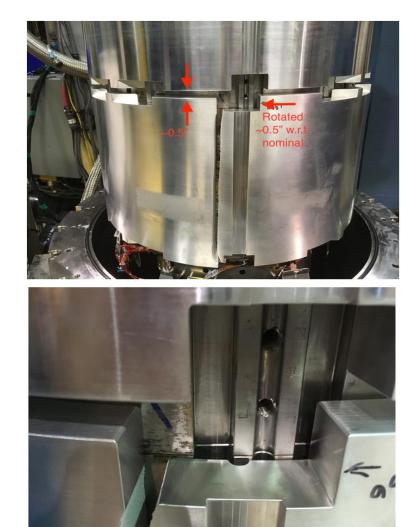
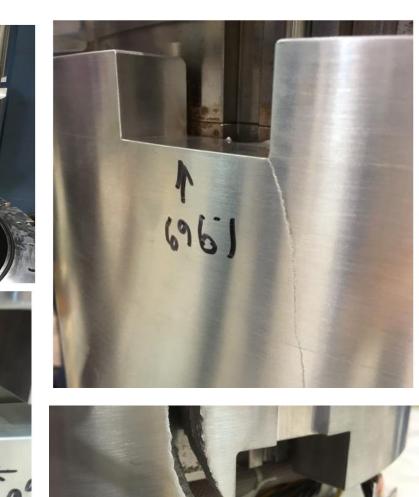
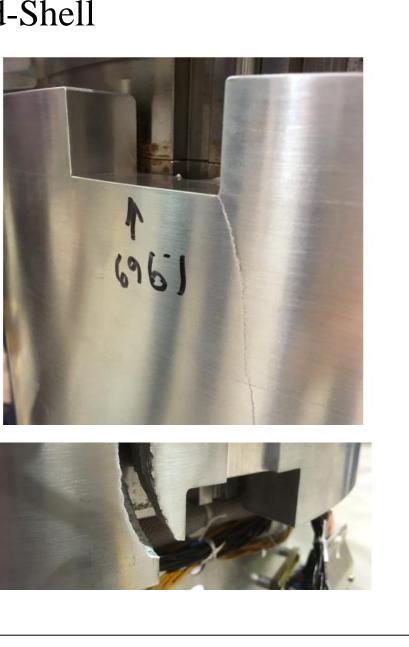
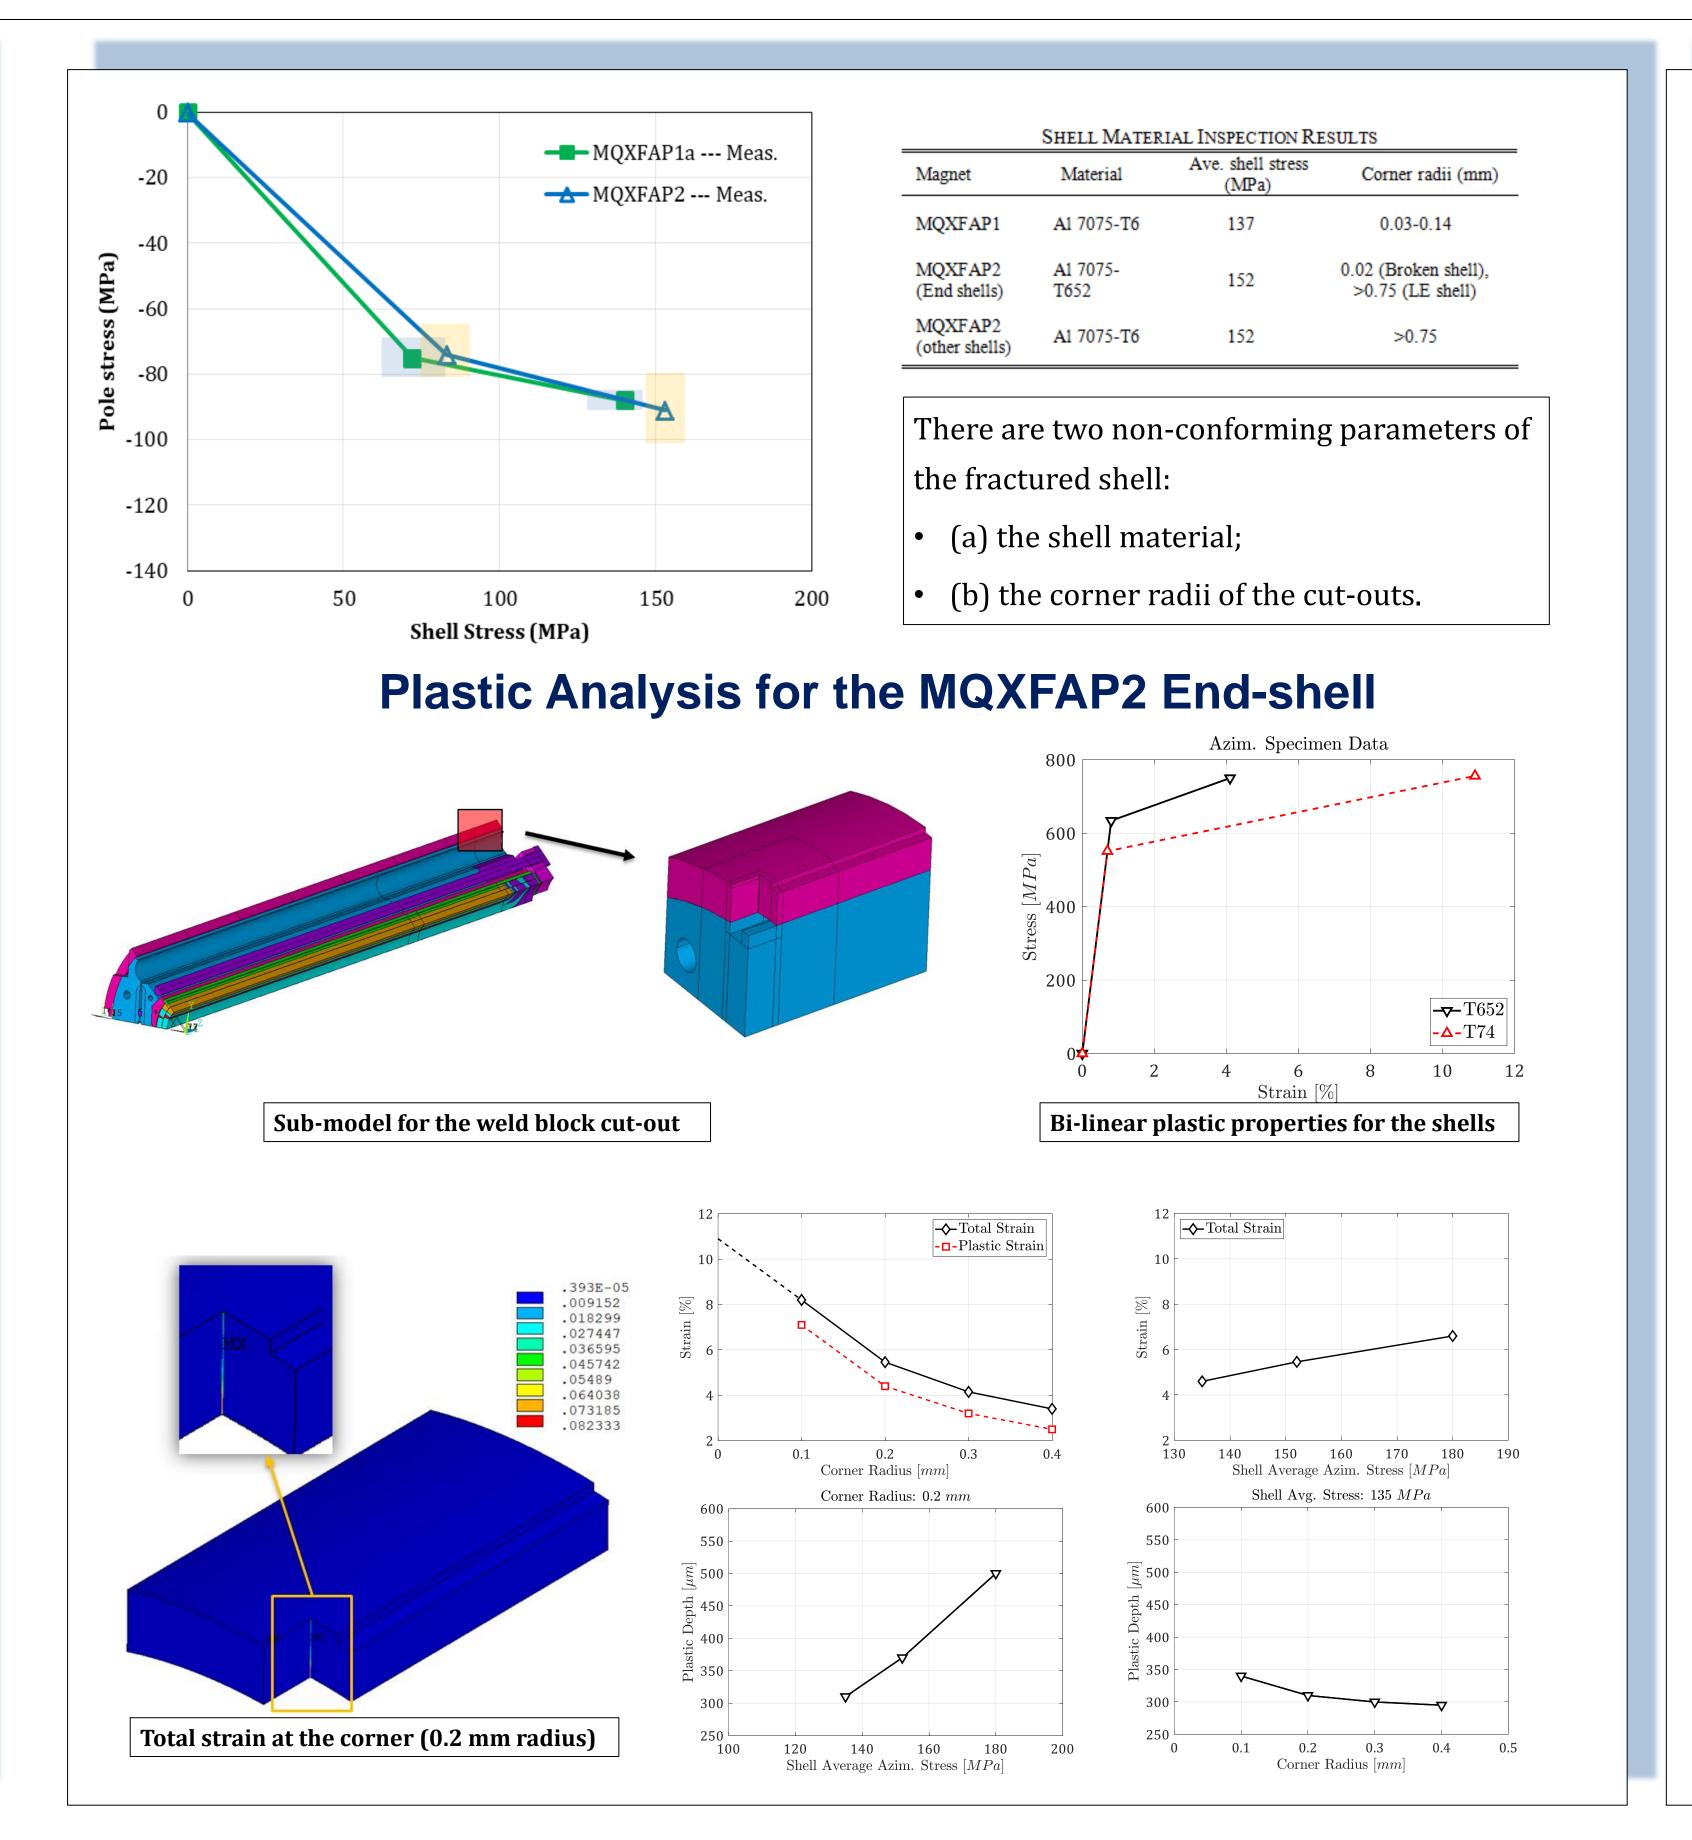
Fracture Failure of the MQXFAP2 End-Shell

The cold test of MQXFAP2 was stopped by a notable unstable structure behavior, which was identified fracture failure on the end shell. A longitudinal crack was plainly evident in the RE end shell. The shell displaced by approximately 15 mm axially, and rotated also about 0.5°. The fractured surface appears rough, and no "fatigue-induced" cyclic rubbing appears present based on microscope checks.

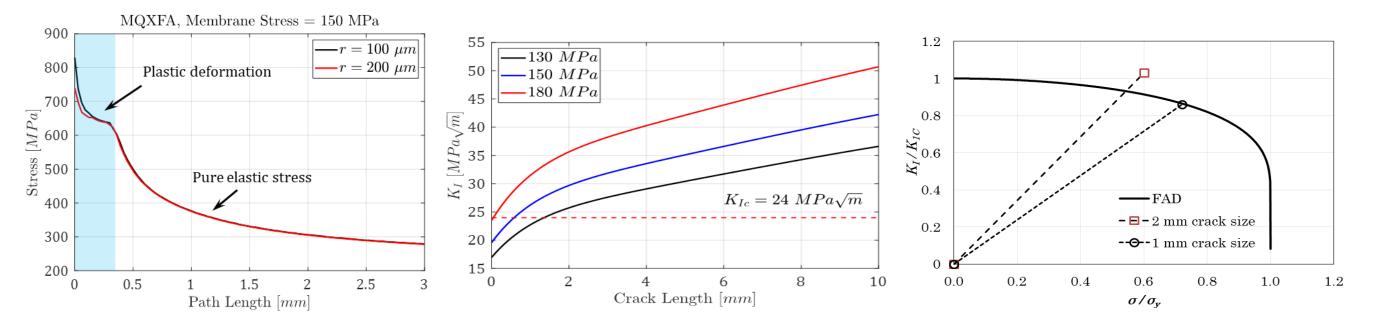
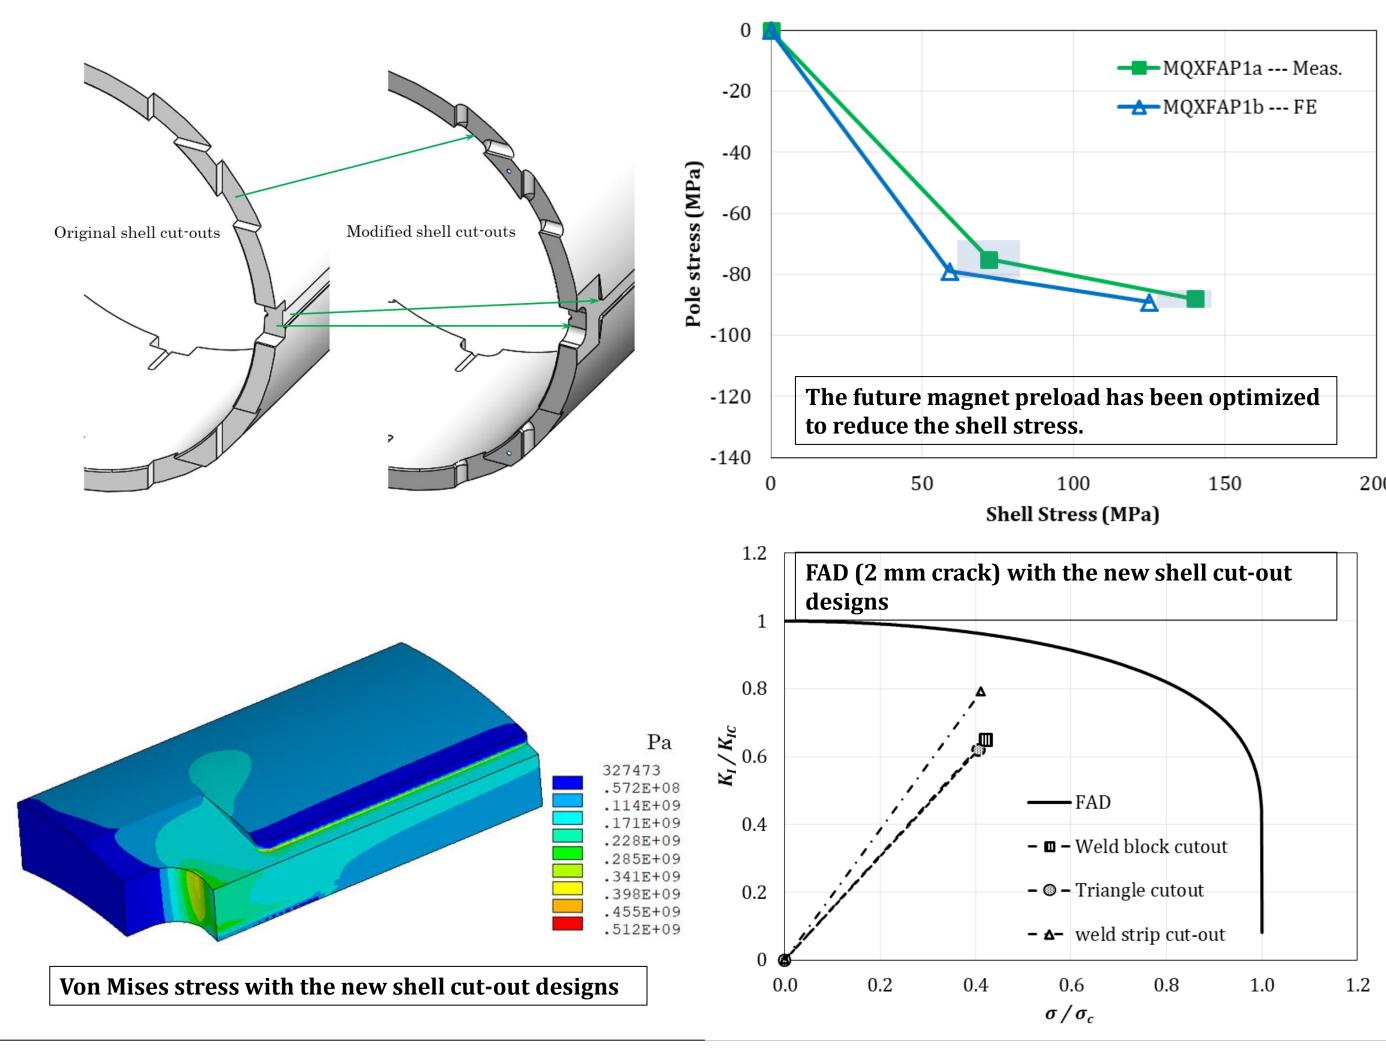
Fracture Analysis and Shell Redesign

- The size of the plastic zone of the cut-out of the MQXFAP2 end shell is close to the critical flaw size with a real corner radius on the level of 0.02 mm.
- It's apparently that the weld block cut-out of the MQXFAP2 end shell does not meet the load factor requirement.

In this paper, we report the fracture analysis of the current shell design, including the elasto-plastic simulations with sub-model technique, and calculations with Linear Elastic Fracture Mechanics (LEFM). Test material properties are also presented. The results of this analysis explain why the end shell of MQXFAP2 failed, and suggest fillets on the end shell notches to meet the margin specified in the Structural **Design Criteria.**
