Internal Review of the LHC Machine Protection System: The Beam Dumping System

Jan Uythoven
For the LBDS Team

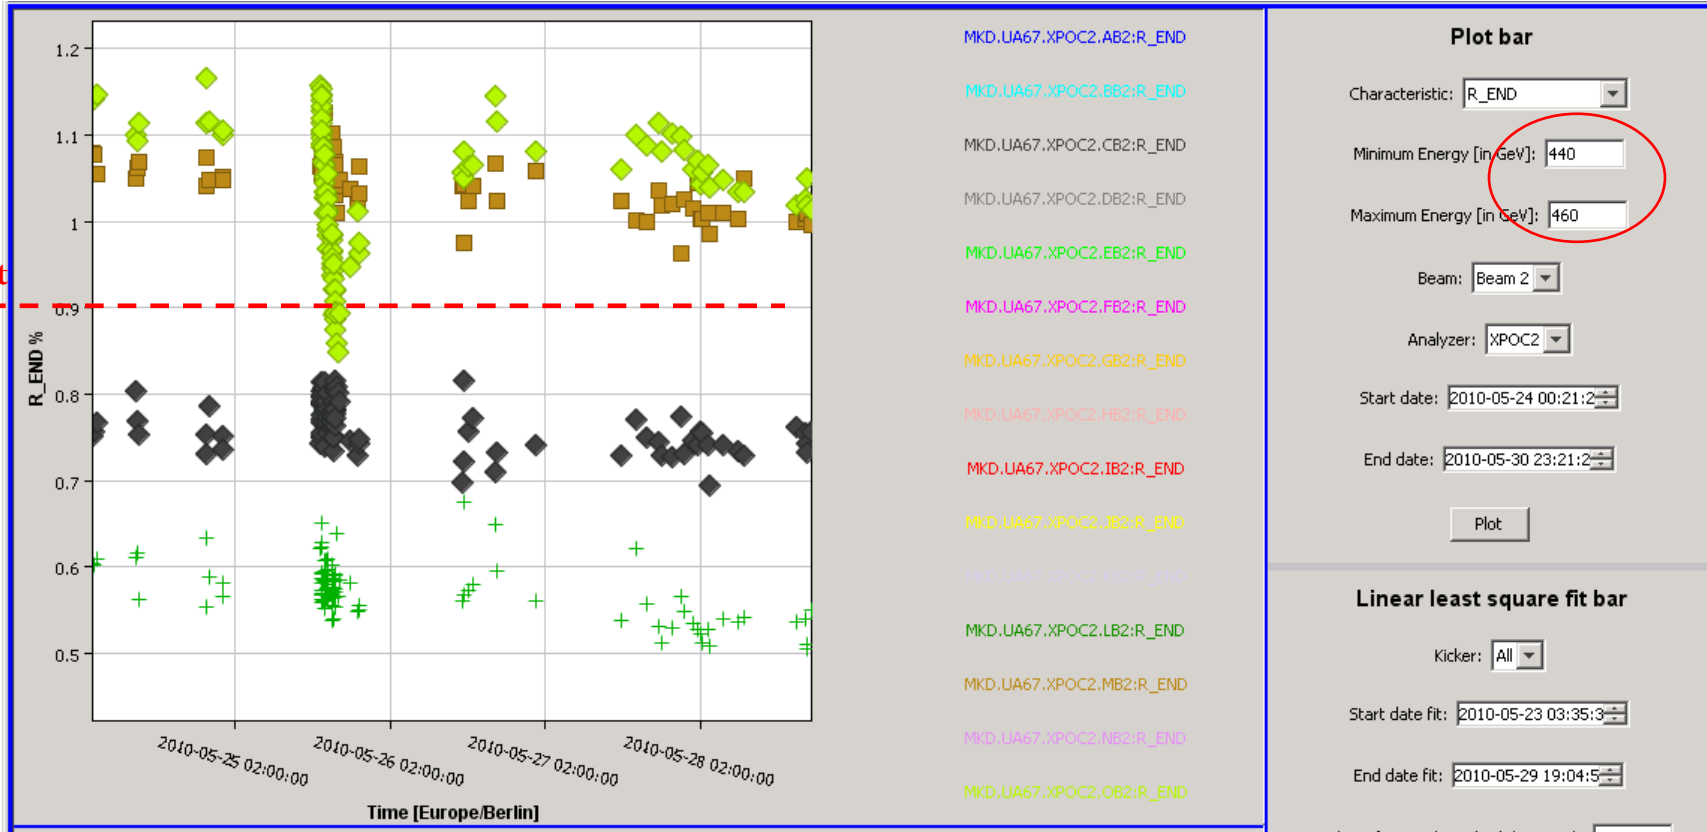
XPOC trend and error leading to generator exchange last technical stop

Reference generator O R_end : 1.40 +/- 0.5 %

References gen M: 1.25 %, gen C 0.85 %, gen E 0.69 %

Conclusions: All R_end references dropped, but most on the replaced generator O.
On top of this: generator O had this sudden drop given false XPOCs.

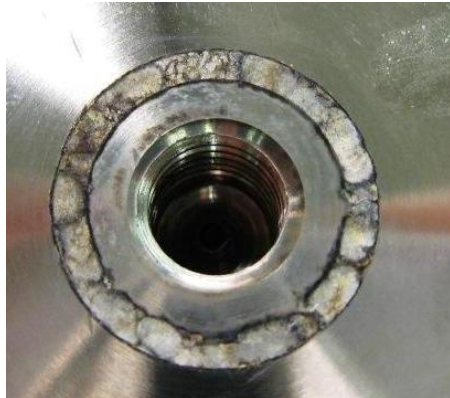
Contact erosion series diode stack not sufficiently tightened

- Two generators replaced during winter technical stop
- One generator replaced week 22 (**generator O last slide**)
- Performance degradation detected by XPOC
- Found GENERAL problem with erosion of contacts – degradation
 - Recall program
 - Check all contacts and connections
 - Redefine torque etc. for the different contacts
 - Need to make modifications in laboratory
 - Replace 2 spares at each technical stop 2010
 - With 4 spares available in 2011, can replace up to 4 generators at each technical stop

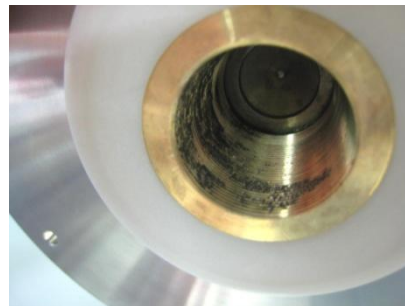
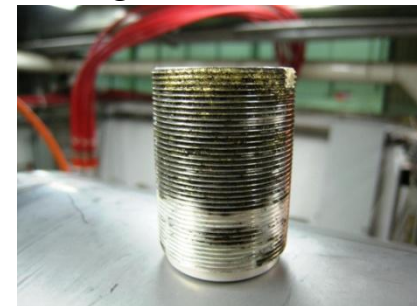
Contact erosion on Exit Box
Replaced on 18 out of 30 generators installed

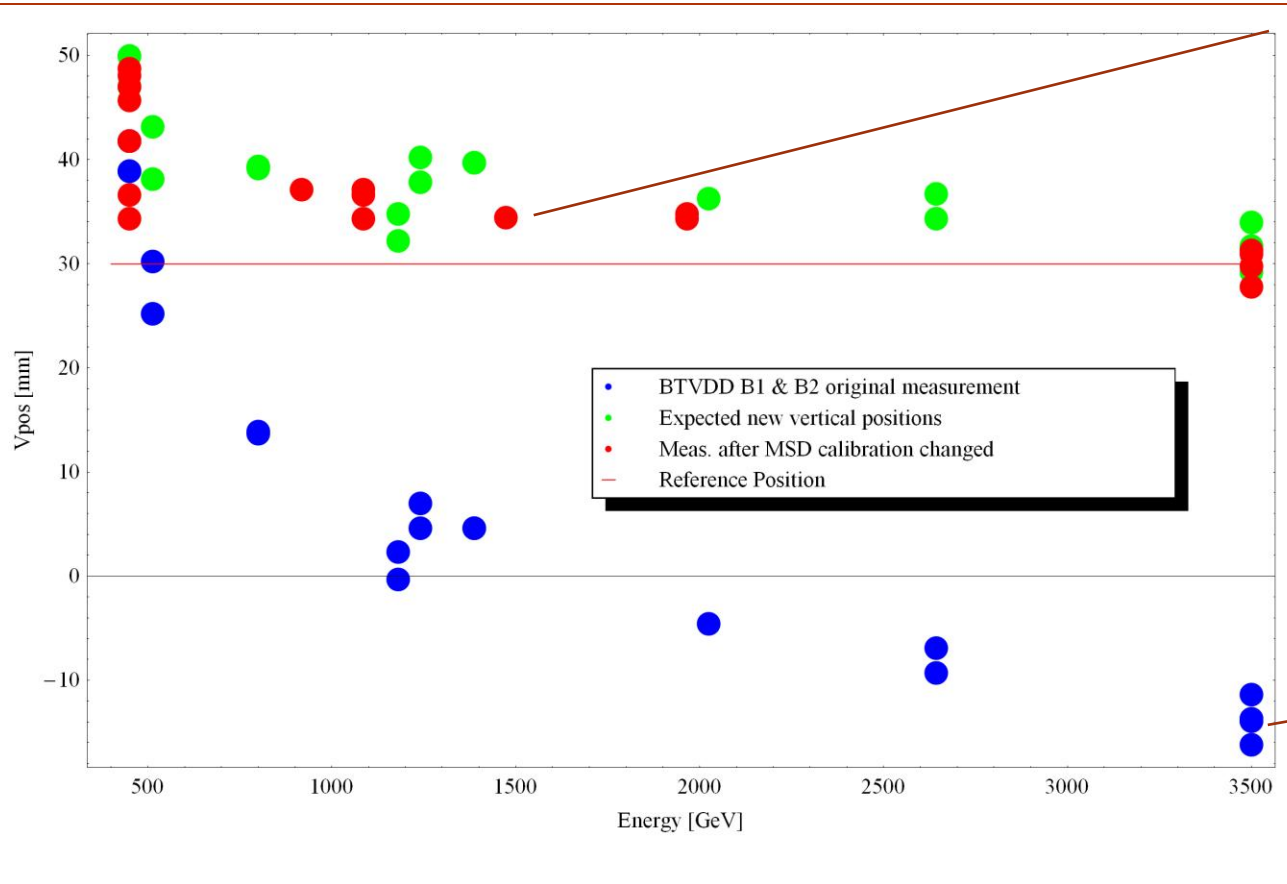
Measured vertical beam positions

Measured position after technical stop. As expected the error at 450 GeV increased. Actions:

- Recalibration MSD hall
- Check hysteresis MSD
- Effect of MKB
