LIU-PSB Working Group Meeting (15/08/2013)

BLM FOR THE INJECTORS PROJECT CABLING NON-CONFORMITIES

Christos Zamantzas (christos.zamantzas@cern.ch)

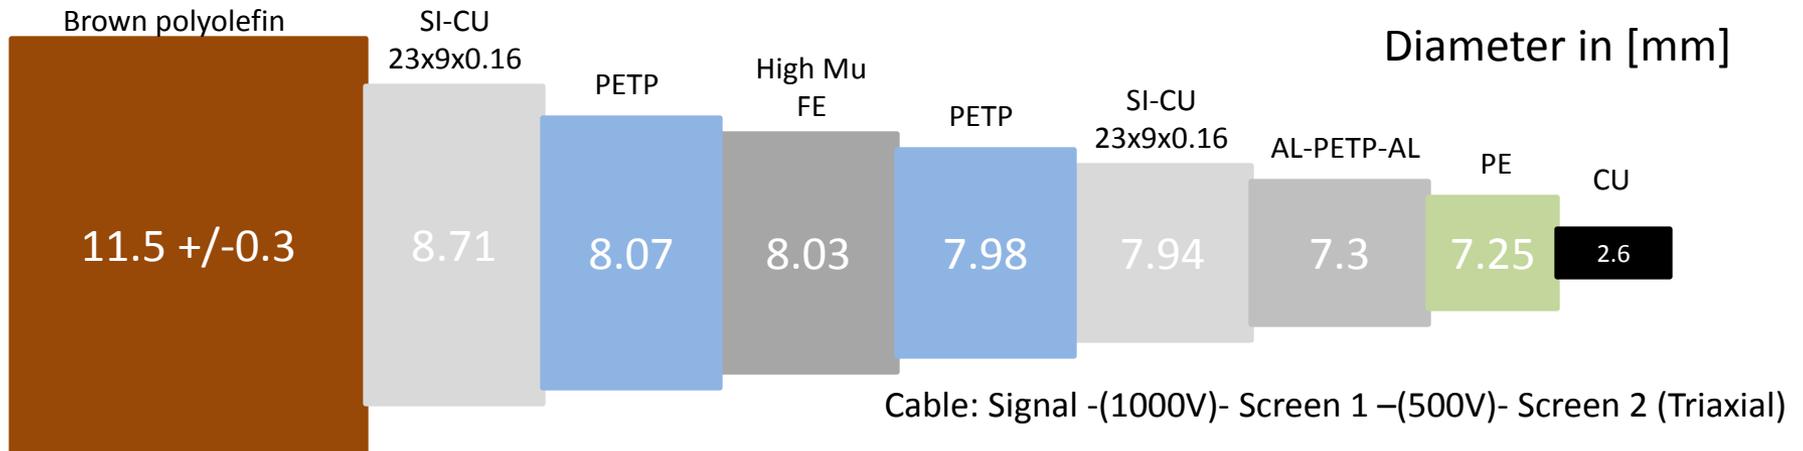
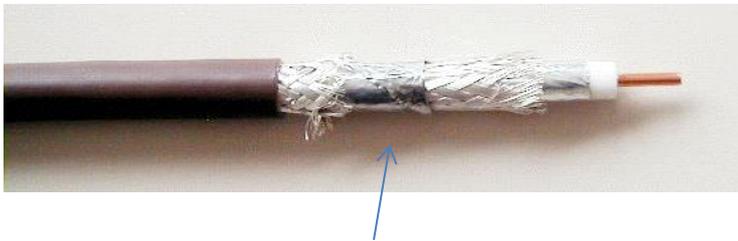
CKB50: non-conformity

- Isolation between the two shields not optimal.
- Added additional steps for the connector assembly to avoid leaks.

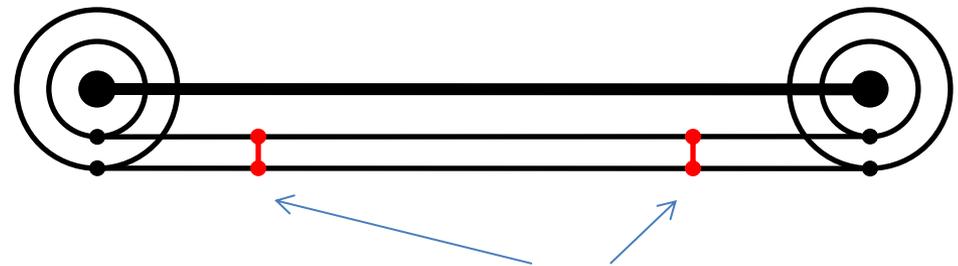
- At random positions discovered shorts between the two shields.
- Not possible to be used with Triaxial functionality.

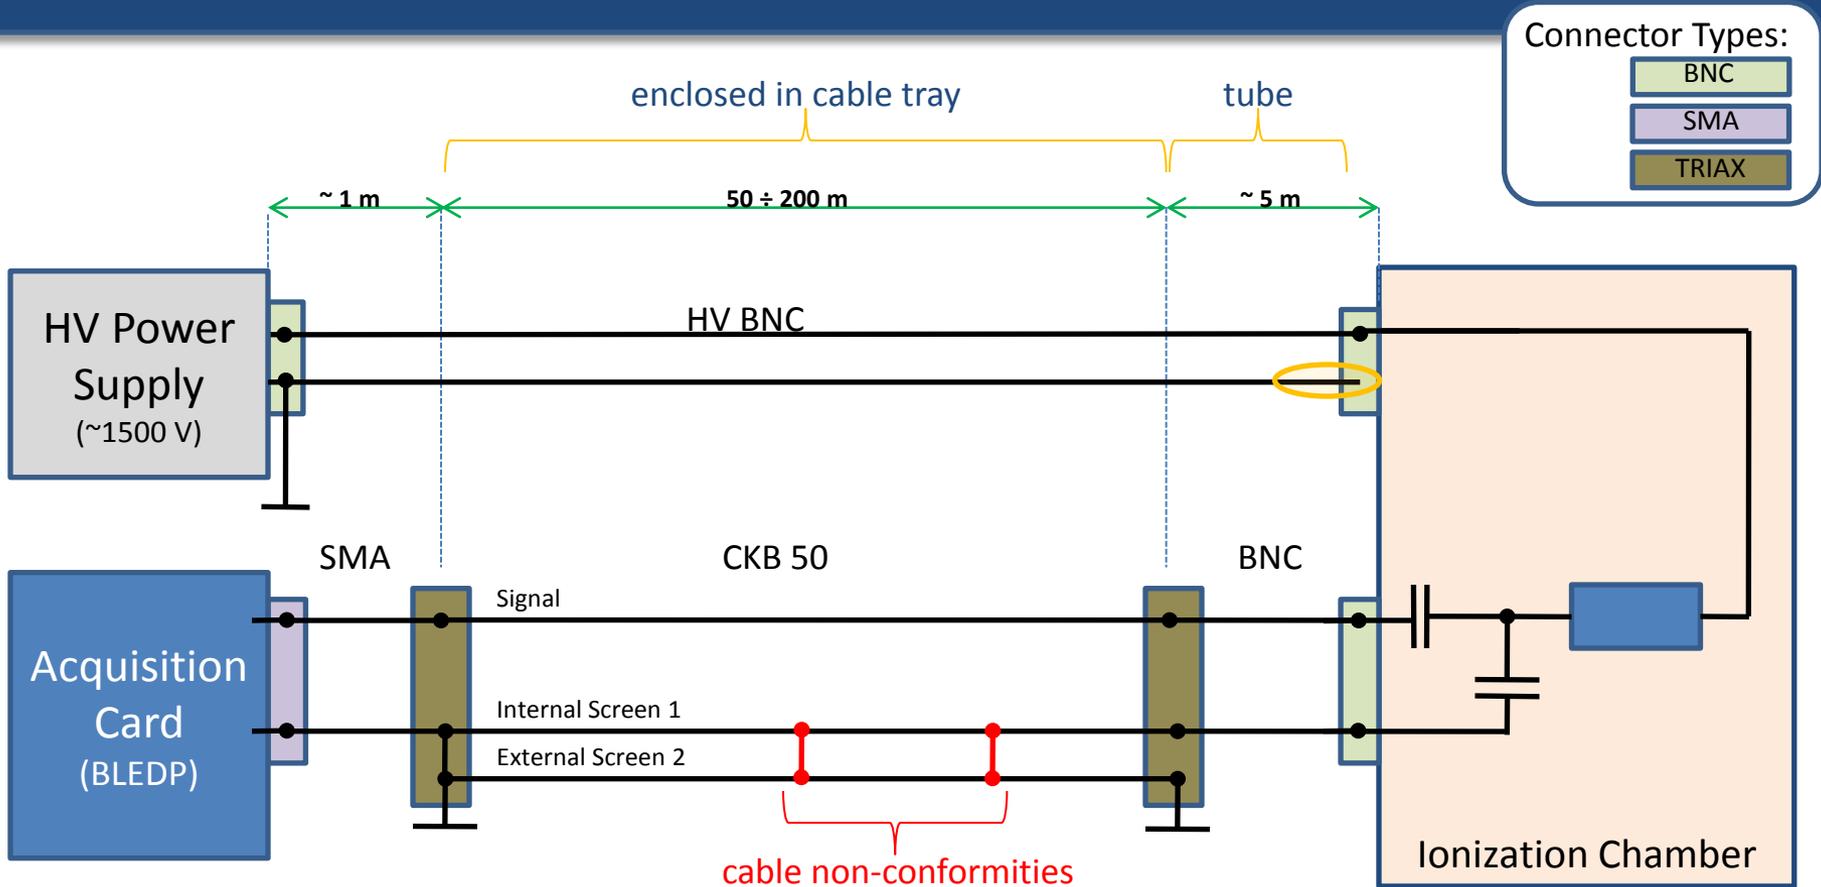
Cabling Non-Conformities

- Internal and External screen are shorted in multiple and random places.
- Non-conformity (most probable) due to thin insulator.
