What did we learn without beam in 2008 ?

Roberto Saban & Mirko Pojer

The Sector 34 Incident

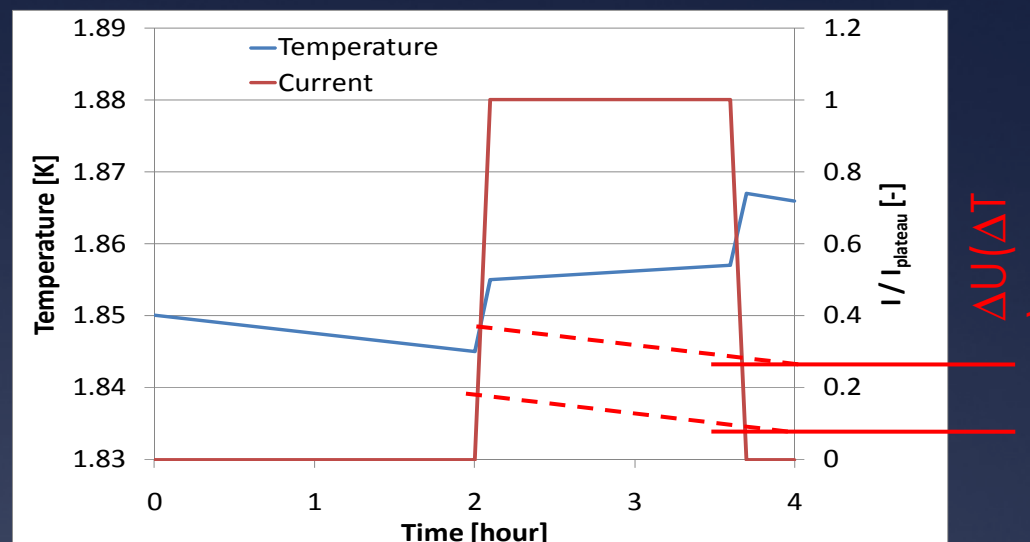
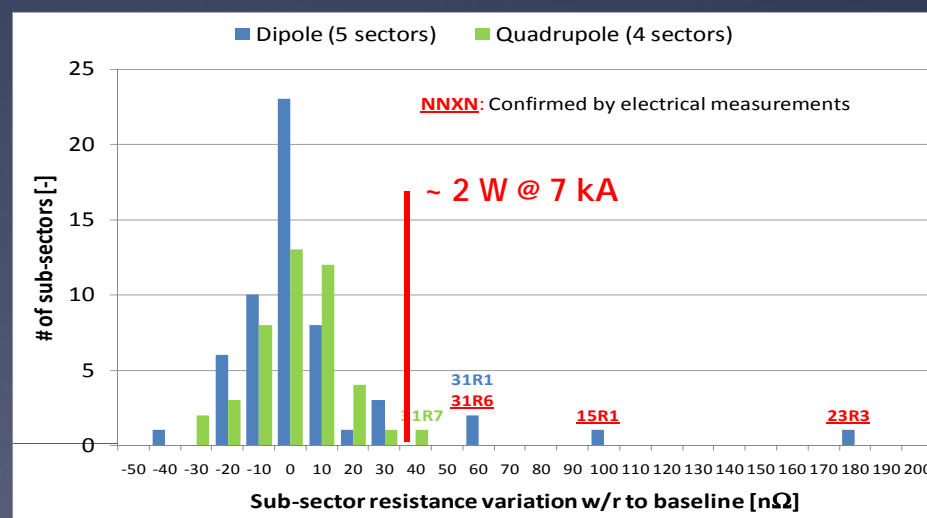
- the baseline slope (valve opening mismatch)
- the temperature increase during powering plateau
- the internal energy variation (J/kg)
- the deposited energy assuming a mass of 26 l/m of He

Before heating	With heating
ΔU [J/kg]	-1.1	78
M [kg]	823	
ΔU [kJ]	-0.92	64.2
t [s]	2880	6600
W [W]	-0.3	9.7
ΔW [W]	10

The new powering procedures will demand mandatory calorimetric and electrical tests in ALL sectors at the beginning of the next LHC powering campaign

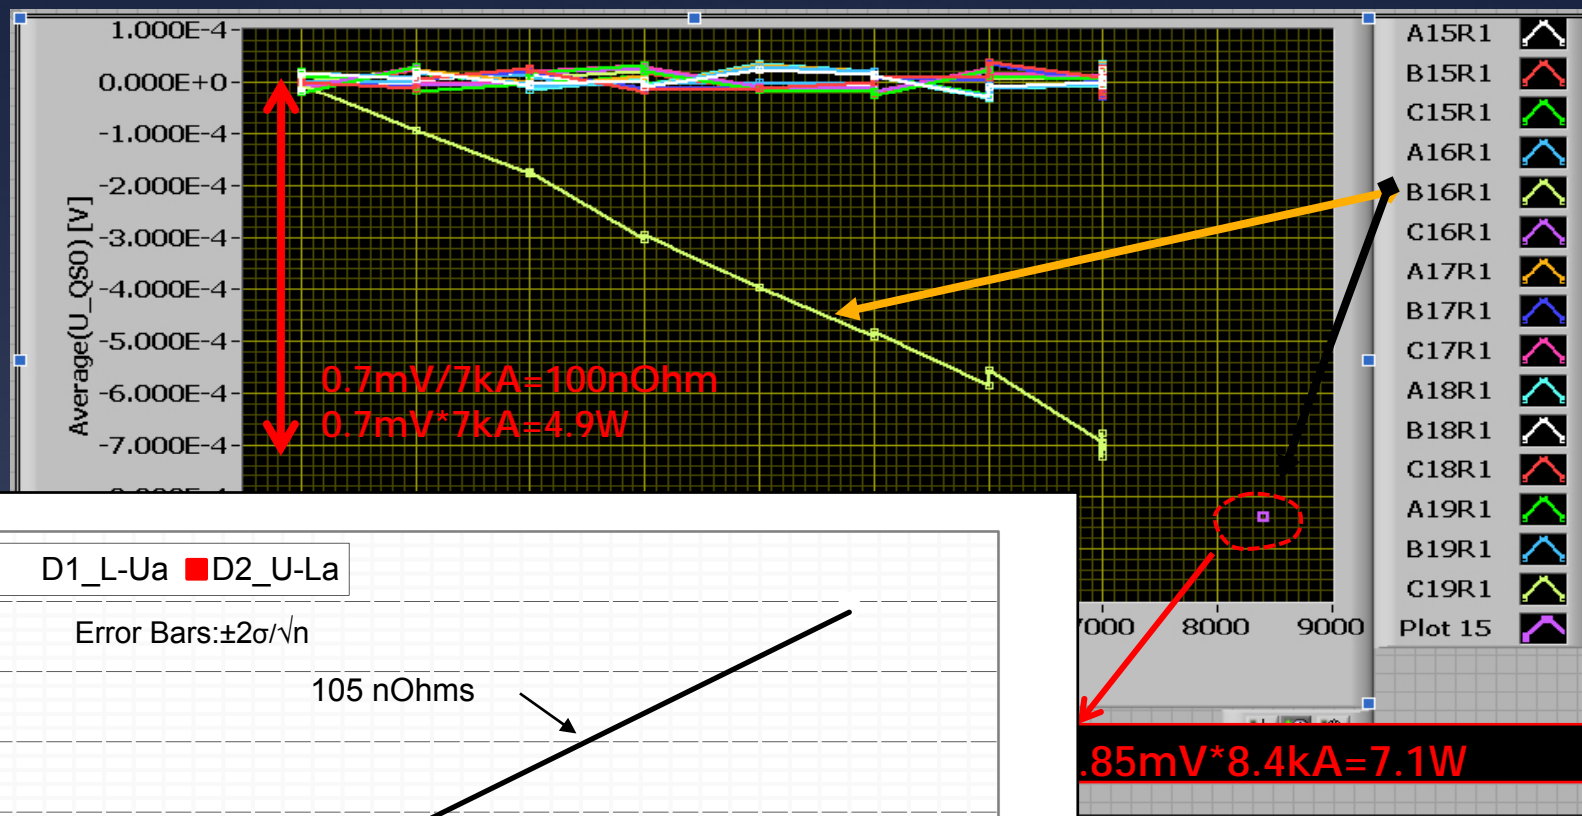
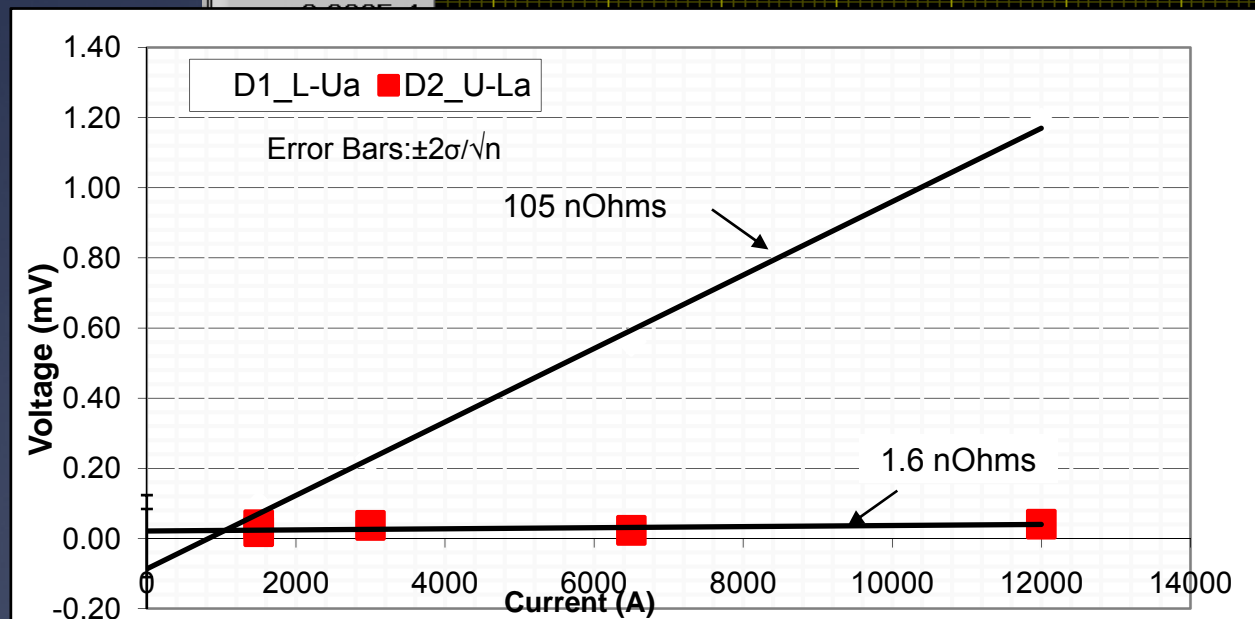
Calorimetric measurements spotted a suspect region in Sector 12

an inter-pole splice
resistance of 105
nOhm in magnet
2334 (B16R1)
