ELENA Source Charging Up status and plans

D. Gamba, R. Gebel, B. Lefort, F. Wenander

27th of Jan. 2021

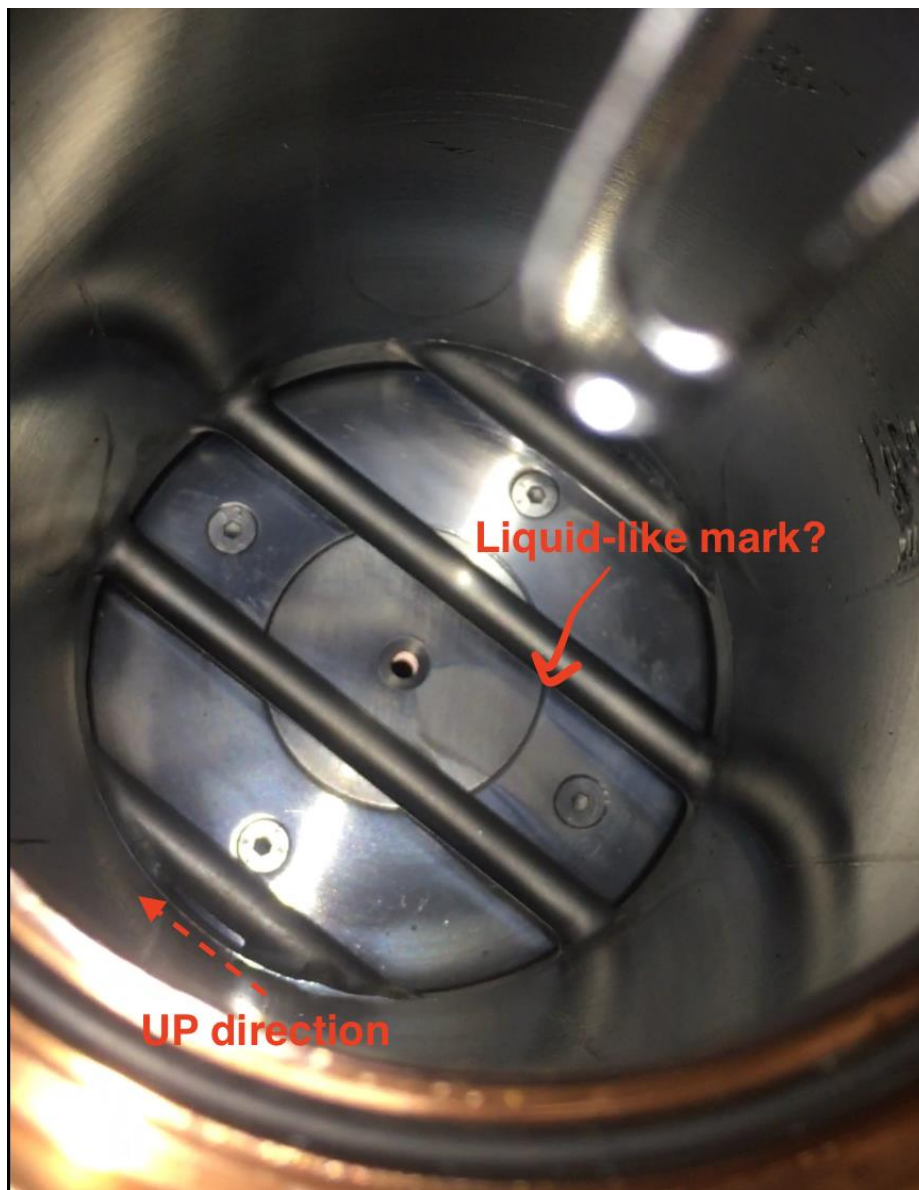
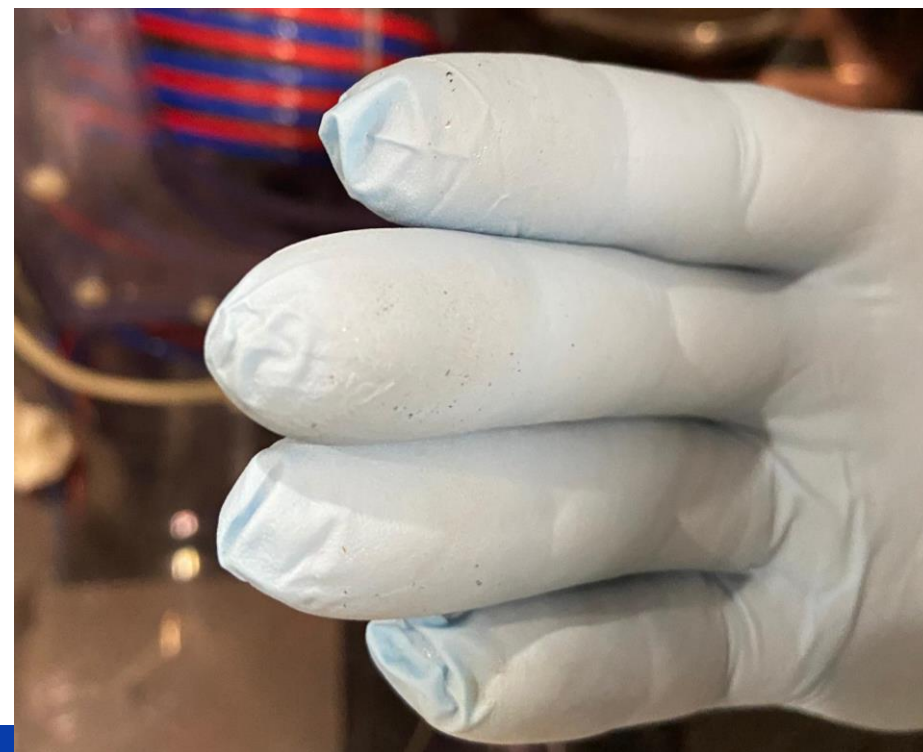
- Surfaces need to be cleaned (carefully!)
 - And see what happens after some time...
- Measurement of magnetic field in the puller can be done with a probe inserted from the plasma chamber side.
 - **TODO:** Ralf to look up about nominal values and provide pictures of the assembly here.

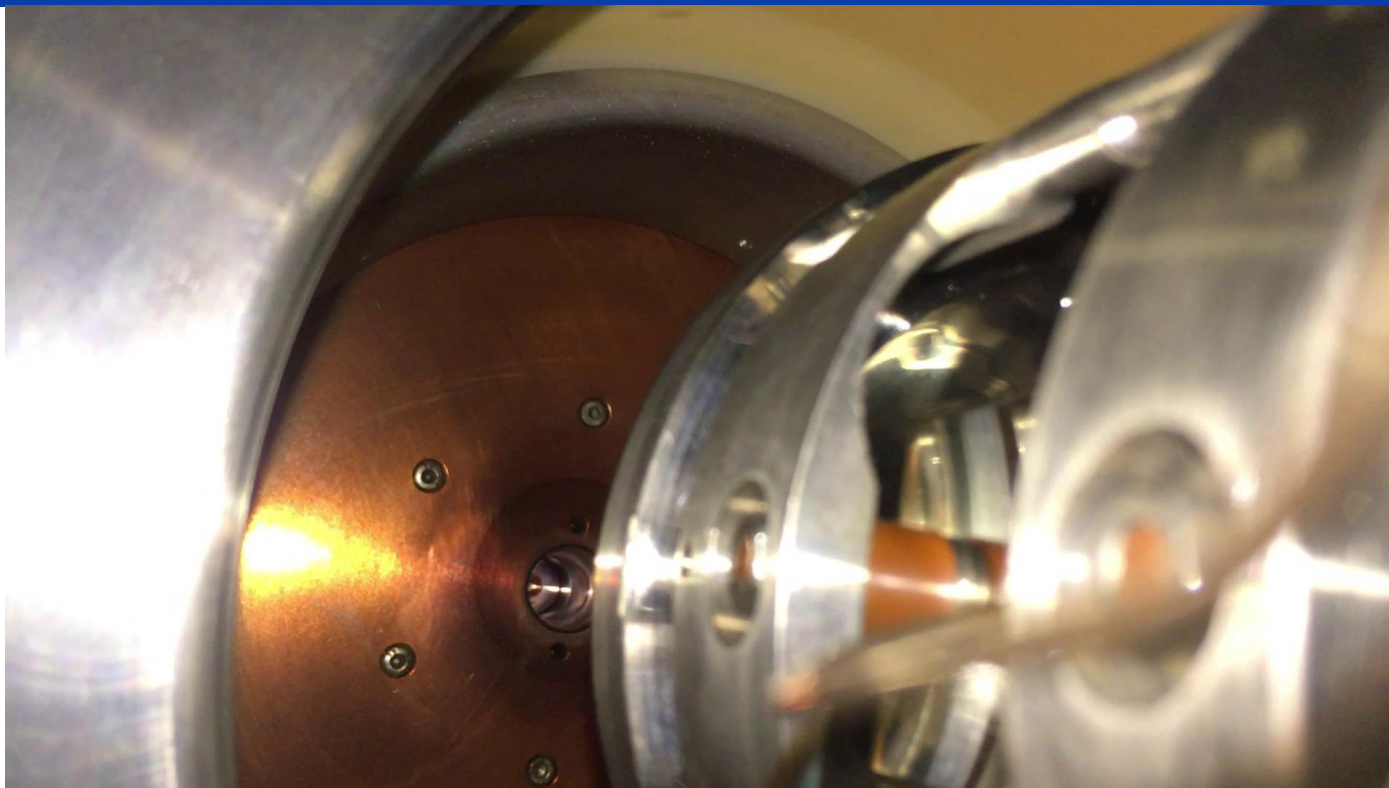
- Marks probably due to ionization of residual charge -> all positive charges go back to puller.
 - Need to make simulations to see where charges go if generated on the ground electrode or in the vacuum in front of the puller.
- **Simulations** (**Ralf** might be able to do some, but not in the short term) also needed to:
 - improve ground electrode shape (i.e. maybe bringing quad assembly closer to puller. This is possible to do even now.)
 - Implement some shielding of isolator
 - **Warning: dark current increases** quickly if one goes too close with ground electrode.
