QL3 Problem

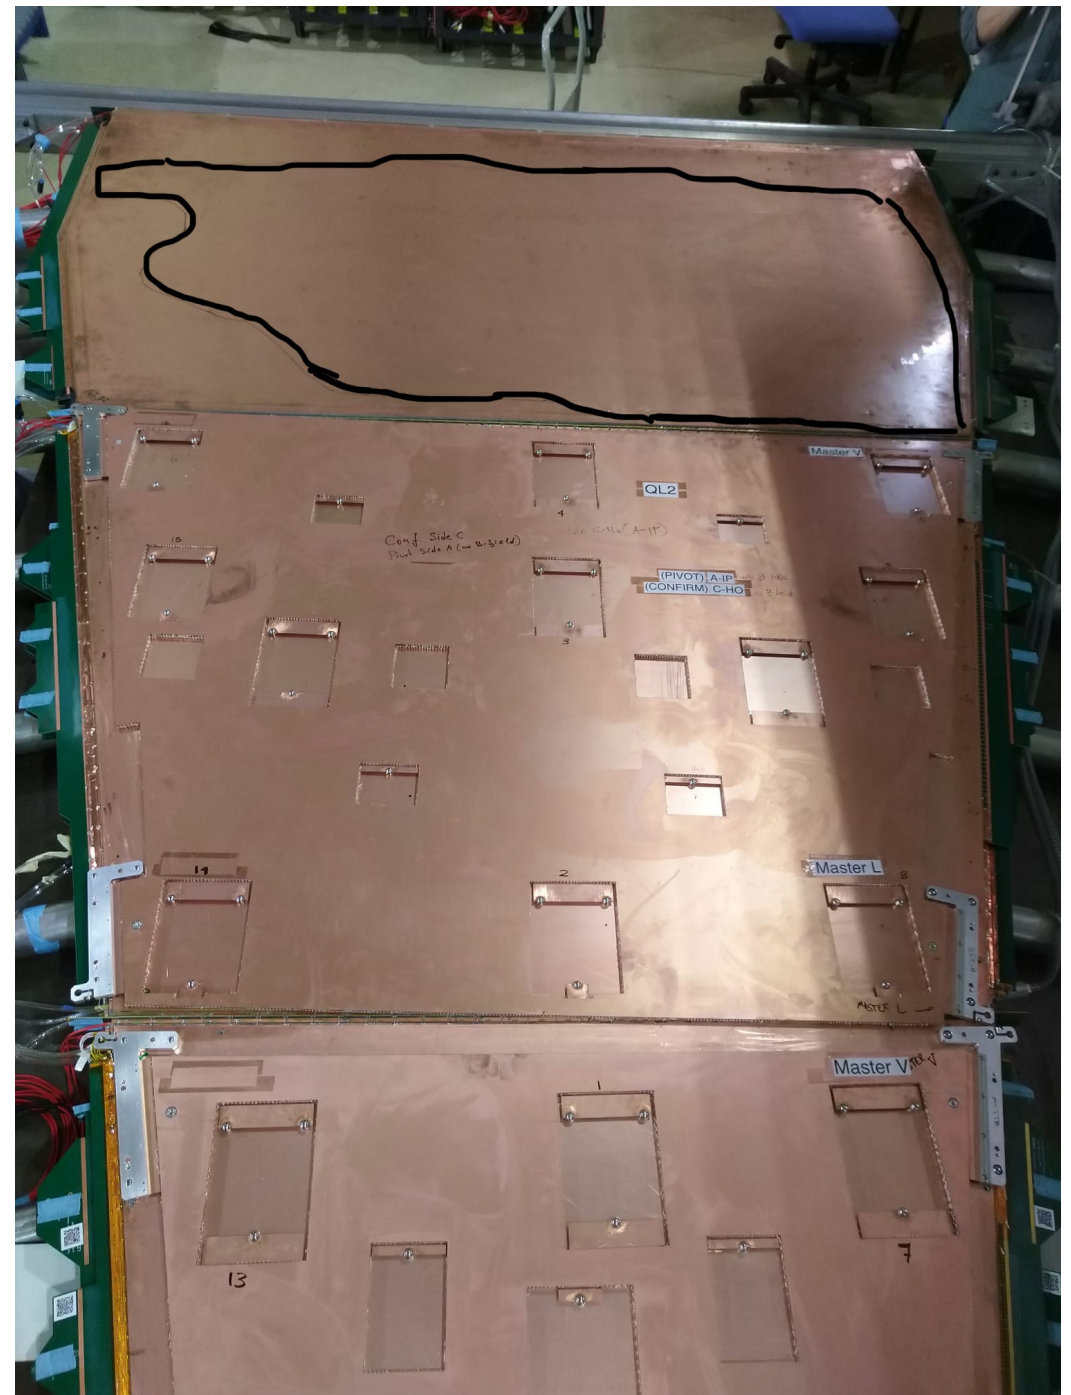
- The copper protection layer is partially detached in the area in black. Usually they fixed this by making small holes in the panel, and injecting epoxy. This is the first time we have this problem on the alignment side.

- Wherever they inject the epoxy, it tends to form a small bubble under the panel. They are wondering where it would be best to inject the epoxy so as to not ruin the position of the alignment platforms.

- They can easily avoid injecting epoxy to the places where the spheres of the jigs will sit.
- If they inject it directly under where the source platforms will sit, it may be that there is no gap between the back of the platform and the surface of the wedge, and so the installation plate will not sit properly on the jig spheres.

- If they do not inject epoxy under the platform, that area in the copper layer will be loose, and could move around....
- The panel is also loose directly where the metal brackets that hold the pins for the QL3 jigs would sit. But injecting epoxy here can be done after our installation.

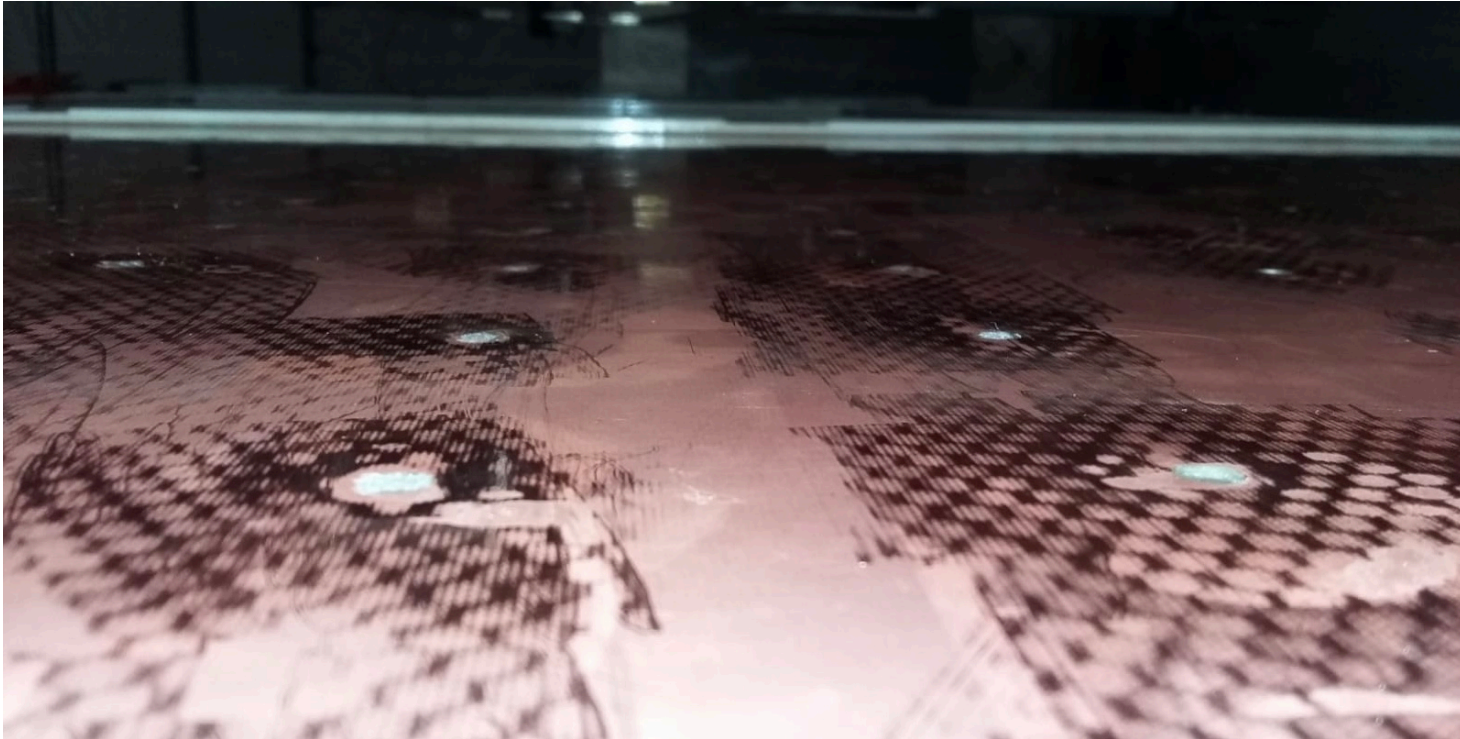
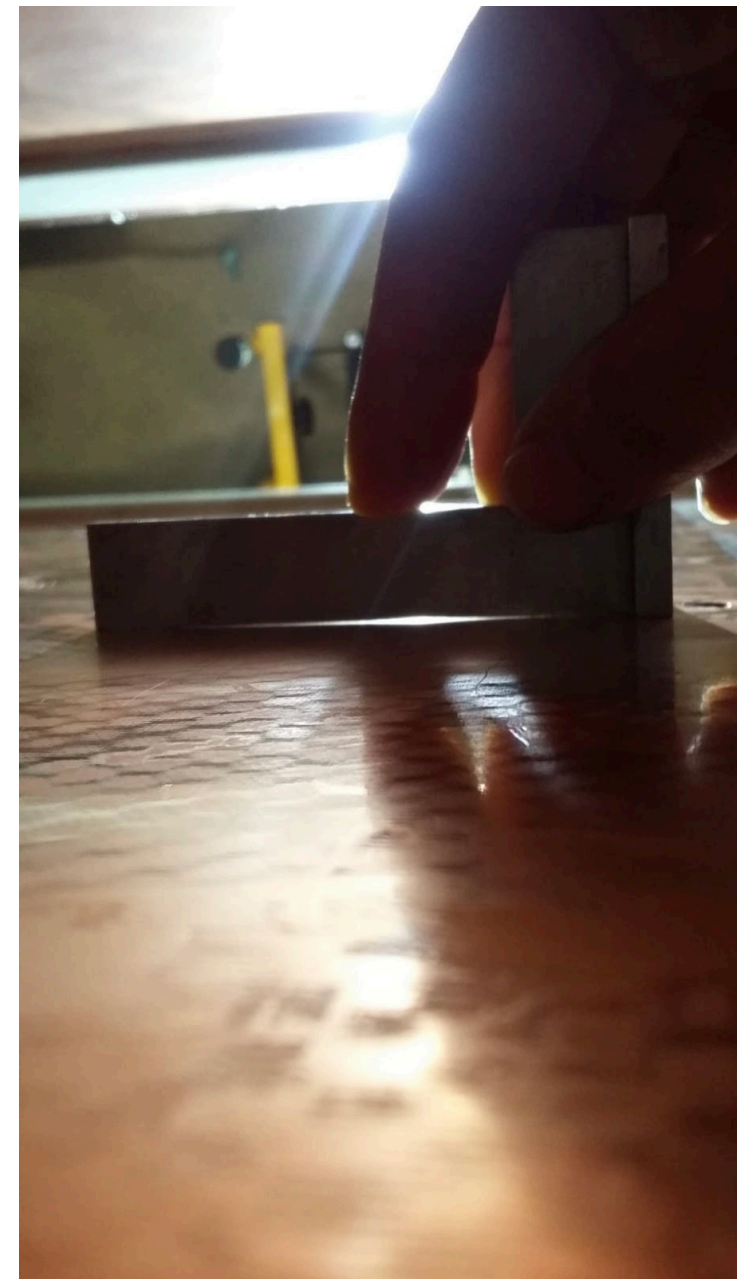
- Bubbles formed are $\sim 100\text{-}200\ \mu\text{m}$ tall.
