Results of the laser-polished sample B-5.5 test (preliminary)

ARIES WP meeting

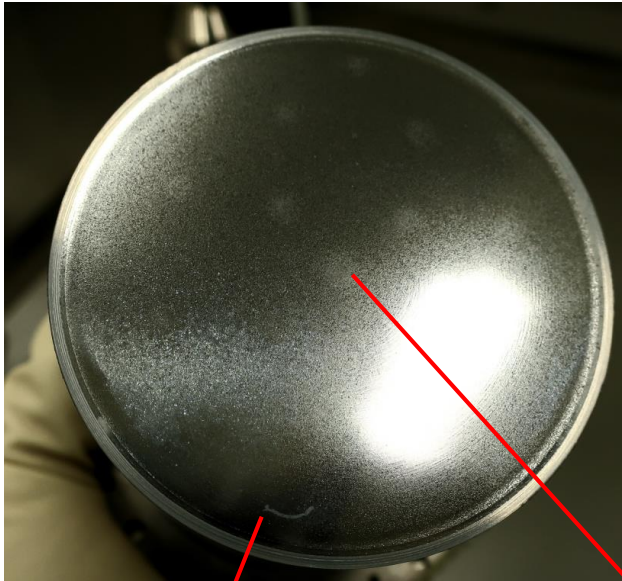
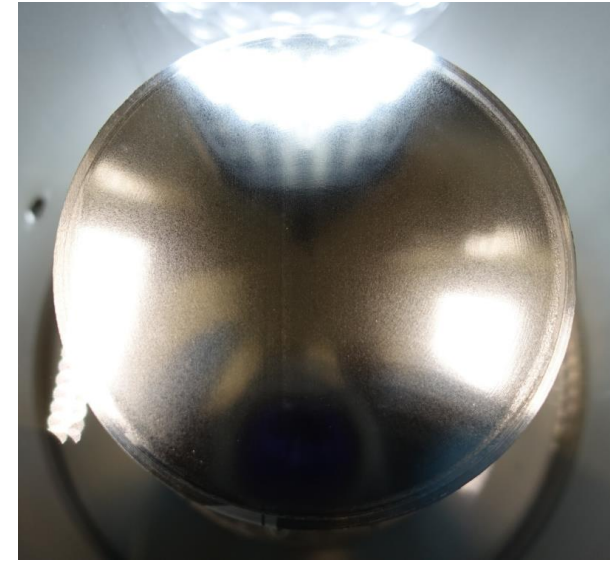
- Some defects removed or partially removed

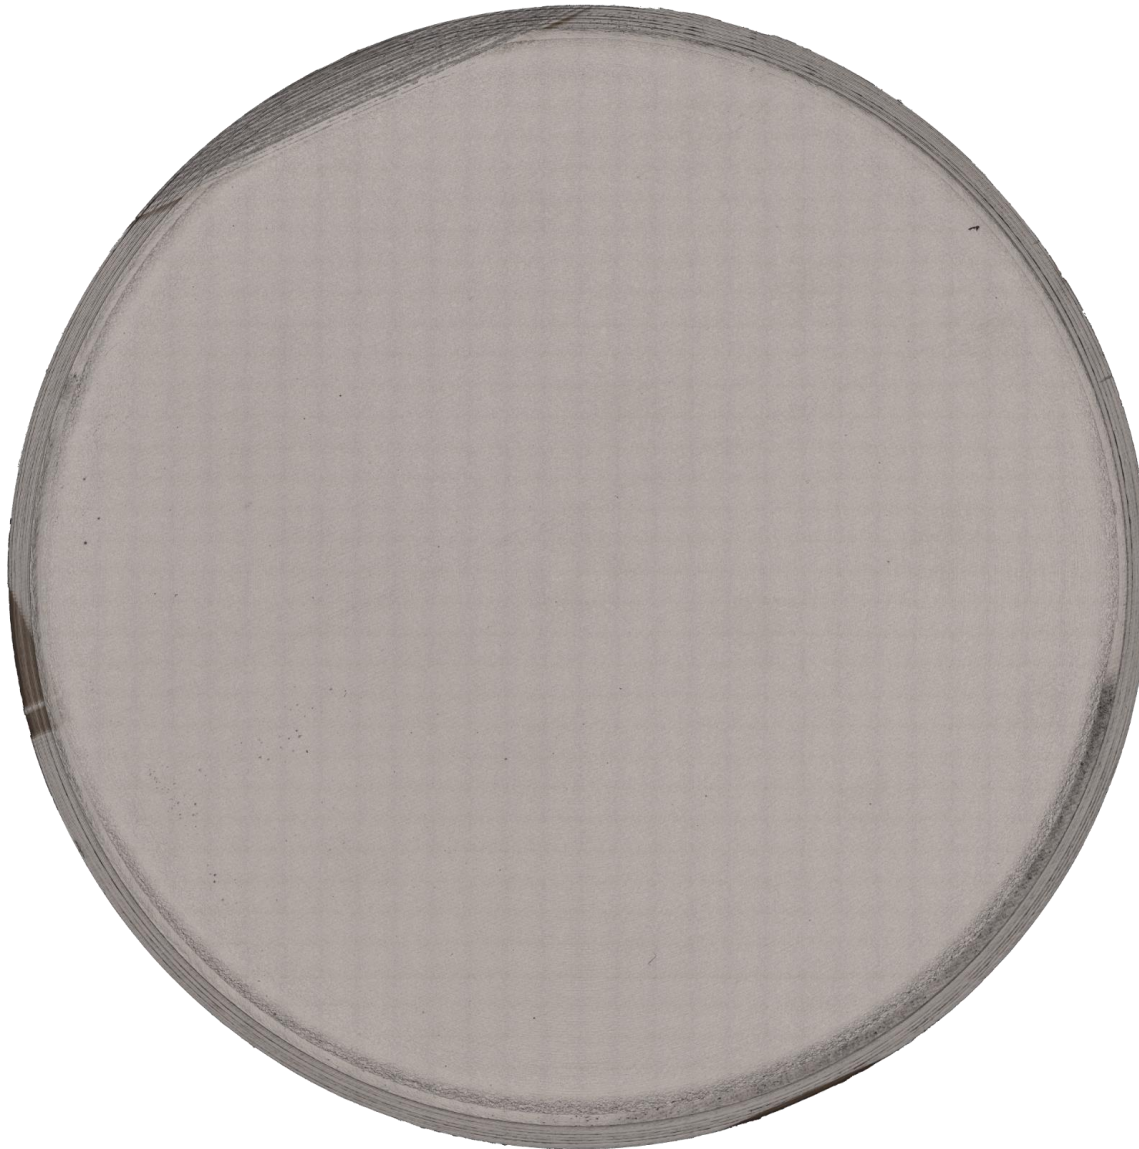
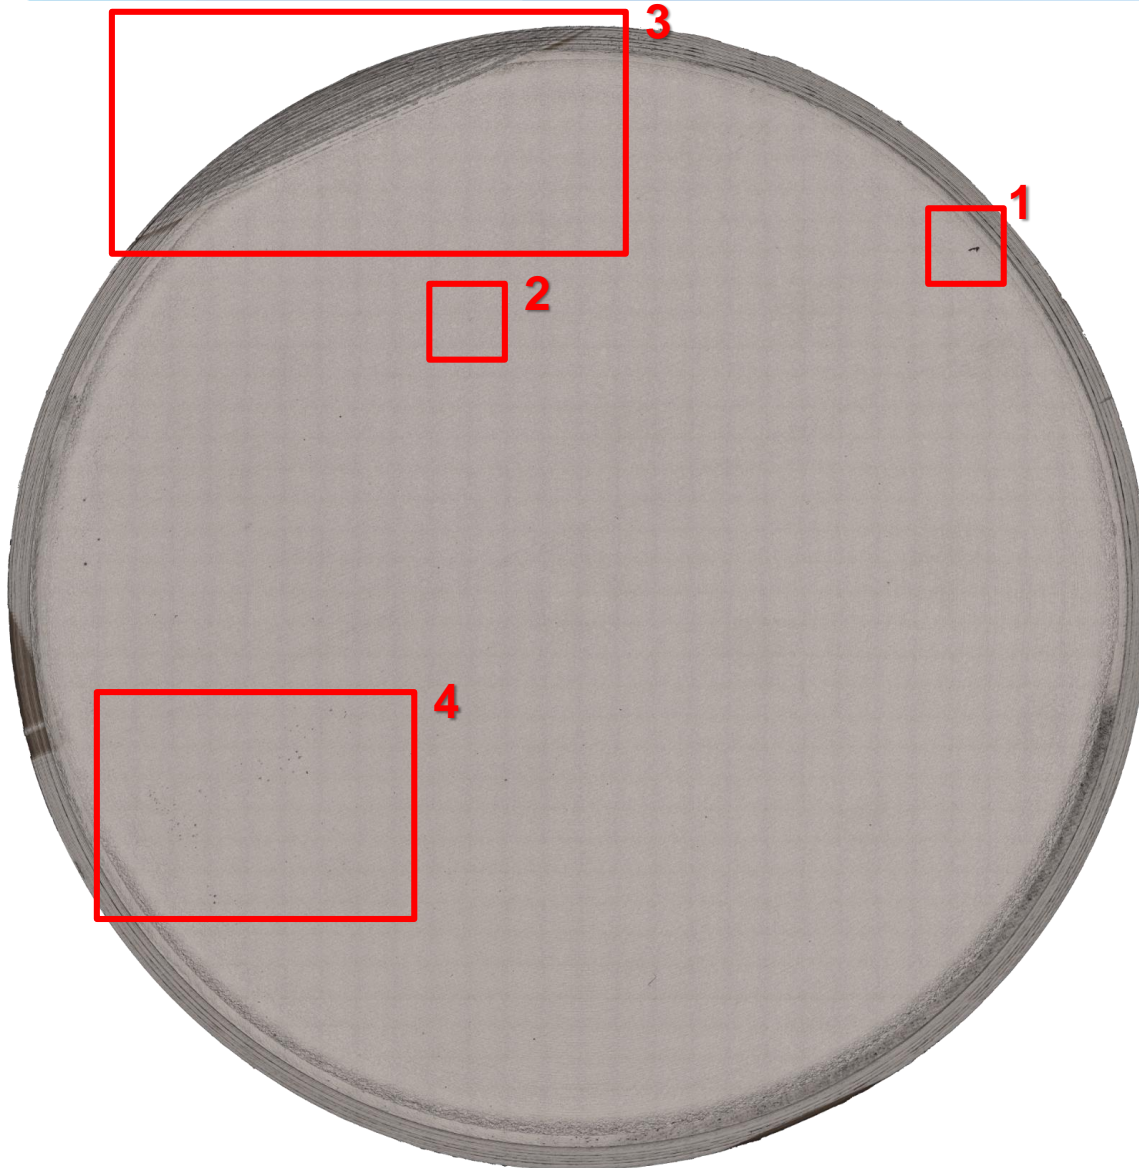
1. Major defect near the edge
2. Minor craters in high field region
3. Laser traces (overpower?) near the edge
4. A “group of craters”

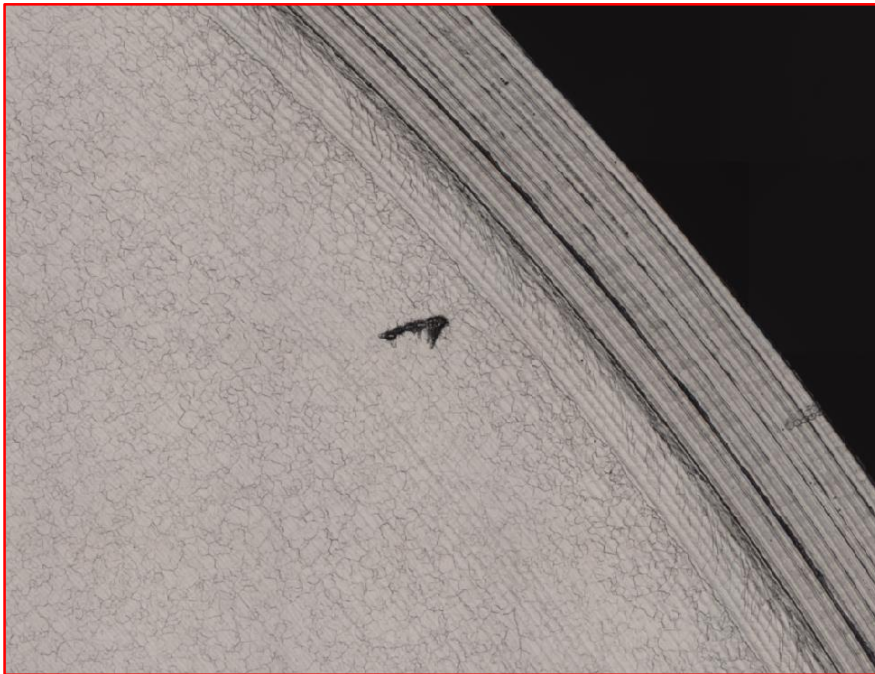
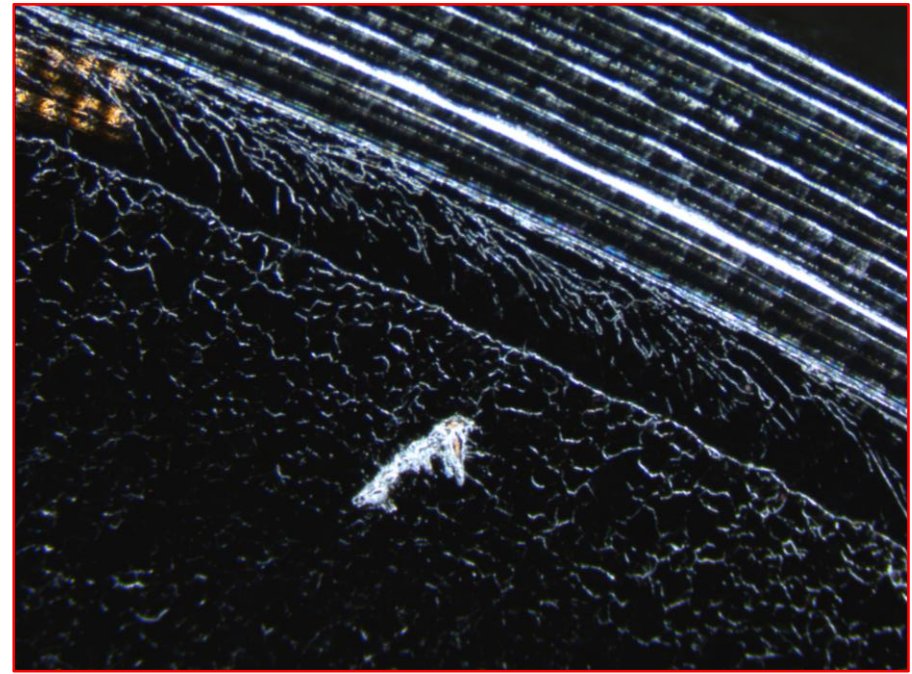
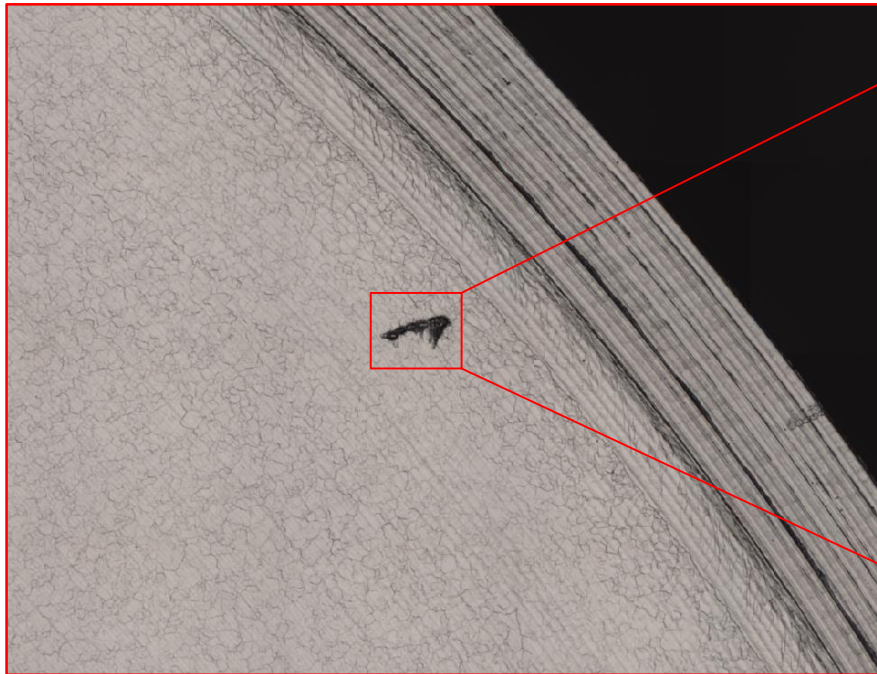
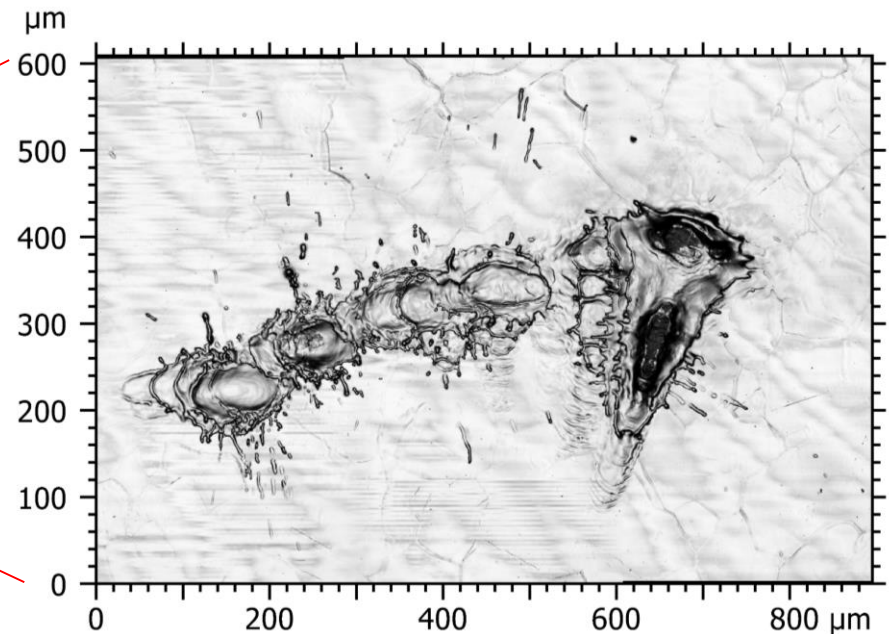
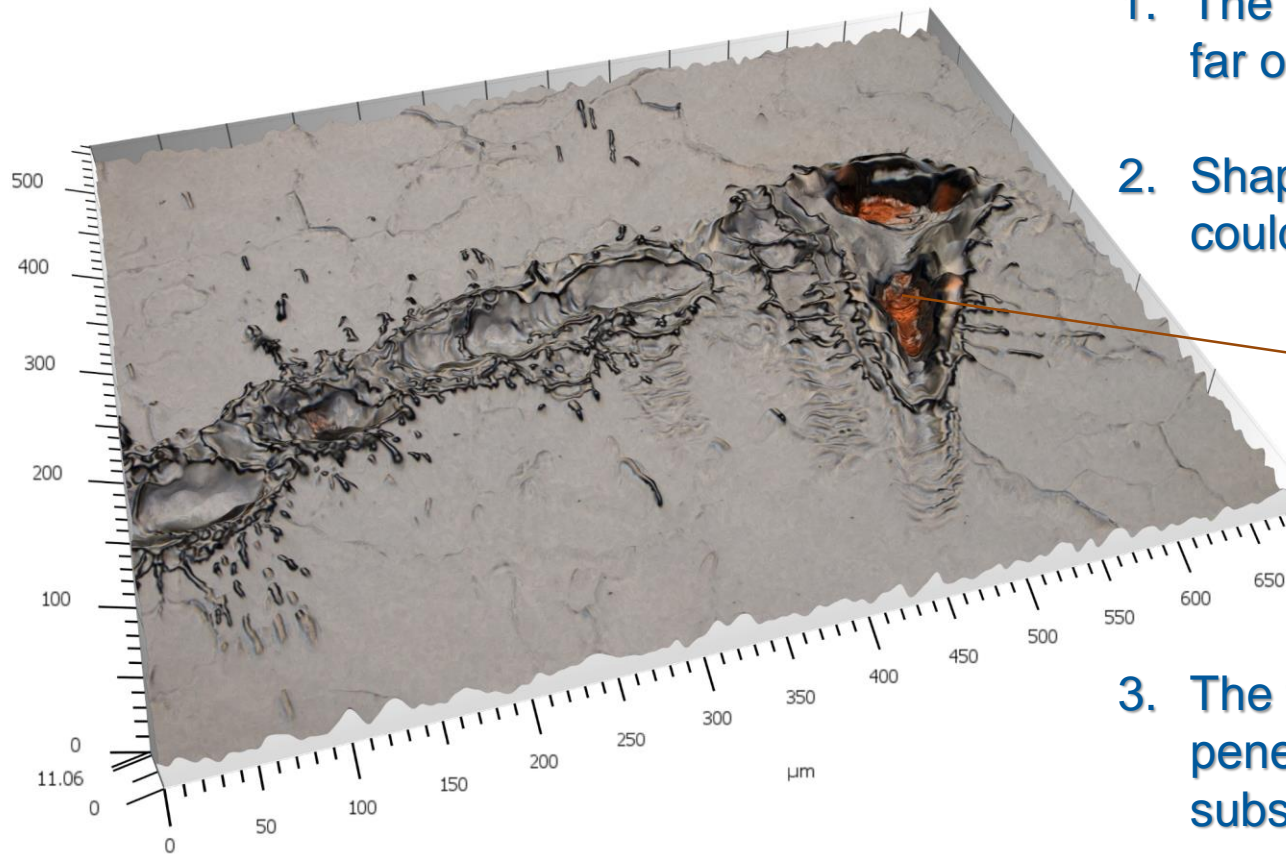
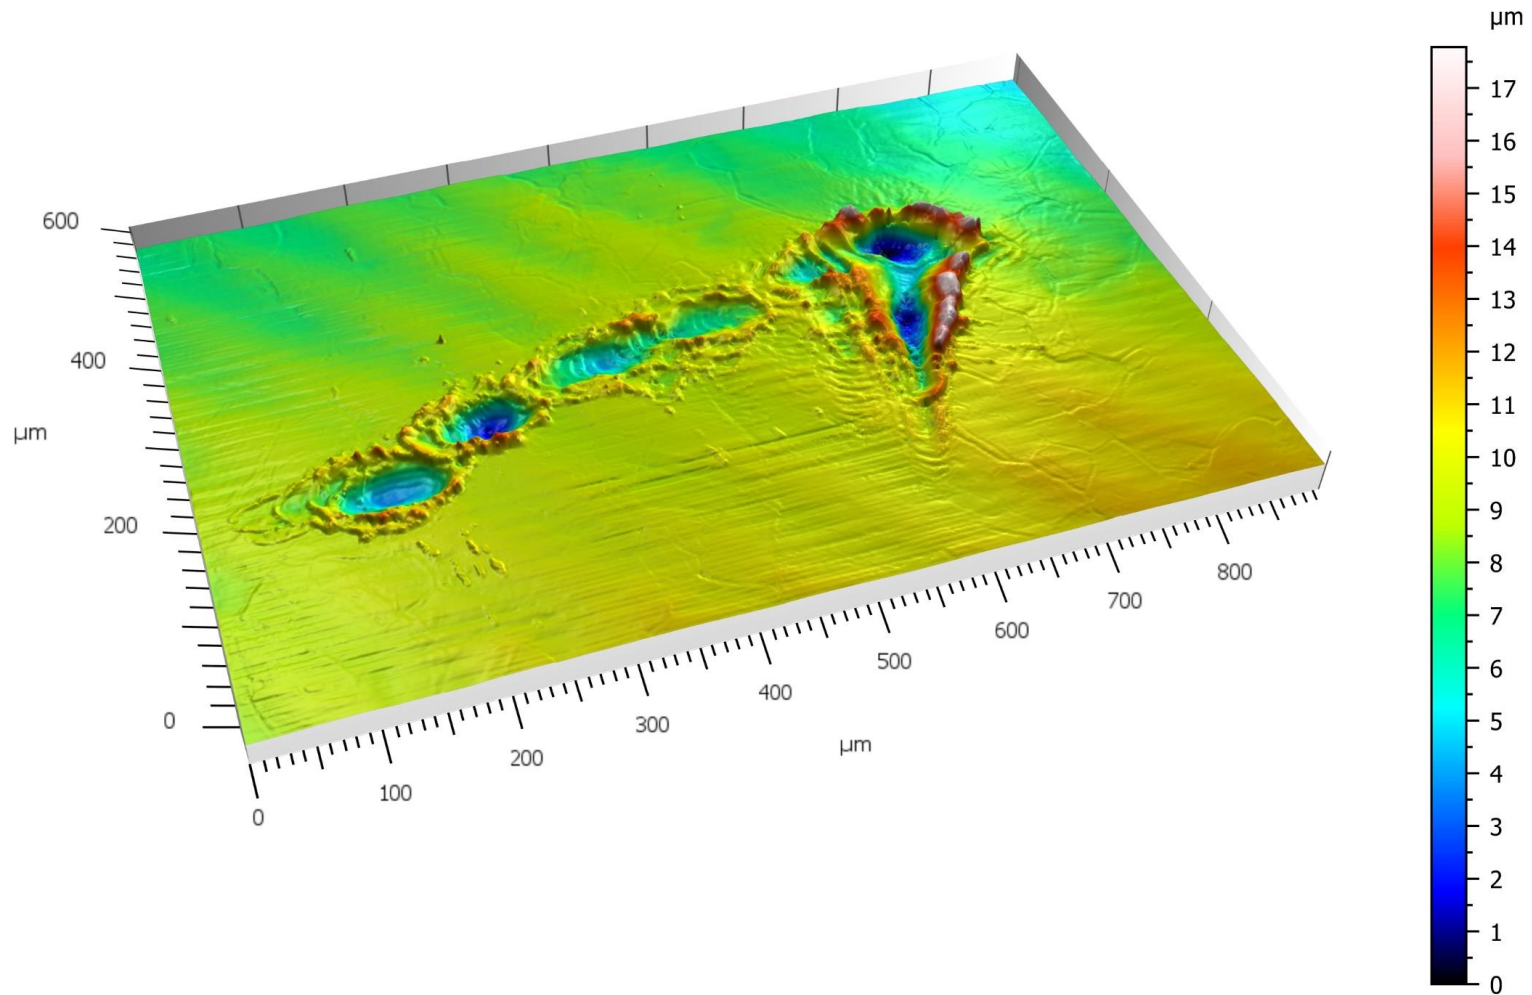
Defect 1 found near the edge:

1. The defect was not found so far on pre-laser coated sample
2. Shape of the defect: the laser could give overpowered pulse

3. The film is completely penetrated by the “shot”, substrate is exposed to RF

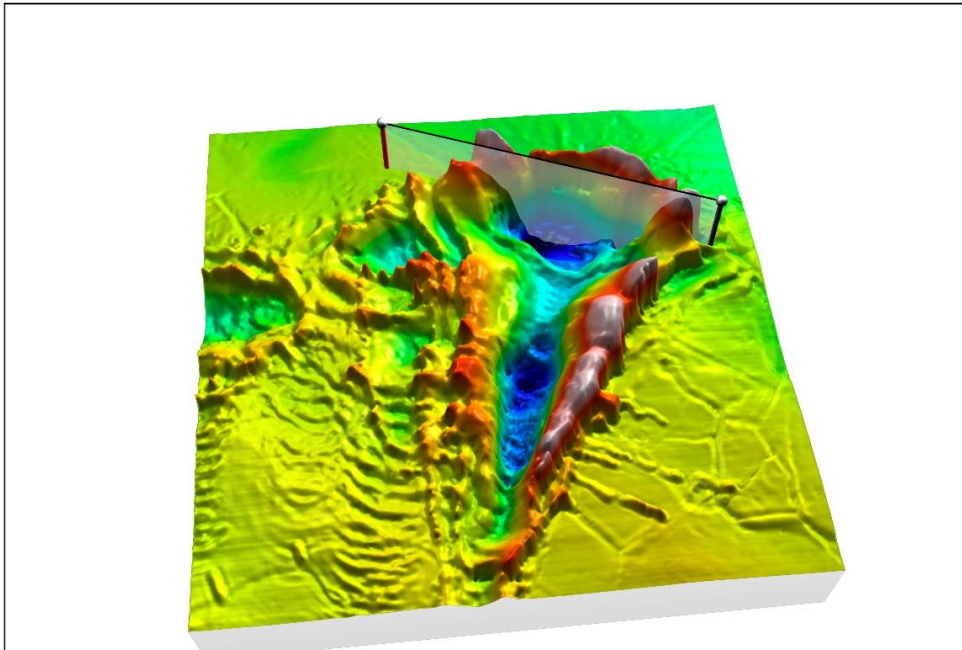
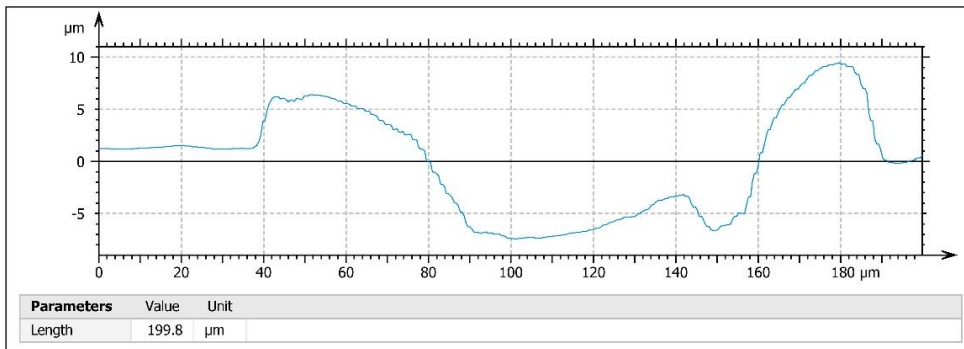
Defect 1 view in 3D:

- The film deepness can be estimated about 5 mkm

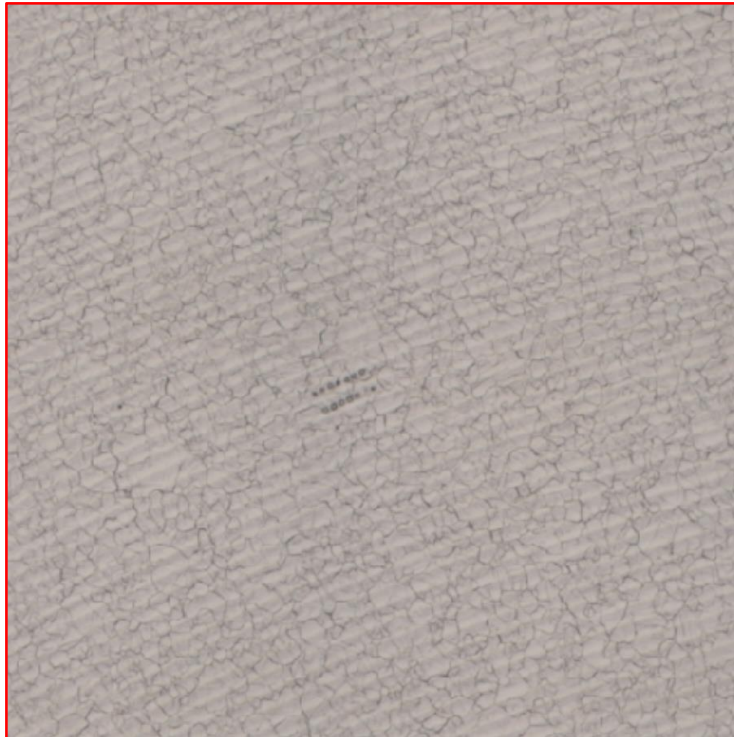
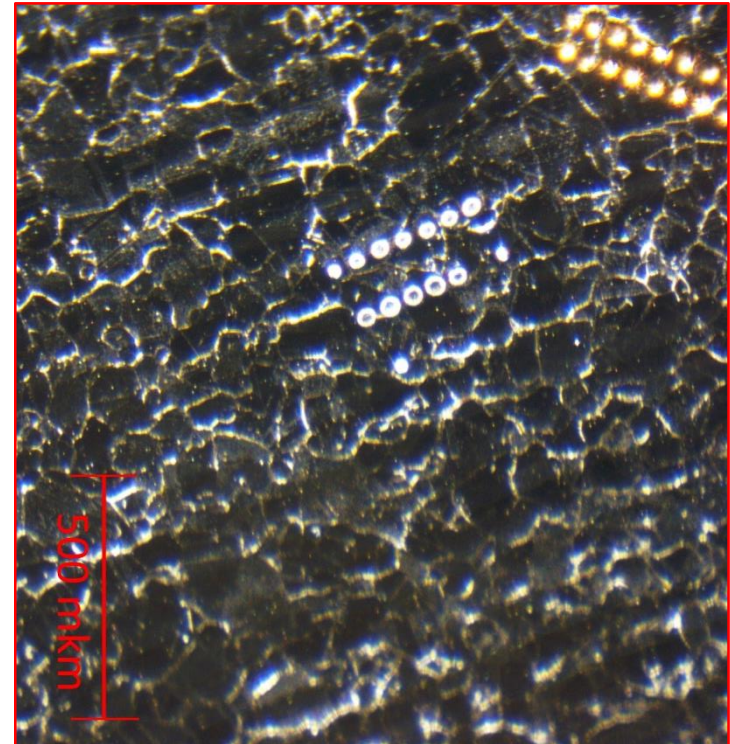
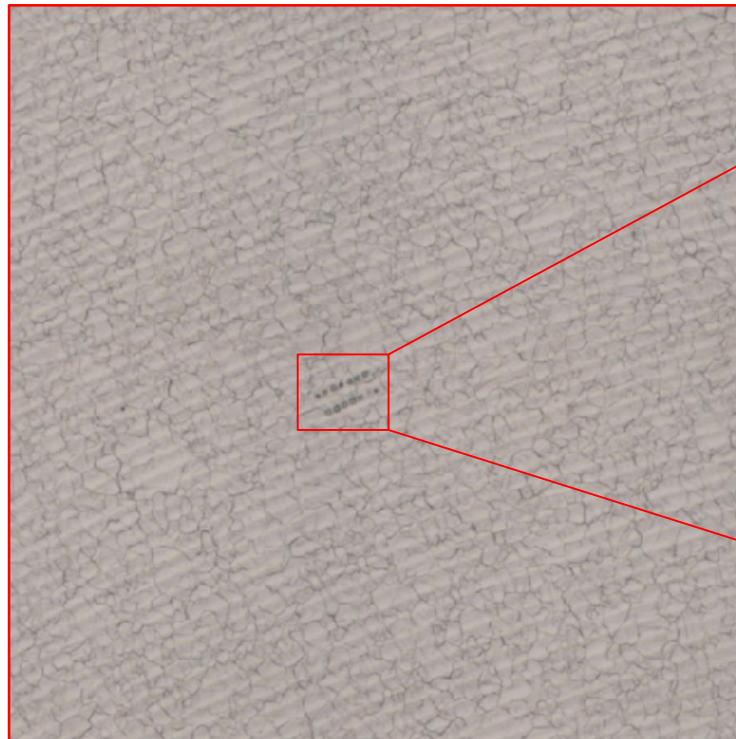
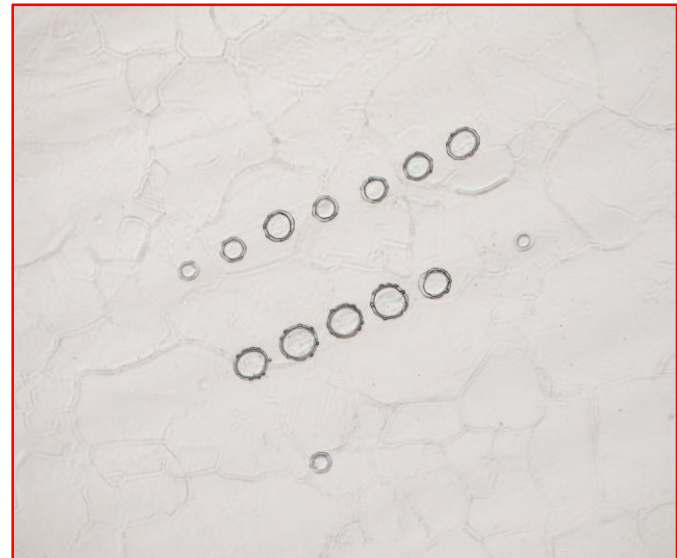
Defect 2 found in the high RF field region:

- Defect again looks like a crater (series of craters), deepness up to 1 mkm
- Roughness from substrate shape (due to mechanical production) is about 1 mkm

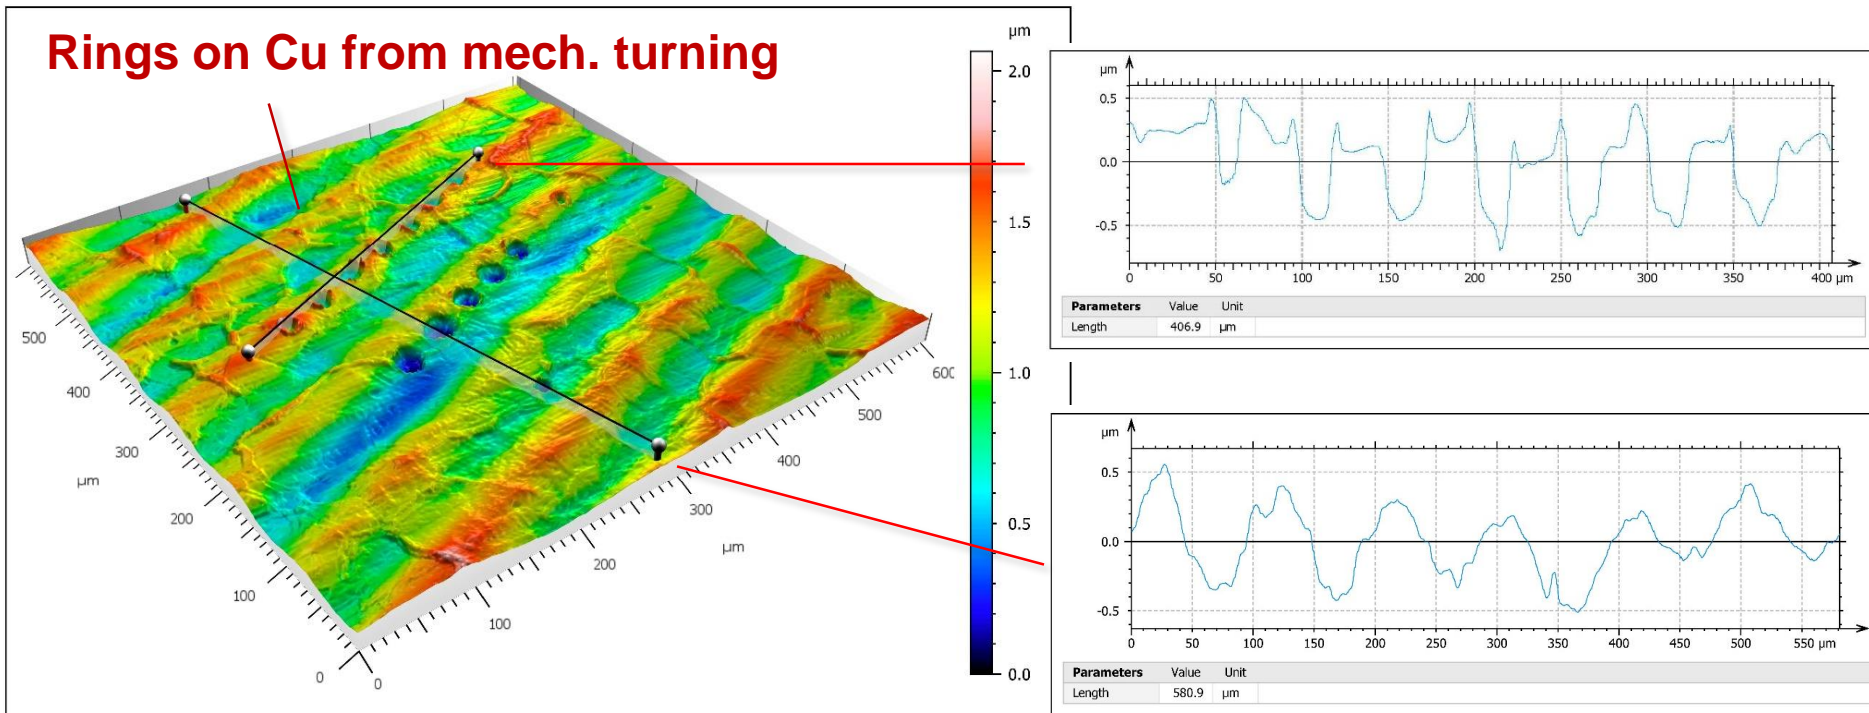
Rings on Cu from mech. turning

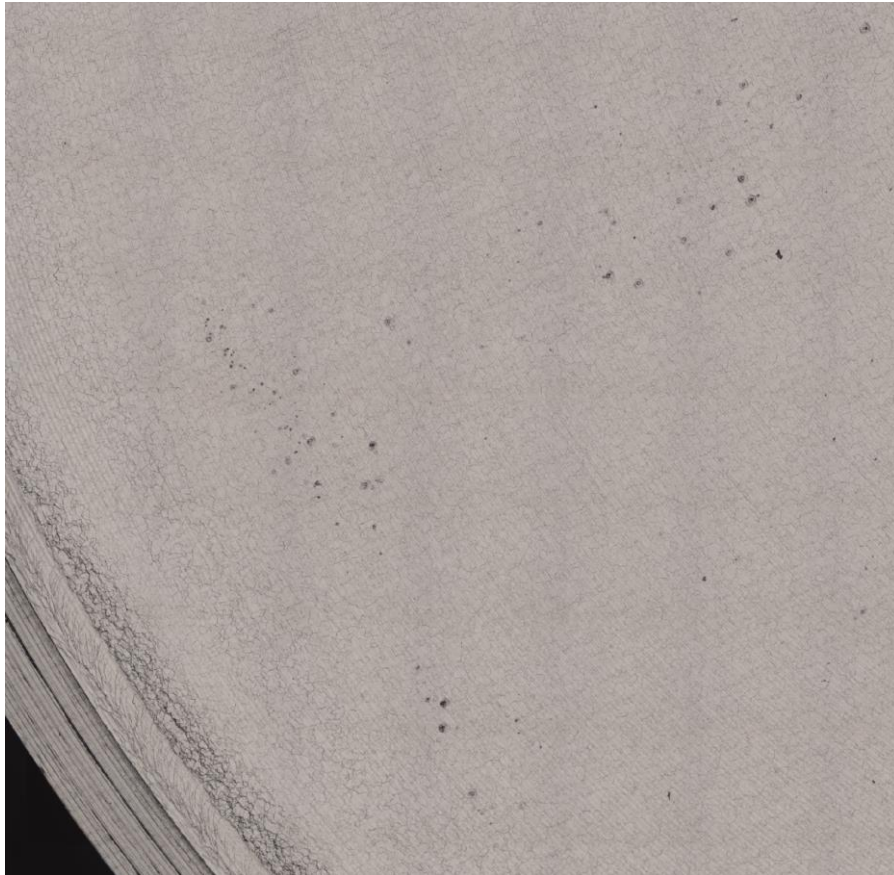
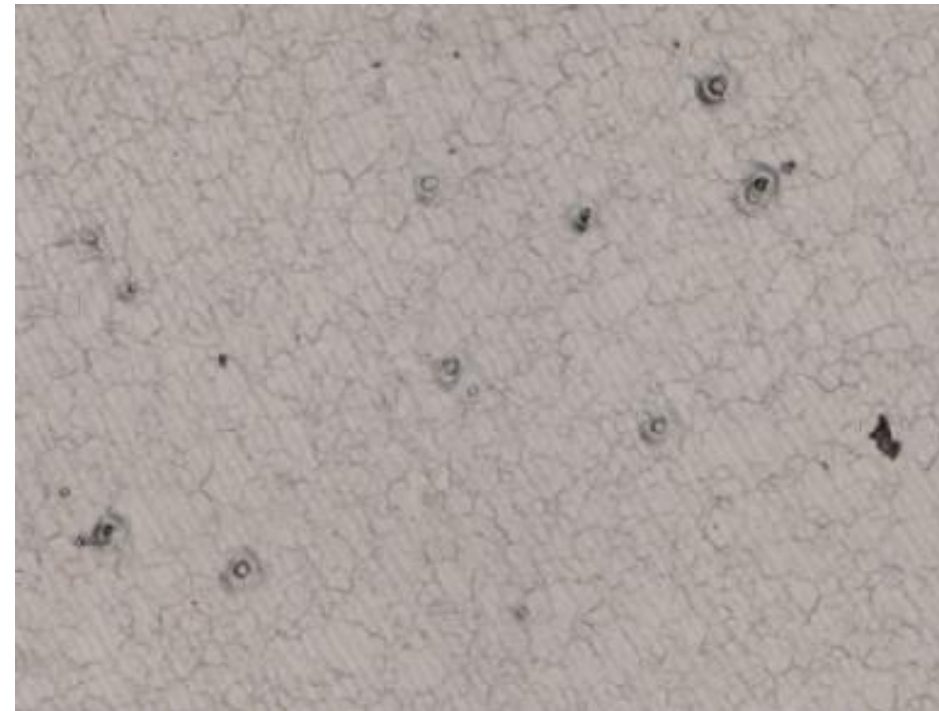
- Craters again?

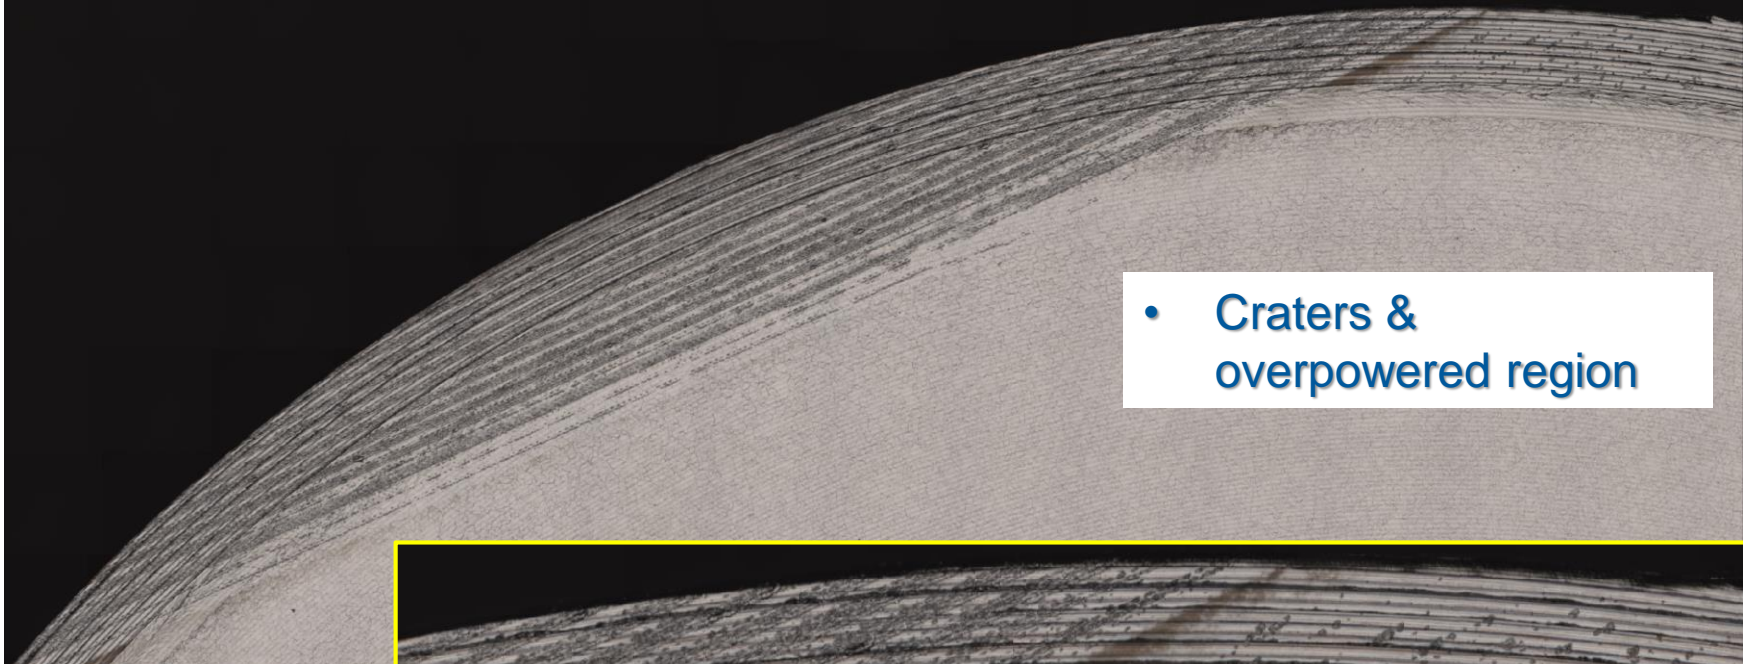
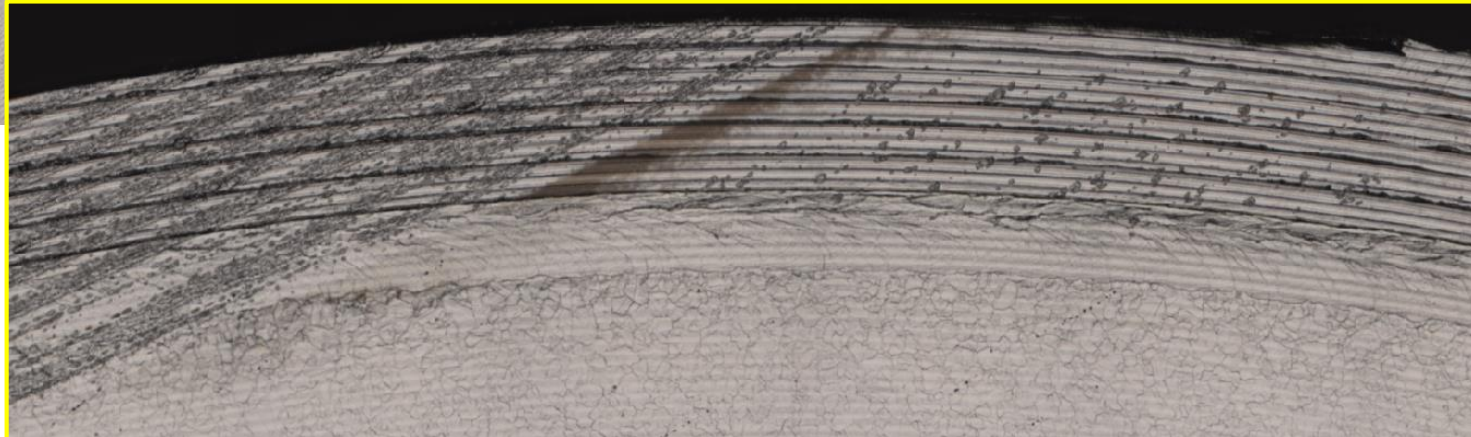
- Craters & overpowered region
