SuperFGD box thermal tests and review

Davide Sgalaberna SFGD mechanics group meeting 8th March 2021

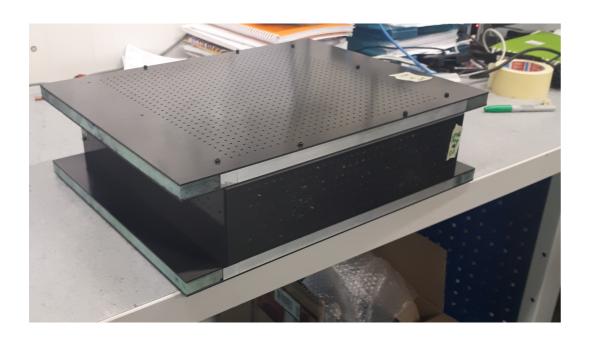
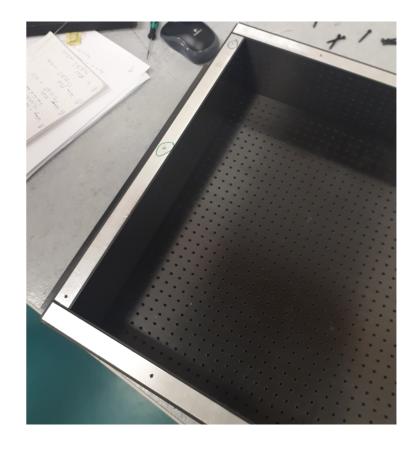
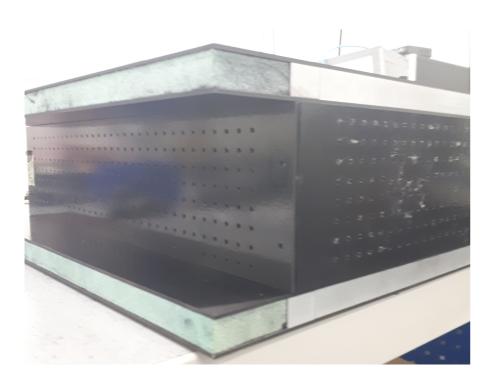
Tested up to 40°C —> no visible problems

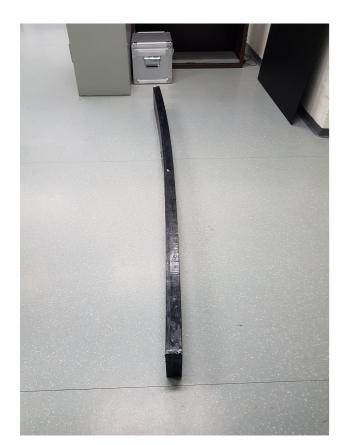
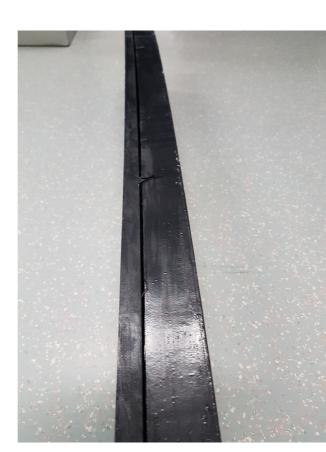
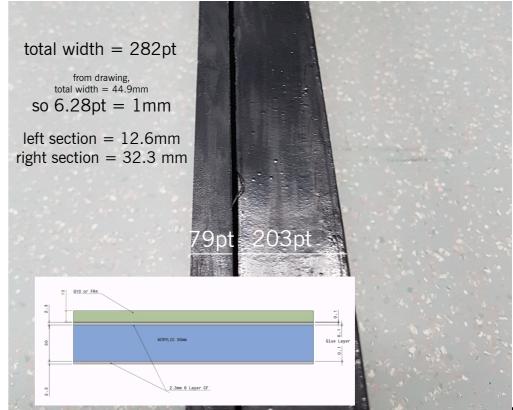
- Quite extreme test were performed
- From room T to 40° C —> no visible problems were found
- From room 40° C to 50° C and then down to -10° C
 - + Apparent failure of glue joint between likely CF and PMMA on the G10 side
 - Visible crack in the upper part of the plate but it seems on the glue coating, not through the PMMA. We will examine this crack in more detail, but it may not be a problem
 - + Permanent deformation of all the materials on one extreme of the panel

- Is the problem PMMA, G10 or both ?
 - + PMMA stable until $\sim 65^{\circ}$ C (to check)
- Did the problem happen at $> 40^{\circ}$ C or $< -10^{\circ}$ C ?
- The panel will be cut and checked in its inner part at different heights
- Hard to say whether providing specs on max T range is sufficient because of lacking of informations

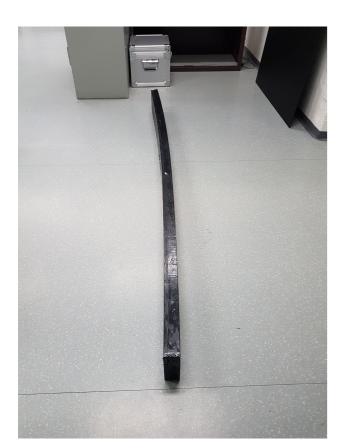
- Quite extreme test were performed
- From room T to 40° C —> no visible problems were found
- From room 40° C to 50° C and then down to -10° C
 - + Apparent failure of glue joint between likely CF and PMMA on the G10 side
 - Visible crack in the upper part of the plate but it seems on the glue coating, not through the PMMA. We will examine this crack in more detail, but it may not be a problem
 - + Permanent deformation of all the materials on one extreme of the panel
