# Thu 27/05/21 18:41

BEQ1 compensator tripped on water cooling failure and interlocked the SPS.

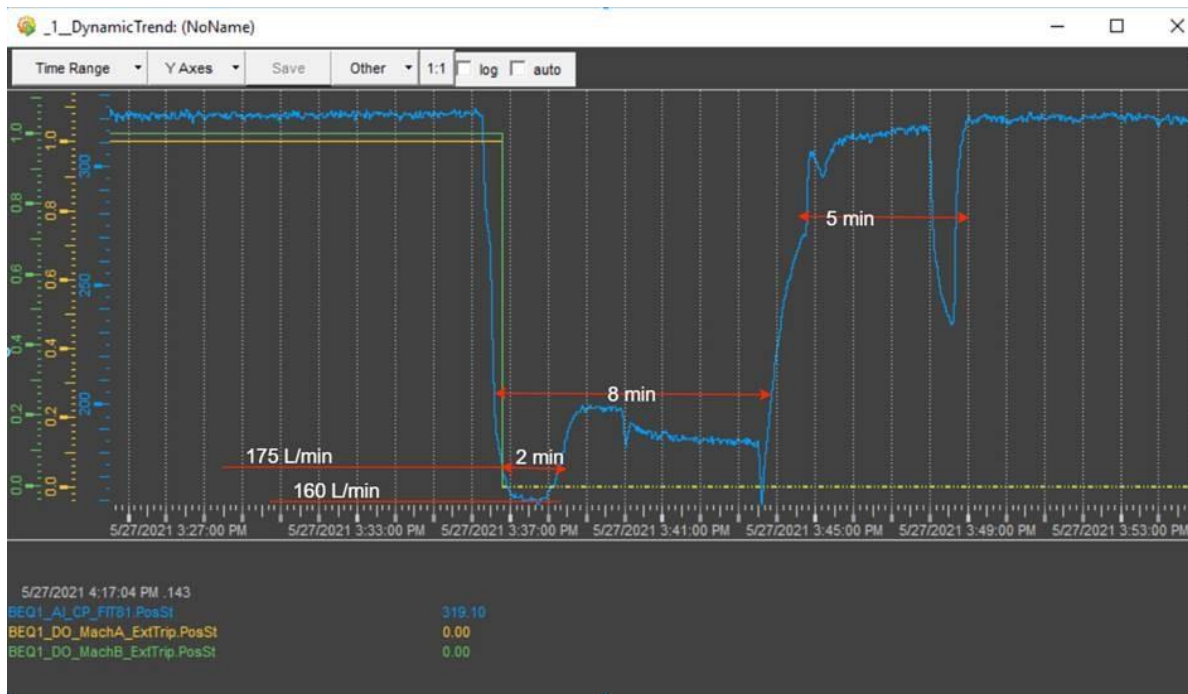
At first a cooling problem was expected, but after investigating with OP-SPS, OP-TI, EN-CV and SIG it was understood that when the SPS is stopped some regulation valves are closed on SIG supply, which is normal, but the BEQ1 sees the low water flow on the primary cooling and tripped the BEQ1.

The graph shows the flow that dropped (blue line).

It will be looked into by the TIOC to propose an interlock based on the cooling water temperature on the secondary side instead.
