Processing and testing of AUP prototype #1 NRFDP001

Paolo Berrutti– Fermilab

WP4 collaboration meeting: AUP-Canada-CERN-UK

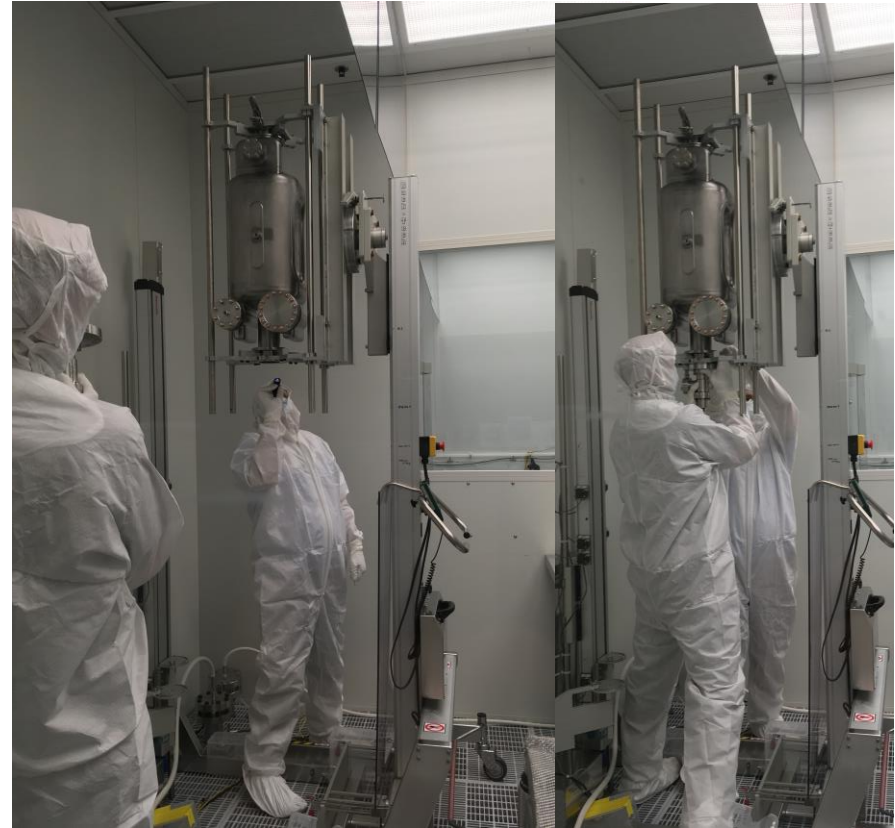
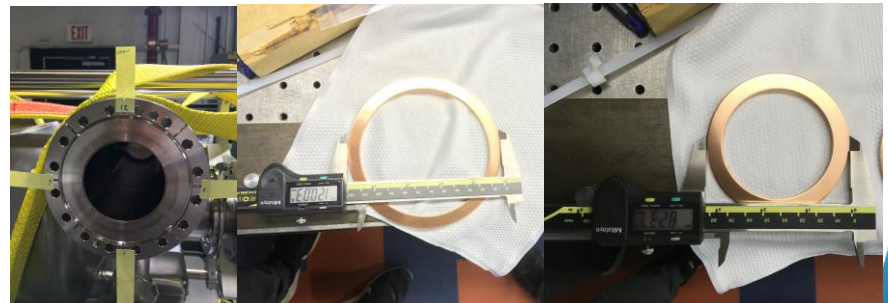
Processing III: Problems with CF flanges assembly

- Multiple times fully assembled bare cavity has been leaking due to a combination of:
 - Knife edge defects
 - Differences in the gasket sizes and tolerances between CERN and US standards
- Problems seemed to be resolved with:
 - Thorough flange inspections followed by knife edge polishing (if needed)
 - Custom gasket machining
- No leaks for prototype #1 at 2K
- Prototype #2 leak test went well: no leaks @ RT

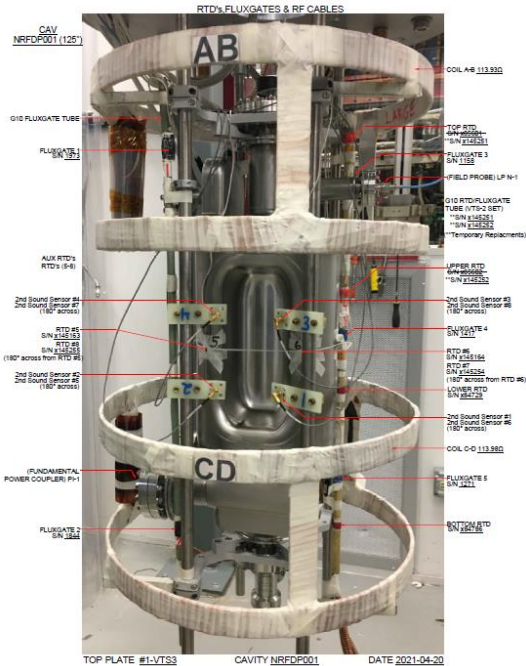
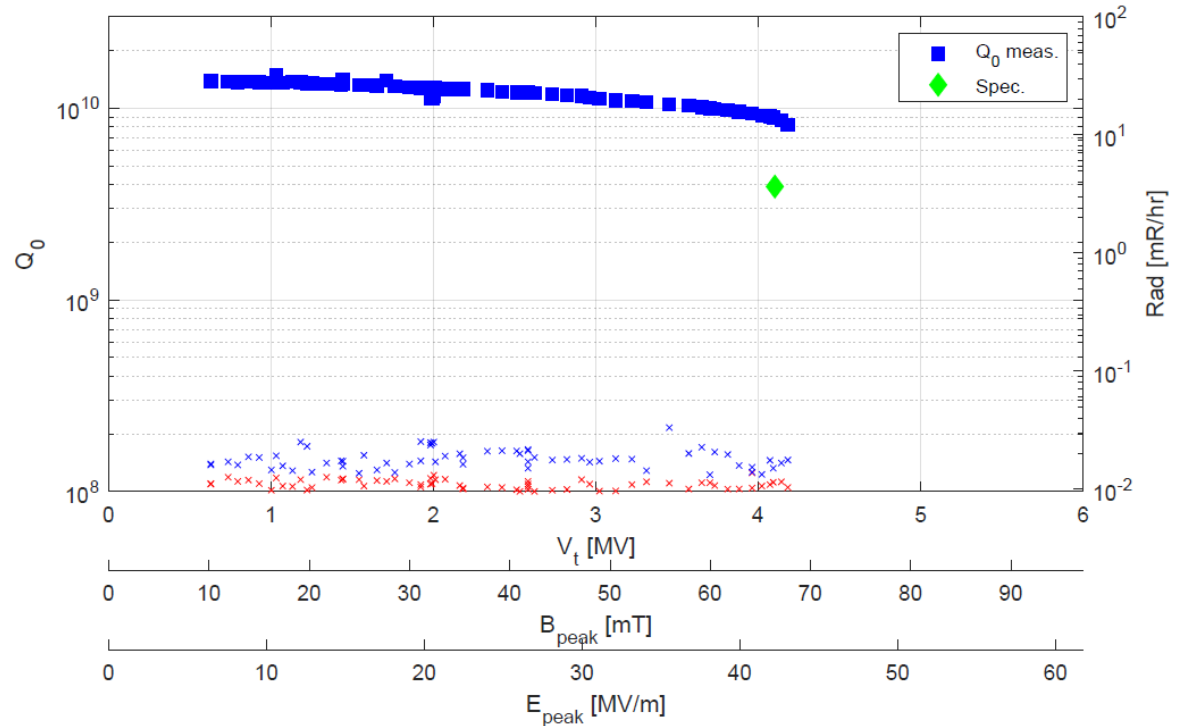
Test I: fast cooldown in compensated field

- $Q_0 = 8.2E9$ $V_t = 4.18$ MV at quench, Low field $Q_0 = 1.5E10$.
- $B_{ext} = 0.6$ mGauss.
- No FE detected: effective HPR and clean assembly
- OST indicates quench spot on top of sensor 3, between corner and end-cap weld (preliminary result)
- Optical inspection showed defect in the probable quench area

- NRFDP001:
 - Complete investigation of quench location and possible mitigation plan
 - Potentially test with HOMs damper from JLAB (later this summer)
 - Cavity jacketing...
- NRFDP002:
 - Bulk BCP
 - 600 C heat treatment
 - Light BCP
 - HPR and assembly
 - VTS (bare cavity)
 - ...

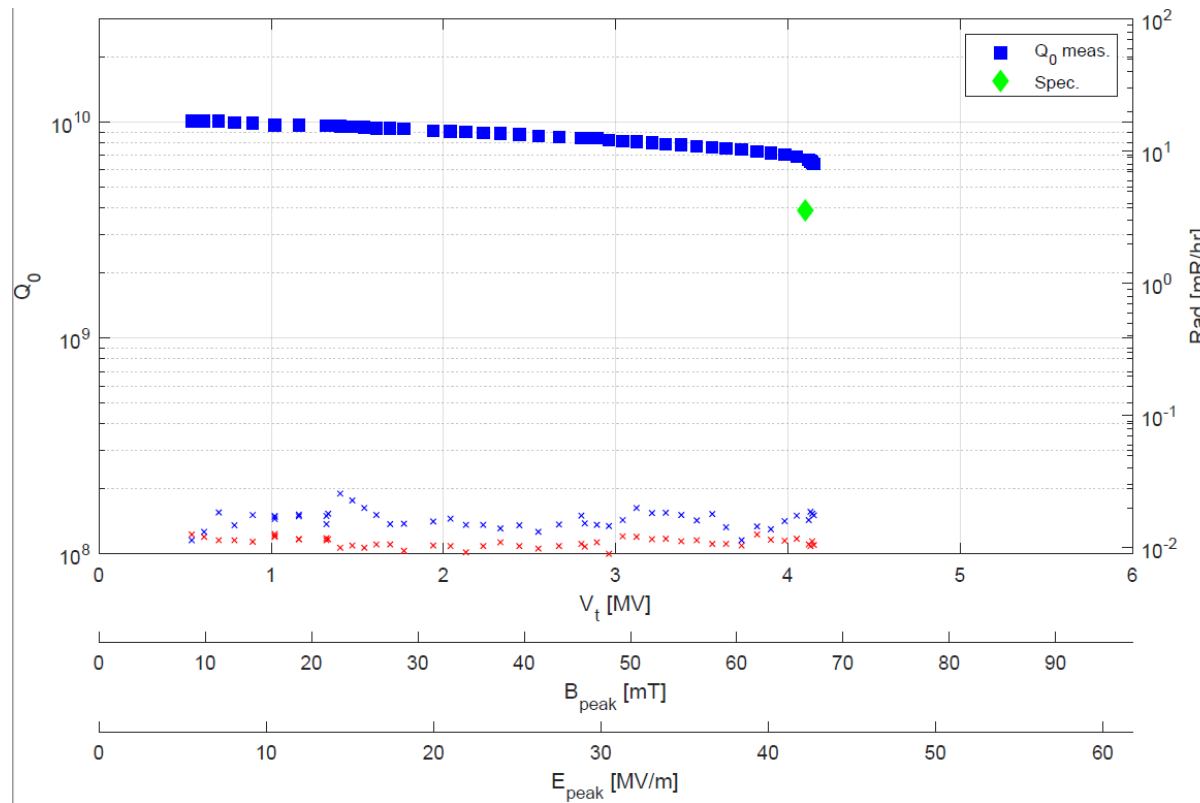
Test II: fast cooldown in 100 mG field

- $Q_0 = 6.4E9$ $V_t = 4.15$ MV at quench, Low field $Q_0 = 1E10$.
- $B_{ext} = 100$ mGauss.
- No FE detected: effective HPR and clean assembly
- OST indicates quench spot on top of sensor 3, location unchanged
- To maximize trapped B slow cool down with B field applied next time
