CRYOMAGNETS, INTERCONNECTIONS, SUPERCONDUCTING CIRCUITS: WHAT TO DO IN 2012/13 IF YOU ARE NOT CONSOLIDATING SPLICES?

J.Ph. Tock, CERN, Geneva, Switzerland,

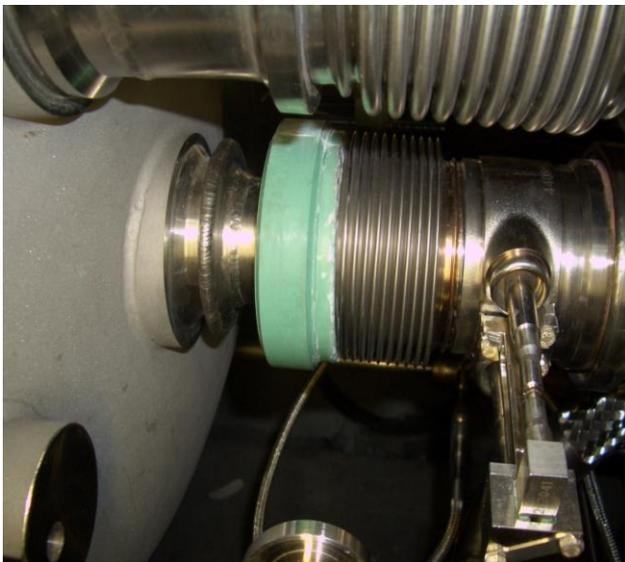
During initial interconnections assembly, about 55 nested bellows were damaged; two of them quite heavily and they were consolidated (see Fig. 1). A thorough analysis by the expert concludes that they can survive a few cycles. As they are working only in case of an error in the cryogenics operation, it is not planned to replace them. This will be confirmed after a very careful inspection. The present procedure to replace them requires a complete exchange of the beam screen so the disconnection of the cryomagnet.

Figure 1: Repaired nested bellows (QBQI.10L5)

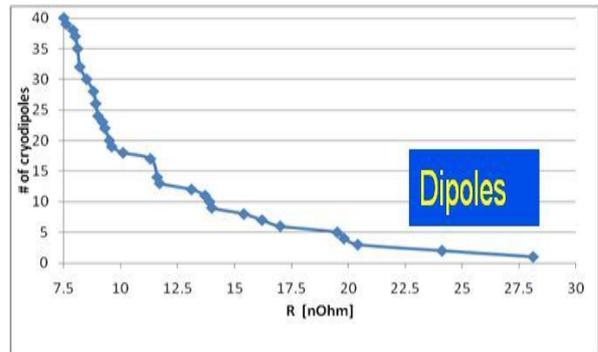
Thanks to the nQPS system, all inner splices of the main dipole and quadrupole cold masses were measured. [12]. The maximum value in a dipole is 28.1 n Ω and about the same in a quadrupole. Figure 2 shows the cumulative number of dipole cold masses with an inner resistance higher than a certain value. These high resistances are not worrying from the cryogenics or electrical point of view. The concern is that a high electrical resistance can reveal a very bad mechanical contact that could fail and open when submitted to electromechanical forces, for example if the splice quenches.

Fig. 2: Dipoles inner splice resistance

In order to estimate the resources and as it is judged a reasonable value [13], the proposed baseline is to replace 8 cryodipoles and 1 SSS, reducing by a factor 2 the highest inner splice resistance in the LHC machine. In parallel, a study and a test programme are launched to gain knowledge on the behaviour of these possibly weak splices.
