CONSEQUENCES OF A HYPOTHETICAL INCIDENT FOR DIFFERENT SECTORS

F. Bertinelli, S. Claudet, C. Garion, J.M. Jimenez, V. Parma, A. Perin, R. Schmidt,
L. Taviani, J.P. Tock & R. van Weelderren, CERN, Geneva, Switzerland.

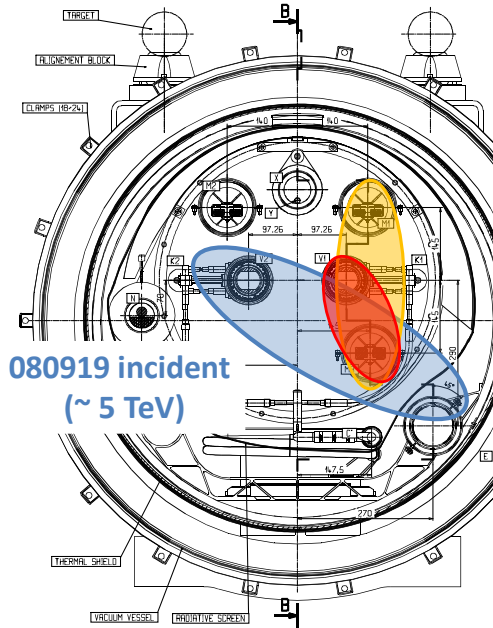
Figure 2: Footprint of electrical arcs.

The 19th September 2008 incident occurred at a main current of 8.7 kA which corresponds to a equivalent beam energy of 5 TeV. Figure 2 shows the footprint of the

incident electrical arc as well as possible smaller ones. With “smaller” electrical arc (i.e. lower magnetic stored energy and/or lower discharge time constant), perforation of the beam pipe cannot be excluded with the present consolidation status (electrical insulation of the beam pipe interconnects foreseen in the next long shutdown).

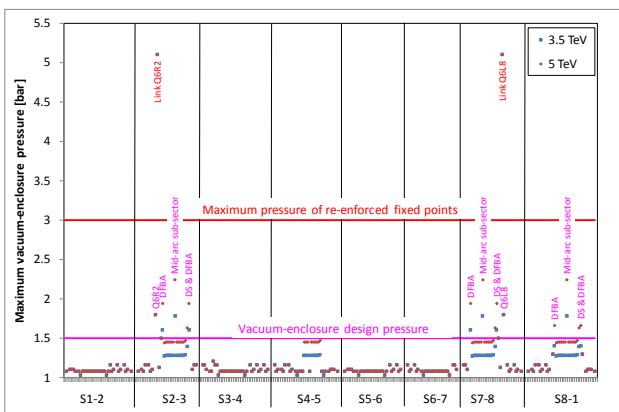
Figure 3: Maximum vacuum enclosure pressure.

With the present consolidation status the maximum pressure appearing during a hypothetical incident is shown in Figure 3 for beam energy of 3.5 and 5 TeV.

Two links of Q6 cryo-magnets (see Table 1) are pressurized above the threshold corresponding to the maximum pressure which can be handled by the reinforced fixed-points (3 bar). These links which have an external diameter of 200 mm can withstand this overpressure.

Other sub-sector vacuum enclosures exceed slightly their design pressure threshold of 1.5 bar (see Table 1). However, the overpressures remain compatible with the

design margins of vacuum enclosures. Above 1.9 bar, plastic deformations could occur in the vacuum barriers of the short straight sections; consequently, at 5 TeV, the vacuum barriers of the mid-arc sub-sectors in S2-3, S7-8 and S8-1 could be affected (see Table 1).

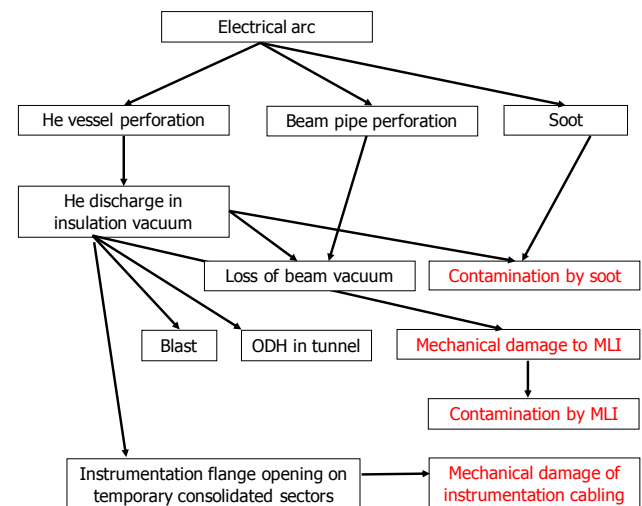
Figure 4: Updated fault tree of an electrical arc in a cryo-magnet interconnect up to 5 TeV.

: In conclusion, mechanical collateral damages are no longer expected up to beam energy of 5 TeV. Figure 4 shows the updated fault tree of an electrical arc in a cryo-magnet interconnect up to 5 TeV. Nevertheless remaining damages are:

- He vessel and beam pipe perforation,
- mechanical damage of MLI,
- contamination by soot of MLI and beam pipes,
- contamination by MLI of vacuum enclosure and beam pipes,
- mechanical damage of instrumentation cabling.

Helium vessel and beam pipe perforation by the electrical arc will require the immediate removal of the two adjacent cryo-magnets.

The mechanical damage of instrumentation cabling mainly for beam position monitors must be in situ repaired on the four short straight sections of the concerned sub-sector before operation restart.

Concerning the mechanical damage of the MLI, the affected length can be scaled from the 19th September 2008 incident taking into account the frictional pressure drop and the discharge valve distribution. In case of a new incident up to 5 TeV, the affected length is scaled to about 130 m, i.e. about 10 cryo-magnets (2/3 of a standard sub-sector). MLI plays an important role in protection of the cold-mass enclosure in case of catastrophic break of the insulation vacuum by air or by helium. Without MLI, the heat flux entering the cold-mass increase up to a factor 10 (from 5 kW/m² to 50 kW/m²) and the pressure relief system protecting the cold-mass enclosure is definitely undersized. Consequently the mechanical damage of MLI in the cryo-magnets by the high helium flow-rate is critical and need to be repaired before operation restart.

Concerning the contamination by soot of the beam pipe, the affected length can be scaled from the 19th September 2008 incident taking into account the quantity of soot introduced during the beam pipe pressurization. During the September 2008 incident, the V1 beam pipe was pressurized to 3.5 bar (without rupture disk opening) and the corresponding contaminated length was 600 m. In case of a new incident, the beam pipe pressurization is limited to 1.1-1.5 bar, i.e. a factor 2.3 to 3 lower. The new expected affected length will be from 200 to 250 m. The contaminated beam pipes cannot be cleaned in situ and the corresponding cryo-magnet must be transported at ground level for cleaning or must be exchanged before operation restart.

Concerning the contamination by MLI of the beam pipes, the full continuous cryostat (~2900 m) will be affected and must be in situ cleaned before operation restart.

All together up to 14 cryo-dipoles and 4 short straight sections will have to be removed and re-installed. The corresponding repair downtime is estimated to about 8 months. This repair downtime could be extended up to about one year if critical components like current feed boxes are affected.

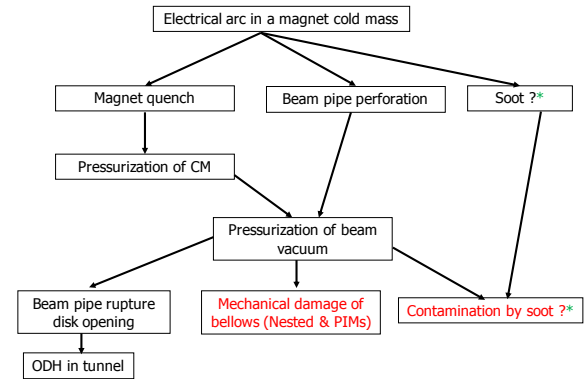
Figure 5: Fault tree of an electrical arc in a cryo-magnet coil.

In case of an electrical arc in a cryo-magnet coil, the beam pipe is directly perforated. This electrical arc will also create a resistive transition of the magnet producing a pressure increase inside the cold-mass enclosure and the

beam pipe. Figure 5 shows the corresponding fault tree and the resulting damages:

- mechanical damage of nested and PIM bellows of the beam pipe,
- contamination by soot of the beam pipe.

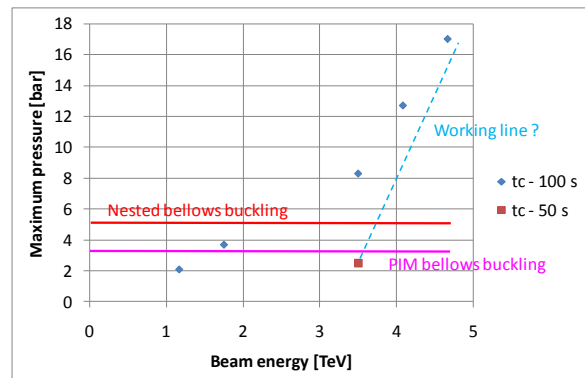
Figure 6: Maximum cold-mass pressure following a dipole resistive transition.

The mechanical damage of the beam pipe bellows occurs when the pressure reaches the buckling pressure of 3.5 and 5 bar respectively for the PIM and nested bellows. Figure 6 shows the maximum pressure developed in the cold-mass following a dipole resistive transition for two current discharge time constants ($t_c=100$ and 50 s). To remain below the buckling pressure of the PIM bellows, the beam energy has to be limited to 3.5 TeV with a current discharge time constant of 50 s. At 5 TeV, the driving pressure inside the cold mass could reach 17 bar corresponding to the quench-valve setting pressure. The beam pipes are presently protected against pressure build-up by only two rupture disks located at the continuous cryostat extremities. Figure 7 shows the pressure profile of the beam pipes for driving pressures of 10 and 17 bar. In both case, more than 600 m of beam pipe could be affected by the buckling of bellows.

Above a beam energy of 3.5 TeV, a large fraction of the continuous cryostat can be affected by the buckling of bellows. The PIM bellows can be exchanged in situ; the exchange of the nested bellows requires the removal of cryo-magnets.
