# Fire in the power cubicle of the BA80 cooling plant

S. Deleval

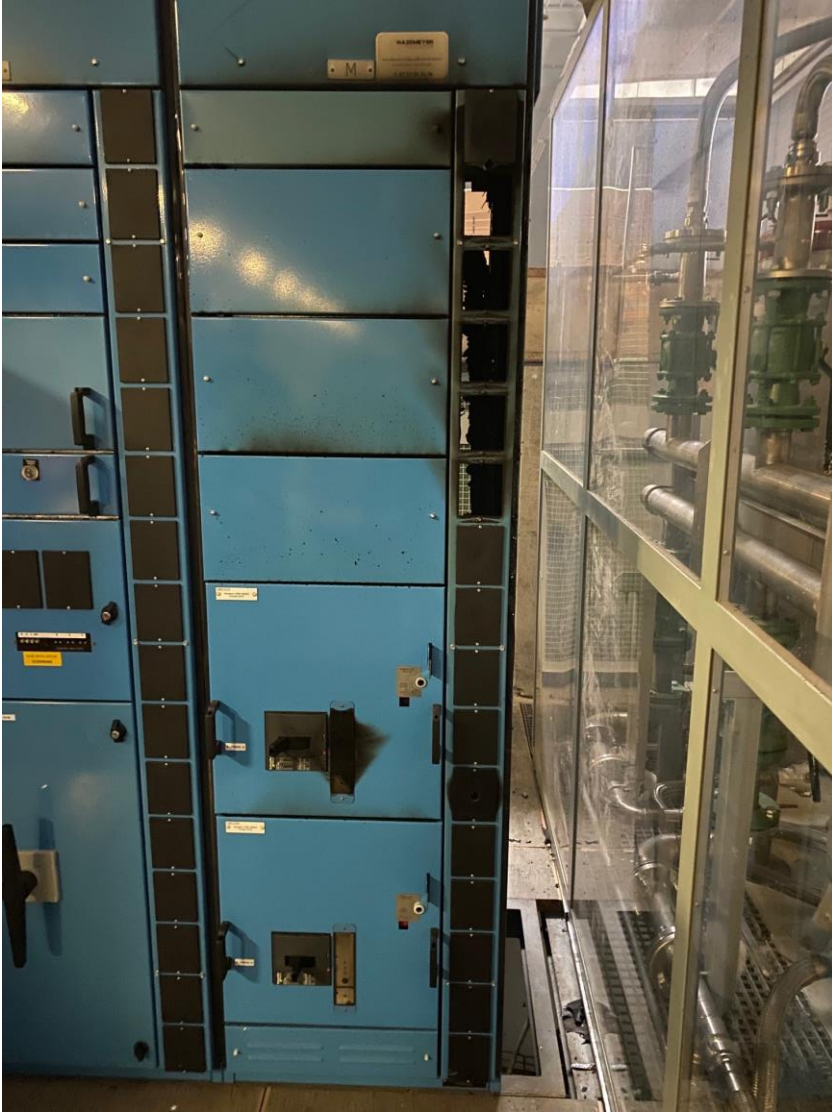
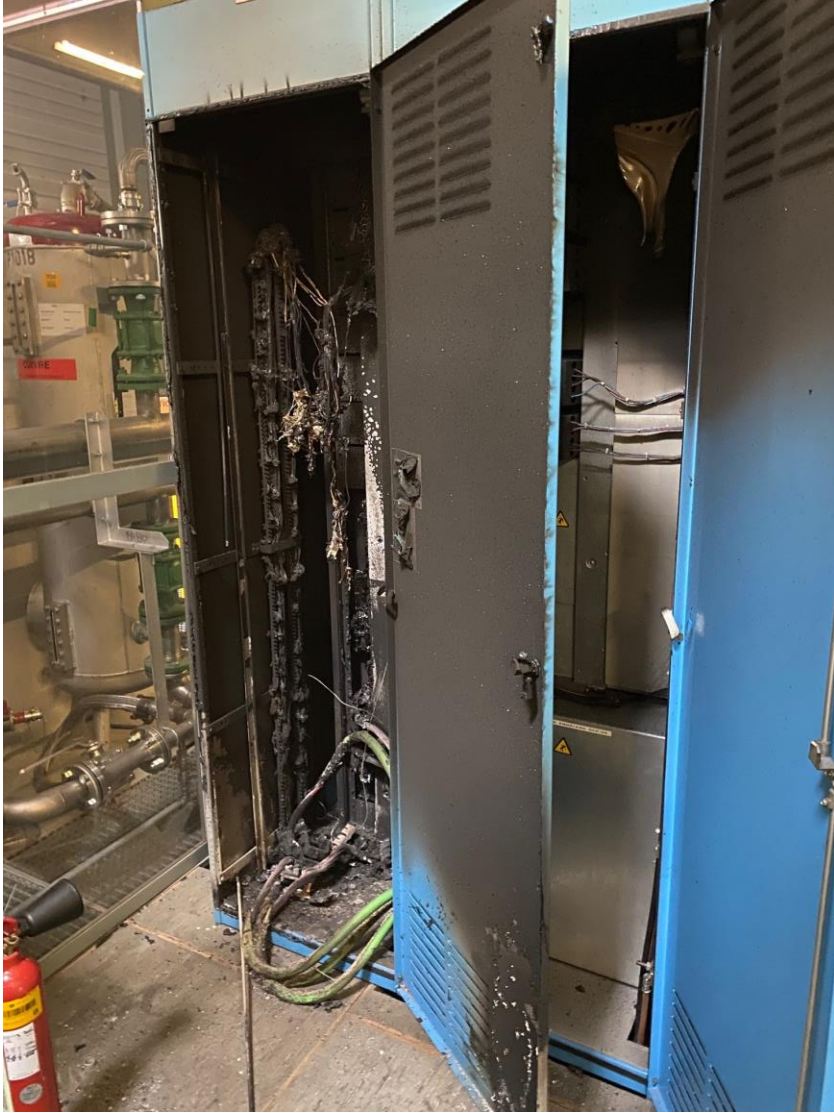
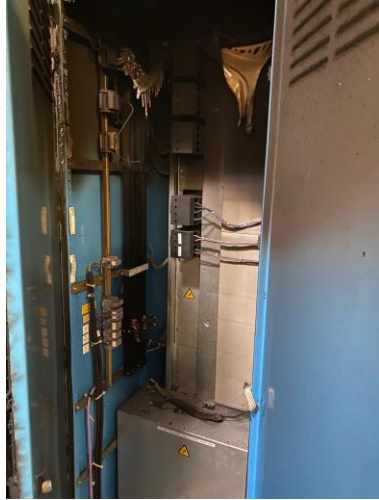
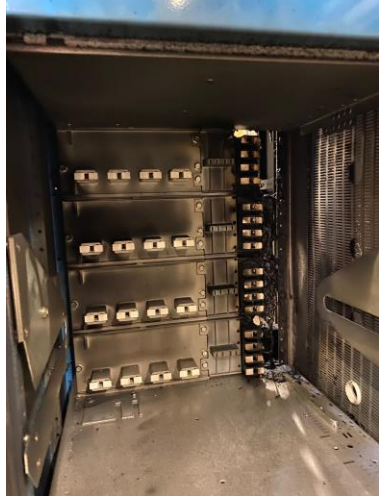
- **Concerned pump stopped at 16h10'06''**
- **Fire brigade intervened and hit the AUG button at 16h10'39''**
  - => stopped ventilations of the building

- **Check of cabling, settings, threshold for the circuit breaker => nothing abnormal found.**
- **Still some information to collect (VFD settings)**
- **Possible cause :**
  - The most probable cause at this stage is a loose connection.

- **Cut the busbar, reorganise and recable the power cubicle to supply two pumps by the not (so) damaged column. (=plan A)**
- **Resupply one or two pumps directly from EL power cubicles. (= plan B)**
