Micromegas Commissioning status report

Athina Kourkoumeli-Charalampidi
On behalf of the Micromegas Commissioning Team

Muon Week 02-05/02/2021

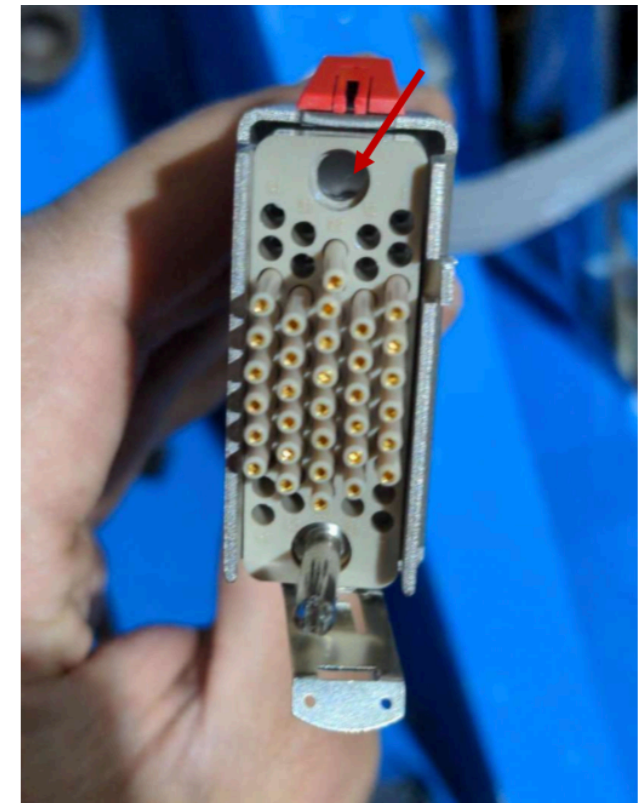
Issues encountered:

- * It can take a few days to reach nominal voltage due to high RH, increased the flow to reduce time
- * Damaged REDEL connectors
 - ▶ Connectors missing alignment pin (A14)
 - ▶ EN/EL team came to fix them
 - ▶ Detracted pins (A14 and A12), some of them were visually ok before trying to connect them
 - ▶ Evidence of improper connectorization
 - ▶ Missing connector parts
 - ▶ Visually checked the connectors of all the other sectors
 - ▶ Another test to perform?
- * REDEL connectors at brackets might need to be re-done due to potential bad crimping
 - ▶ Stelian will test them

These issues were discussed and the BB5 team now controls and protects the connectors before transportation

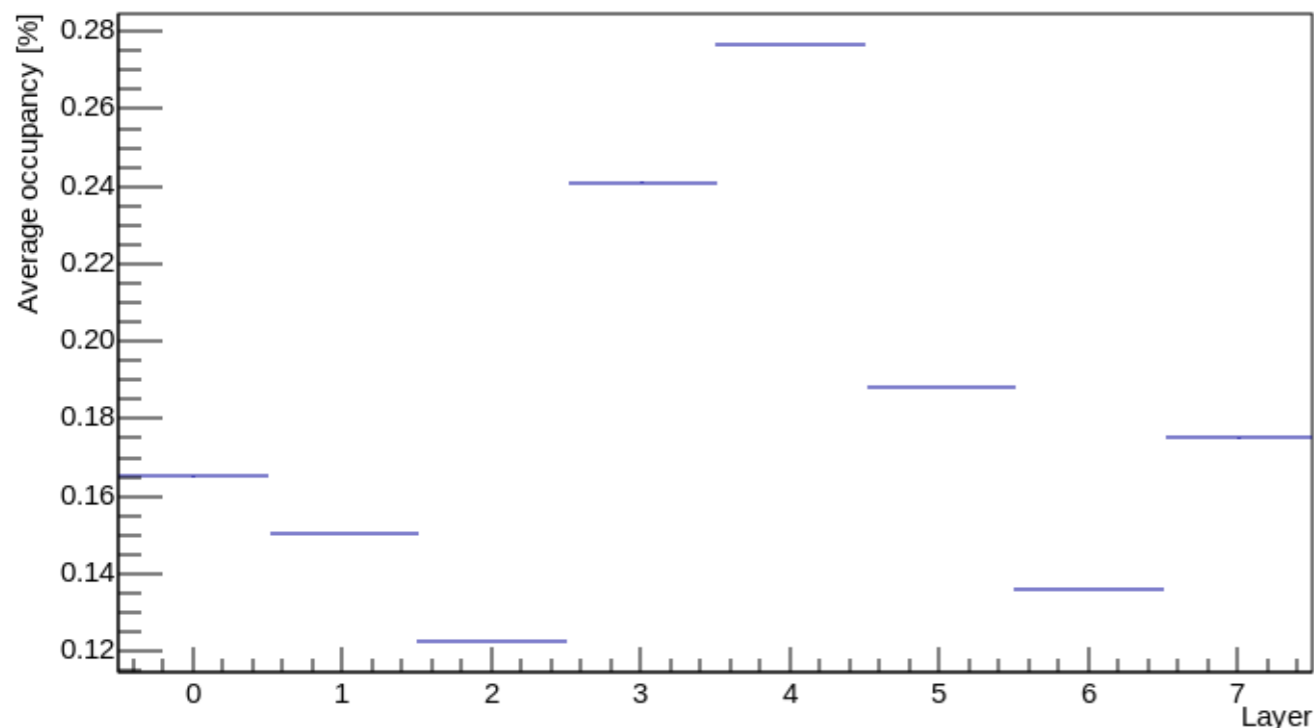
Sector occ. = 0.18 % (1.1% of channels above 3% occ.)

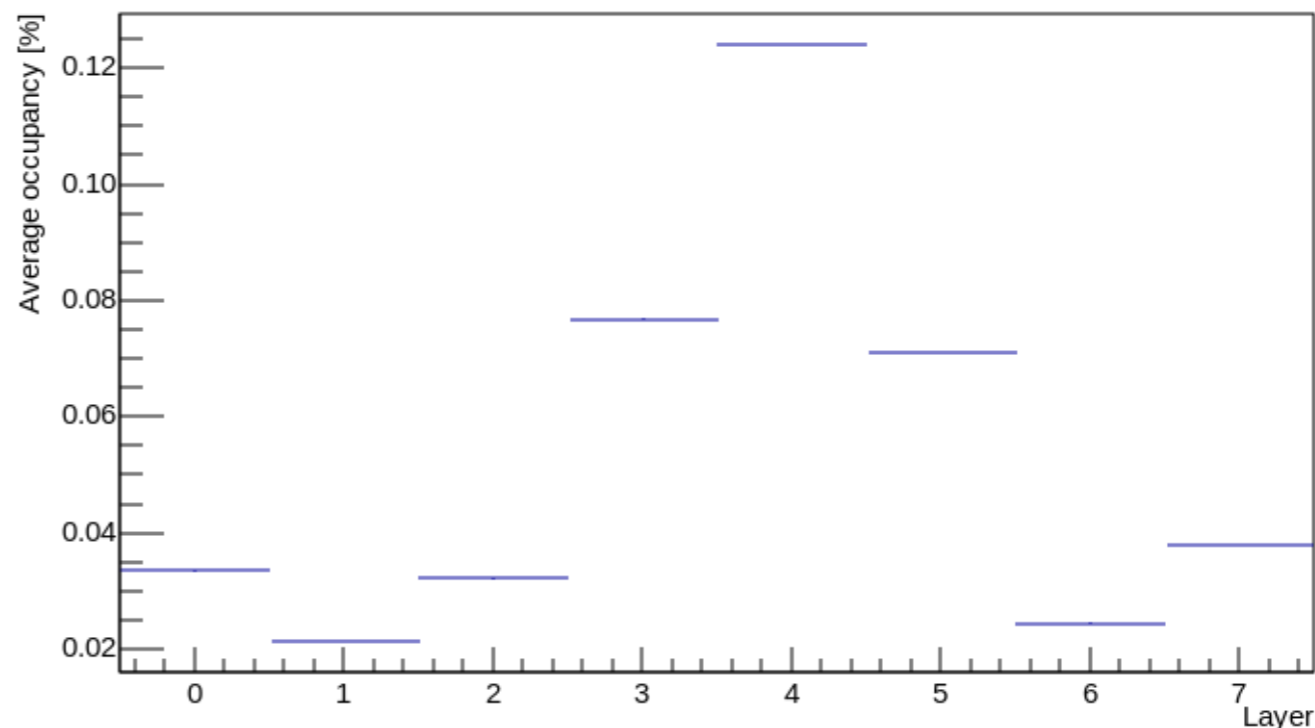
Sector occ. after masking = 0.053 %

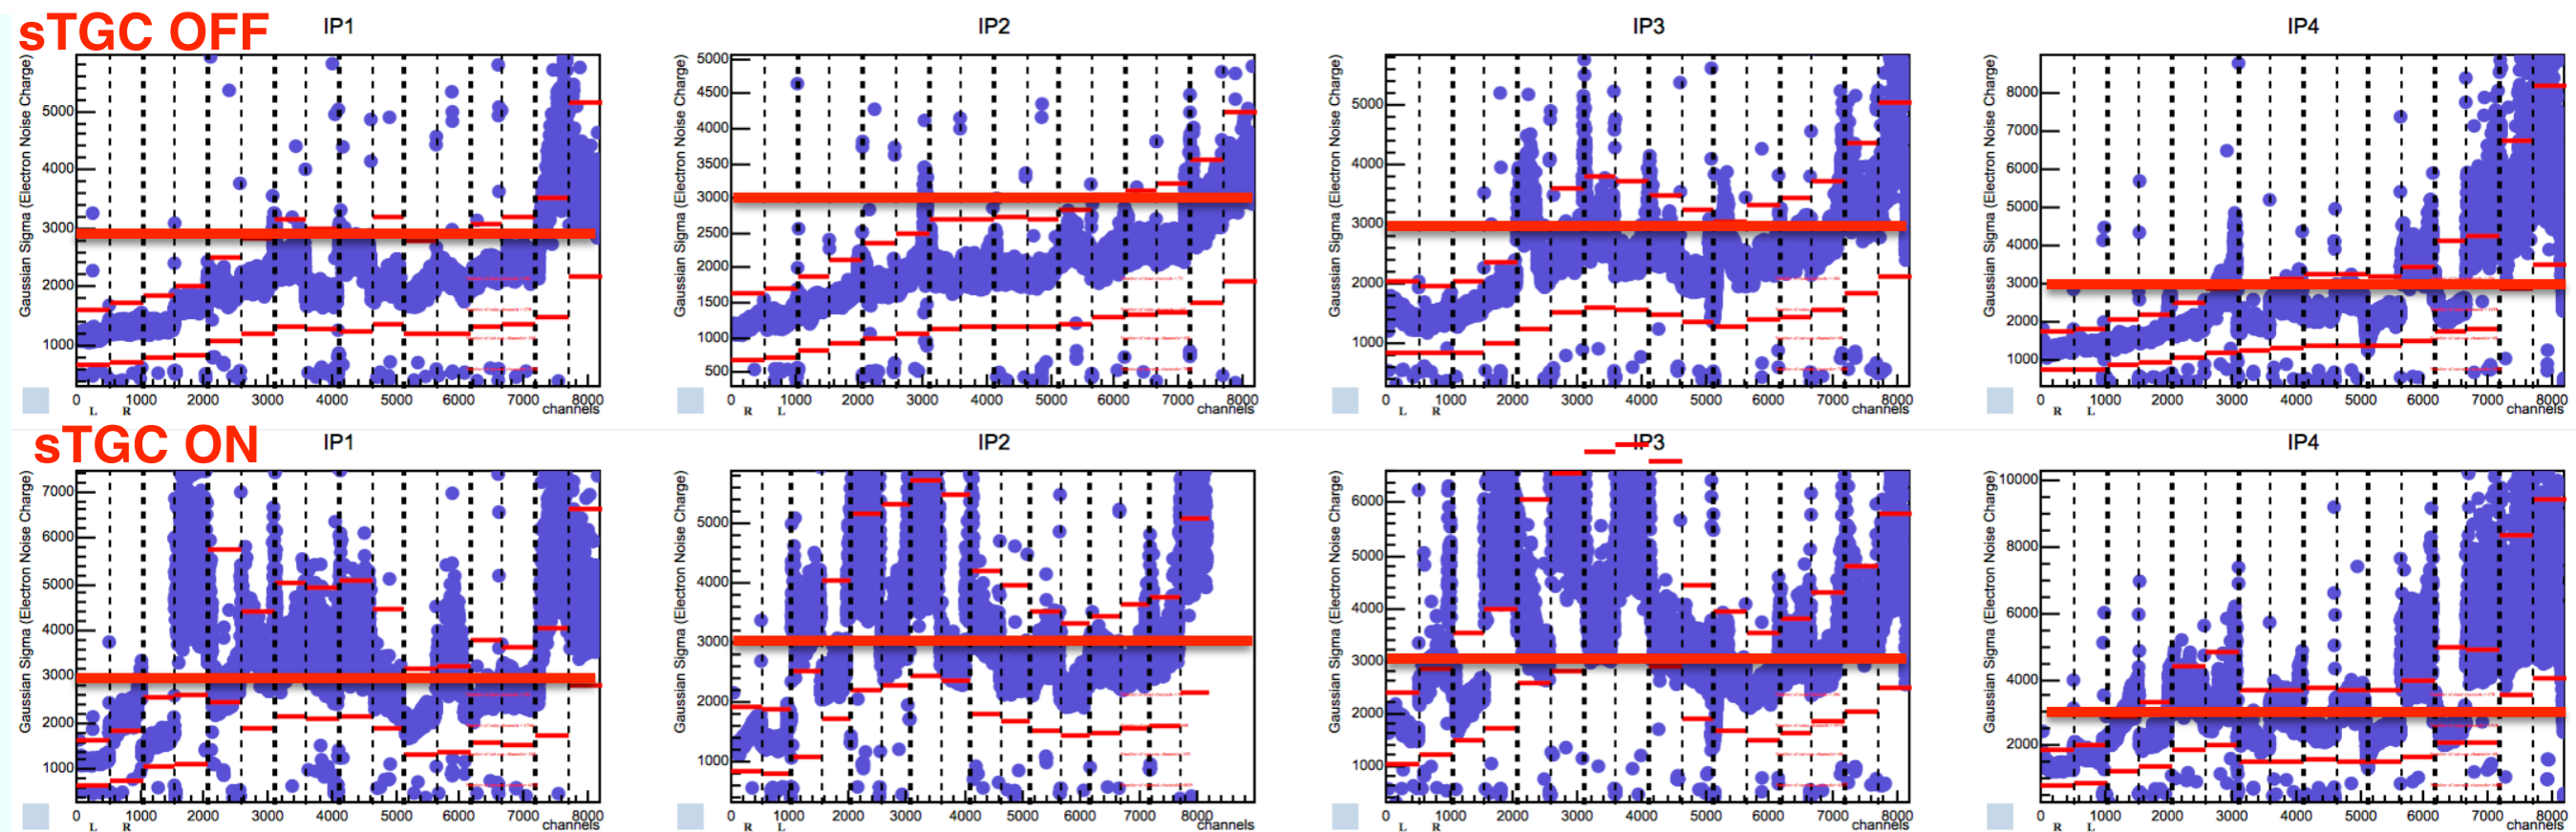
Noise on A14 on wheel (August)

Performed hundreds of tests in order to try to find the source of this noise

- * Through all these tests at 191 and BB5 it was understood that the noise peaks in PCB 3 and 6 were due to the ADDC FEAST noise (support from E. Romano) -> Faraday cages
- * The grounding was also improved by adding thicker GND cables
- * A14 was also tested off-wheel but unfortunately after re-opening sTGC
 - ▶ Could not reproduce sTGC affecting MM (at least not to such extent)
 - ▶ After the refurbishment we were able to track that it was probably due to lack of ICS BC GND

We were able to reduce the general noise levels through improved GND (also thanks to BB5)

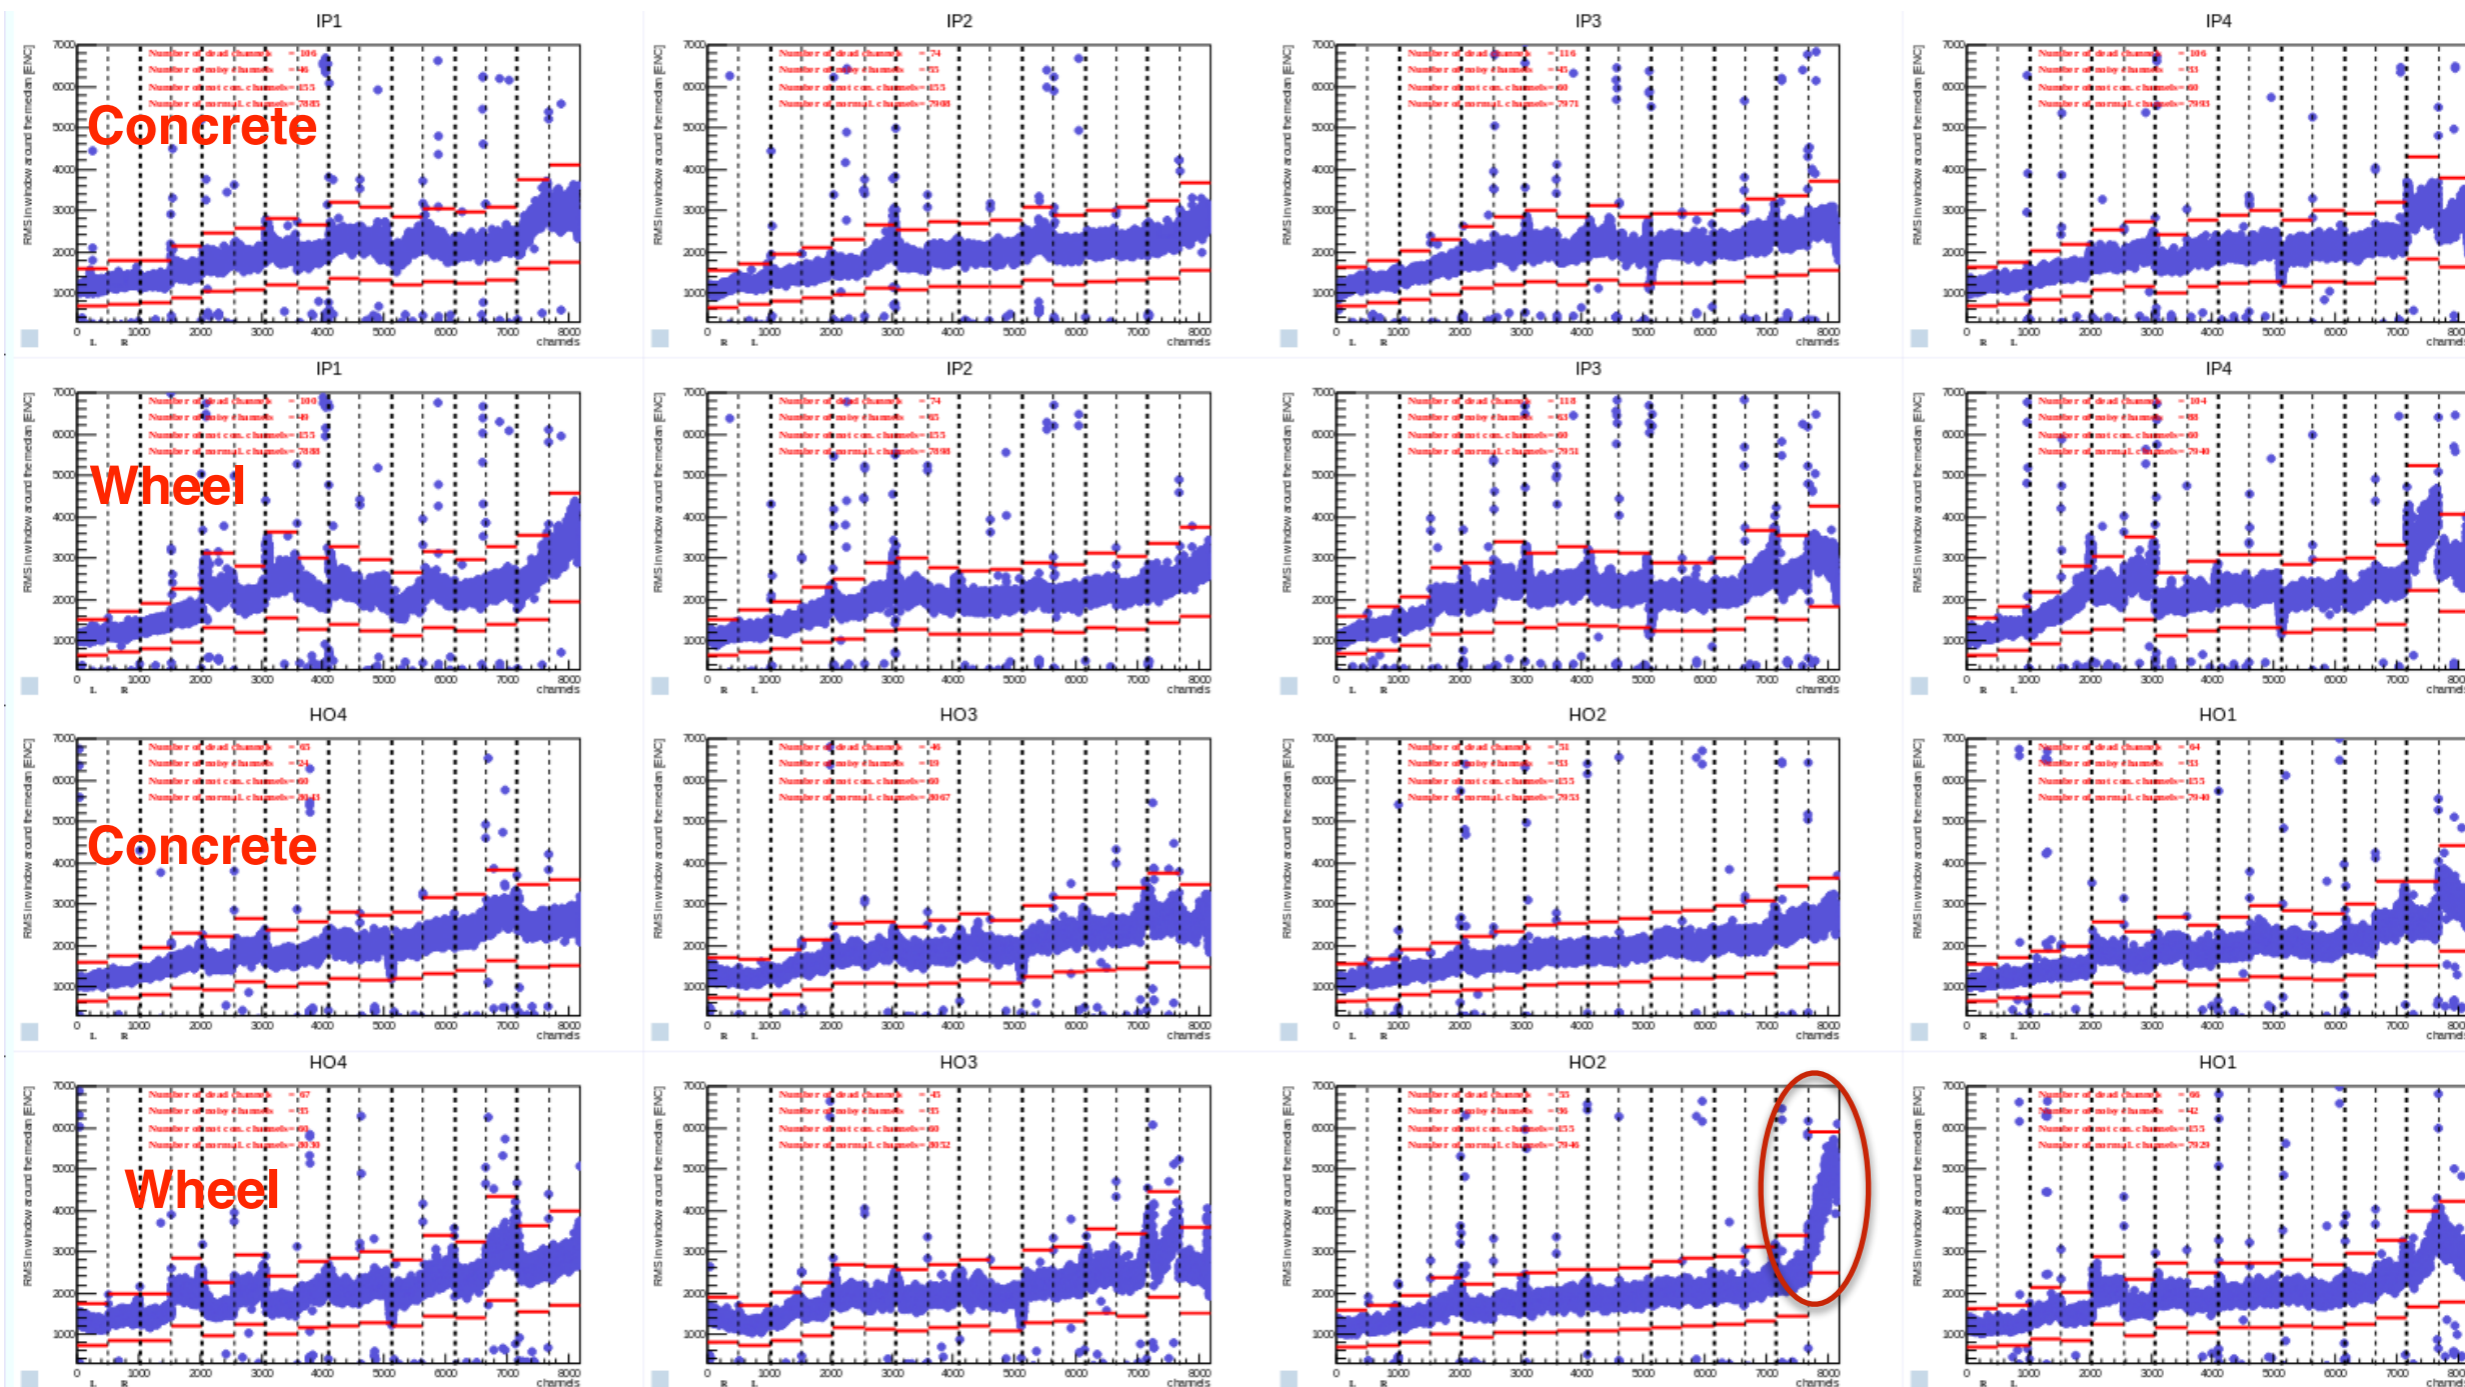
A14 summary plots on-wheel

- ▶ sTGC ON did not make any difference in noise
- ▶ HV ON (new scheme) introduced a bit of noise, but non-significant

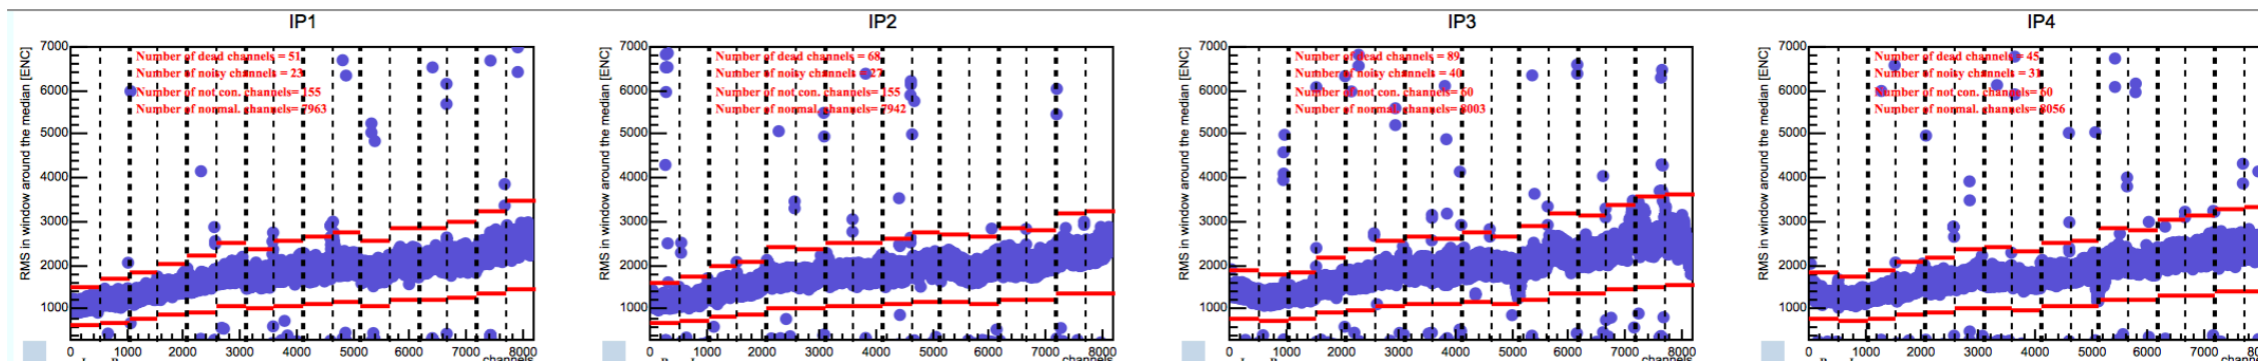
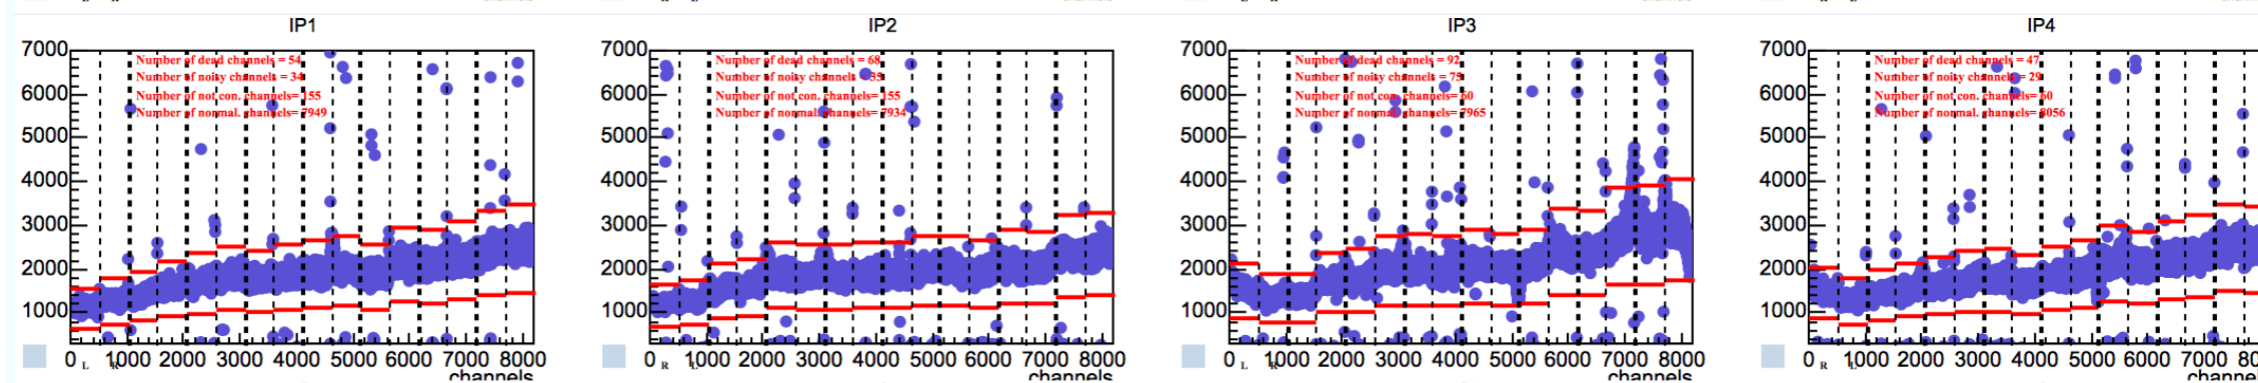
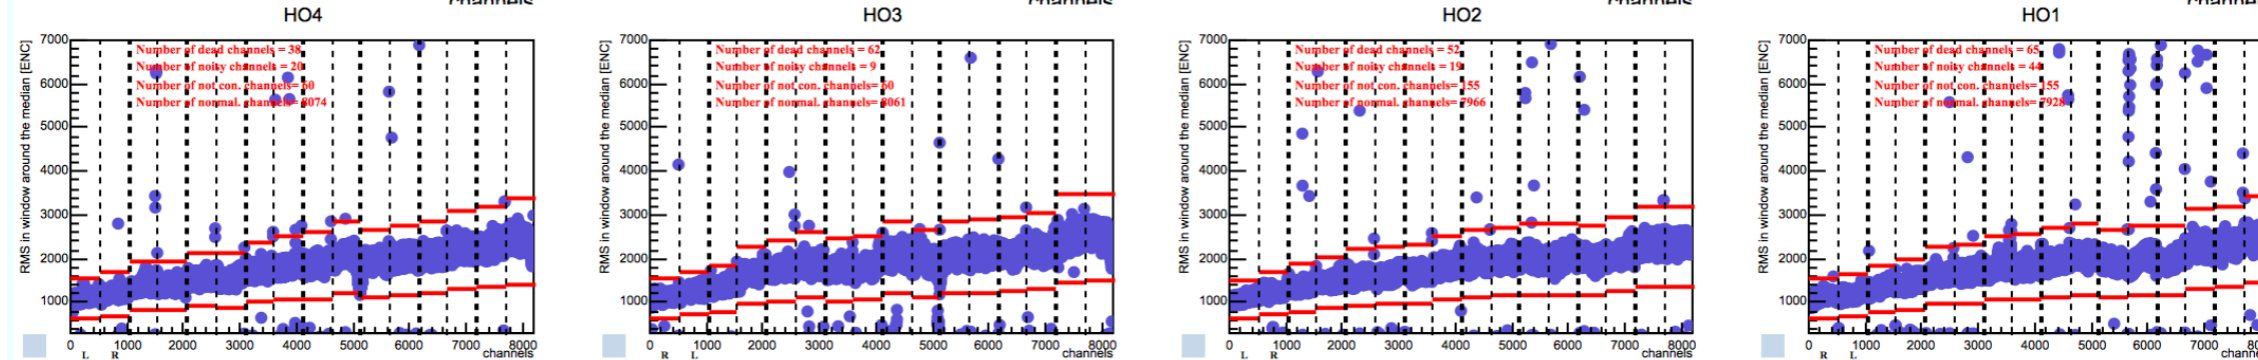
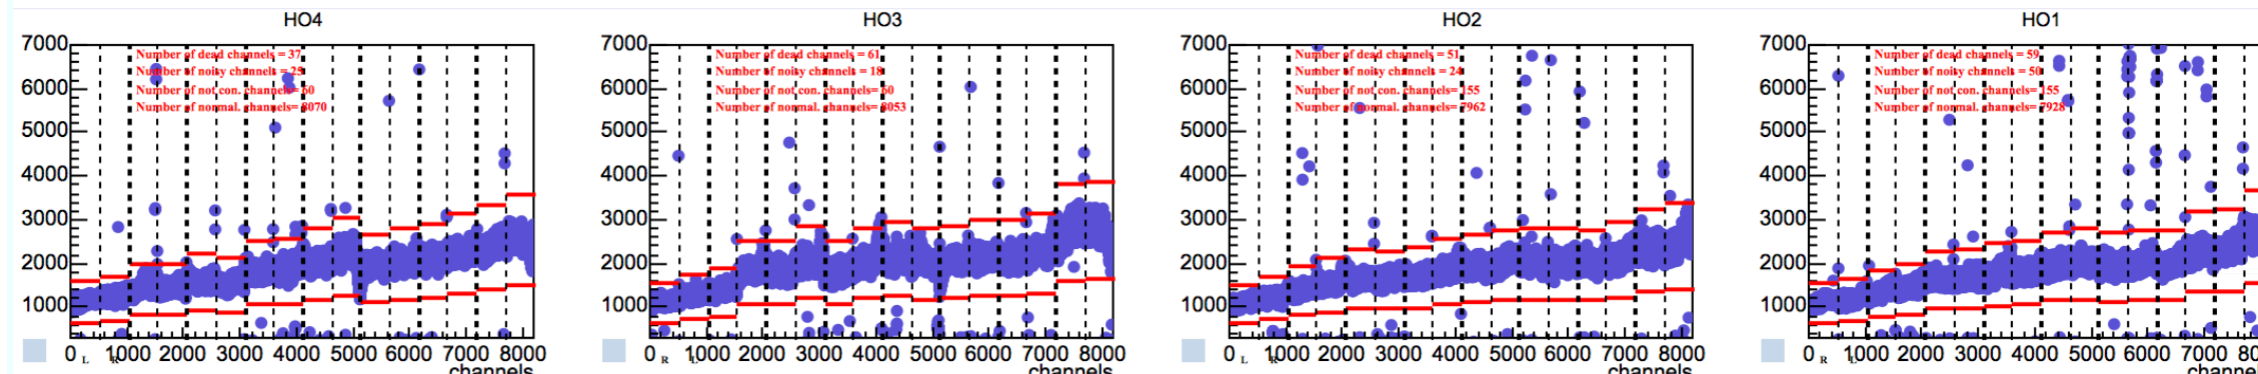
A12 summary plots on-wheel

► sTGC ON did not make any difference in noise

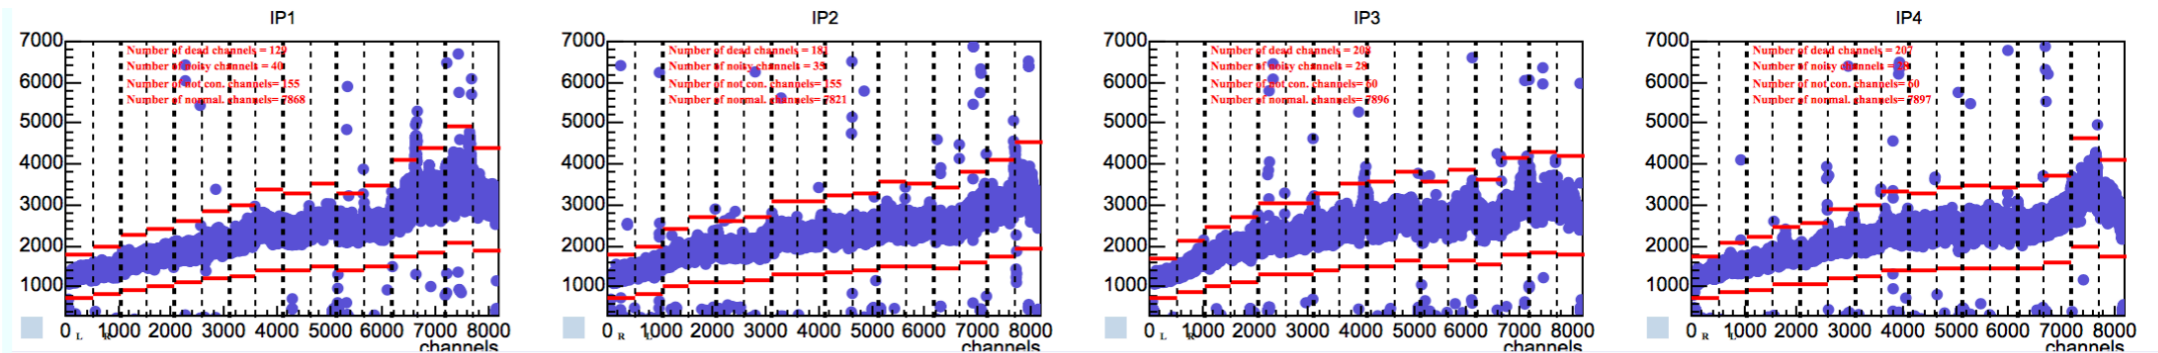
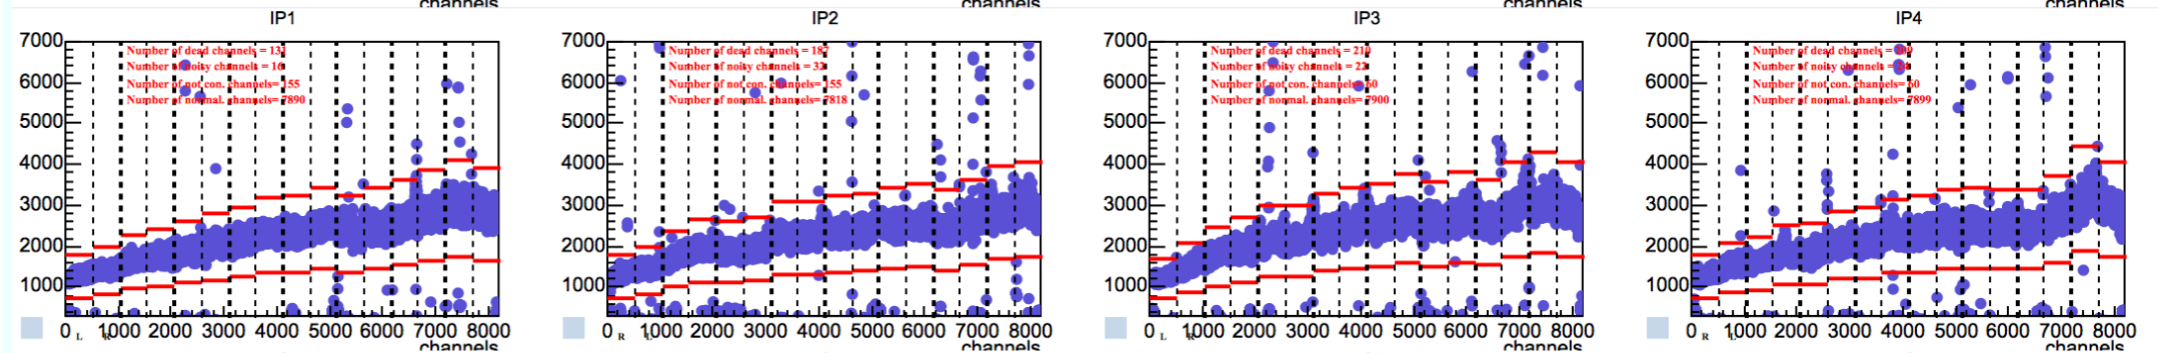
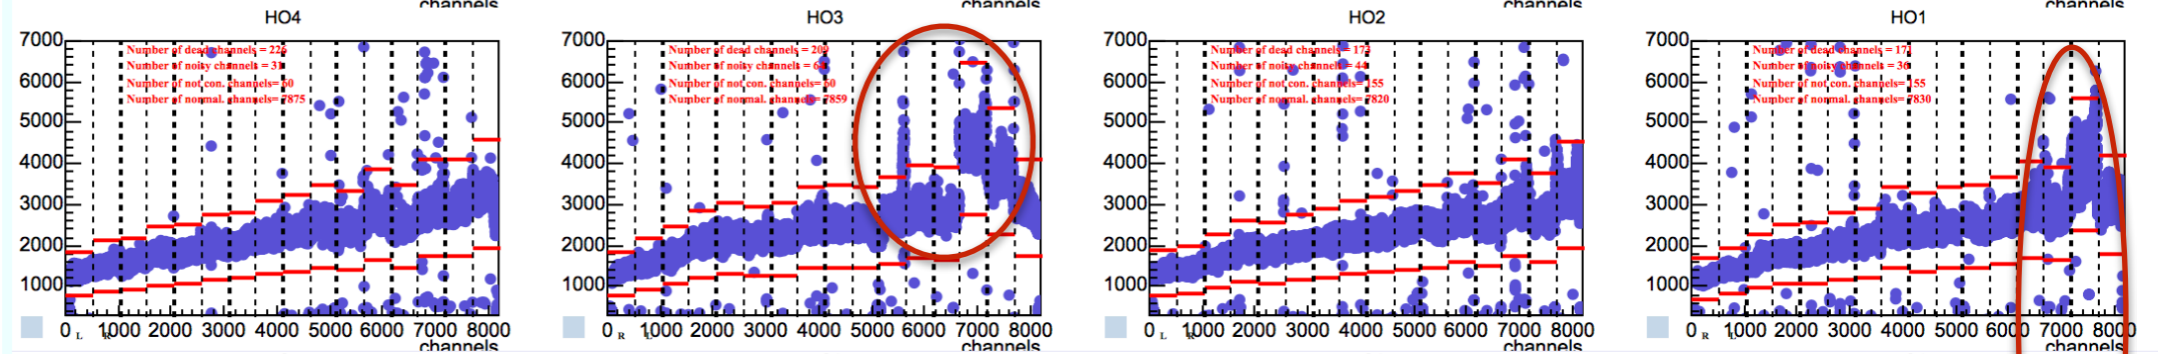
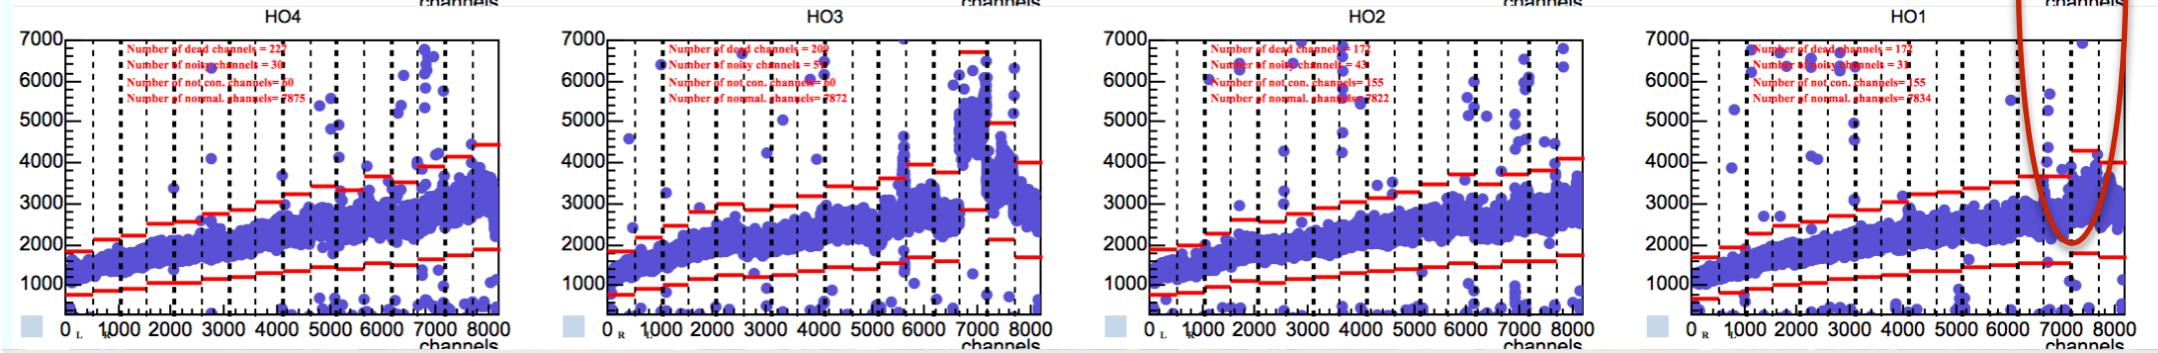
A13 summary plots on concrete blocks (sTGC OFF)

- ▶ Noise reduced with modified ICS front panels (especially HO1)
- ▶ Testing A13 with ICS large sector, to test with sTGC ON
