Mechanical *Instability* of Cables

[302.2.03 Cable Fabrication]

Ian Pong – LBNL (302.2.03 L3 and CAM)

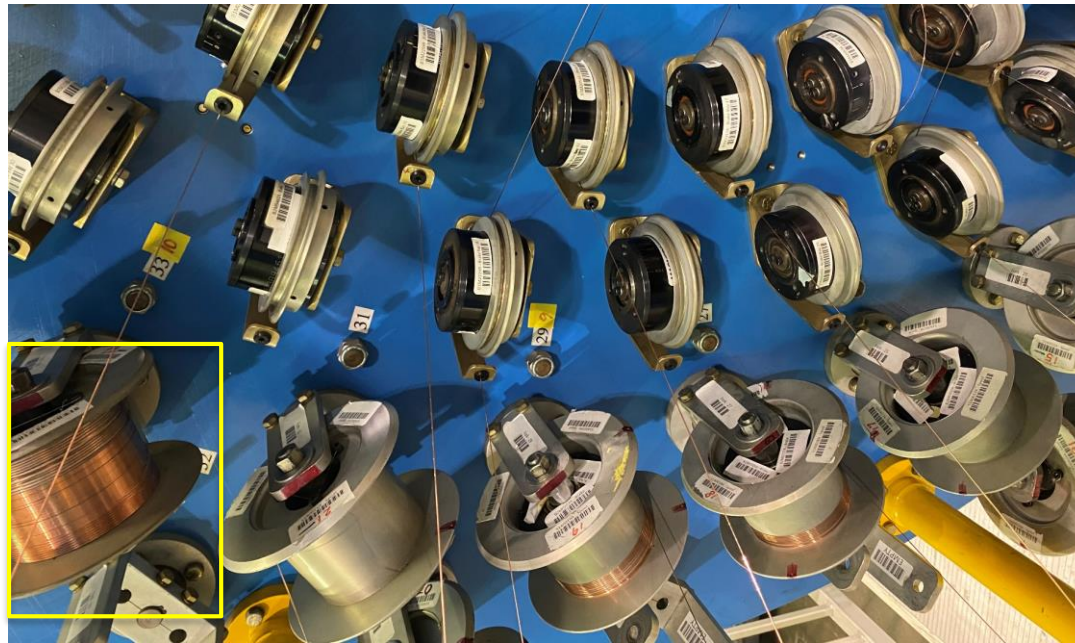
- During wire stringing (#1156), one strand was unusually slippery and difficult to string onto cabling machine
 - Post-cabling, an excess amount of residual wire was found at this fork same position (~25 m. Typically just a few meters)

One respool showing excessive residual strand

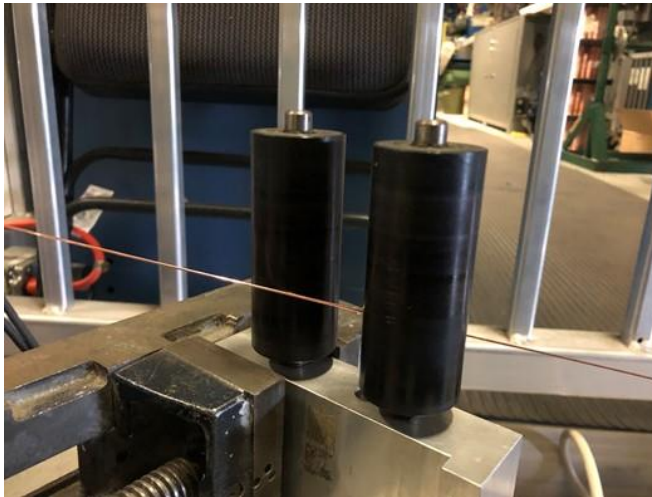
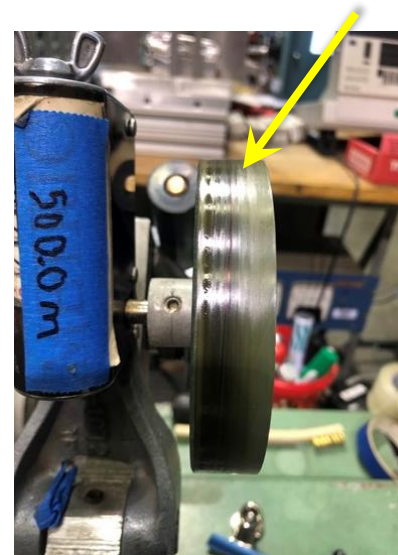
- For next cable (#1157), post-startup short cable samples for 10-stack thickness were unusually unstable.
- Also, during respooling of #1157, one vendor spool was 'missing' ~500 m of length (one unit respool length)
 - Correspondingly, many respools were found to be ~10% overweight
→ Too much length onto the respools
- Respooling equipment & pulleys found to be oily

- Most Likely Cause: *Oily wires caused footage counter slippage and cable short-sample instability*
 - Oil transferred to equipment, cross-contaminating other strands
- Immediate (concurrent) actions:
 - ‘Stop Work’ order initiated
 - Concern about future cable stability during coil winding
 - Meeting called with wire vendor
 - Kudos to our wire procurement counterparts for fast action (302.2.02)
 - Notification of L2 & QA managers

- Known affected wire sent back to vendor for recleaning and/or exchange
- Equipment and spools cleaned
- Cables not yet made, but with Asgard strands in their strand maps, were cancelled
 - New cable strand maps created using new, clean wire
 - Example: Cable AUP 057: Cable #1157 → Cable #1257

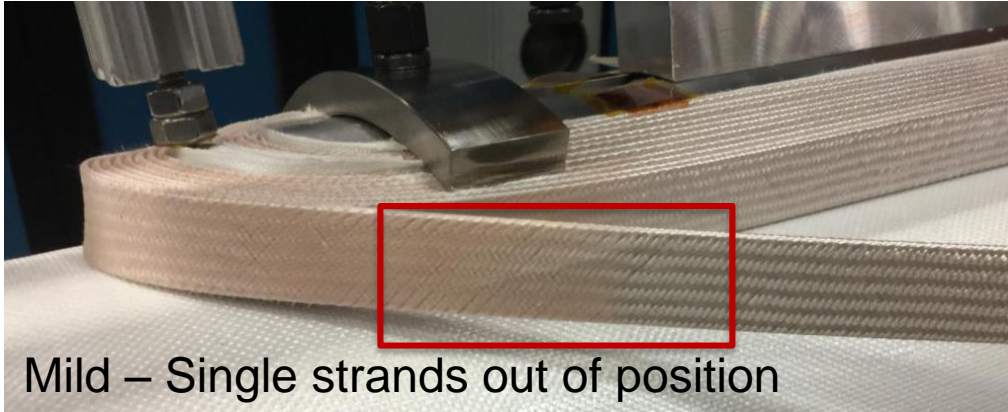
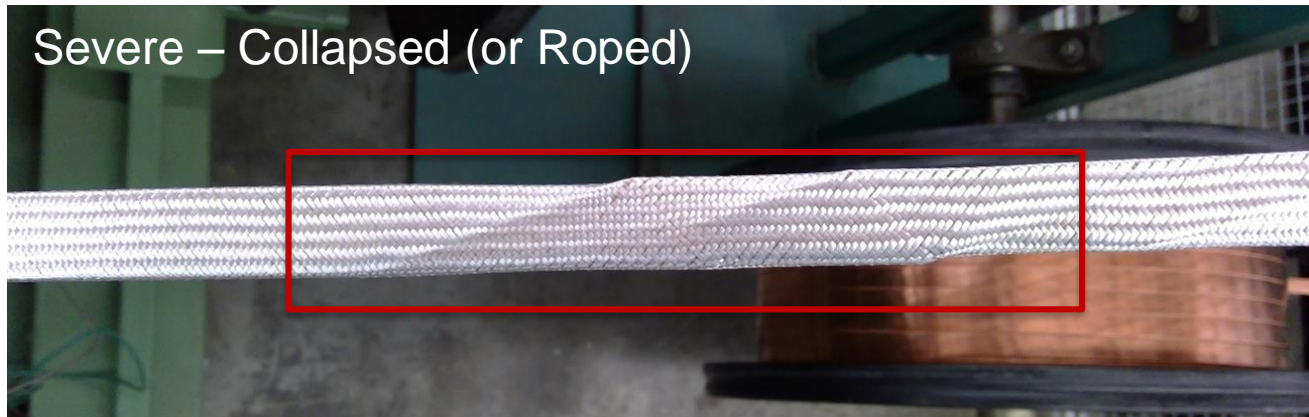
Popped Strand Examples

- FNAL reported two cables in close succession that had too many popped strands for effective respooling
 - Cables #1147 & #1151. Put on hold.
 - #1153 & #1154 were reported difficult to use, but coiling completed
- Subsequently found that #1147 & #1151 had some overly long residual strand lengths in post-cabling archive.
 - #1151 used one Asgard wire. #1147 used zero Asgard wires.

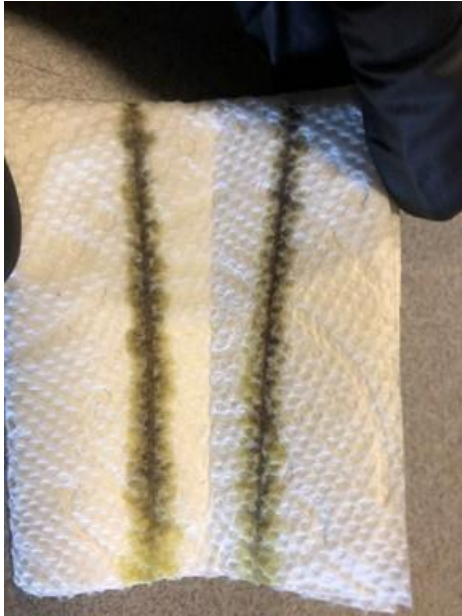
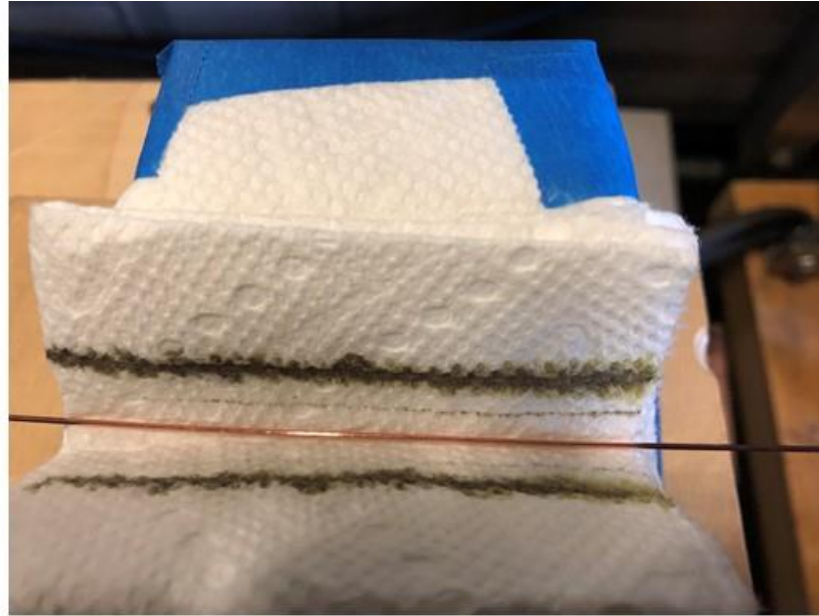
Lubrication Wiped from Strand

- Wire passes through paper towel during respooling
- The above after < 500 m of wire
