3rd IFAST WP9 meeting

D. Tikhonov

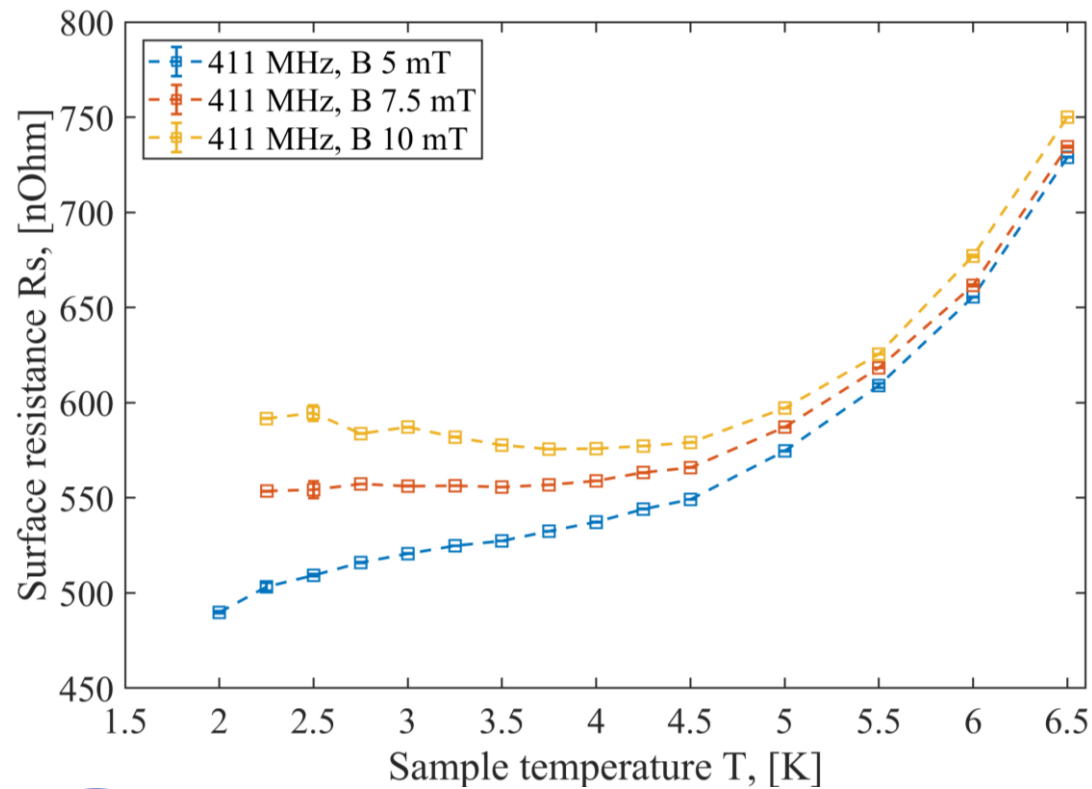
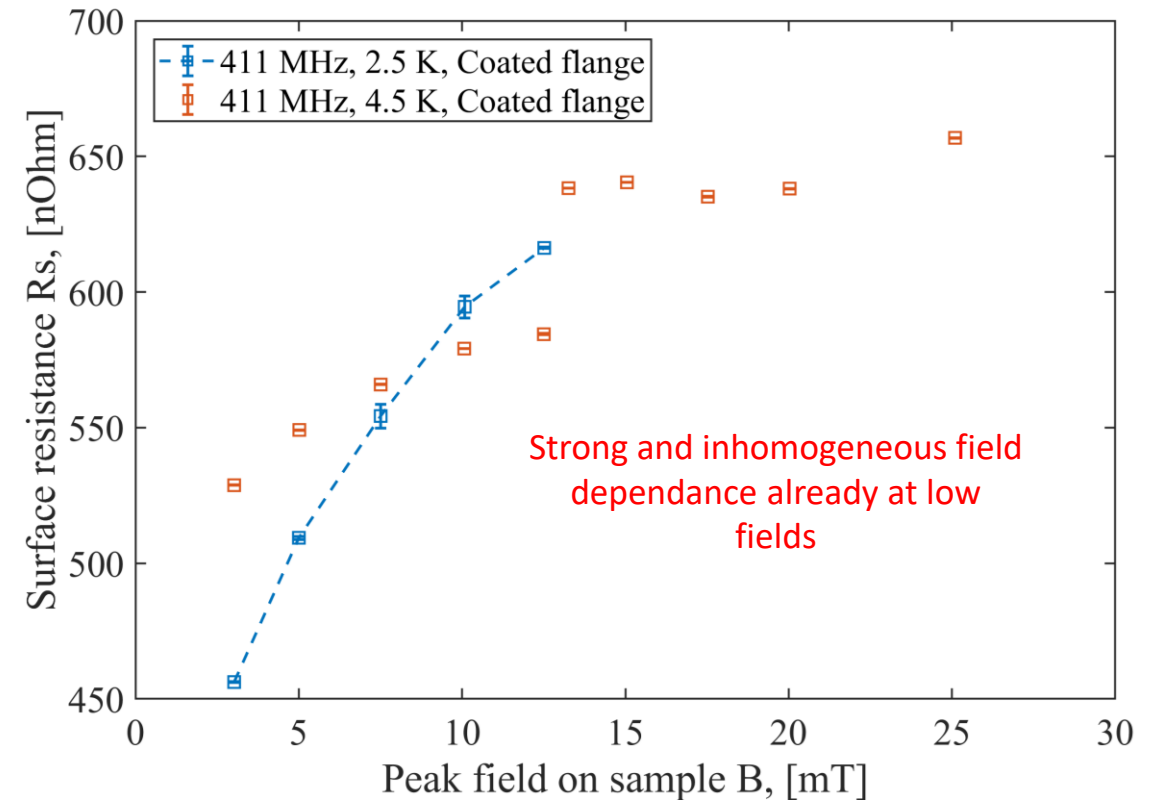
Measurements at 410 MHz already shows poor performance of the film with **Superconducting coated flange**

The maximum field achieved is a limitation from heating due to high R_s

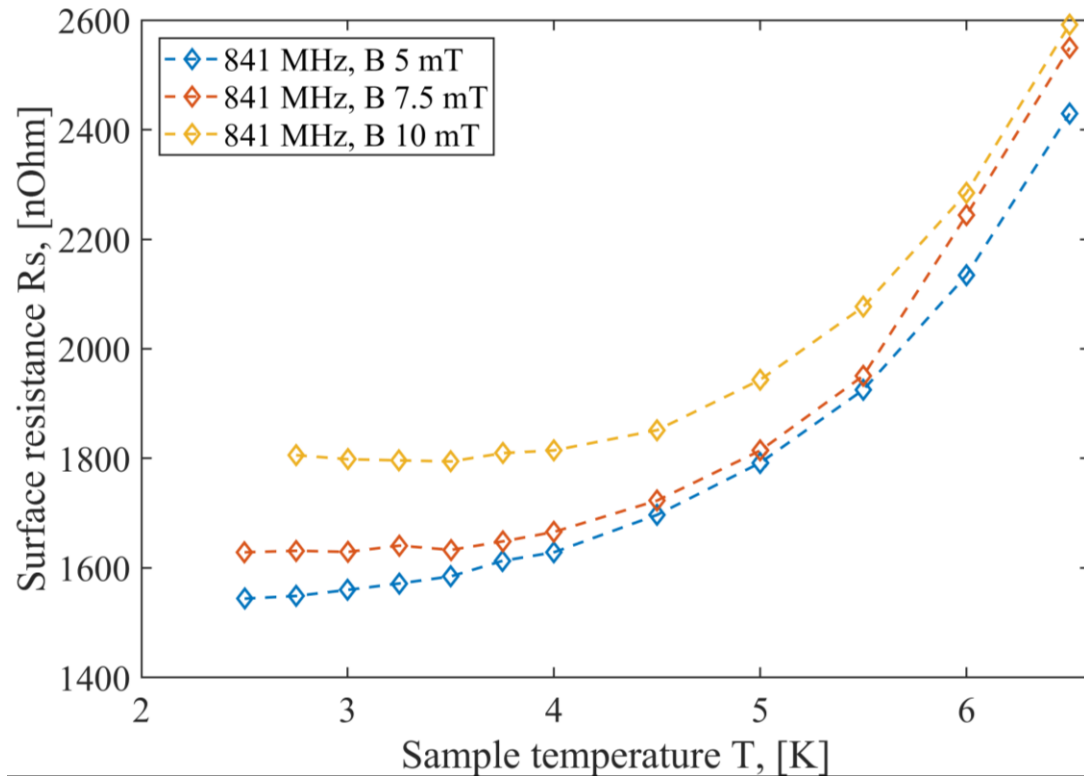
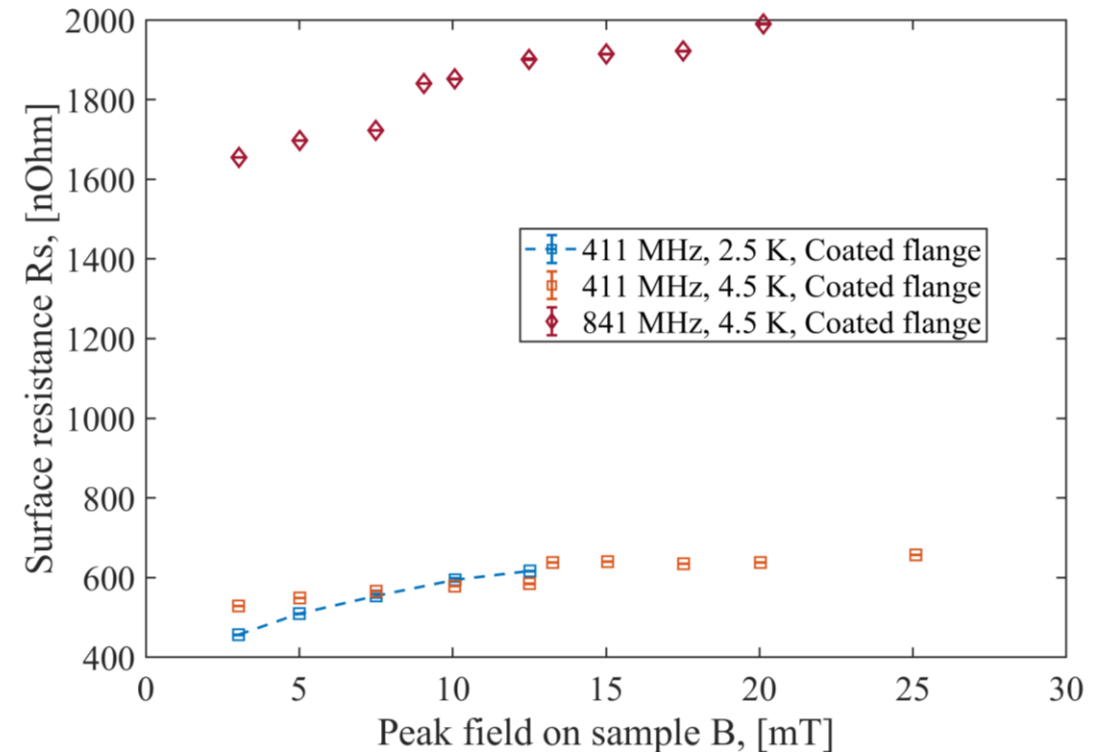
Measurements at 840 MHz also shows High Res

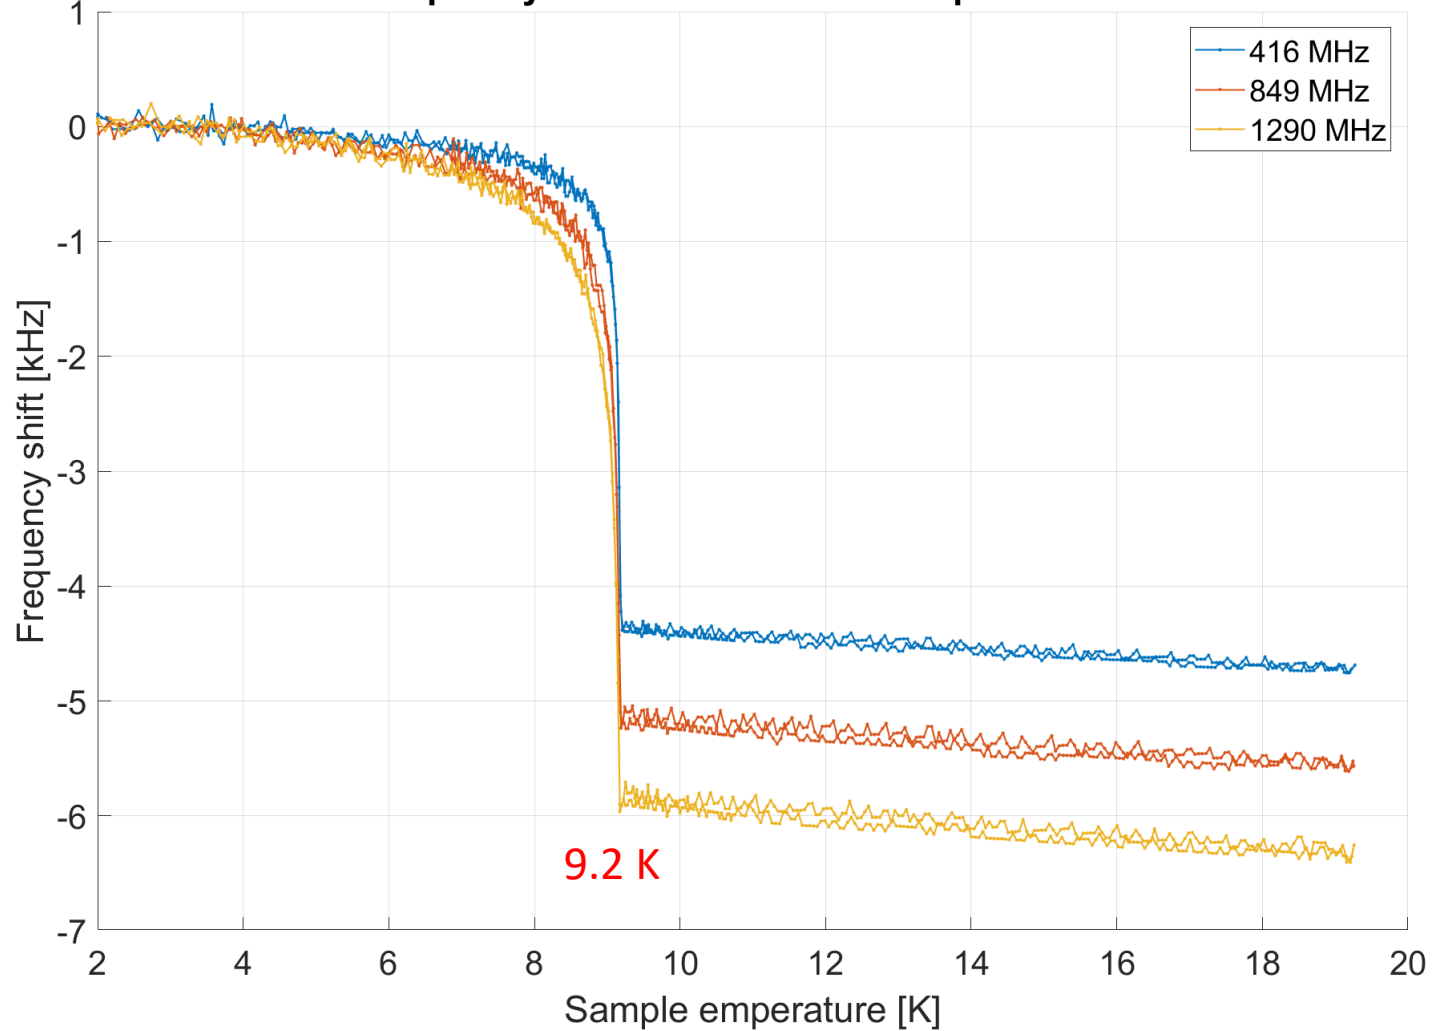
Measured resonance frequency shift as a function temperature for the thin film sample

Wide frequency shift did not show any indication of NbN T_c (at least before further evaluation)

The Nb T_c from the shift gives value: 9.2 K

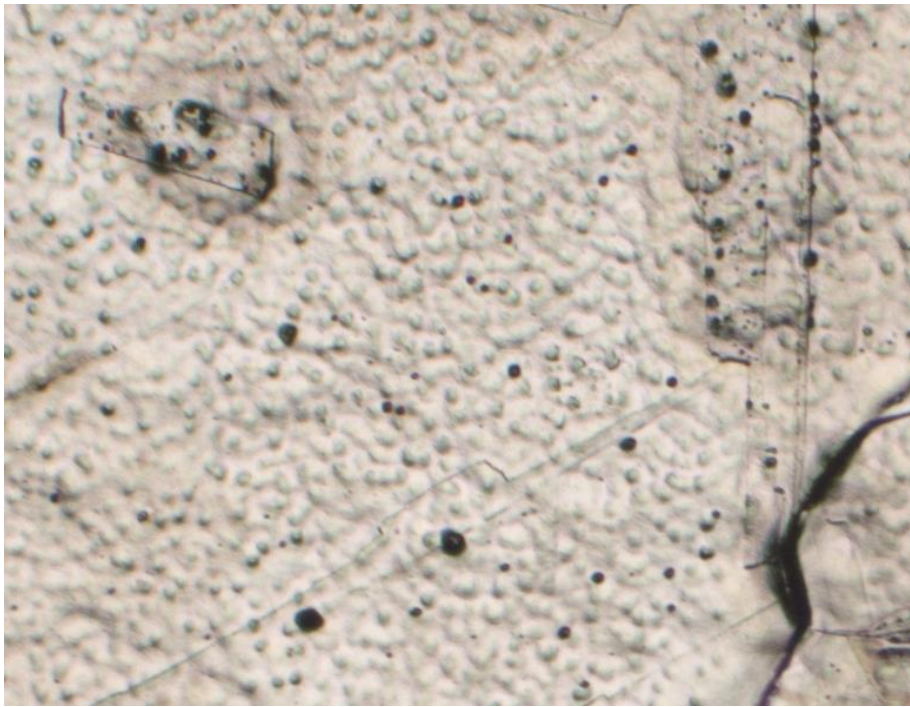
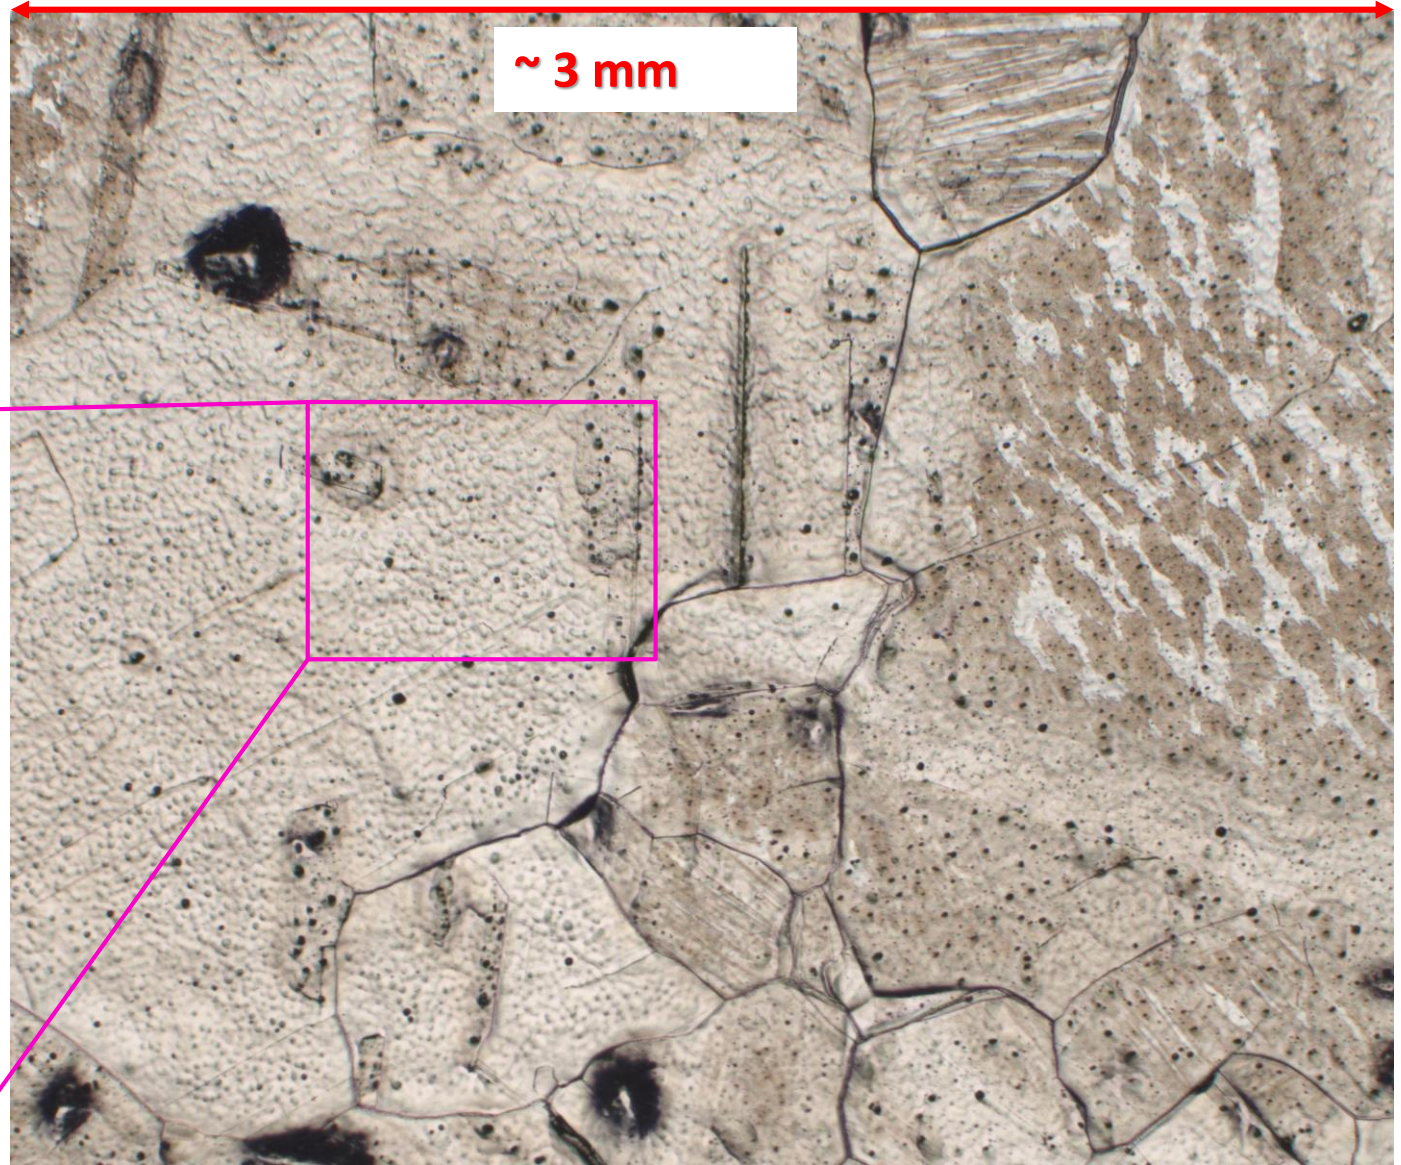
Small pitting

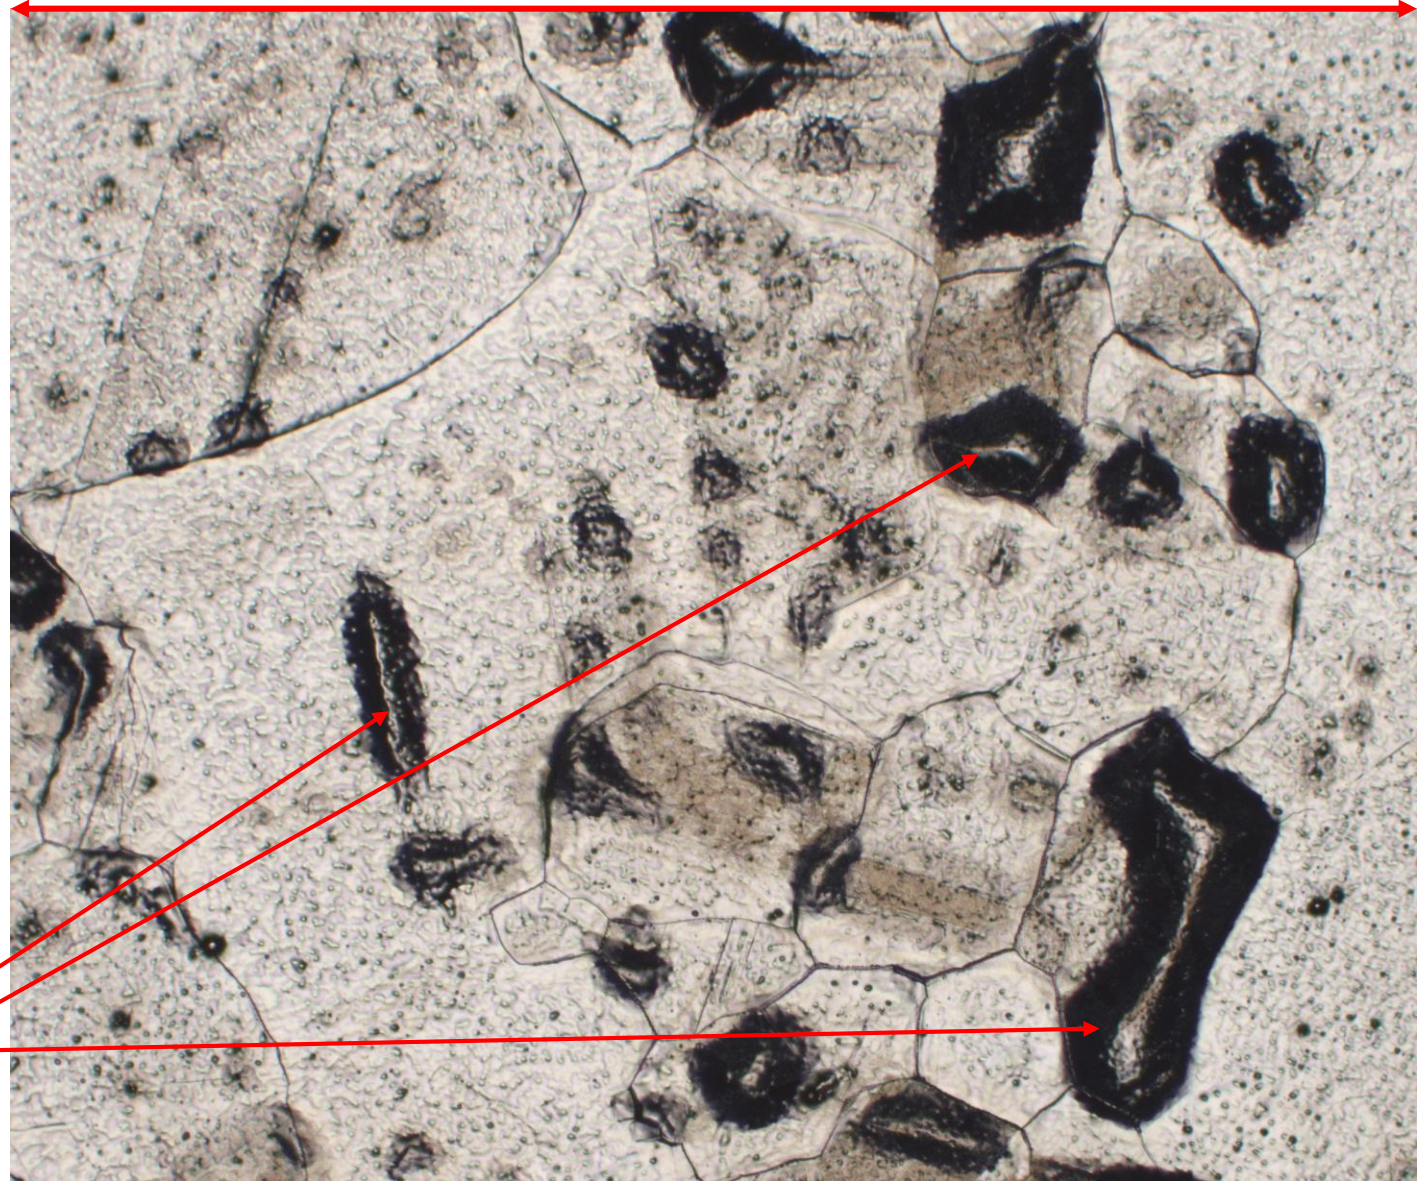
HILLS

**Stretches,
explosions?**

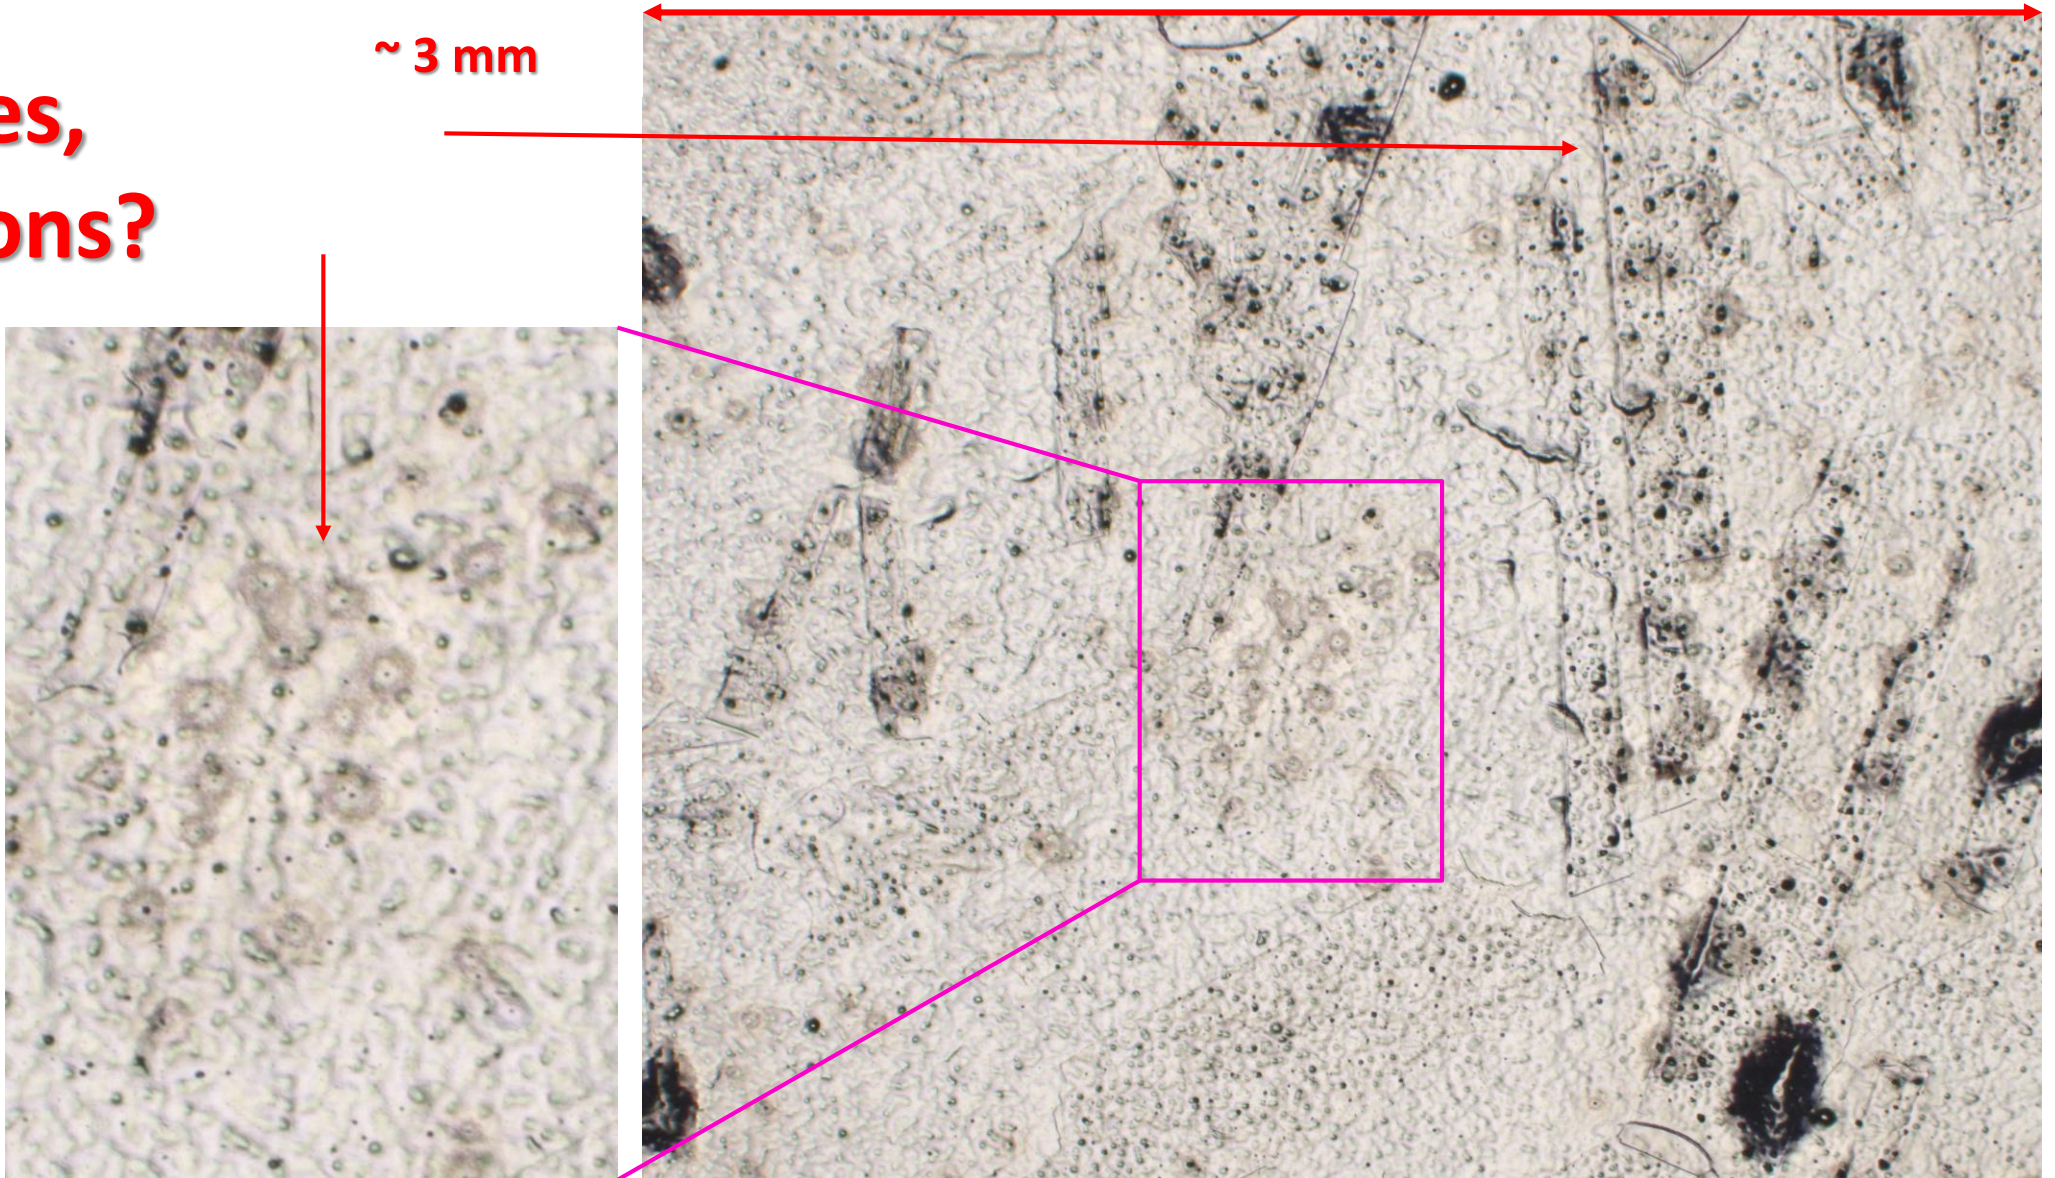
- 6 mkm hills with observable pitting on them

- Film is very defective (in future we should consider if to test films with so many visible defects)
- Hills could be delaminated film or anomalous film growth or defects on copper due to **high heating**.
- Film performance is quite poor
- We should use HIPIMS method rather than DC MS

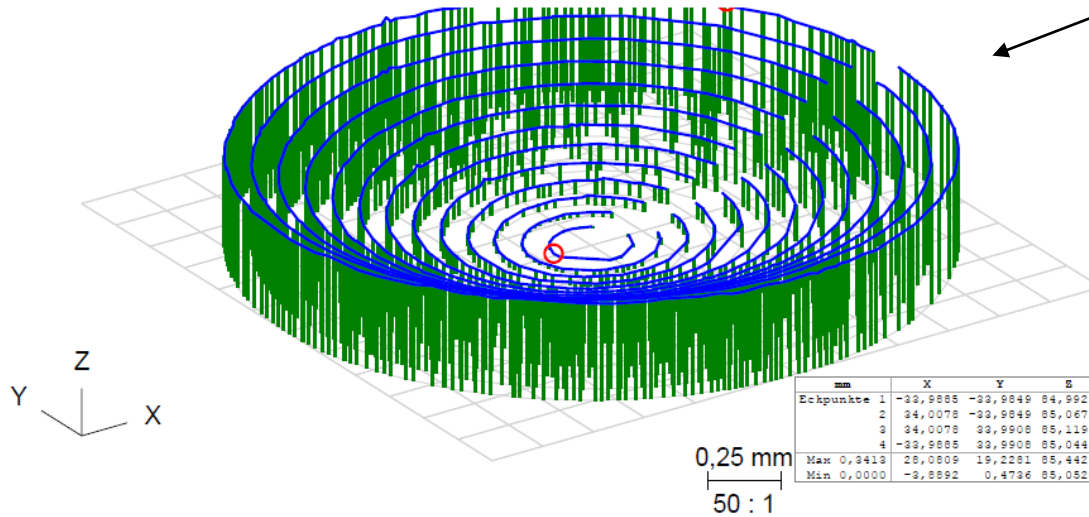
Sample top surface profile is bended with the center point ~ - 0.3..0.4 mm

Possible reasons of deformation:

1. Turning
2. Heating to high temperature
