Rich Wall Status for 2022

M. Alexeev & colleagues

Università di Torino & INFN Torino

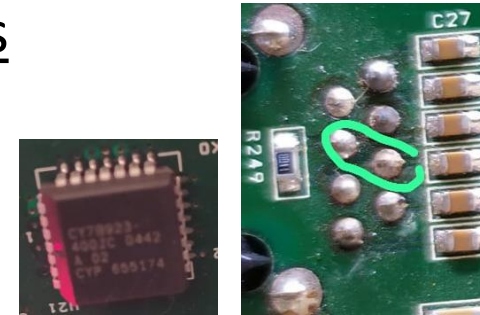
I had decided to try to physically check the signals on the HotGeSiCa modules to evaluate the data propagation and localise eventual problematic modules

- ❑ The idea is to trace on the level of the Hotlink interface chips the data transmission signals and to check the general presences of all the signals on the boards

It seems form the first observations that there is the **trigger on all the elements** of chain but it **might not be properly "read"** by the GeSiCas and the FE cards

- ❖ We plan to proceed this investigation during the next MD
- ❖ If confirmed, that would indicate we have some generalised problem
- ❖ It could be an electrotechnical problem
