The 1MV MITICA power supply beyond the modern technologies limits: first experience during integration phase

M. Boldrin (Consorzio RFX - Padova) on behalf of NBTF Team

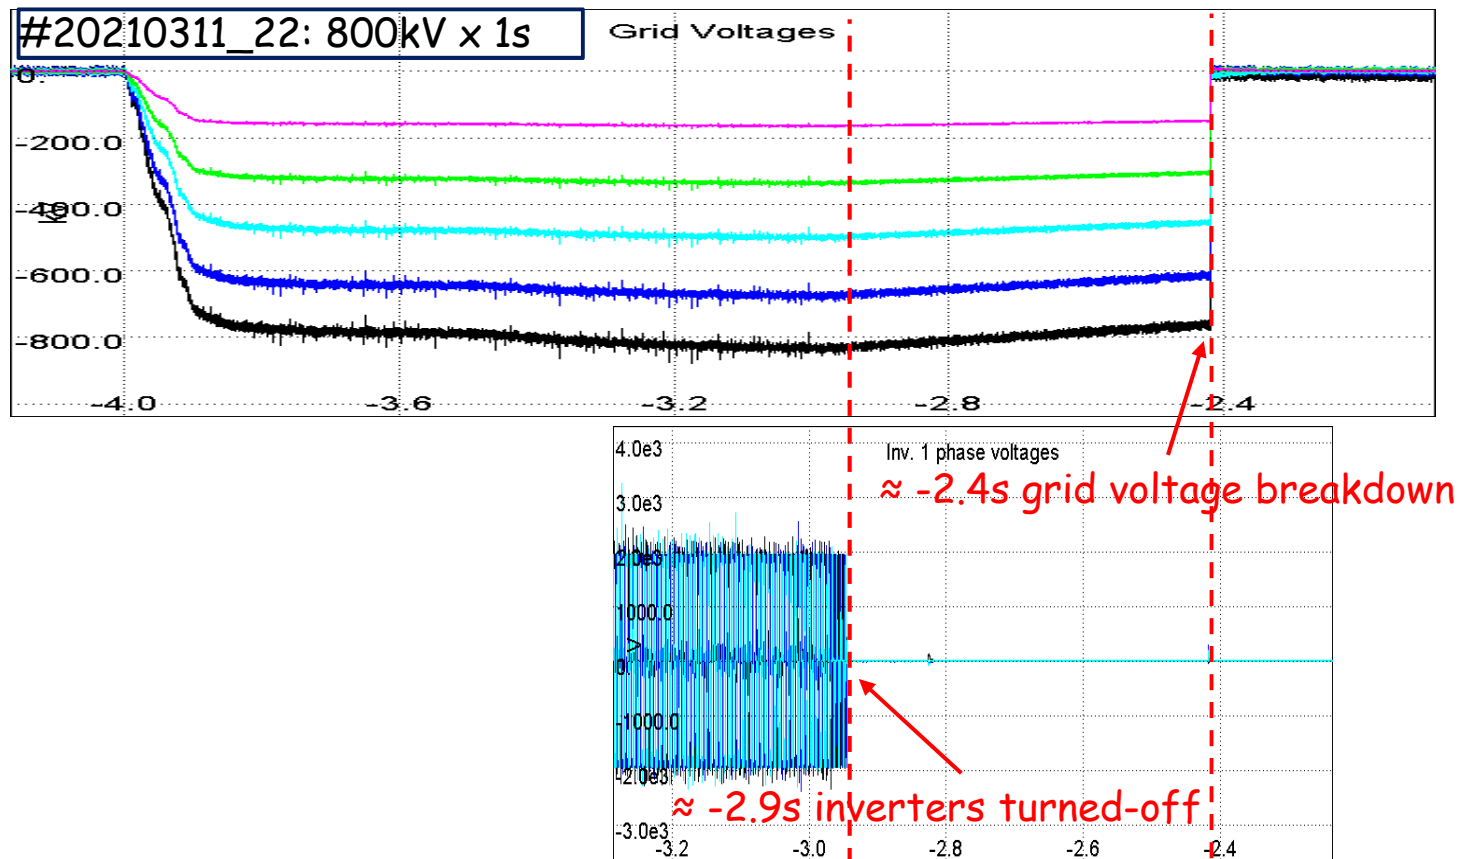
- No load tests, reaching smoothly 700 kV x 1000 s at a first attempt in such large NBI, an important result in view of ITER/DEMO
- during pulse 800 kV x 1 s, a grid voltage BD occurred at ≈ -2.4 s, 0.5 s after inverters switch-off (≈ -2.9 s).

- In DCG1 (-800/-1000 kV) a diode arm was found damaged
- the location of the BD was not identified

- Thanks to the fast transient model, the dynamic of the failure was explained, demonstrating the need of an additional DCG diodes protection
- The realization of such protections has to be implemented together with the replacement of the diodes (JADA/Hitachi)
- Carry out an insulation test campaign to identify the possible weak insulation point originating the BD

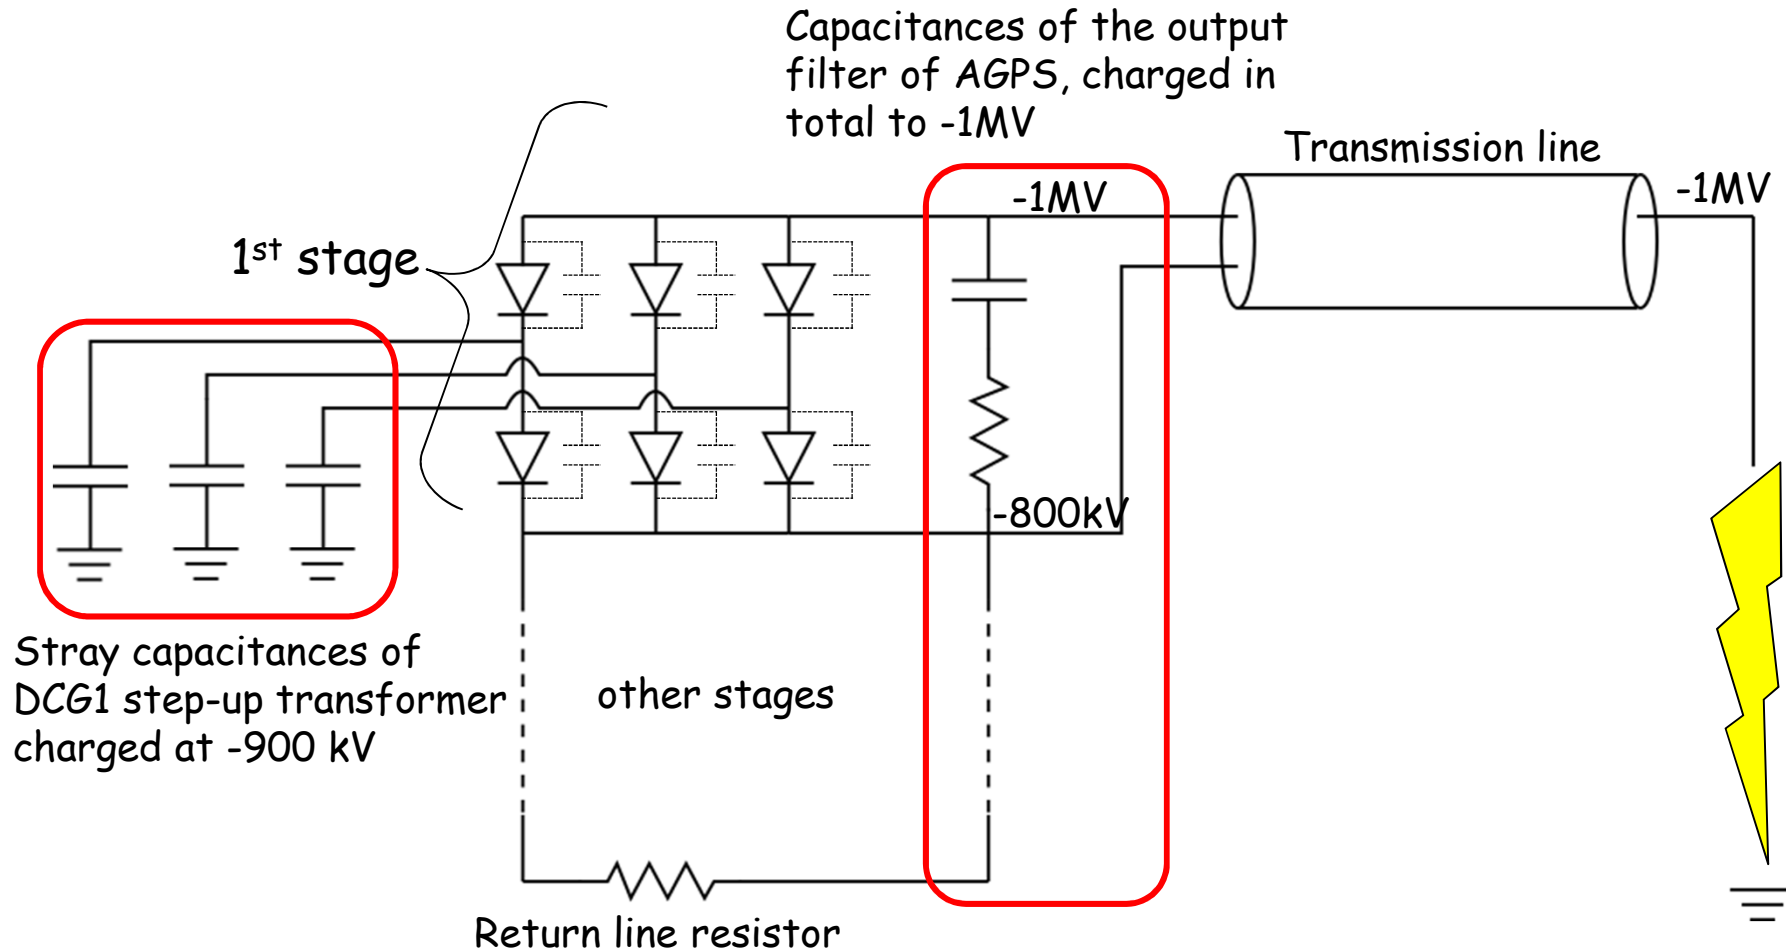
Schematic of the system for the analysis of the diodes fault

The capacitances, charged at high voltage, discharge via the transmission line towards the BD.

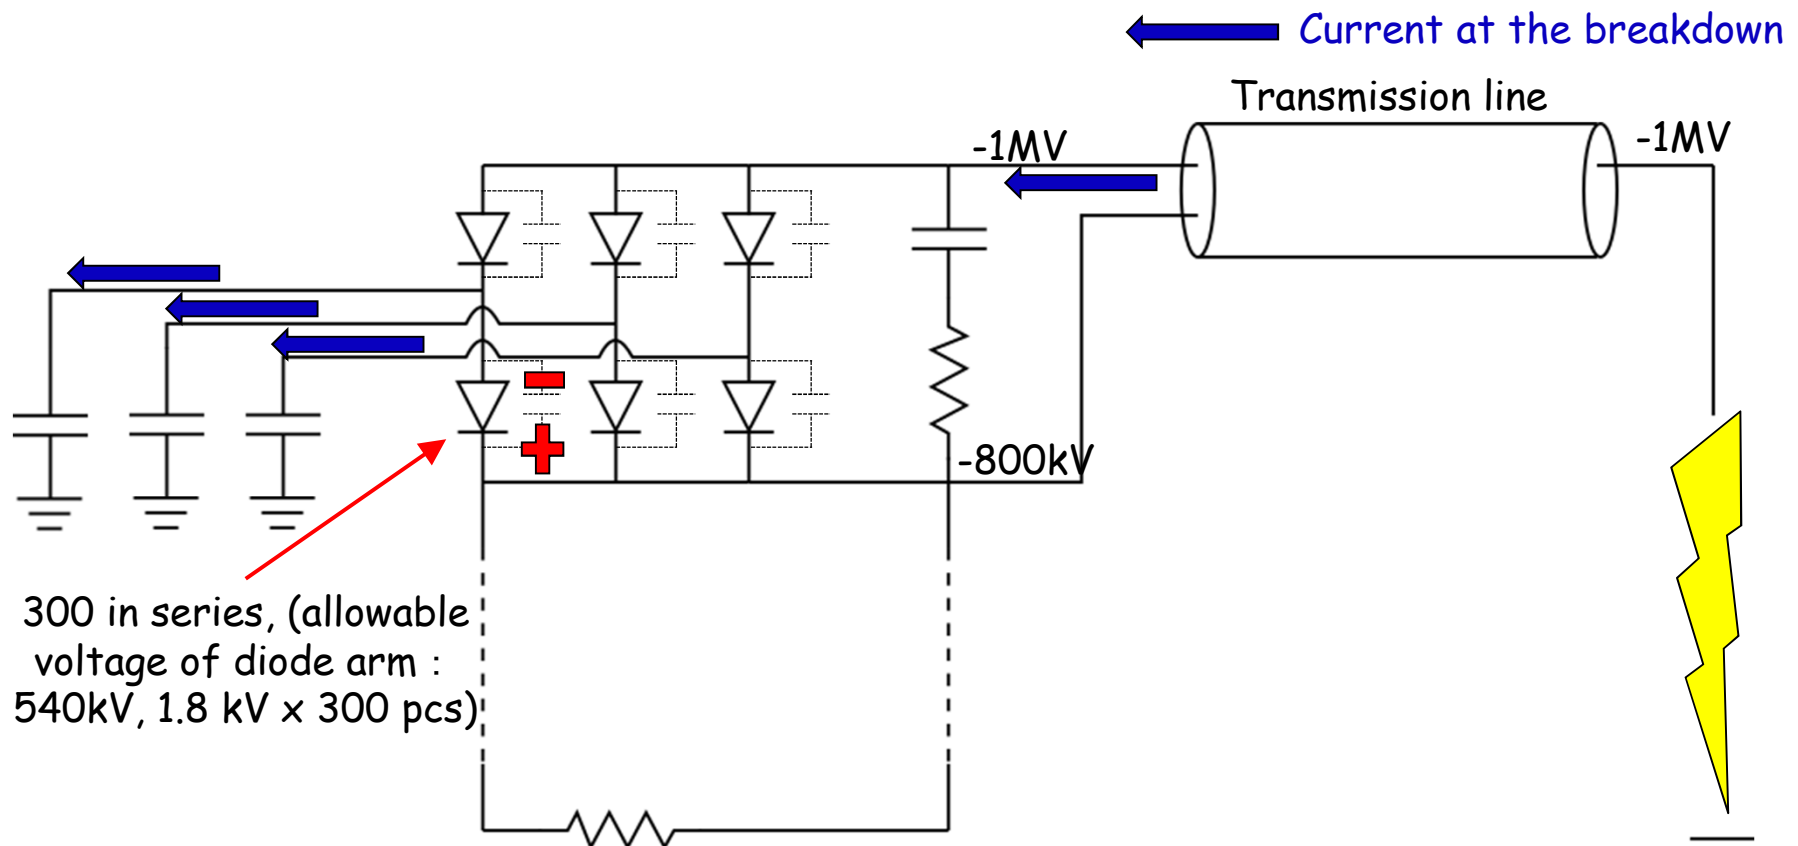
Overvoltage on the diodes

This produces an **overvoltage** on the positive legs of the diodes bridge. The phenomenon is more complex: the dangerous overvoltage causing the fault derives from the uneven distribution of the transient voltage on the diode elements composing the leg (300 in series) determined by the diodes stray capacitances versus the tank where they are installed, overcoming the even huge design margin and leading to the arm fault per cascade effect.

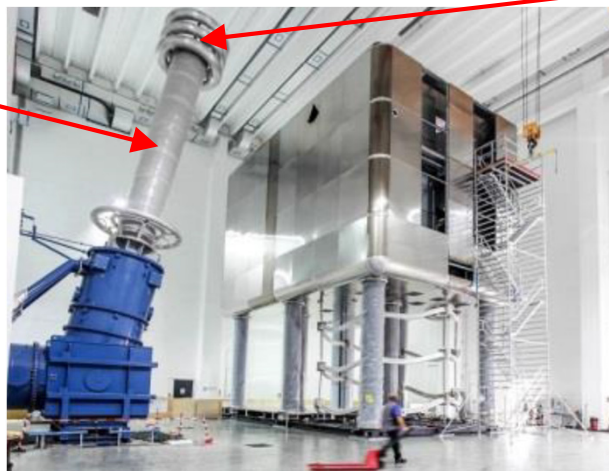
Event: once reached 1 MV, after about 1 s, an arc was observed on the top of the bushing, lasting in total for about 2 s (the fault was interrupted by the intervention of the Buchholtz protection of the transformer)

- Complete inspection of other components, both in air and in gas: no evidences of BD
- Damages were found on the insulating transformer bushing (melted materials), both in air and SF₆ side, while the transformer itself was only polluted (soot/dust)

- a BD generated in an unknown location produced an impulse overvoltage (hundreds of kV in tens of μs) towards the transformer and was hence applied between phases and neutral
- The transformer, according to standards, is a D/Yn 22/6.6 kV with 170 kV Lightning Impulse (BIL) insulation level (with possible additional margin added by the Supplier)
- This surge triggered sparks both on the top and also inside the bushing
- Fast transient model was developed to explain the failure dynamic, *generated by different LC transients as in the previous case*

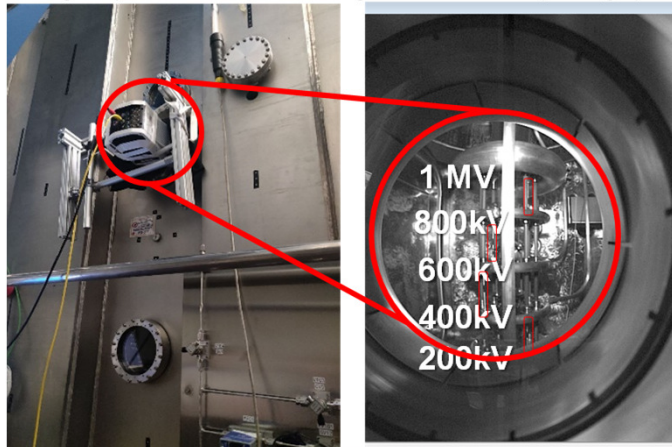
high speed camera looking at the SCD spark gap

1. no precursors of the BD on air insulated equipment were detected;
2. images acquired by the camera looking inside the vessel confirmed that an arc occurred between the SCD electrodes (but only visible on the 2 higher voltage stages);
3. a strong sound was registered inside the HVH (but not originated inside the HVD1) as well as nearby the SCD vessel; the sound was captured by the 6 ambient microphones but at the same starting time and all the microphones saturated, making therefore impossible to discriminate the source position;
4. additional electric measurements patterns were compatible with a discharge *between the high voltage conductor(s) and the return line*, hence likely occurring in the SF₆ insulation.
