# *The Curious Case Of The* **VTR<sub>x</sub> RECEIVER FAILURES**

EP-ESE Electronics Seminars  
18 January 2022

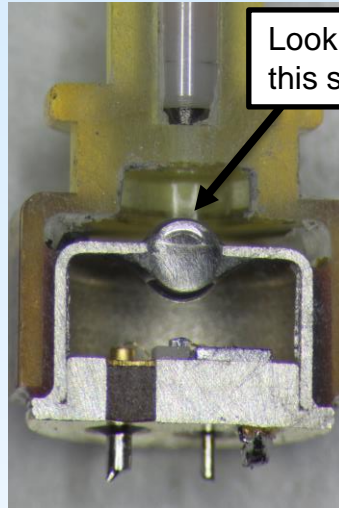
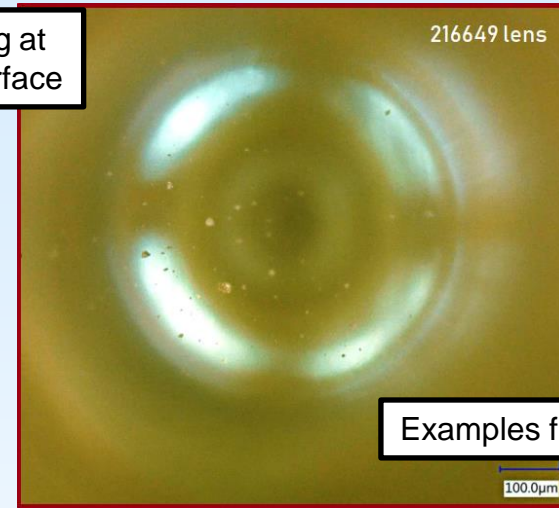
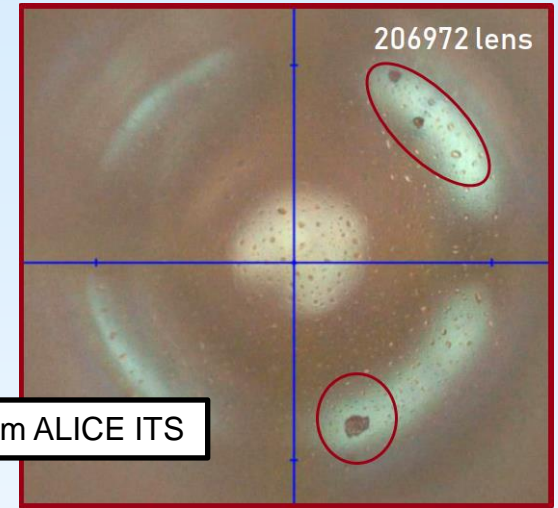
Examples from ALICE ITS

- User observed contamination the surface of the ROSA ball lens
- Concern was that the glue that holds the ball lens in place or some other residue could soften and/or move when the device is operated and therefore cause varying attenuation
- None of the returned samples had enough contaminant to explain observed drifts in the RSSI
- All bad looking samples that had caused problems in the experiment had also been wet cleaned by the user
  - Impossible to say what was residue of the cleaning process and what was real contamination

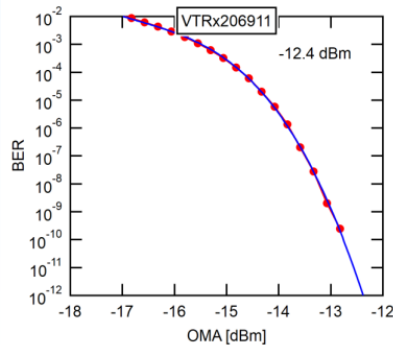
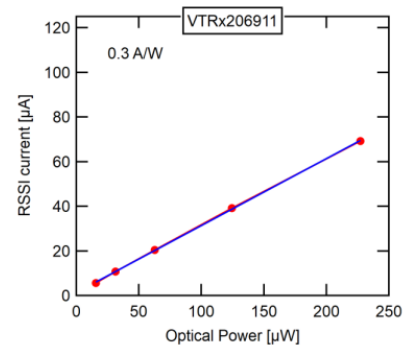
Device returned from ALICE ITS

- Dozens of modules imaged and no contamination that could cause significant signal attenuation observed
  - Ball lens receives the expanded beam from the fiber
- 64 ROSAs (4 from each production lot) were imaged, kept at 85C for 120 hours, and imaged again
  - No changes in contamination observed

Not enough evidence for ball lens contamination theory

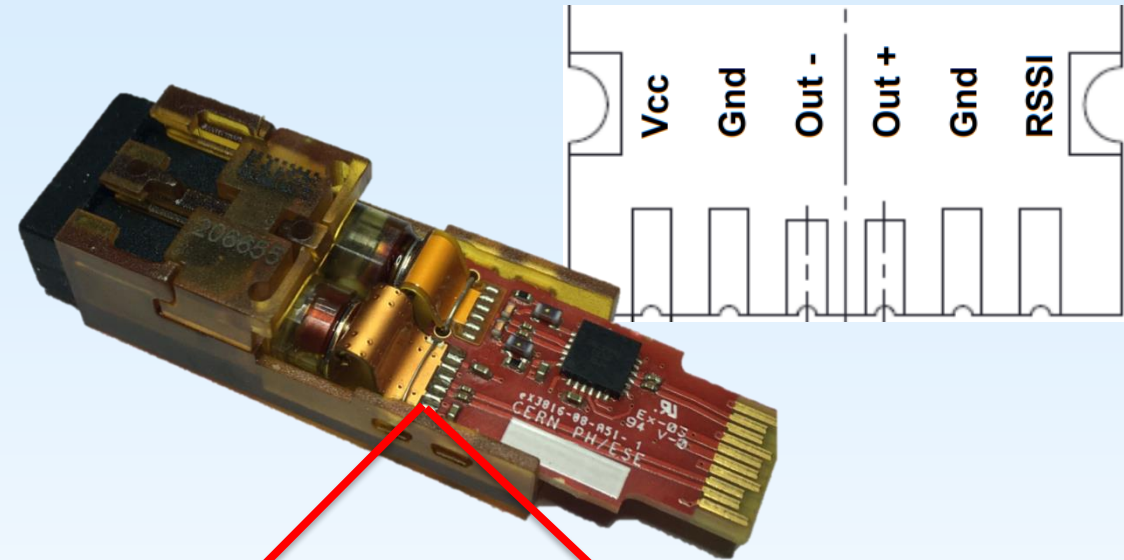
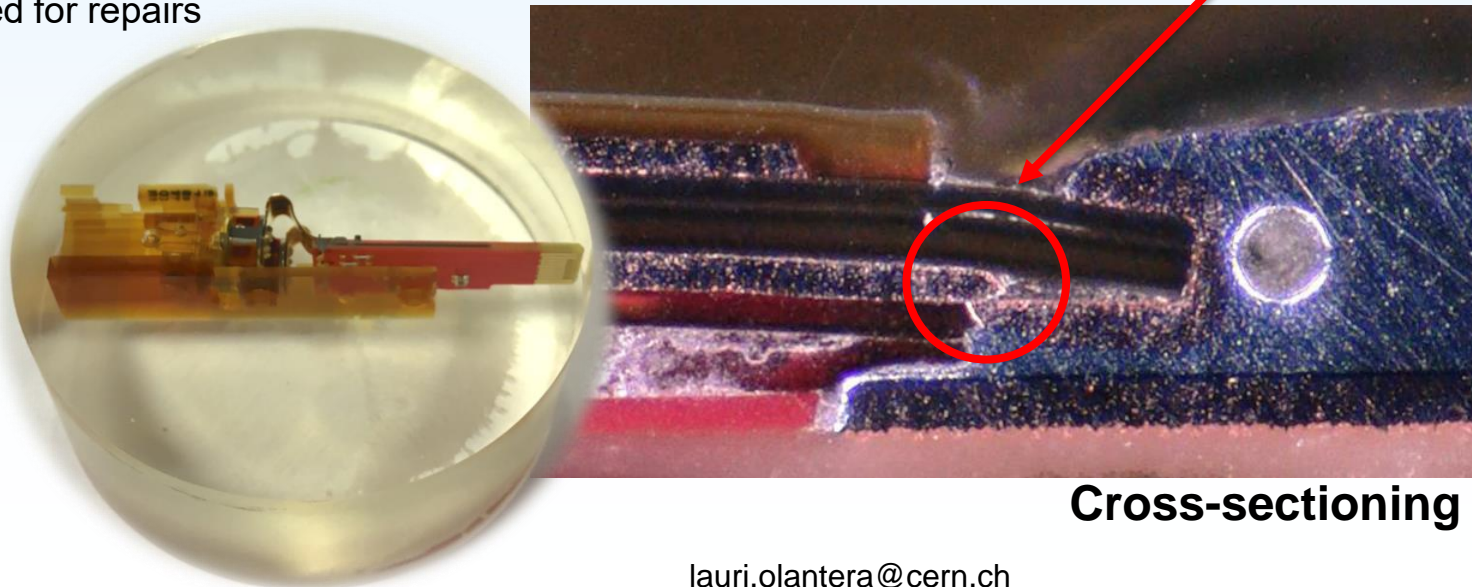
- A weakness in the flex design was identified
  - Cracking possible at the edge of coverlay
- 140 VTRxs tested in thermal cycling
  - -40 to +85°C, 500 cycles
  - 12/140 (8.6%) showed issues at some point in the testing
  - 11/12 failures directly due to flex
- New flex designs where the discovered weaknesses fixed
  - 160 VTRxs (3x40 with new flex versions and 40 with old) samples through same temperature cycling
  - No failures
  - New version easier to assemble
    - Preferred for repairs

Cross-sectioning

X-ray Tomography (μCT)

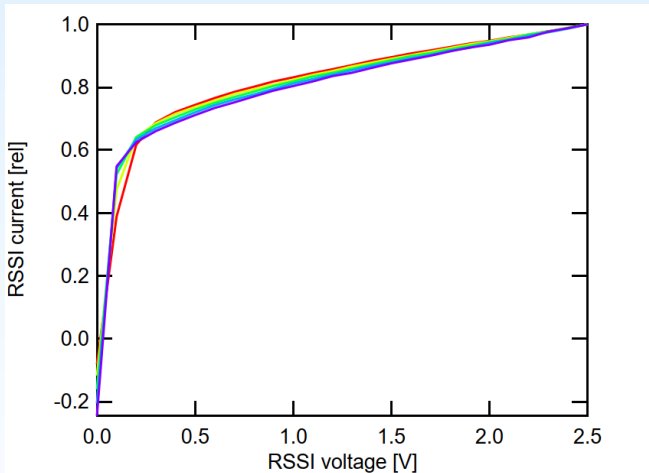
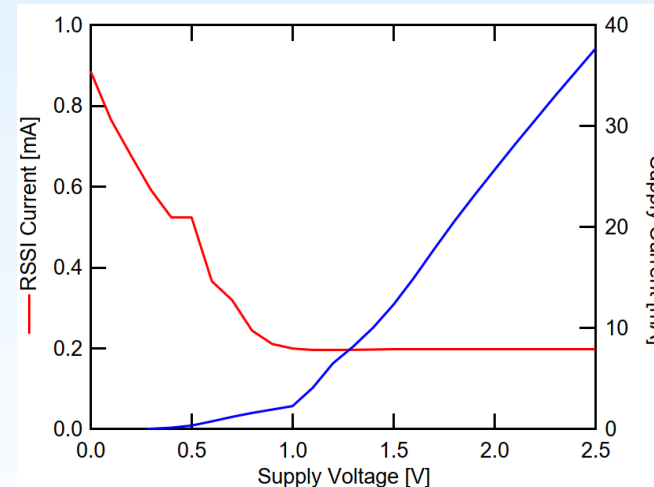
- Flex cracks and partial cracks could change the supply and RSSI voltage levels
- Very large RSSI voltage drops required for significant changes in RSSI currents
  - This would be only monitoring issue, users have reported loss of communication
- Problems with supply voltage could cause a loss of link, but reduced supply voltage has very little effect on the RSSI current and when reduced enough RSSI current starts to increase

No evidence to support flex cracks to be the main cause of the observed problem

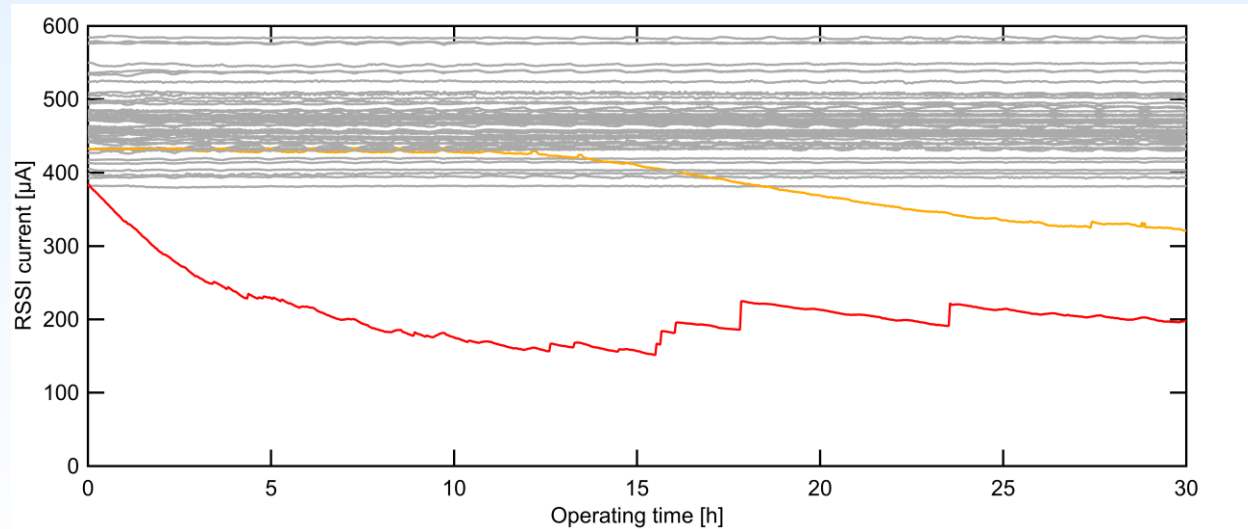
- **Reminder:** at this point we were still struggling to reproduce the problem in our lab
- We had started to prepare large scale setups
  - If enough samples are running, we must observe this issue at some point!
- 50 devices running continuously inside a temperature chamber
  - We could control the temperature and try to provoke the failures
- And this happened without even turning on the chamber:

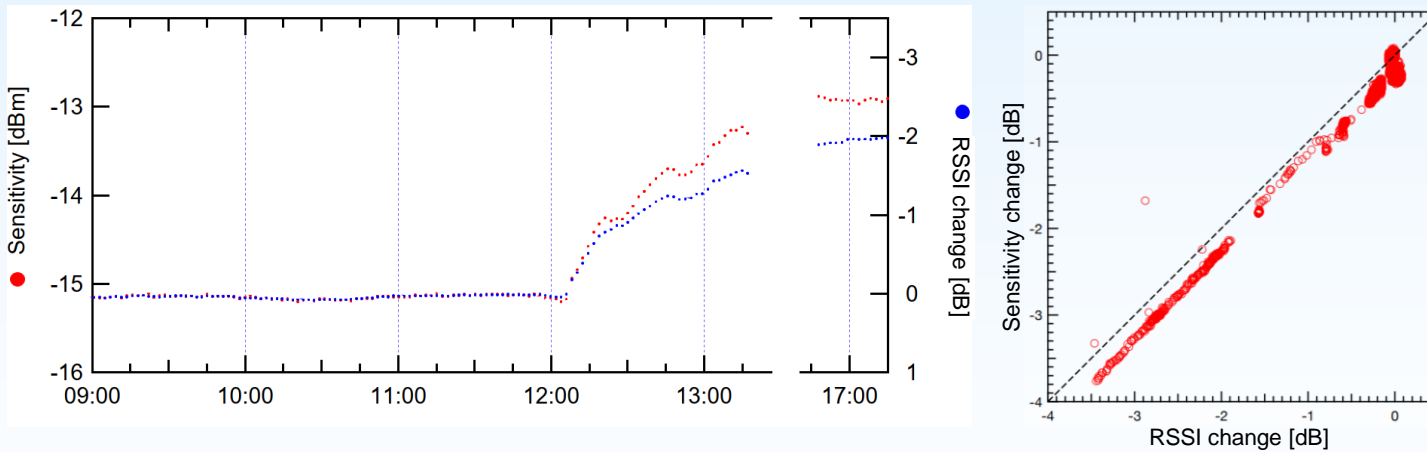
- Second setup was constructed in a similar way but with an additional high-speed test slot that allowed full functional test on one VTRx
- First drifting module was moved to this slot:

- The RSSI drift shows almost identically in the sensitivity!
- We are losing the light input somehow

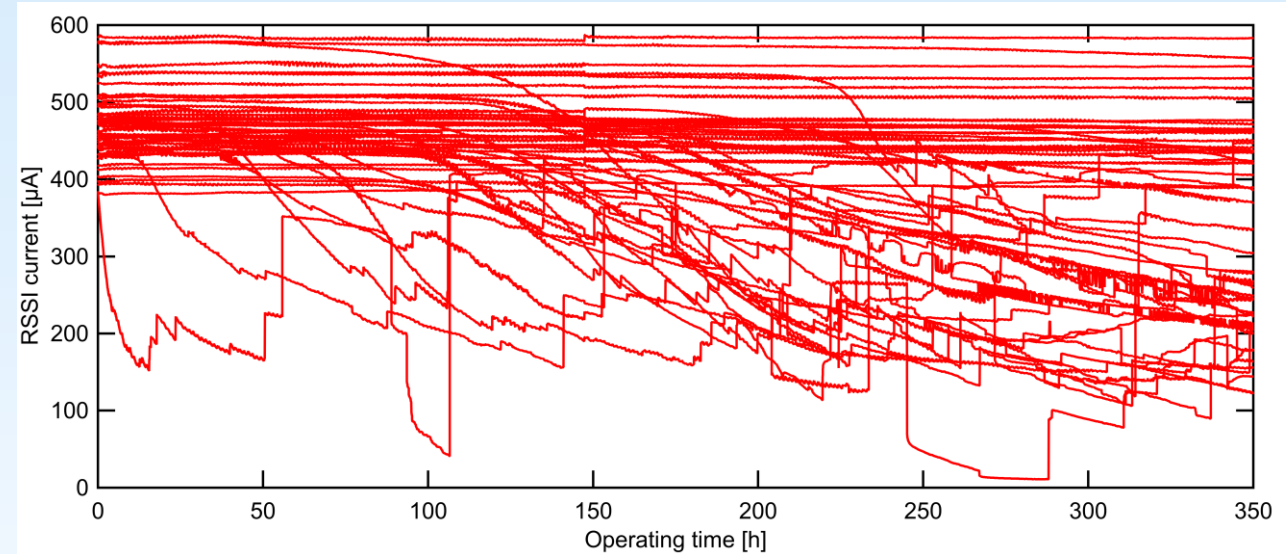
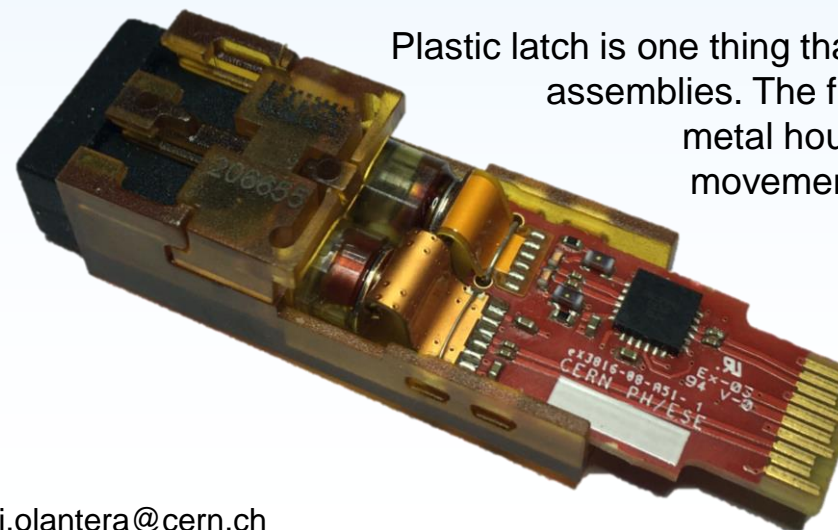
- Something on the light path? Misalignment?
- Added mystery: seemingly random recoveries, sometimes partial, sometimes complete!?
- If we have introduced some contamination inside the ROSA during the assembly, maybe it could move when heated, but still how would the contaminant just suddenly disappear?
- Maybe high temperature softens something in the assembly and allows small movements?
  - If you try hard enough, you could imagine a process where external stress causes slow movements and even sudden changes when some kind of relaxation occurs

Plastic latch is one thing that differs from a commercial assemblies. The fit is not as tight as in typical metal housings and allows little more movement between the components

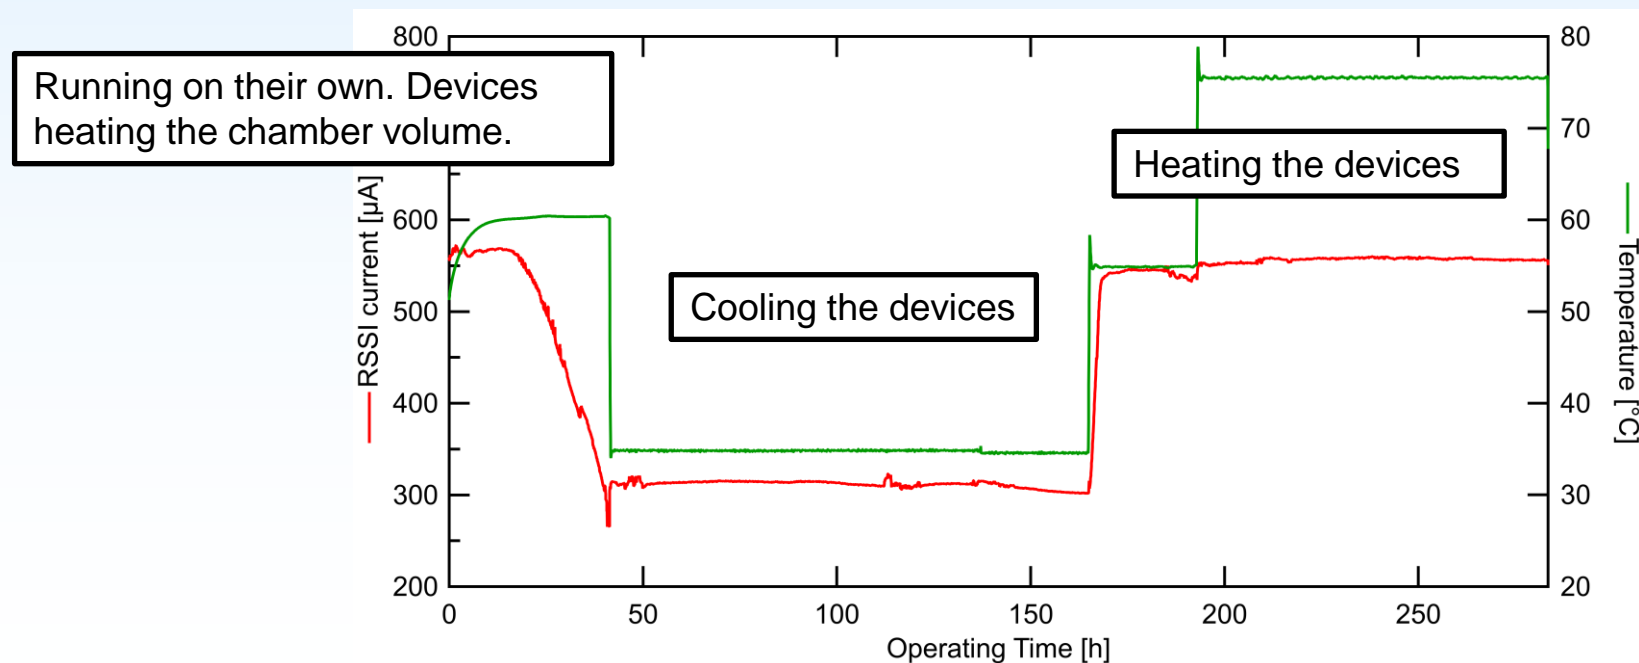
Wait, what? Cooling stops the RSSI drift, but heating makes it even better??

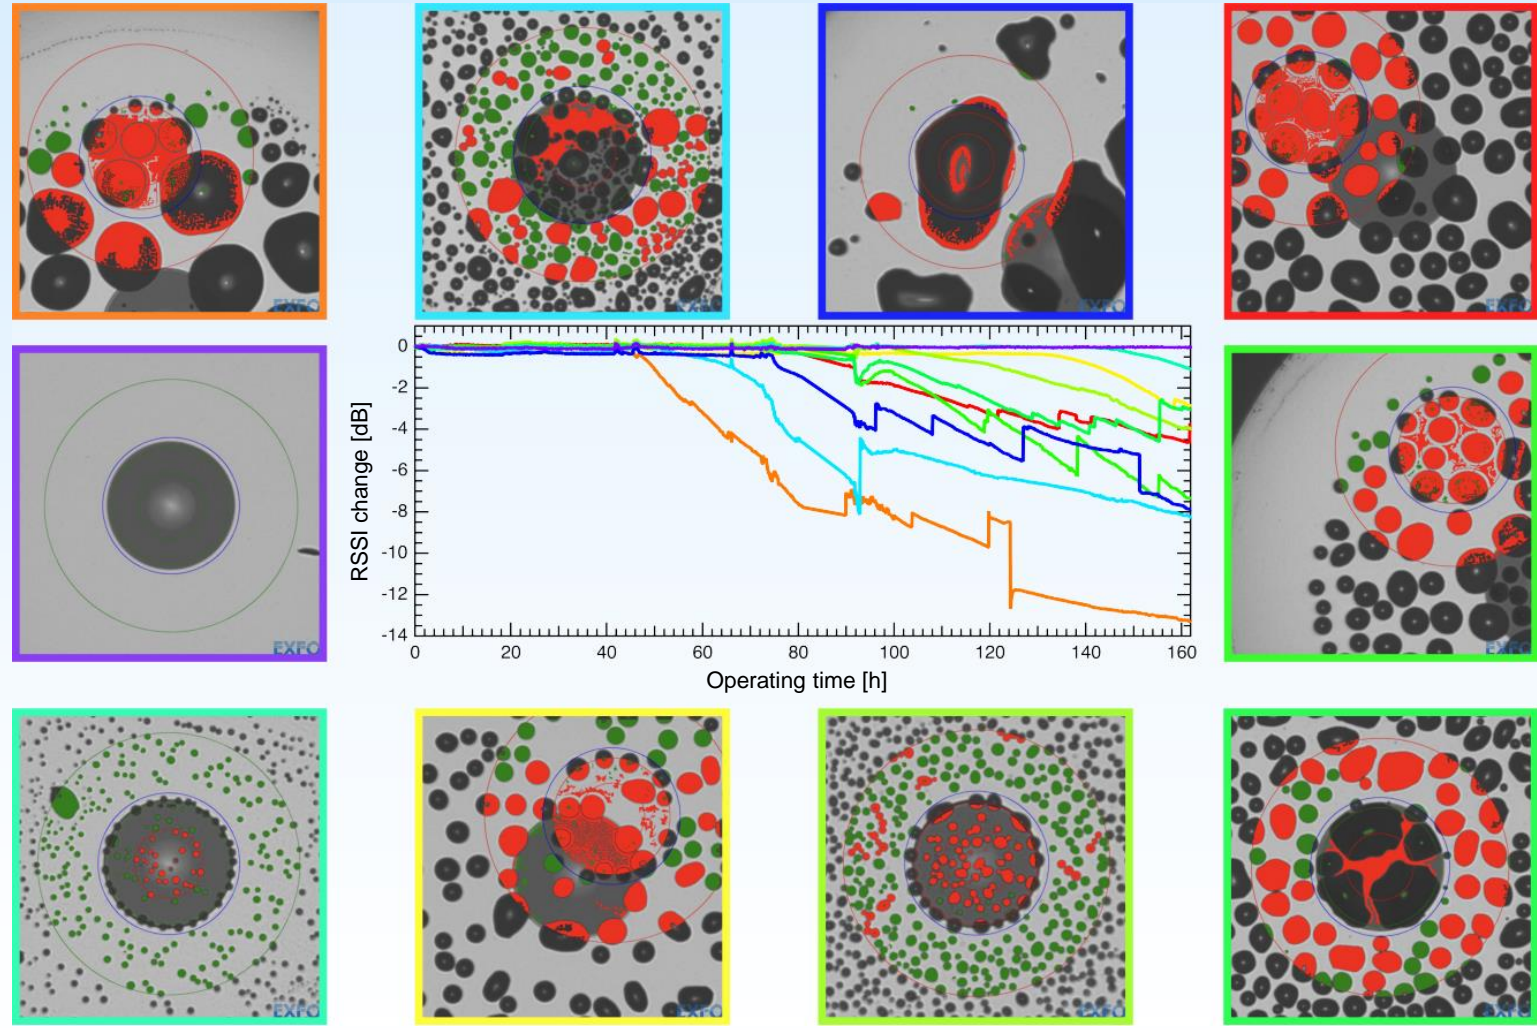
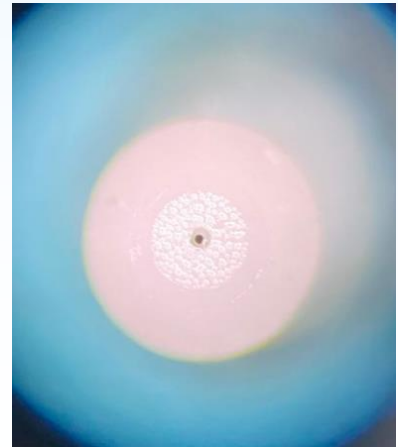
Image from J. Dittmann CMS HCAL

- A new idea came from CMS HCAL investigations who observed contaminate on a fiber end-face
- This observation was very quick to confirm using the drifting samples in our setups
- Contaminant is volatile and evaporates at room temperature in minutes/hours depending on quantity and conditions

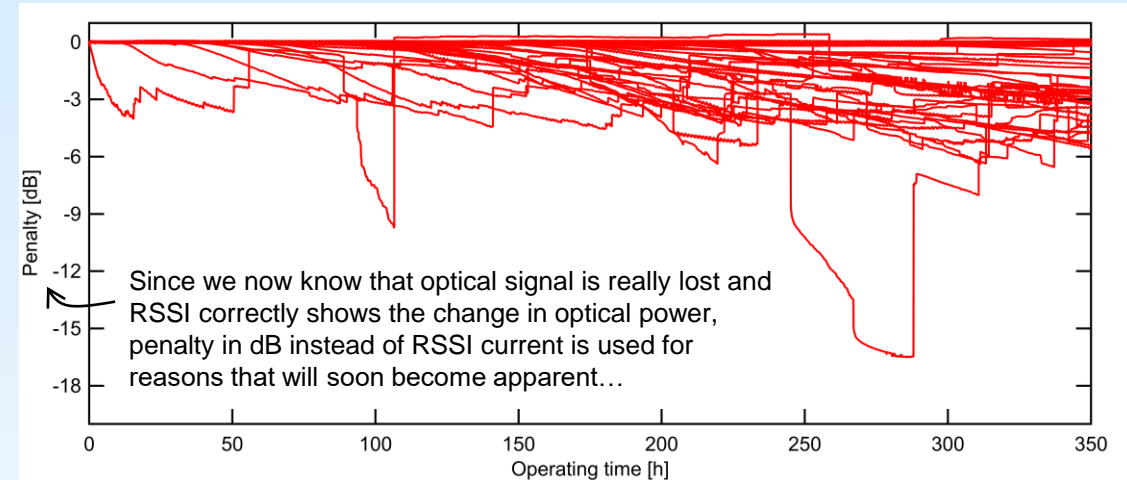
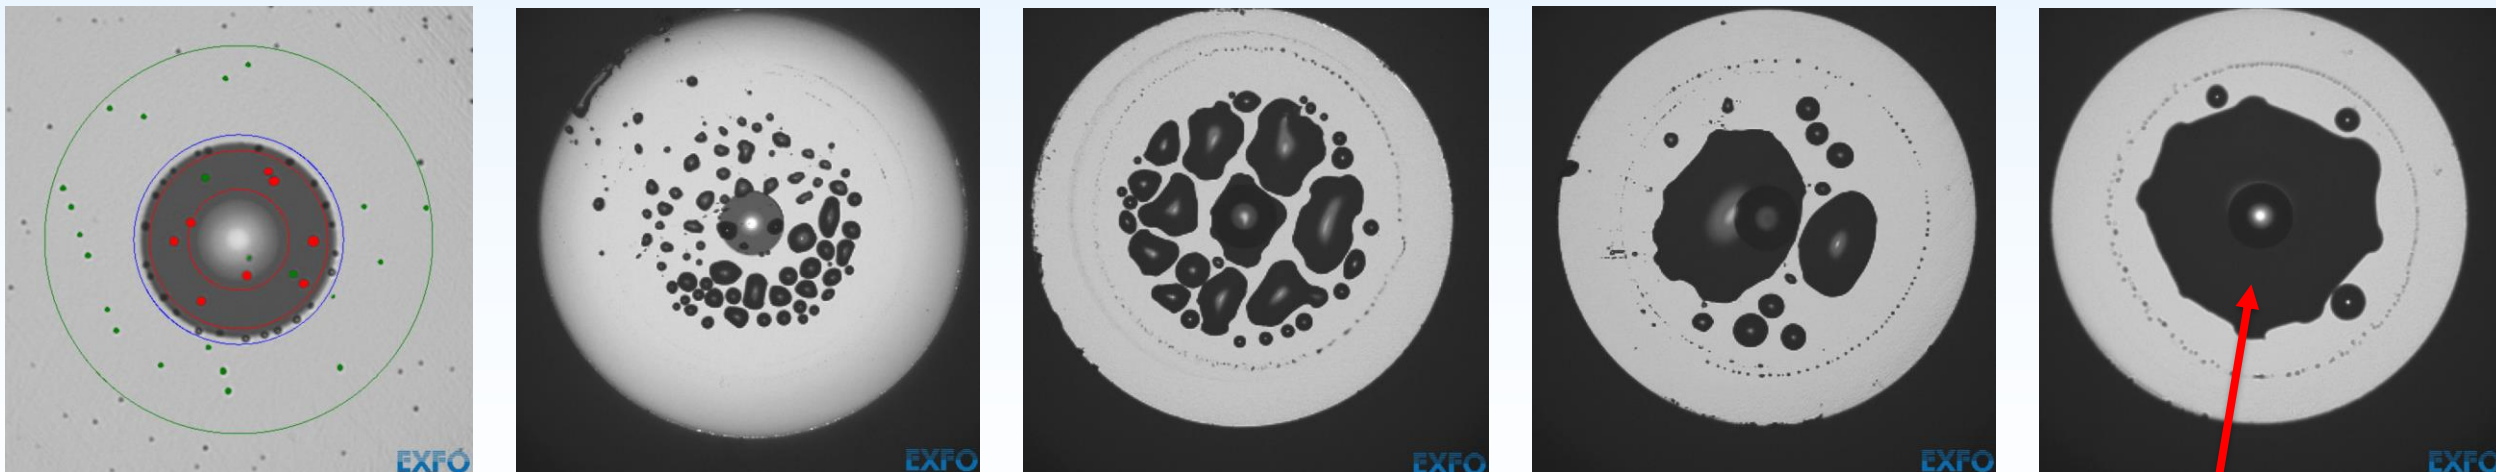
- Contaminant condenses and forms bubbles that grow
- Bubbles are somewhat mobile, especially due to surface tension when smaller bubbles combine and form larger bubbles
- The main reason for optical losses is **not the attenuation** caused by the contaminant **but the refraction!**
  - Bubbles act as small lenses on the fiber-end face

Examples of contamination bubbles at different stages (not the same fiber).

Interesting sidenote: looks pretty bad, right?  
Worked perfectly: uniform contaminant layer does not refract the light too much...

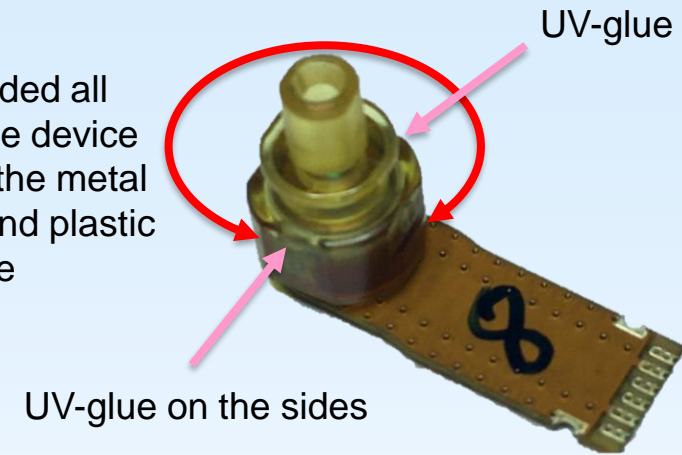
- Metal TO-can is actively aligned with the plastic receptacle and tacked in place with two dots of UV glue on opposite sides of the package
- Final structural strength is achieved with epoxy that is applied on all sides of the assembly and then heat cured
- Assembly recipe gave us a list of potential contaminant sources

Epoxy added all around the device between the metal TO-can and plastic receptacle

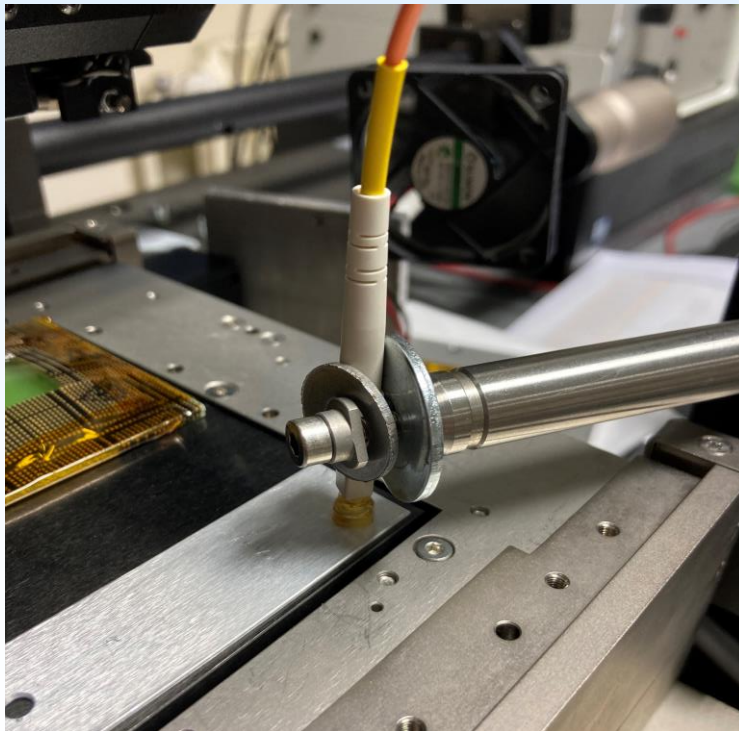
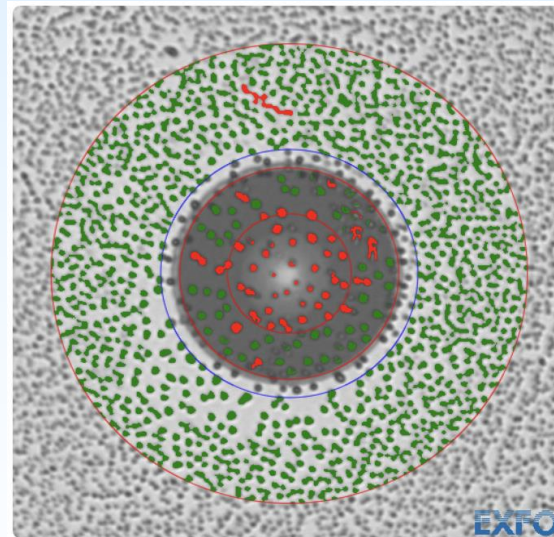
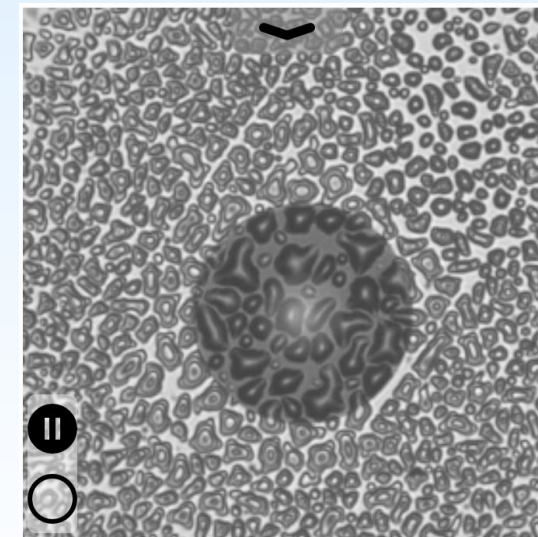
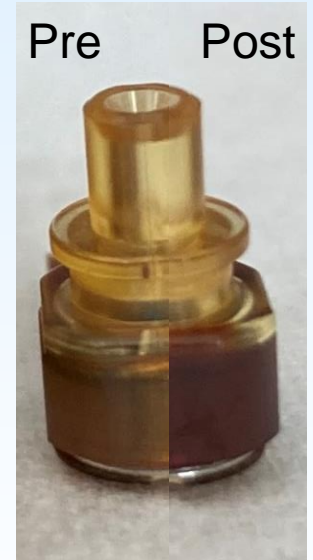
- Epoxy sample from ROSA heated on a hot plate and collected on a clean fiber using a new receptacle
  - Looked like the contaminant observed in our lab and at the experiments
  - Also stuck on the fibre end-face for longer time
  - We were also able to change the epoxy colour with extra curing, which could be a sign of insufficient initial curing

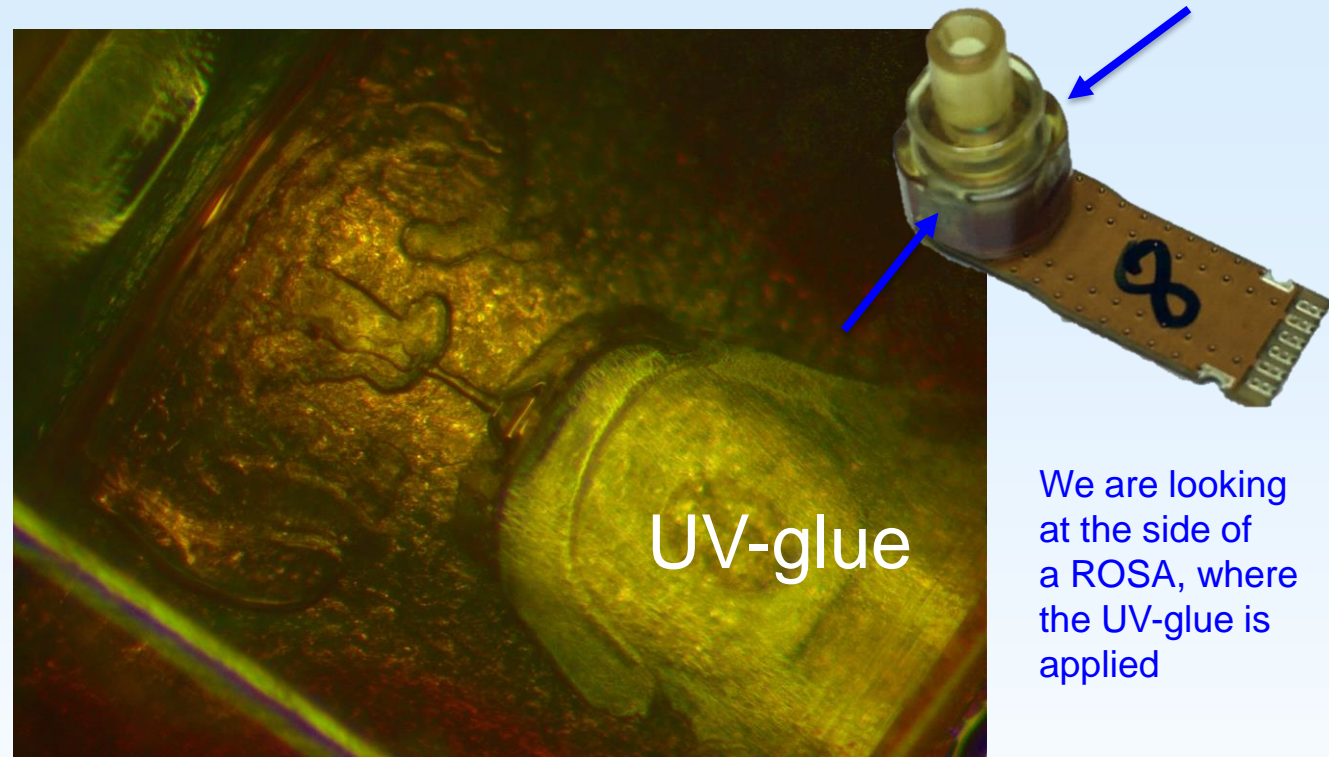
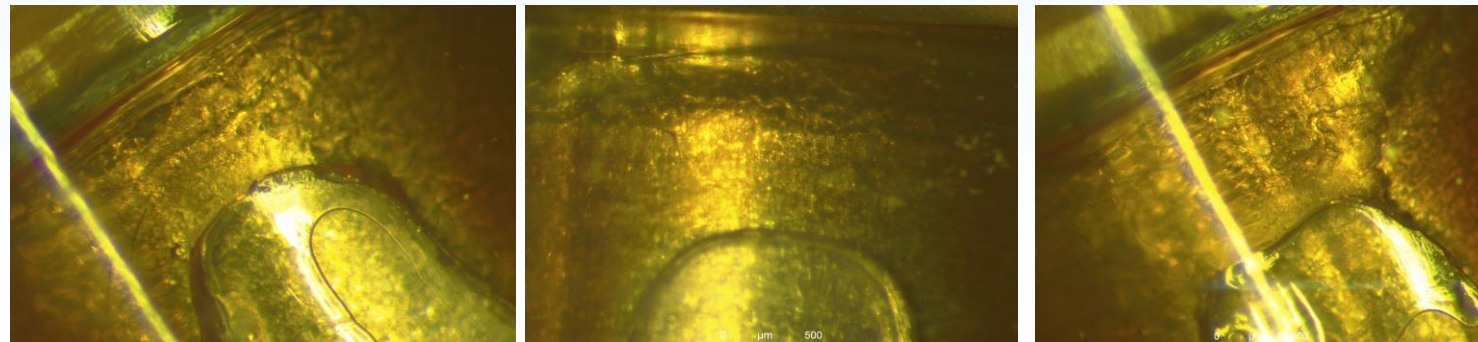
- UV-glue supplier technical experts gave opinion that multiple regions within the glue clearly indicate incomplete curing
- What happens to unreacted monomers is difficult to predict
  - e.g. mixing with epoxy, reactions catalysed by metal TO-can, ...
- **One of the unreacted monomers from the UV-glue could decompose into diols**
- Application of the UV-glue has been rather **poorly controlled process**
  - Quantity, location, apparent cure level varies
  - **Could explain why there are so big differences in how and when the drifting occurs in different samples**

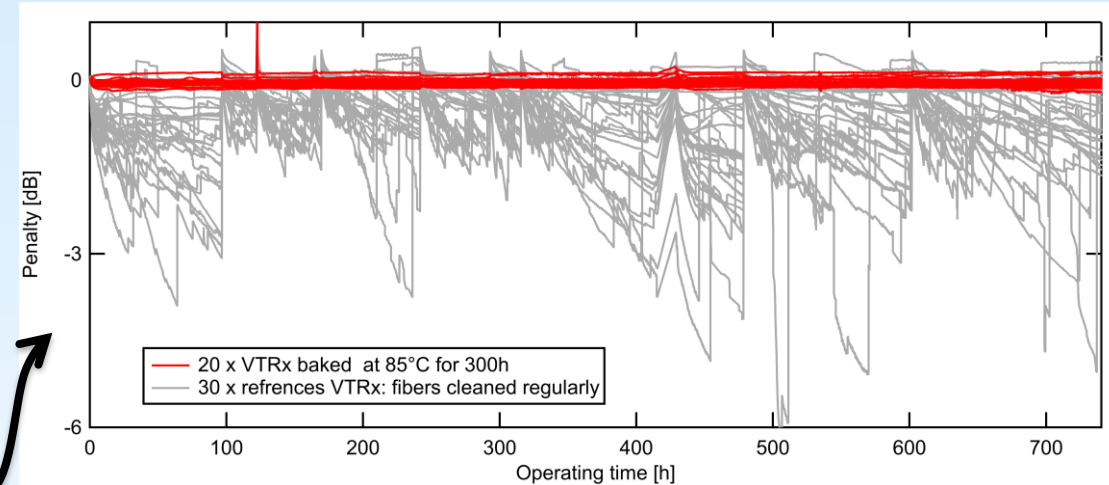
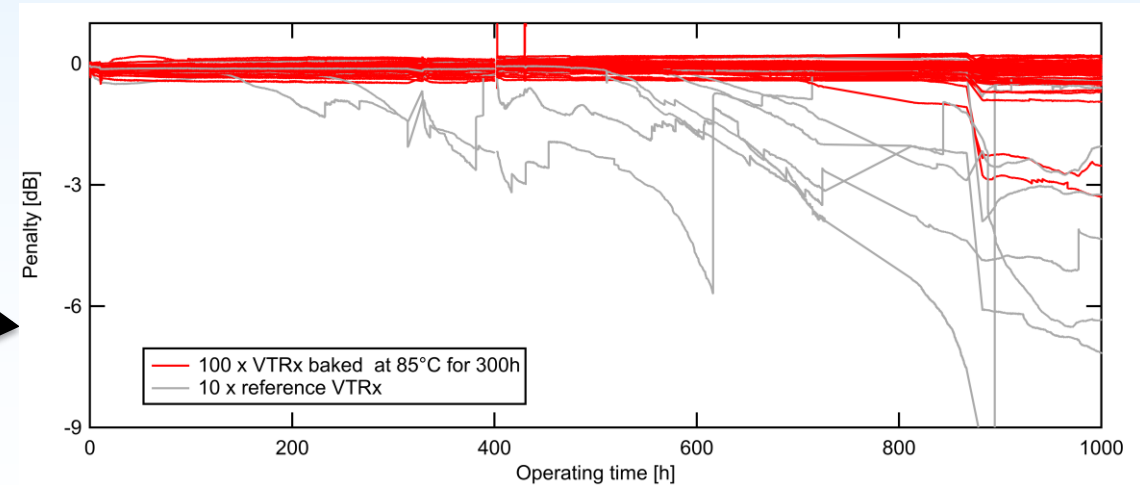
- Several different bake-out profiles and post cures, both heat curing and UV curing, were tested
  - 120°C for 2h (post curing the epoxy)
  - 65°C for 48h
  - 85°C for 50h
  - 85°C for 130h
  - UV-post curing different times
- Finally, 300h at 85°C seemed to have made a significant difference
- While we started to prepare bake-out facilities, a larger sample set baked 300h at 85°C was being tested
  - Eventually, and unfortunately, 300h bake did not seem to be a perfect solution
  - However, it definitely made a big difference
- Standard bake-out process was chosen to be **500h at 85°C**

Signs of drifting

Gaps in the data taking
