Current Magnet Status

Spectrometer Solenoid Review

October 25, 2010

Steve Virostek
Lawrence Berkeley National Lab

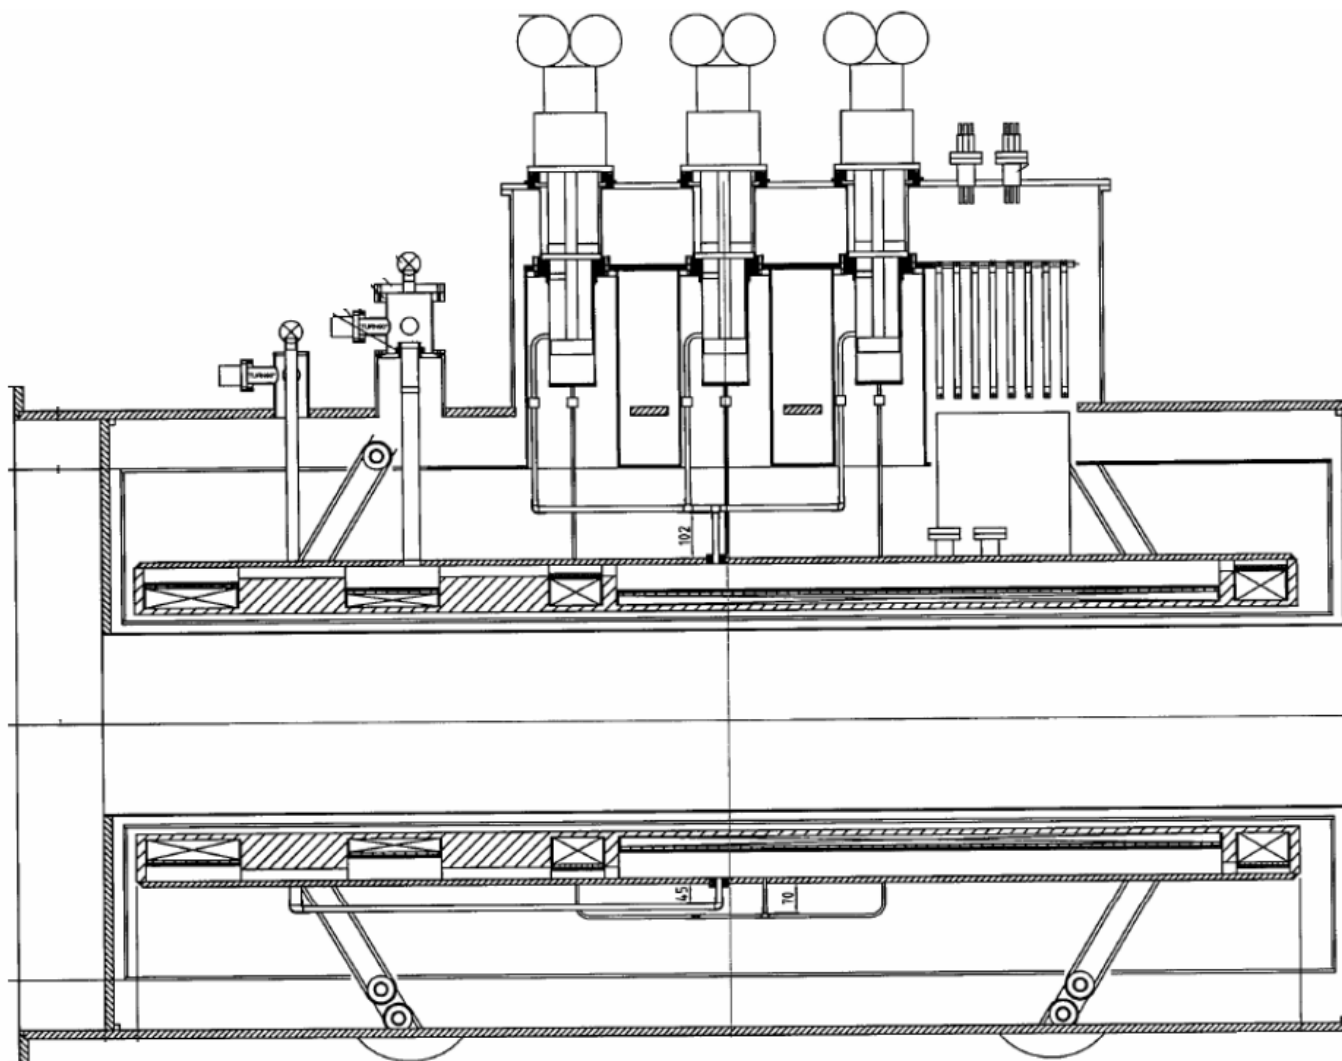
Magnet 1 Cross Section

- Magnet 1 was built per the specifications of the original Wang NMR design report dated 9/6/06
- The cooling circuit consisted of small diameter tubes that fed recondensed LHe to the bottom of the cold mass and directed helium vapor from the top of the cold mass to the cryocooler recondenser cans
- Upon cooldown, the cryocoolers were not recondensing helium due to the liquid and vapor return lines being blocked by frozen
- While cold, the magnet was trained with all five coils running in series to a peak current of 196 amps was reached
- The training was discontinued when the available LHe ran out
- Magnet 1 was disassembled in order to allow modification of the recondensing circuit

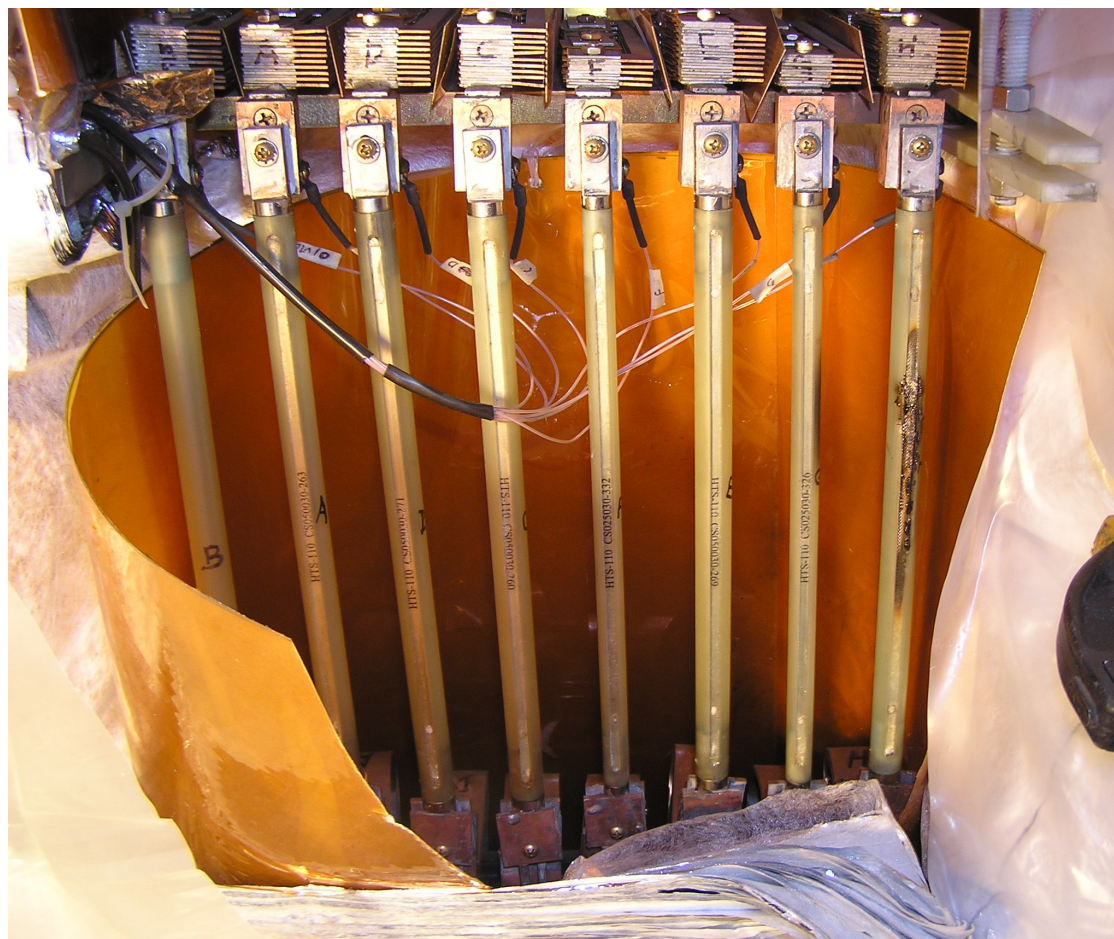
Burned Out HTS Lead

- The second magnet was assembled with a series of design changes
 - replacement of the cooling circuit with large diameter tubes connecting the condensing cans directly to the top of the cold mass
 - addition of an LN reservoir connected to the shield
 - replacement of the thin, flexible copper straps that connected the shield to the 1st stage copper plate with thicker 1100 aluminum straps
- Upon cooldown, the cryocoolers appeared to be recondensing helium, but the magnet did not reach an equilibrium with no LHe boil-off
- The training of the magnet commenced, and a current of 238 amps was reached at which point an open circuit was detected
- After warm-up, the magnet tower was opened, and a burned out HTS lead was discovered; the failure was caused by inadequate cooling of the HTS lead upper ends at their connection to the 1st stage Cu plate

- A review committee was convened by MICE management in 11/09 in order to assess the magnet design and to recommend modifications
- Per the committee, a single-stage cooler was added to increase cooling at the HTS lead upper ends and to help reduce the shield temperature
- With the HTS lead issue solved, Magnet 2B was trained in series to 258 amps when a coil lead was again found to contain an open circuit
- The failure was traced to the M2 coil close to the He/vacuum feedthru
- Training on the Center, E1 and E2 coils in series continued and reached a current of 270 amps
- Also noted was the fact that the three 2-stage coolers plus the single-stage cooler could not maintain a closed LHe system

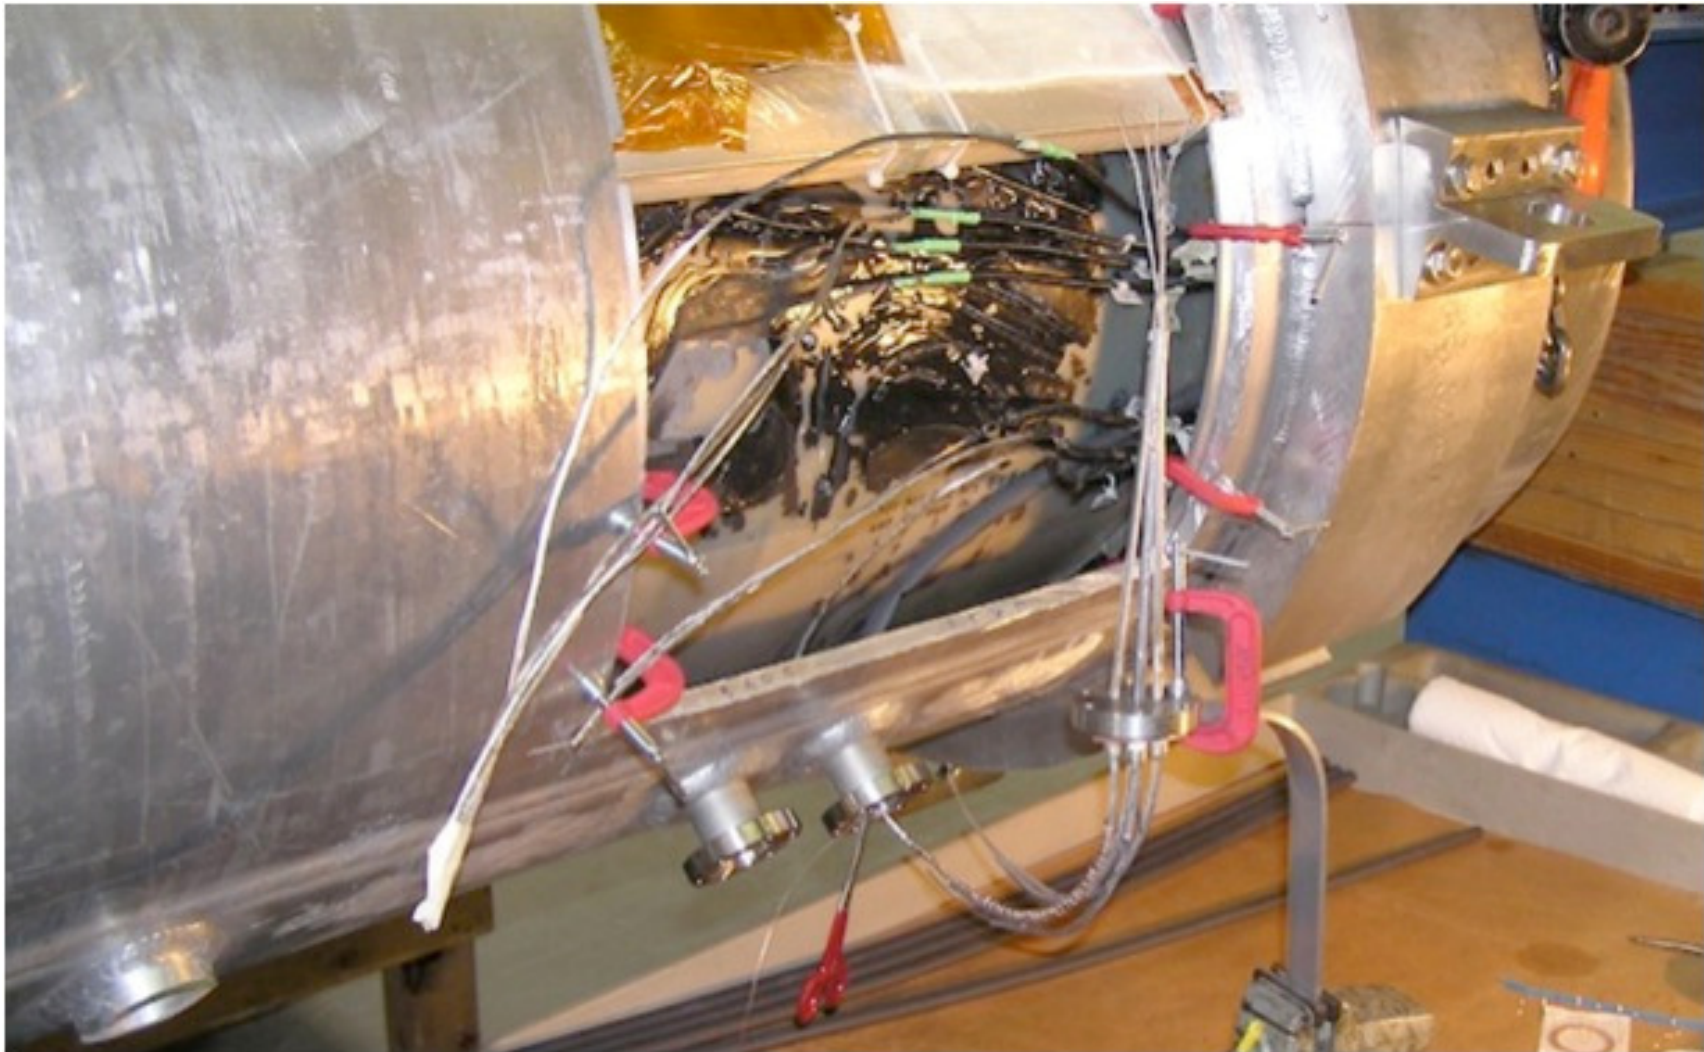
Magnet 2B Cold Lead Repair

- After warm-up of Magnet 2, the cold mass was removed from the vacuum vessel and opened
- The failed lead was located just inside the cold mass feedthrough
- Analysis of the failure indicated that the conductor adjacent to the feedthru will require the addition of extra copper to stabilize it against movement and to enhance conductive cooling (see M. Green write-up)
- This improvement was carried out on Magnet 2B during the repair of the failed lead
- Magnet 1 remains disassembled and will require opening of the cold mass to make the same modification
- The Magnet 1 thermal shield had been previously modified to enhance its thermal conductivity to the cold mass support intercepts and to allow for a more thermally conductive connection to the cryocoolers
- The Magnet 2 shield has not been modified
