Author(s): **Steve Virostek**
Date: **10/19/10**

TECHNICAL NOTE

MICE Spectrometer Solenoid: Current Magnet Status

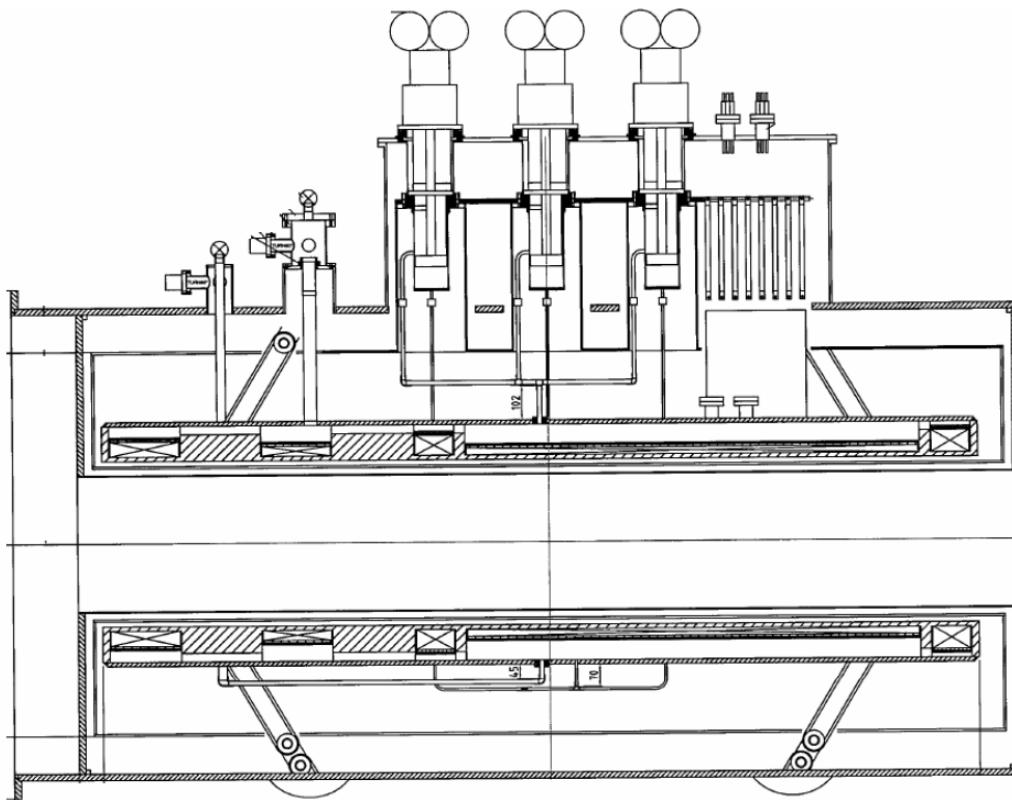
The first magnet assembled and tested (Magnet 1) was built per the specifications of the original Wang NMR design report titled "Final Engineering Design for MICE Spectrometer Solenoid Magnets" and dated 9/6/06. The LHe cooling and recondensation circuit for this magnet consisted of a series of small diameter tubes that fed the recondensed LHe to the bottom of the cold mass and directed helium vapor from the top of the cold mass to the cryocooler recondenser cans. A cross section of the magnet showing this configuration is provided in Figure 1.

Upon cooldown of Magnet 1 to 4.2K, it was discovered that the cryocoolers were not recondensing helium due to blocked liquid and vapor return lines. It appears likely that the lines were blocked by frozen nitrogen. Prior to cooling down with LHe, the system is pre-cooled using LN. If the system is not fully purged of nitrogen using a thorough pump/purge procedure, then the remaining nitrogen can be frozen by the LHe and cause blockage of the cooling lines, as likely occurred in this case.

Figure 1: Cross section of Magnet 1.

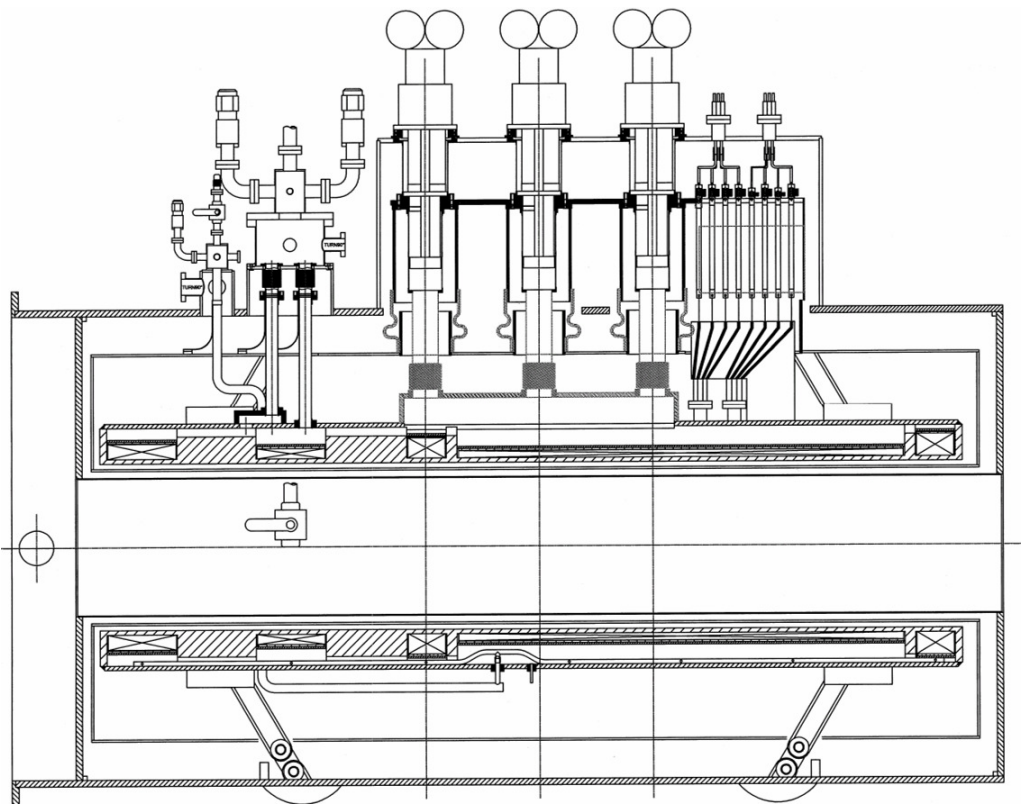
A cross section drawing of Magnet 2A showing this modified configuration is provided in Figure 2.

Magnet 2A was cooled down, and the cryocoolers appeared to be recondensing helium; however, the magnet did not reach an equilibrium condition where there was no LHe boil-off. The training of the magnet commenced, and a current of 238 amps was reached at which point an open circuit was detected. After warm-up, the magnet tower was opened, and a burned out HTS lead was discovered (see Figure 3). Subsequent investigation and review of the temperature sensor logs indicated that the upper end of the HTS leads were inadequately cooled at their connection to the 1st stage copper plate.

Figure 2: Cross section of Magnet 2A.

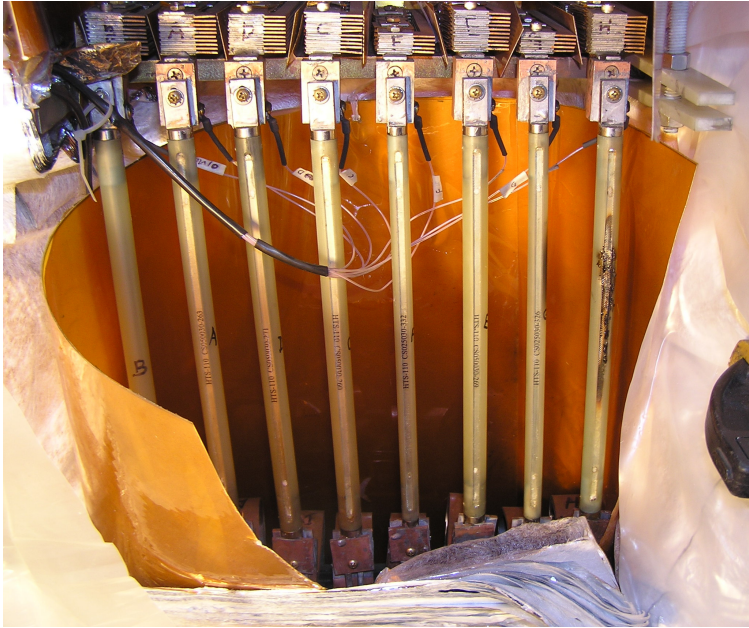
Figure 3: Burned out HTS lead in Magnet 2A (right).

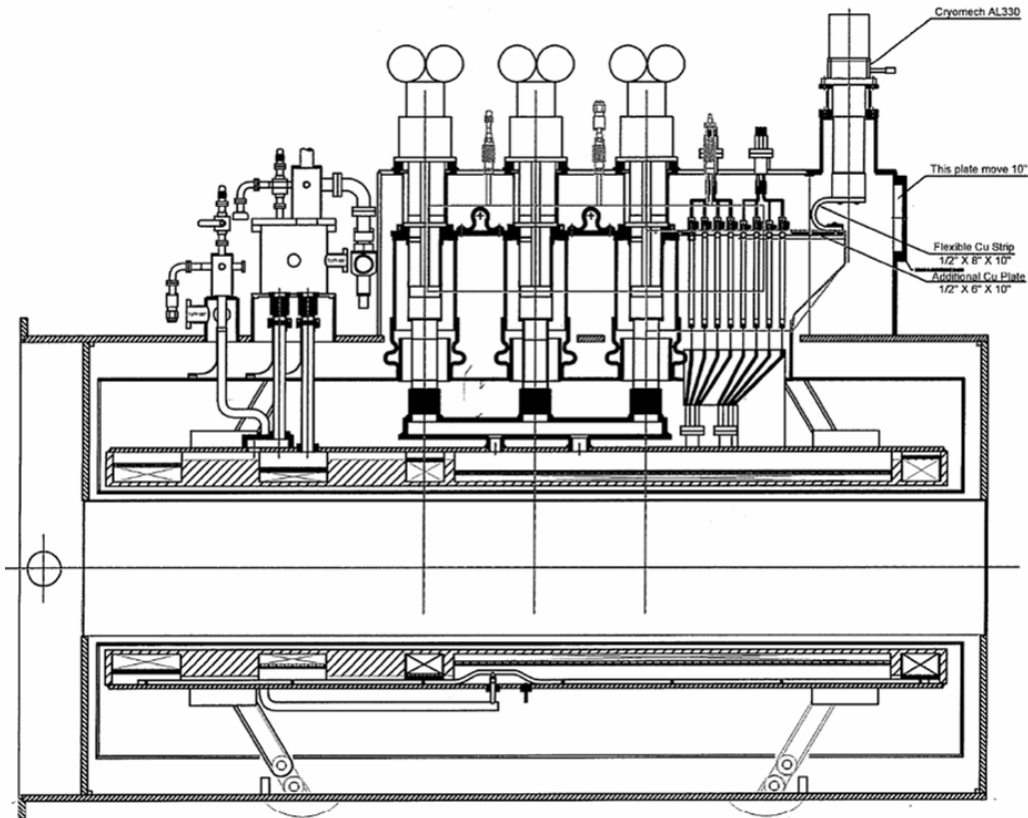
A review committee was convened by MICE management in 11/09 in order to assess the magnet design and to recommend modifications. Per the committee's recommendation, a single-stage cooler capable of removing 170 watts at 55K was added to increase the cooling power at the upper end of the HTS leads and to help reduce the shield temperatures. A cross section of the magnet showing this configuration is provided in Figure 4, and the single stage cooler details are shown in Figure 5.

Figure 4: Cross section of Magnet 2B.

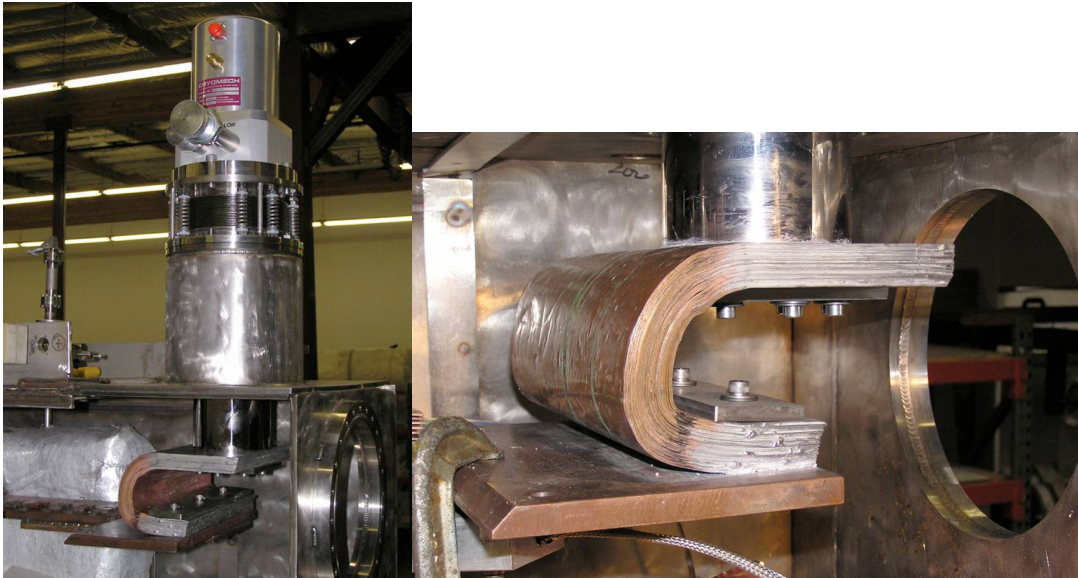
Figure 5: Magnet 2B single stage cryocooler (left), and the cooler connection (right).

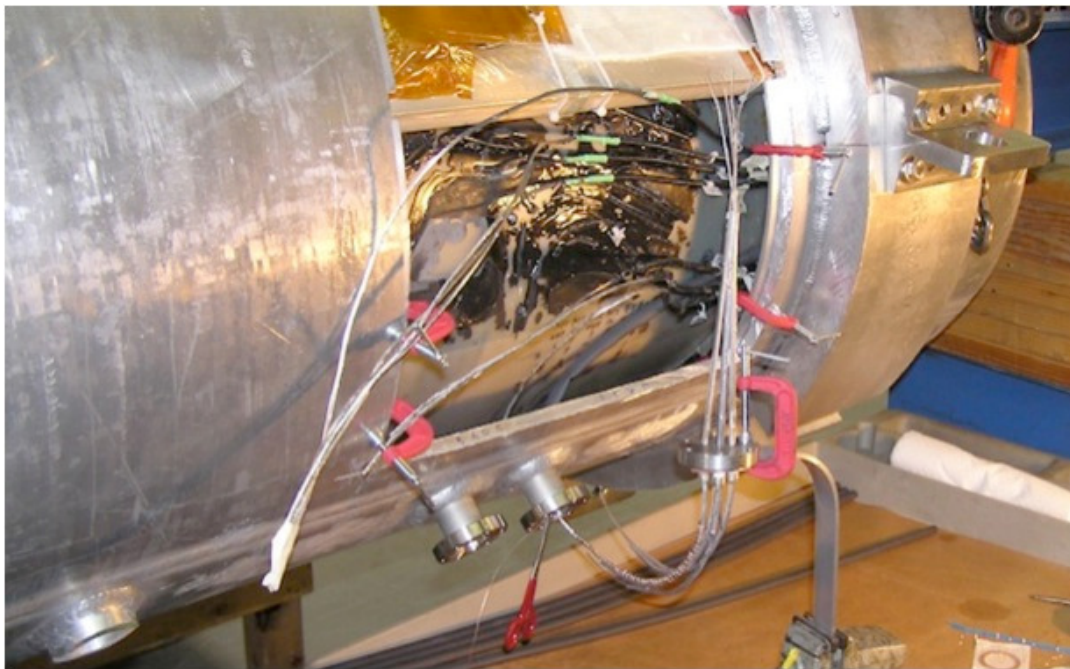
After warm-up, Magnet 2 was disassembled and the cold mass opened; the failed lead was located just inside the cold mass feedthrough. Analysis of the failure area indicated that the conductor adjacent to the feedthrough will require the addition of extra copper to stabilize it against movement and to enhance conductive cooling. This improvement was carried out on Magnet 2B during the repair of the failed lead (Figure 6).

Figure 6: Repair and stabilization of the Magnet 2B cold leads.
