The ATLAS RPC system for the LHC Run-3

D.Boscherini (INFN-Bologna)

RPC 2022

XVI Workshop on Resistive Plate Chambers and Related Detectors

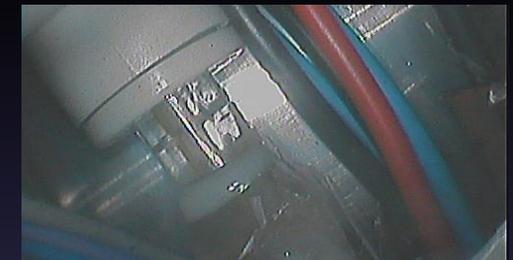
Leaks originate in the gas inlets which tend to crack due to inborn fragility, aggravated by mechanical+chemical stress, pump vibrations, pressure spikes
Cracks develop slowly (months) until reaching a breaking point

incomplete crack

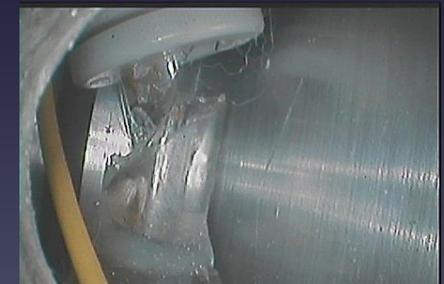
complete breakdown

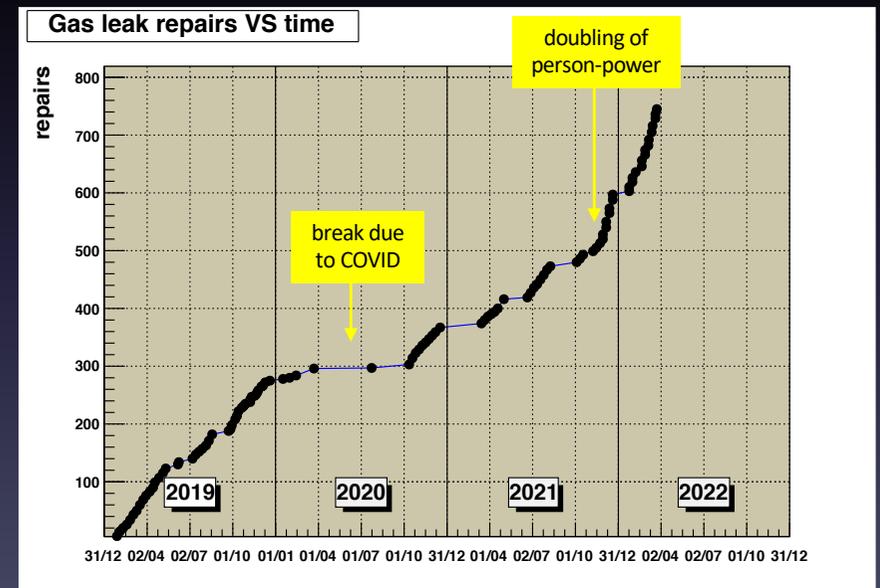
cumulative number of repaired chamber-layers

- needed to keep under control the continuously developing leaks
- task is very difficult due to problematic access
- endoscope driven operations: spraying glue and/or insertion of a new inlet
- intensive effort by our Dubna colleagues, with long interruptions due to COVID

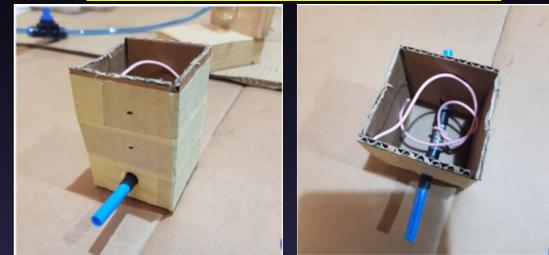
mockup boxes with a leaky pipe

Proposal is to use an **expansive resin** to fill the service boxes hosting the gas inlets in order to form gas-tight rigid blocks

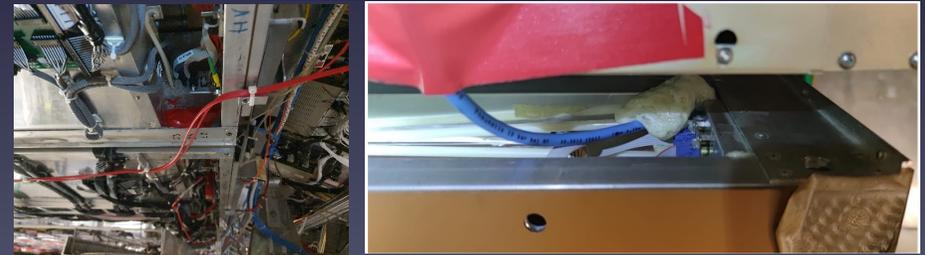
Technique tested in ATLAS on 100 boxes for validation
Results are very promising

resin applied in ATLAS

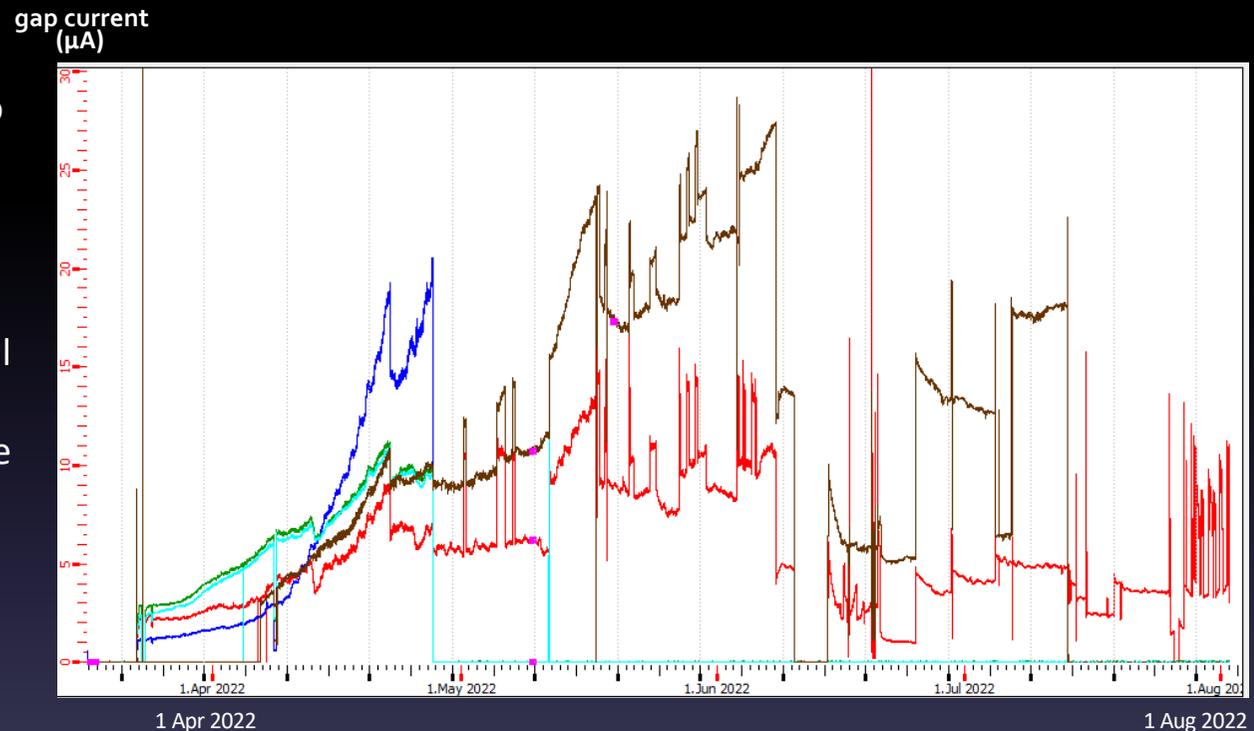
Several gas gaps belonging to different gas and HV layers showed currents drifting up

- additional current mostly ohmic \rightarrow no substantial alteration of the gas mixture or working point
- good gas flow (neighbour chambers sharing same distribution behaving well)

time evolution of current for a few gas volumes

Initially HV channels lowered to preserve the gas gaps,
then gaps disconnected from HV to recover trigger coverage \rightarrow \sim 80 gas volumes currently disconnected

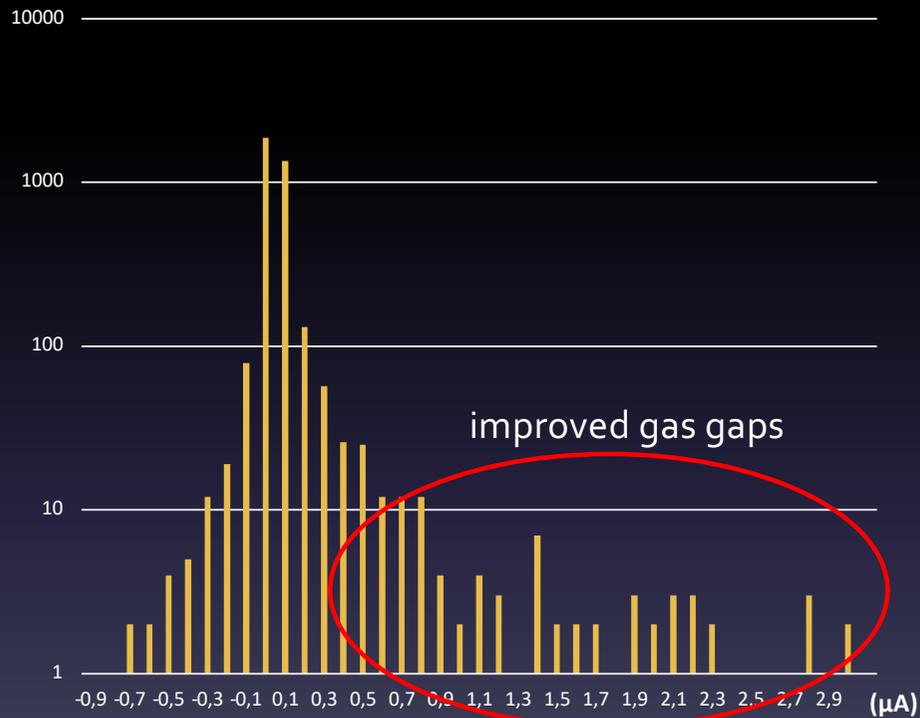
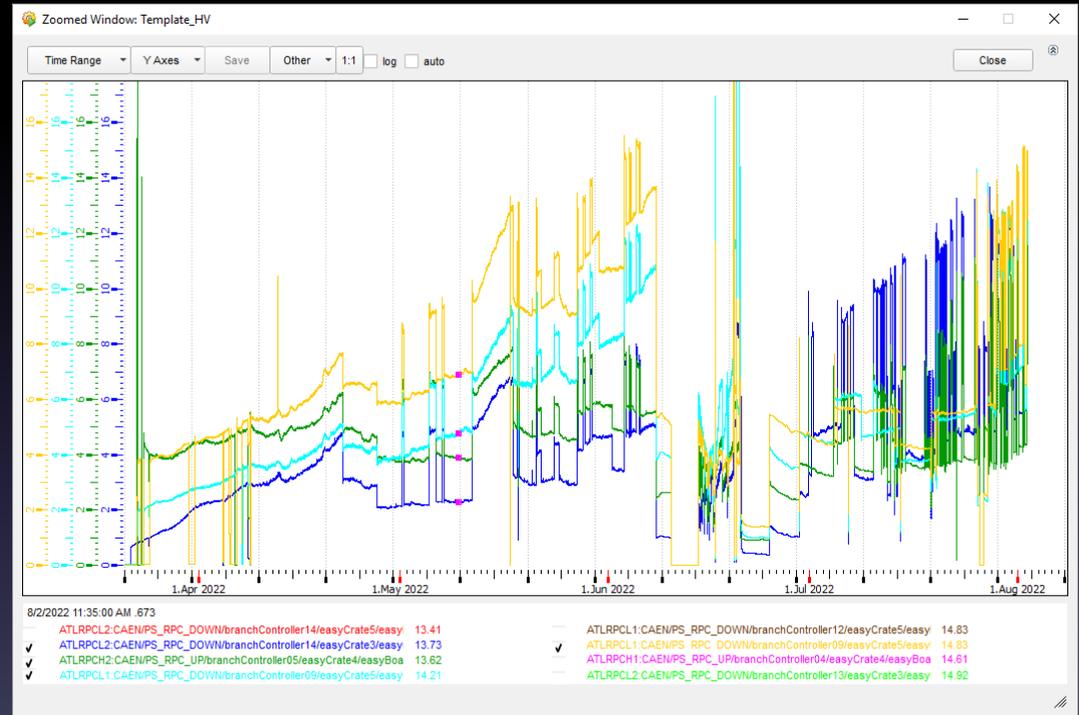
Difference of gap current (before-after) at 9 kV

Improvement observed. A few gaps with current still drifting up. However, time with Argon was short. Further conditioning to be planned for next YETS

Procedure attempted with the aim to remove any internal deposit (typically HF compounds) producing an increase of the ohmic current
