TT40 accident on 25/10/04

Analysis

Introduction

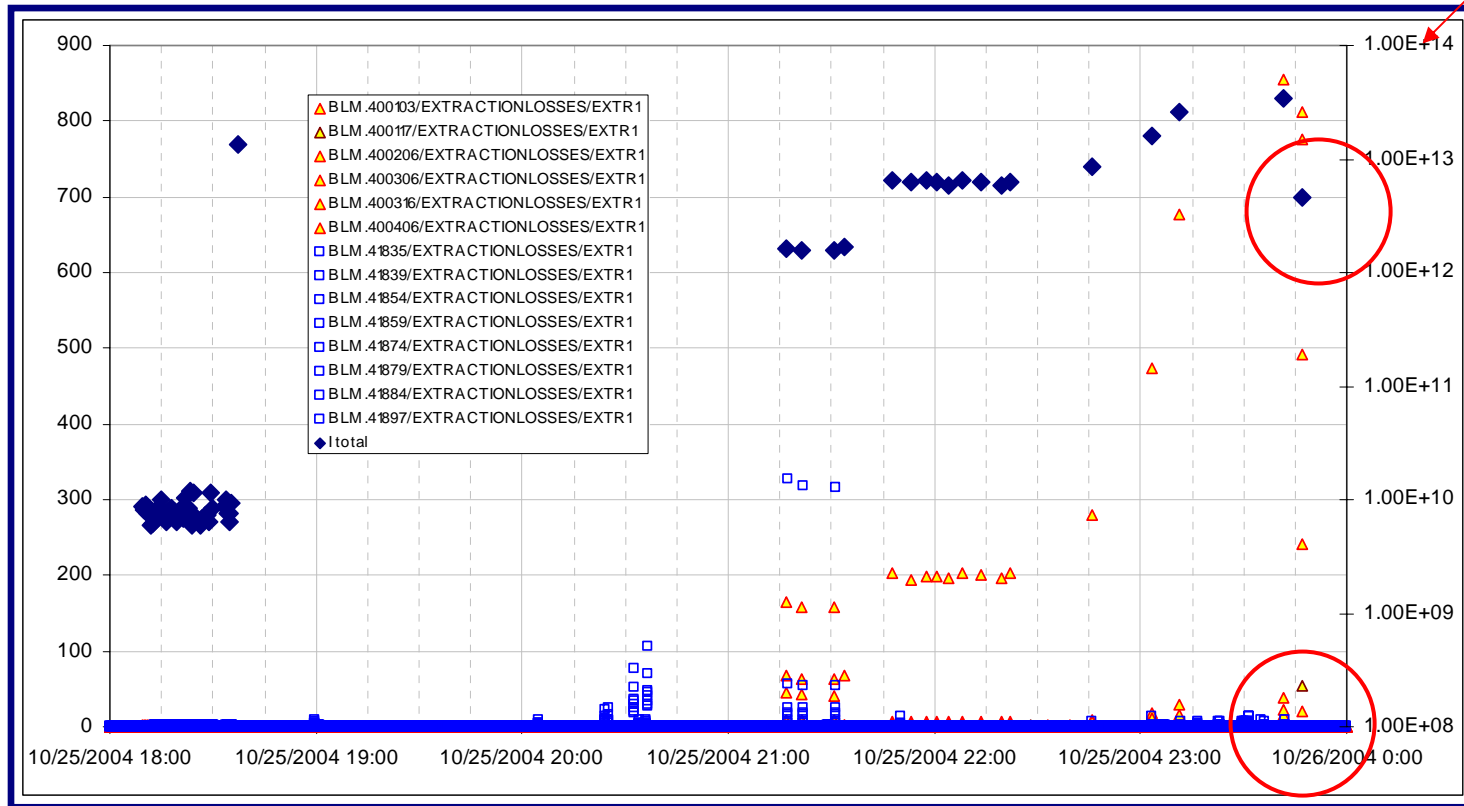
Conclusion : No losses on the septum for the bad extraction. Kicker OK.

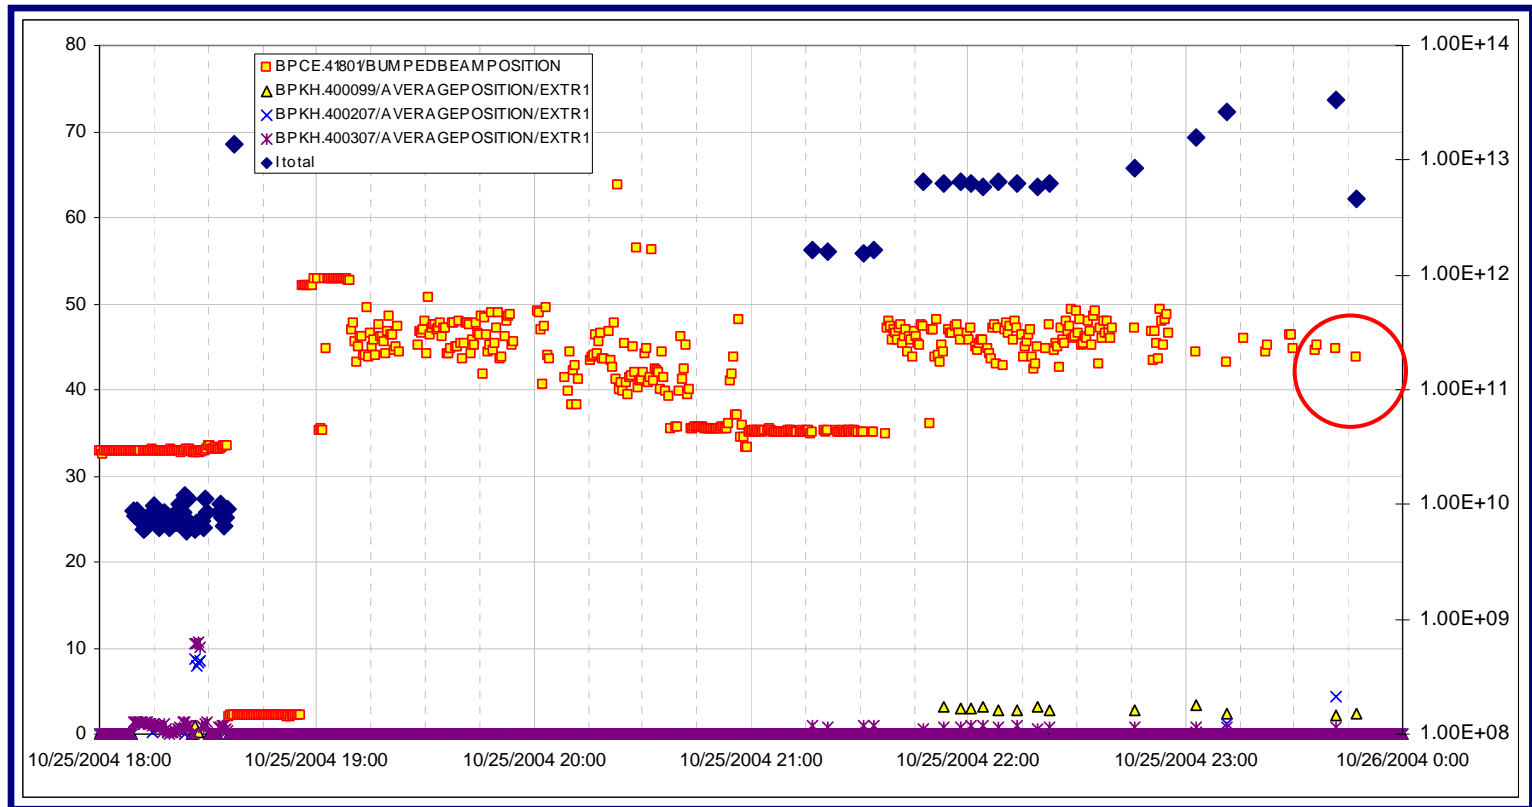
Conclusion : Bumped beam was in the correct position

(Note: high BPCE noise, pick-ups were saturated)

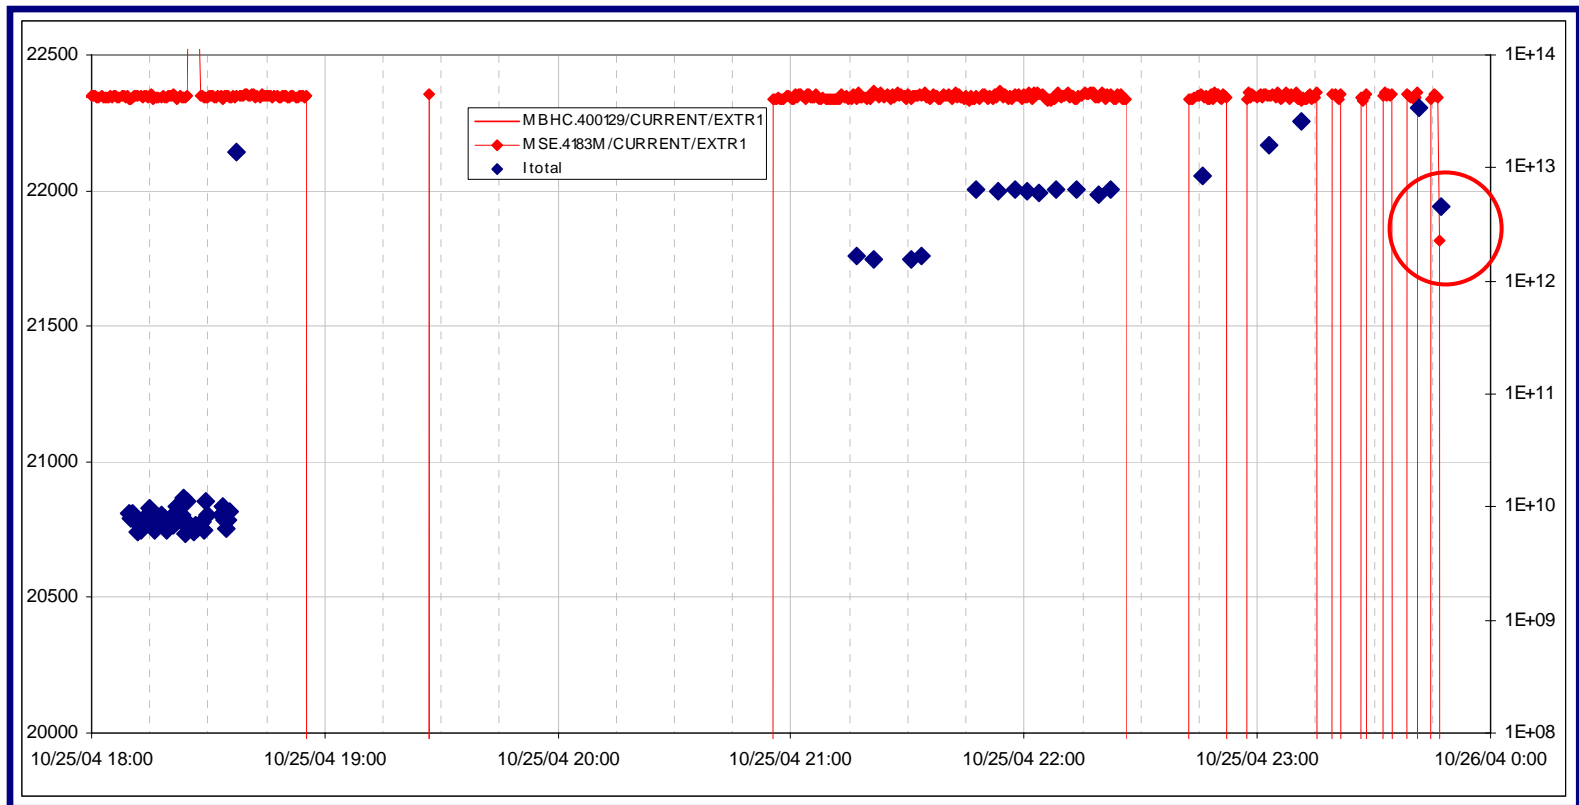
Conclusion : MSE current appears to be ~2.5% low at extraction

(Note: ~8 MSE trips previous to the accident)

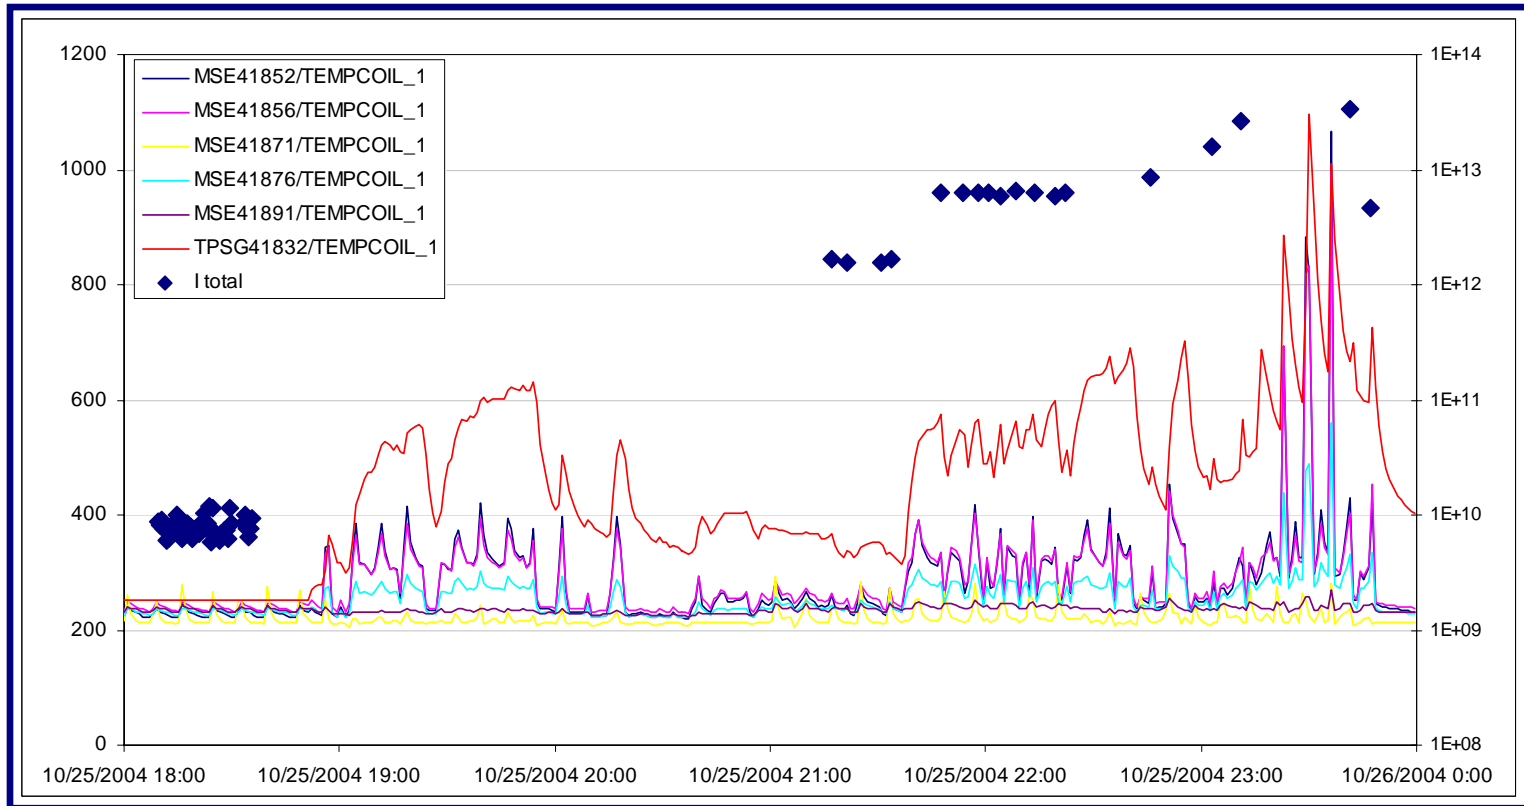
Conclusion : MSE temperature probes pick up beam signals with high intensity beam. Equipment expert disabled the temperature interlocks on the PLC side and extraction continued

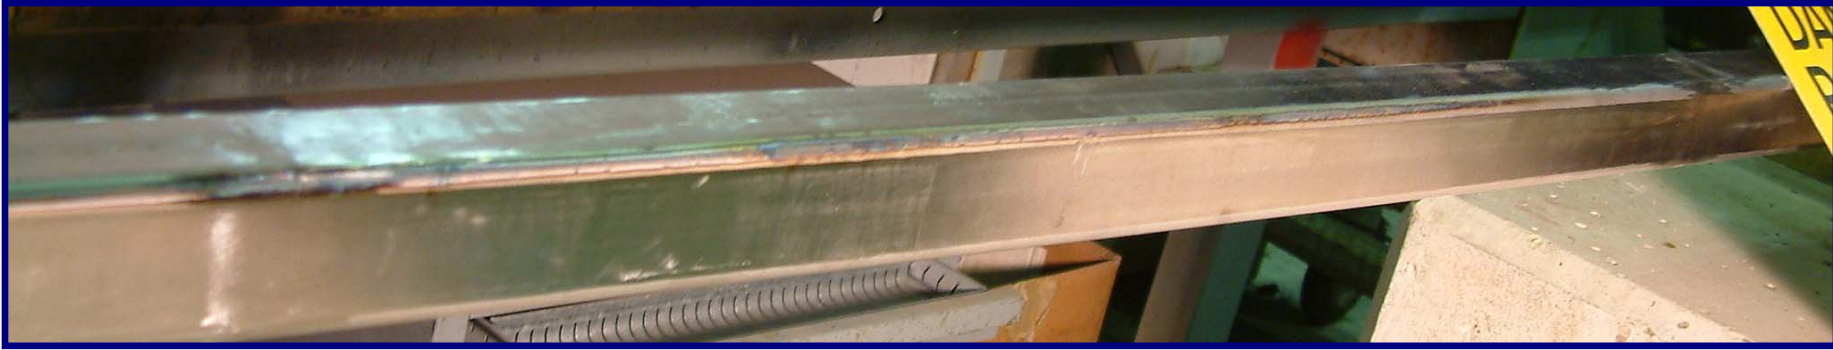
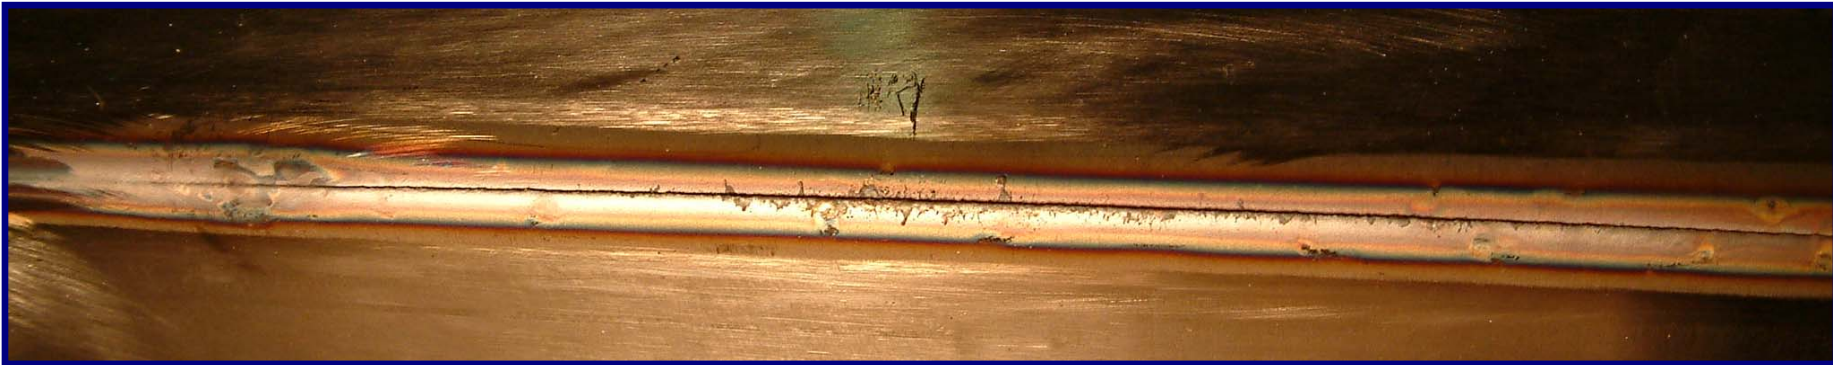
- Signs of beam impact for ~1.2m on right-hand mid-plane of vacuum chamber.
- Molten material ejected onto the other side of the chamber over ~1m.
- Chamber wall is cut through for ~20cm – traces of molten material on the outside.
- No signs of heating from any impact on the large exit flange of the magnet (i.e. no significant primaries penetrated through the chamber).

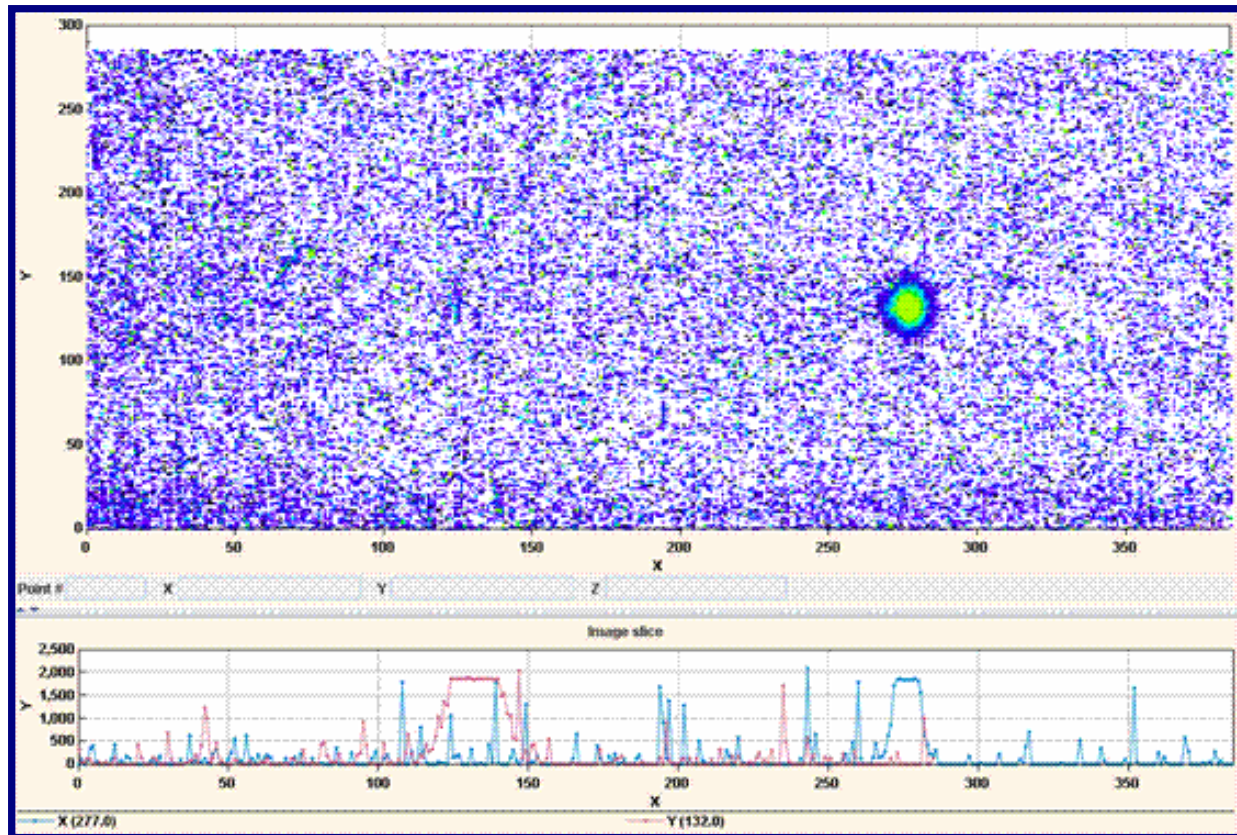
- BTVI 4001 screenshot at 23:47:36 captured the beam
- The beam passed 10.8 mm horizontally to the inside of the position for the previous shots

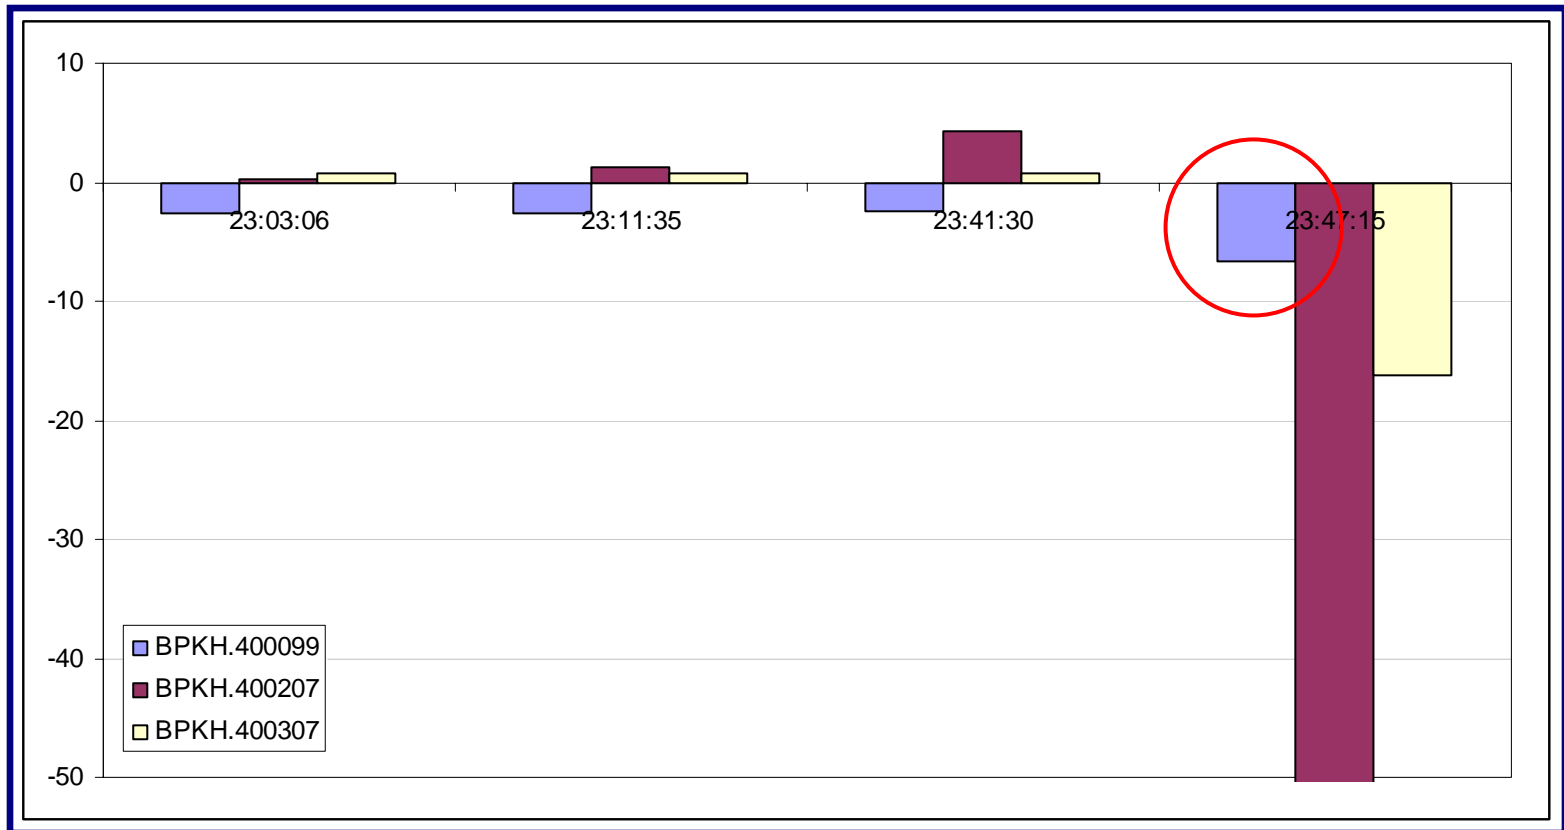
BPK400099 indicates a trajectory about 4.3mm inside the previous ones

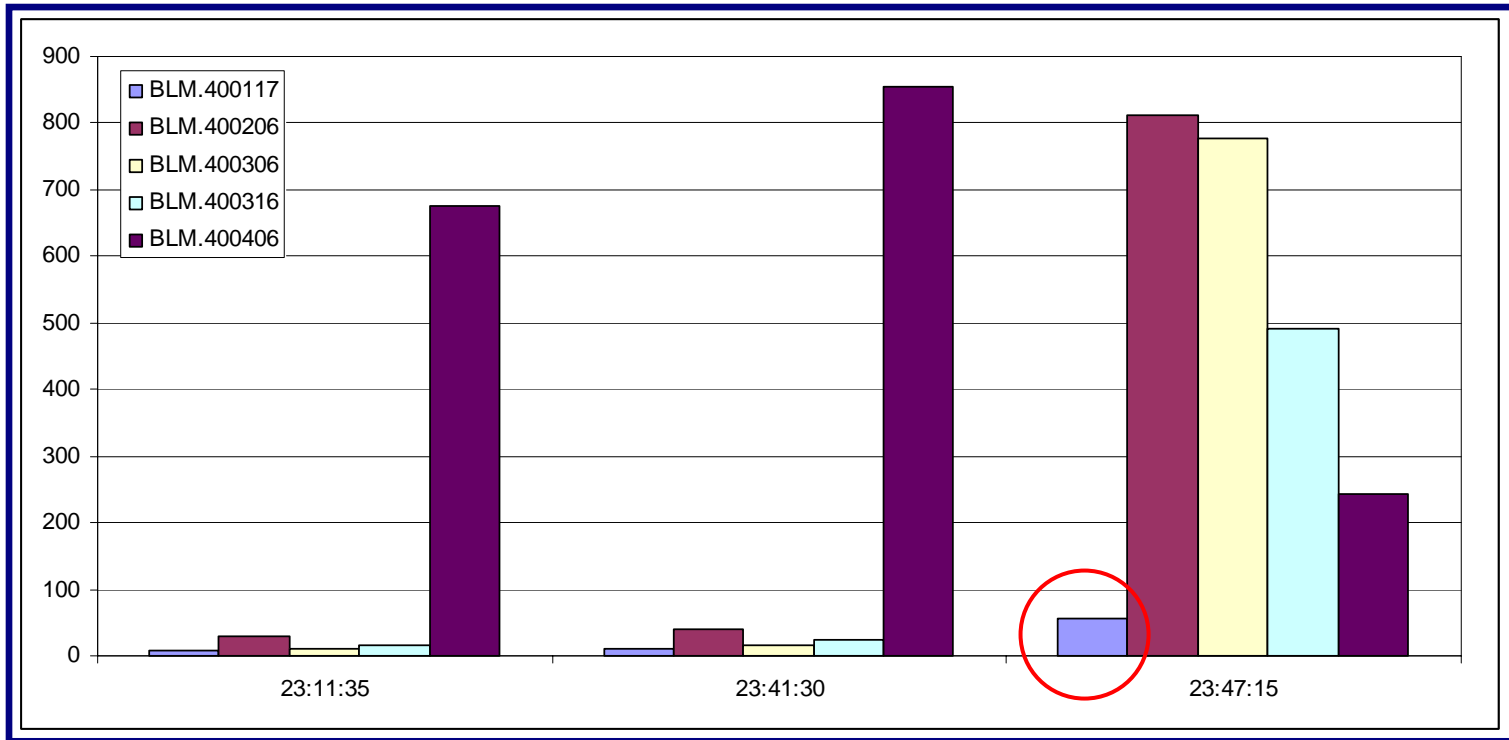
- BLM 4002, 4003 record the accident on the magnet
- BLM 4001 reads higher – backscattered radiation OR losses on QTMD4001?

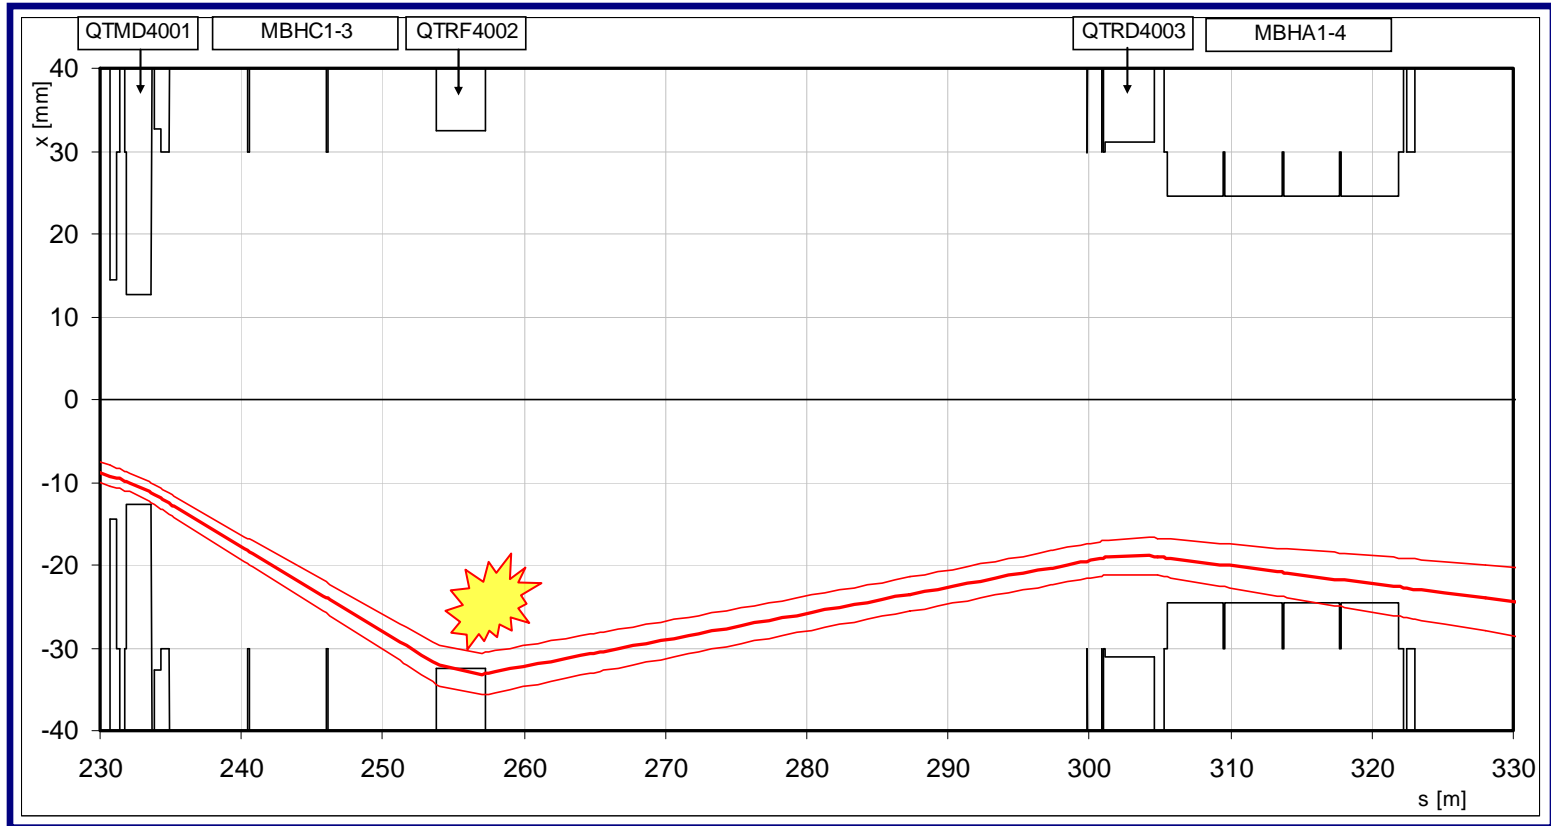
- A trajectory ~consistent with the observed BTV and BPM readings, and the damage location in the QTRD, requires an MSE $\Delta I/I_{\text{nom}}$ of -5.1%.
- The impact angle at the chamber is calculated at 0.59 mrad.
- The beam size (1σ) is 0.7 mm in both planes.

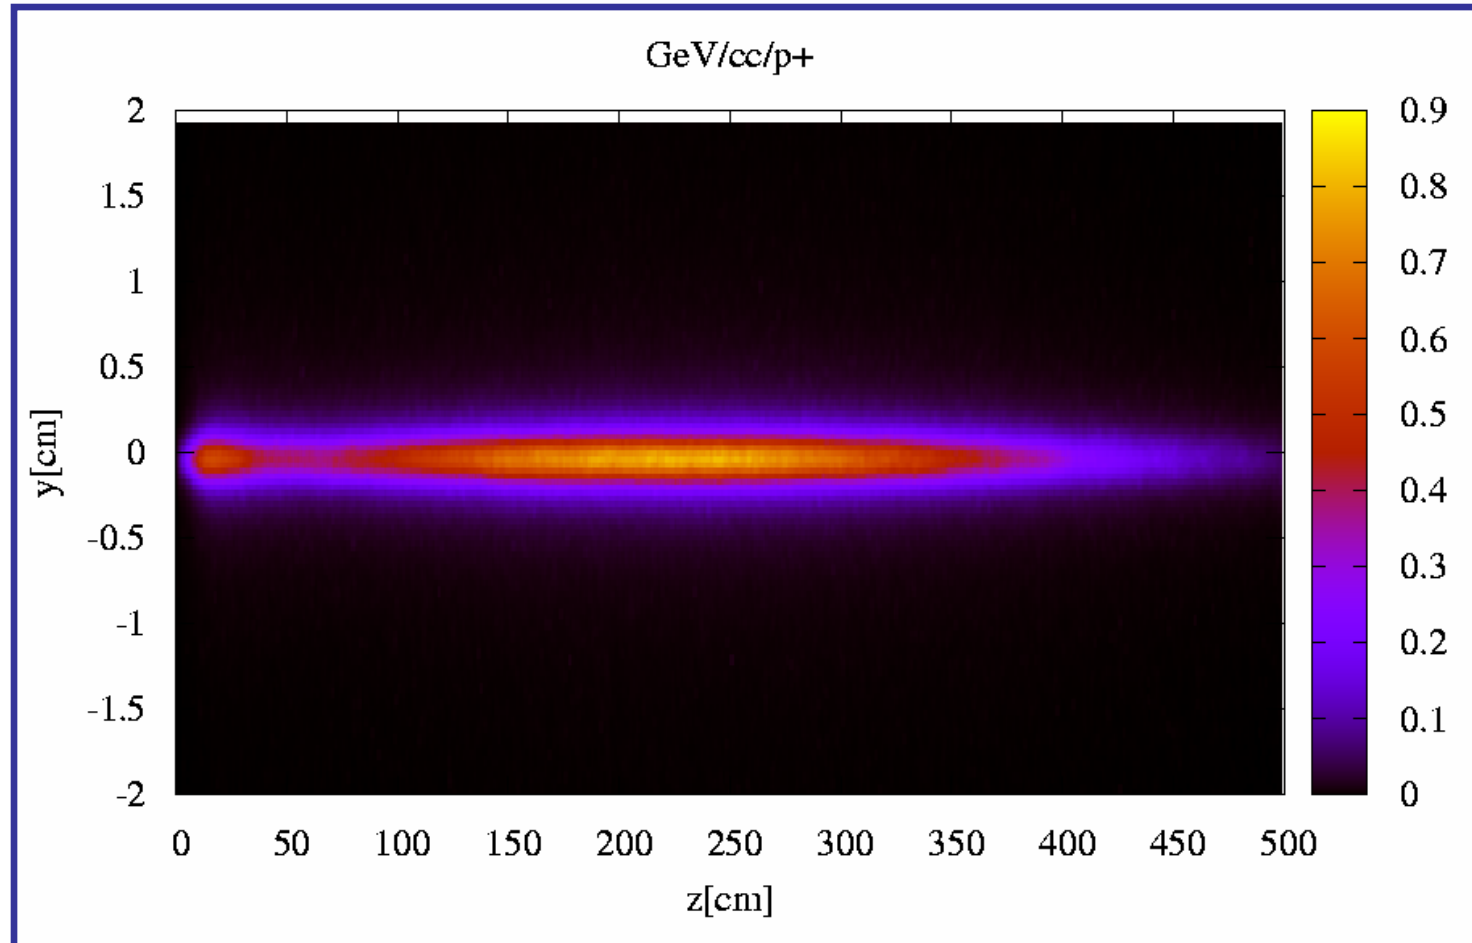
- A FLUKA model of the impact was made with the 1mm steel chamber and the calculated parameters ($x' = 0.59\text{mrad}$, $s_x = s_y = 0.7\text{mm}$, $3.4 \cdot 10^{13} \text{ p+}$).

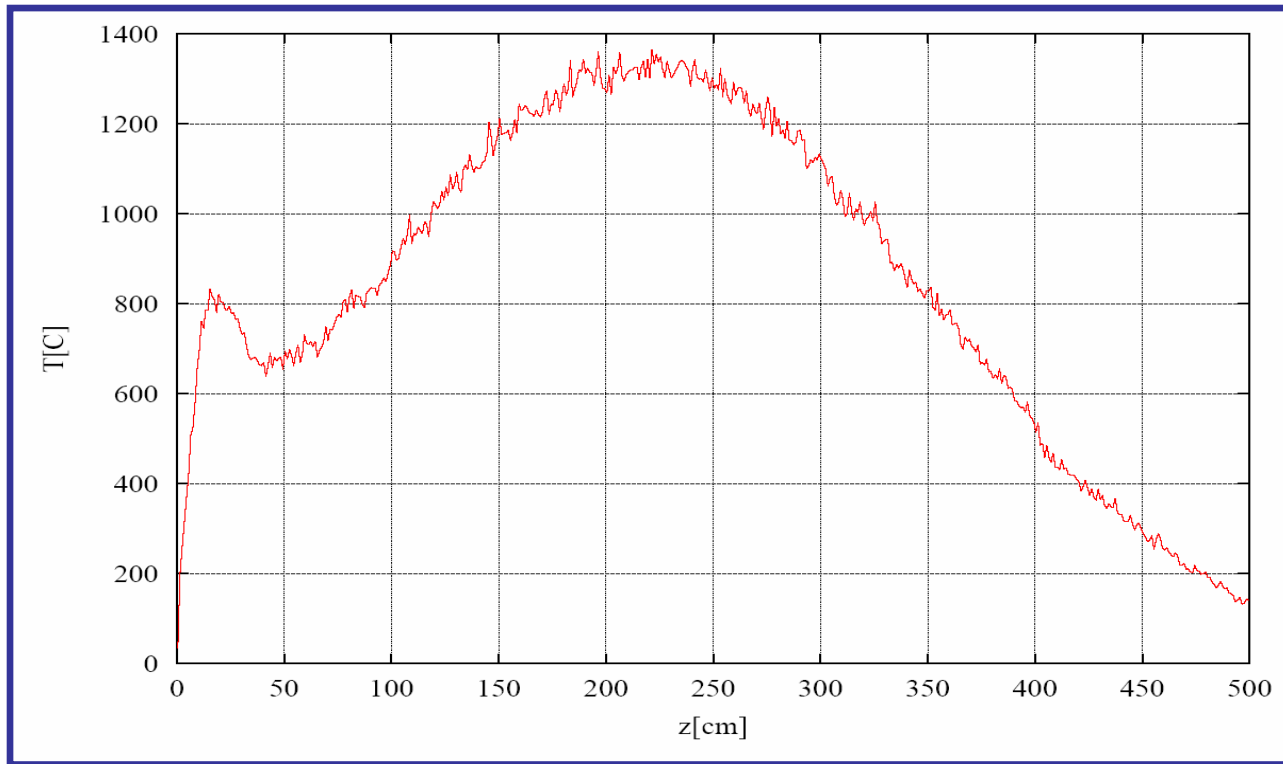
- Melting point (304L) is about 1400 C, so this first simulation seems to underestimate the energy deposition
- Probably indicates that the beam impacted more upstream....

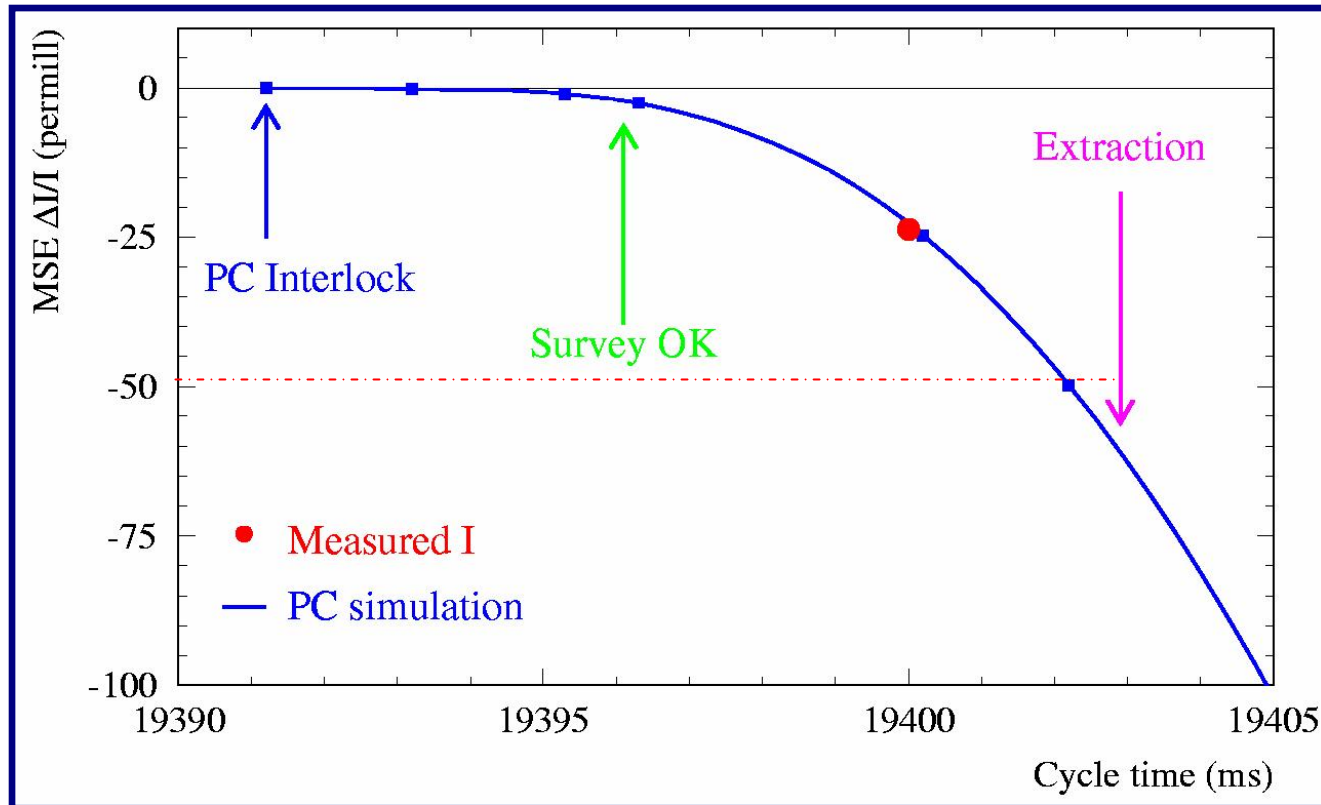
- The I_{MSE} surveillance window only works to about 7ms before extraction
- The current measurement happens at the nominal extraction time - about 3ms before real extraction (kicker prepulse delays)
- The MSE time constant is short ($L/R = 23ms$).... $\Delta I/I$ is about -5% in the 11ms
- At the time of the surveillance $\Delta I/I$ was about -0.5 % - still inside tolerance window

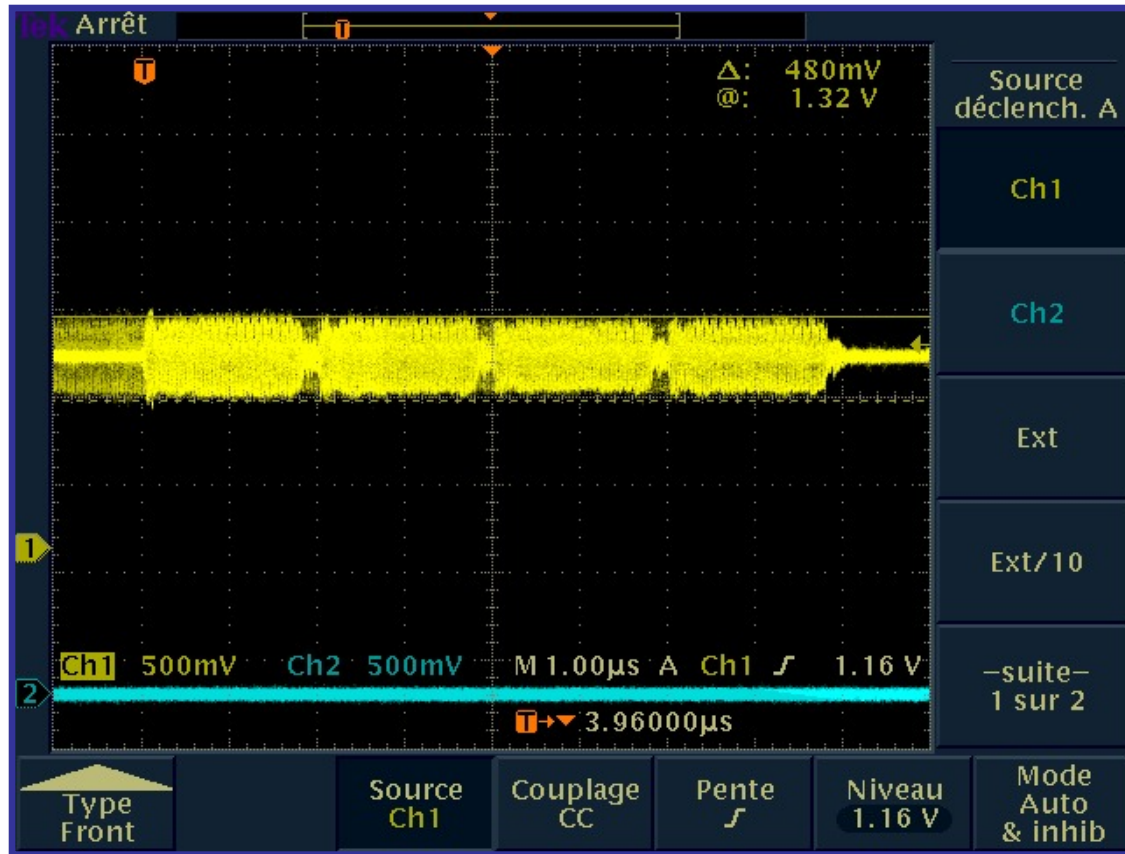
- Crosstalk over cables and within PLC into other channels, increasing with beam intensity, number of connections (reduces as tanks get disconnected)
- MSE tripped also with noisy Pt100 interlocks disabled in the interlock matrix
