# Beam Interlock System Electro-Magnetic Compatibility Testing

B. Todd AB/CO/MI MPWG 9<sup>th</sup> June 2006

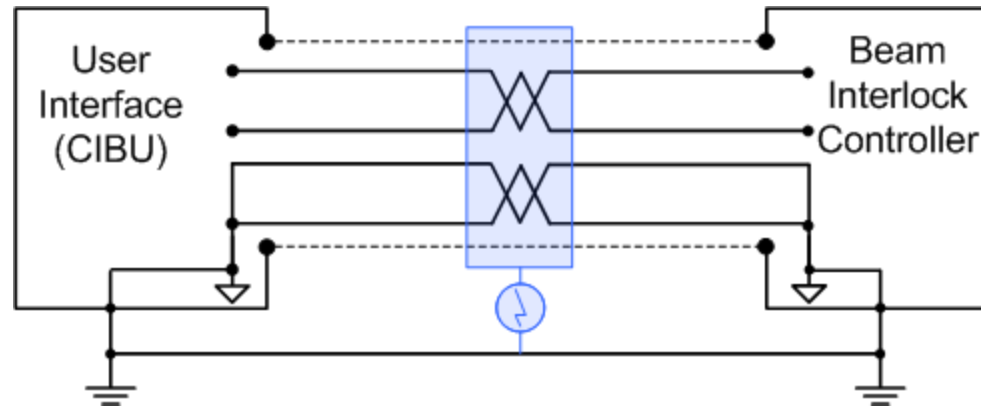
## Cable with FULL Shields FULL Grounds

Full Shield, Full Ground	Severity Level			
	0.5kV	1.0kV	2.0kV	4.0kV
<b>User System Output</b>				
TRUE	A	A	A	A
FALSE	A	A	A	A

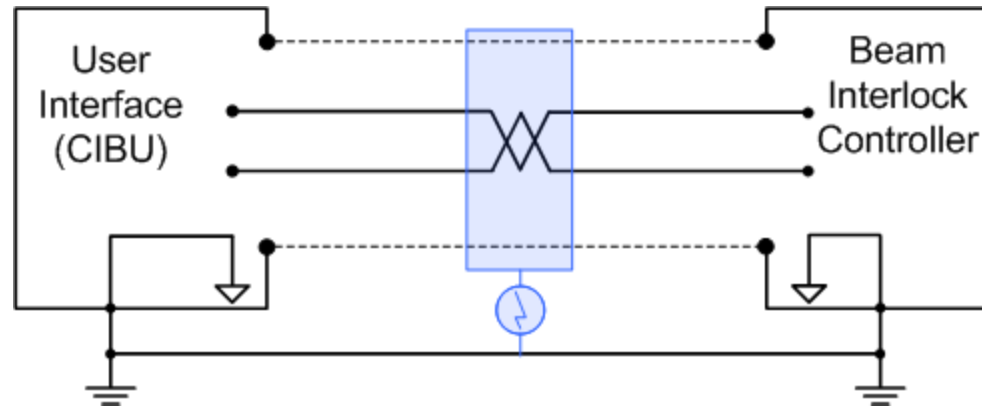
## Cable with FULL Shields NO Grounds

Full Shield, No Ground	Severity Level			
	0.5kV	1.0kV	2.0kV	4.0kV
User System Output				
TRUE	A	A	A	A
FALSE	A	A	A	A

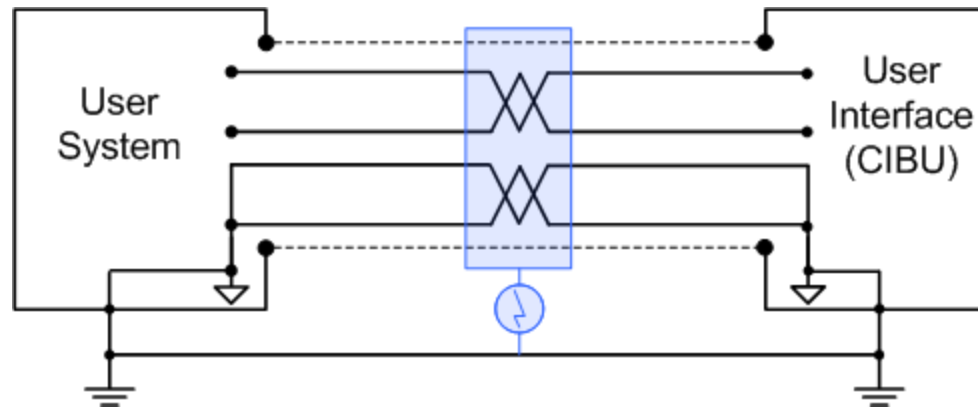
## Cable with FULL Shields FULL Grounds

Full Shield, Full Ground	Severity Level			
	0.5kV	1.0kV	2.0kV	4.0kV
User System Output				
TRUE	A	A	A	A
FALSE	A	A	A	A

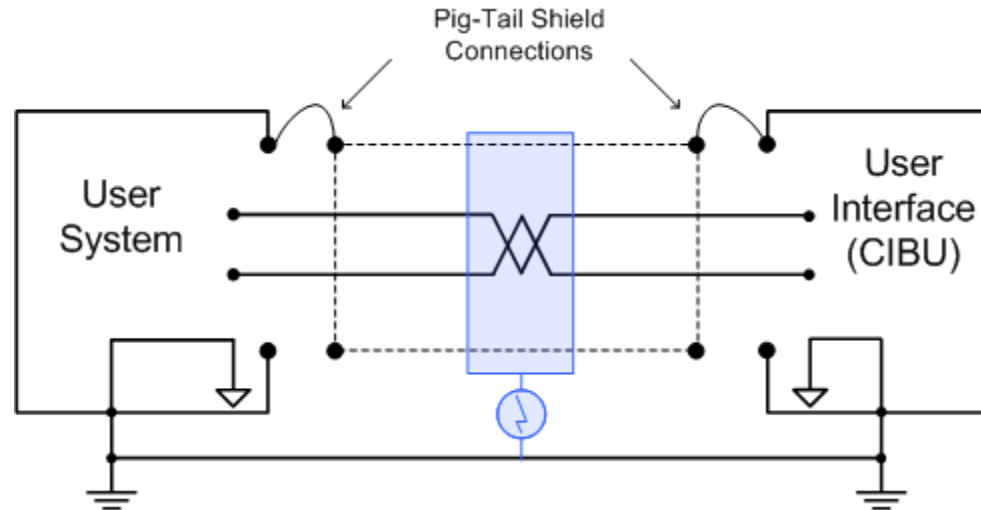
## Cable with Pig-tail Shield **No Grounds** E.G. Vacuum System

Two Pig-tails, No Ground	Severity Level			
	0.5kV	1.0kV	2.0kV	4.0kV
User System Output TRUE	A	A	A	D
User System Output FALSE	A	A	A	D

**Power PC Crashed – Ethernet Controller Stopped responding**

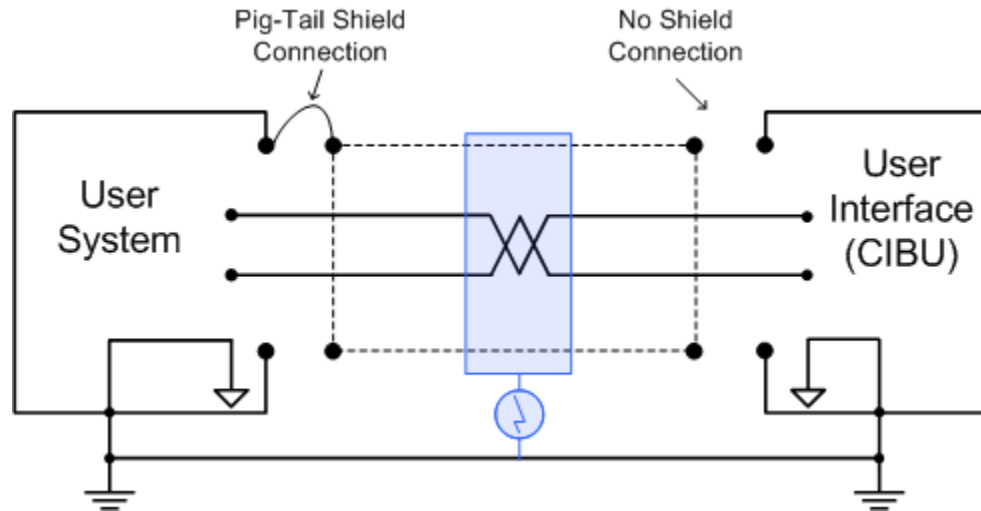
## Cable with One Pig-tail Shield No Grounds E.G. BLM System

### Glitches recorded in History Buffer

One Pig-tail, No Ground	Severity Level			
	0.5kV	1.0kV	2.0kV	4.0kV
User System Output	0.5kV	1.0kV	2.0kV	4.0kV
TRUE	A	B	B	C
FALSE	C	C	C	C

Permit FALSE on each salvo

Permit TRUE on each salvo

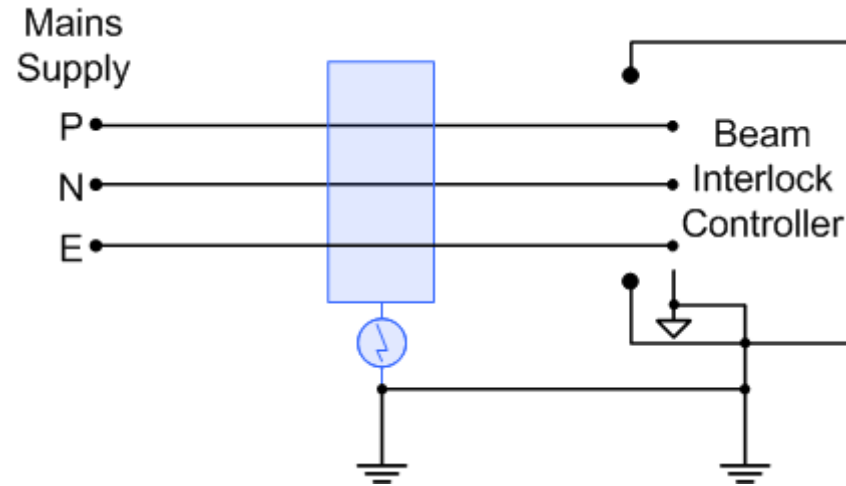
## VME PSU, Specified as “IEC-61000 Tested”

Severity Level			
	0.5kV	1.0kV	2.0kV	4.0kV
VME PSU	A	A	A	A

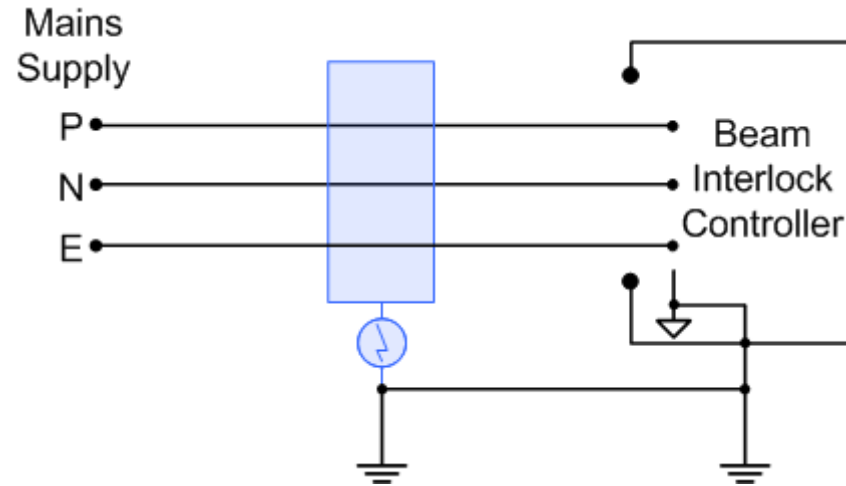
CIBU PSU (CIBD), Specified as “IEC-61000 1kV”

Supply has been double encased, and has mains filter

Severity Level			
	0.5kV	1.0kV	2.0kV	4.0kV
CIBU PSU	A	A	A	D

**Power PC Crashed – Ethernet Controller Stopped responding, SW Permit FALSE**
