# CIBU connection Review

BT, BP & IRR AB/CO/MI 12December 2008

## 1<sup>st</sup> presentation: CIBU Failure in UJ33 *(Benjamin TODD)*

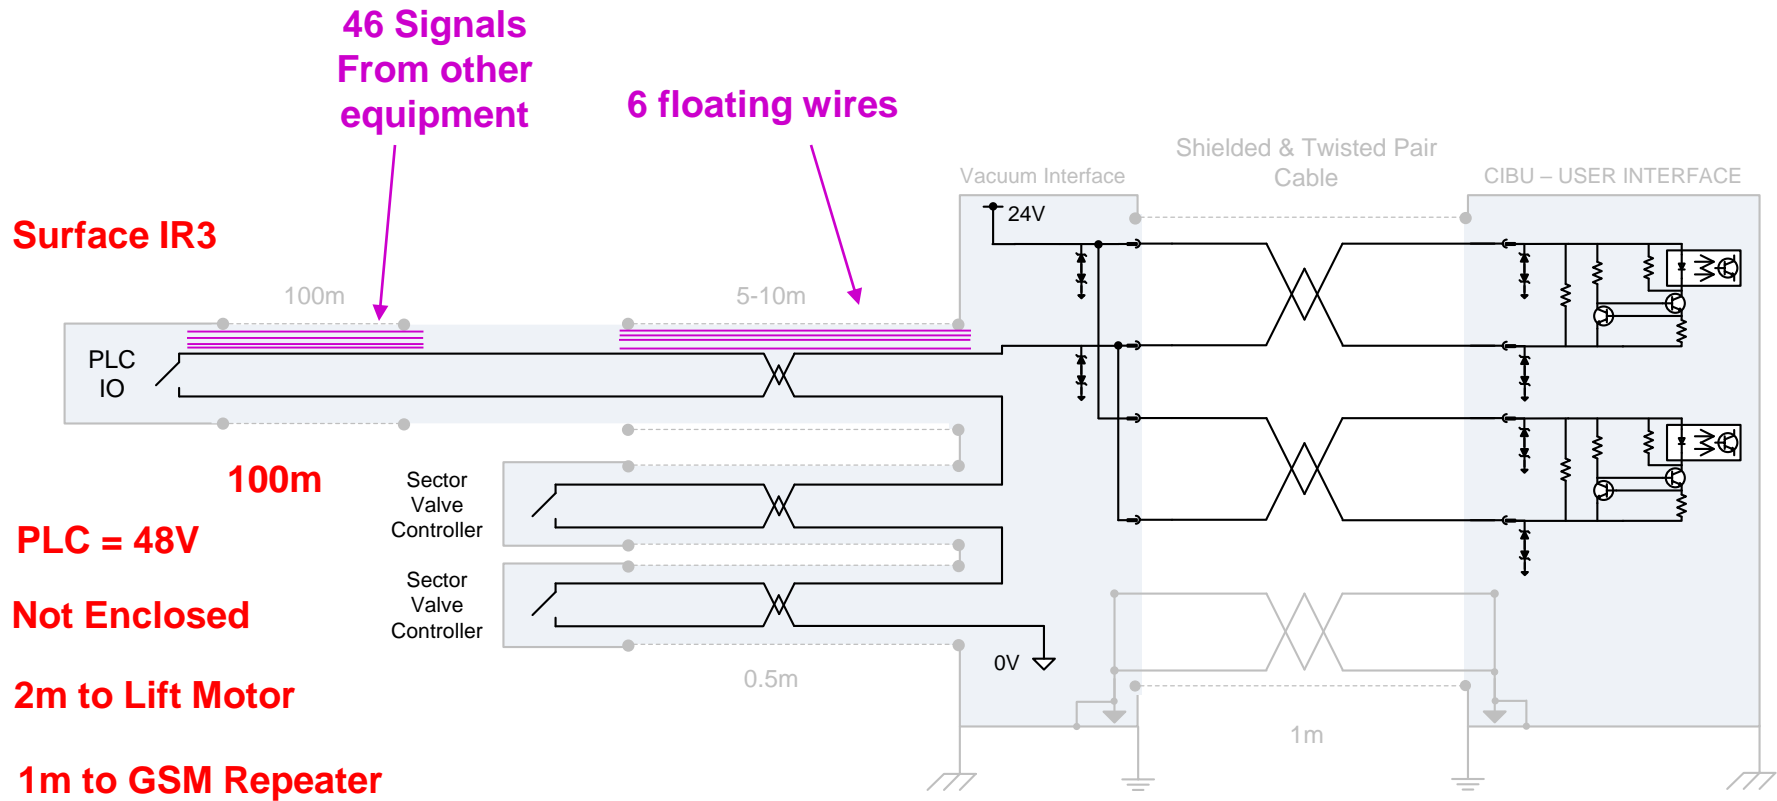
Surface IR3

6 floating wires

PLC = 48V

Not Enclosed

**WHEN CONNECTED  
CIBU ALWAYS TRUE  
(next slides)**

Access – Connected Panel to Surface PLC incorrectly initially  
...took several attempts ...

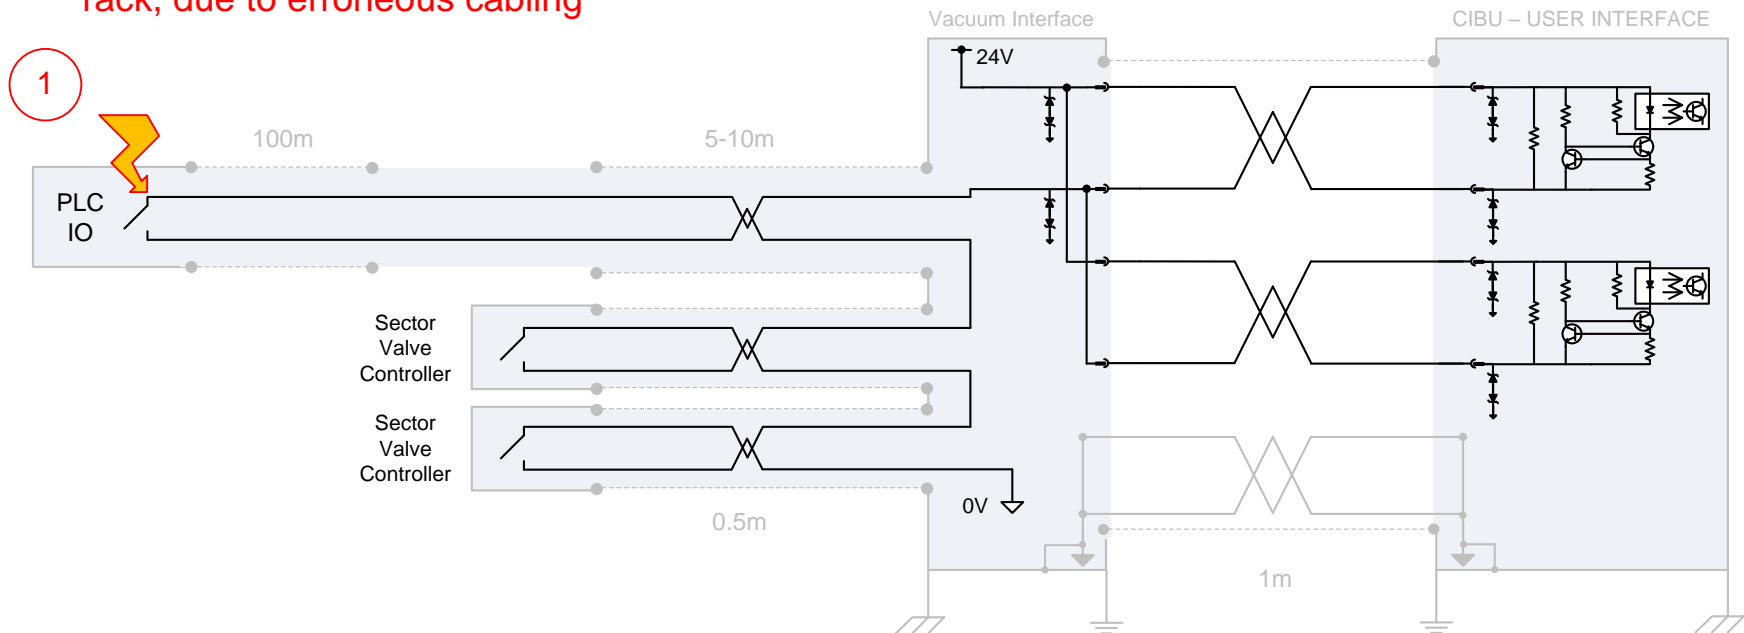
## Presumed Failure

### 1. Excessive Voltage

Is applied in the Access System PLC rack, due to erroneous cabling

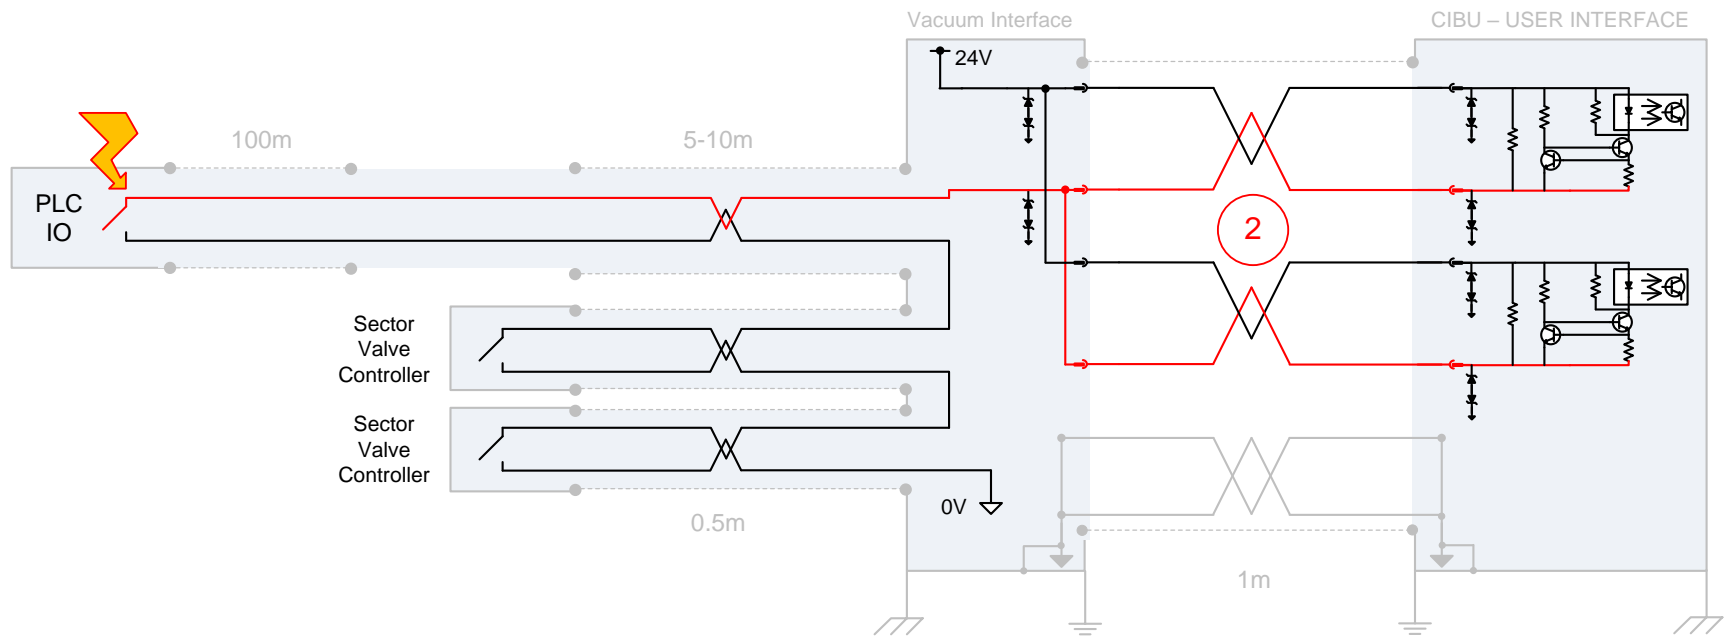
2. This subjects the CIBU negative current loop to an excessive voltage (48V)

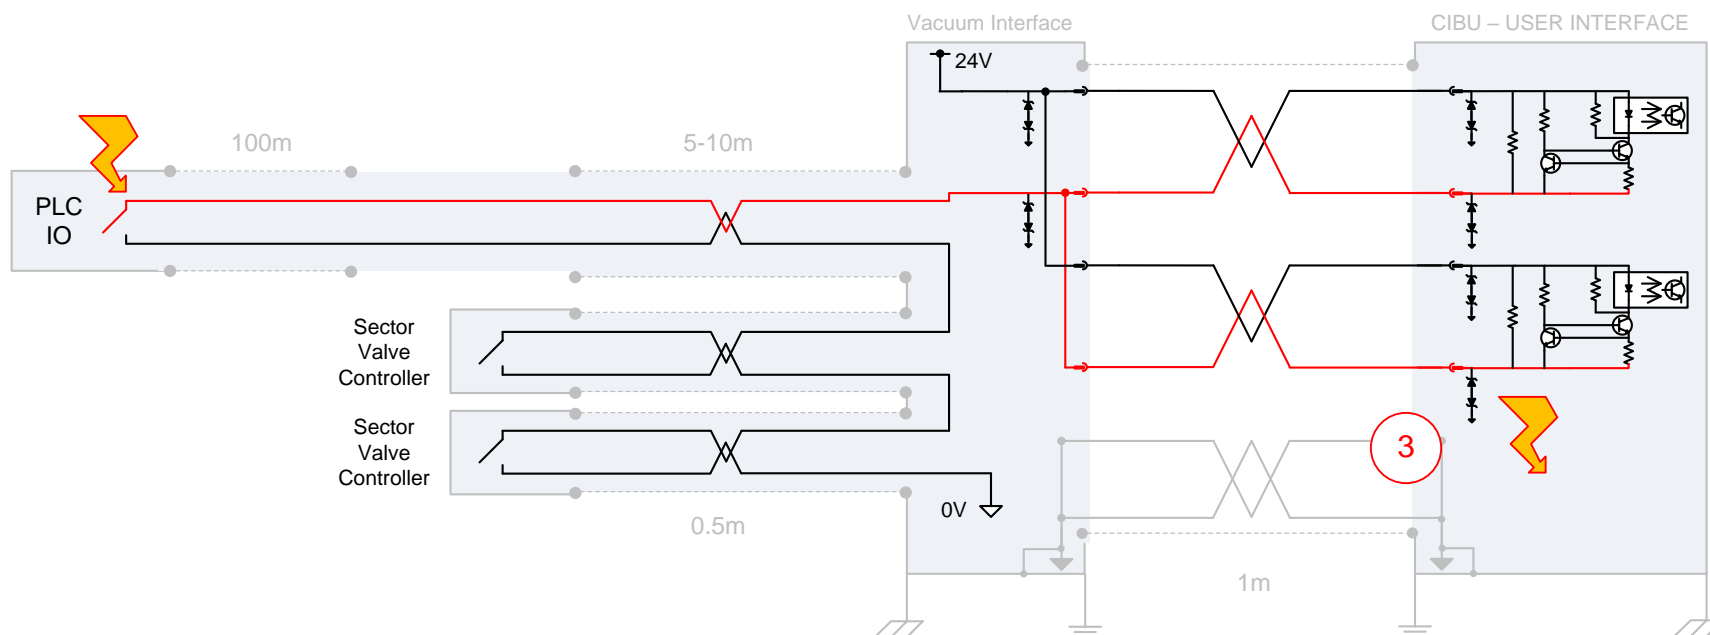
3. The Transient Voltage Suppressor (SM6T30CA) Clamps the voltage and dissipates the energy

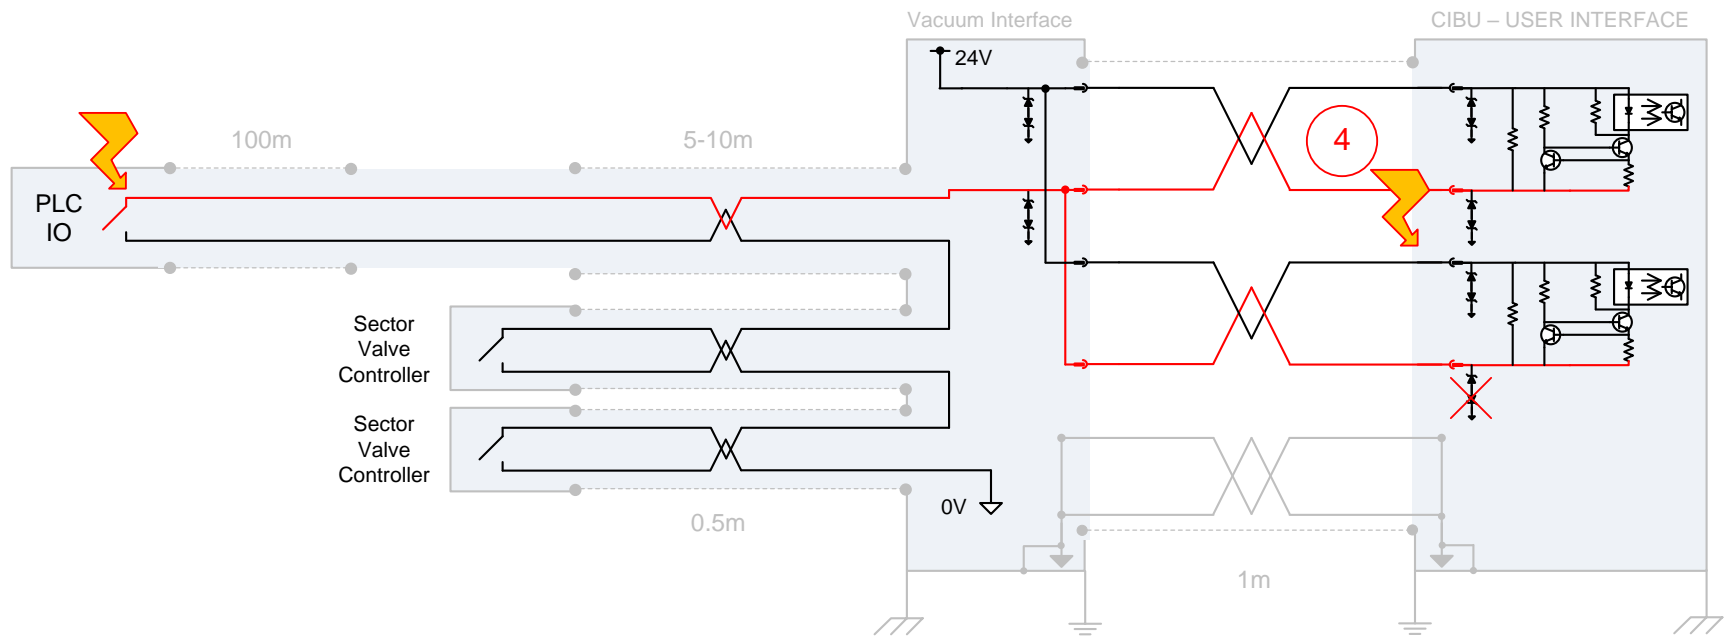
4. Experiments show that after 1-2 seconds the TVS will fail, this TVS fails open-circuit  
The 'A' loop TVS now absorbs the excess

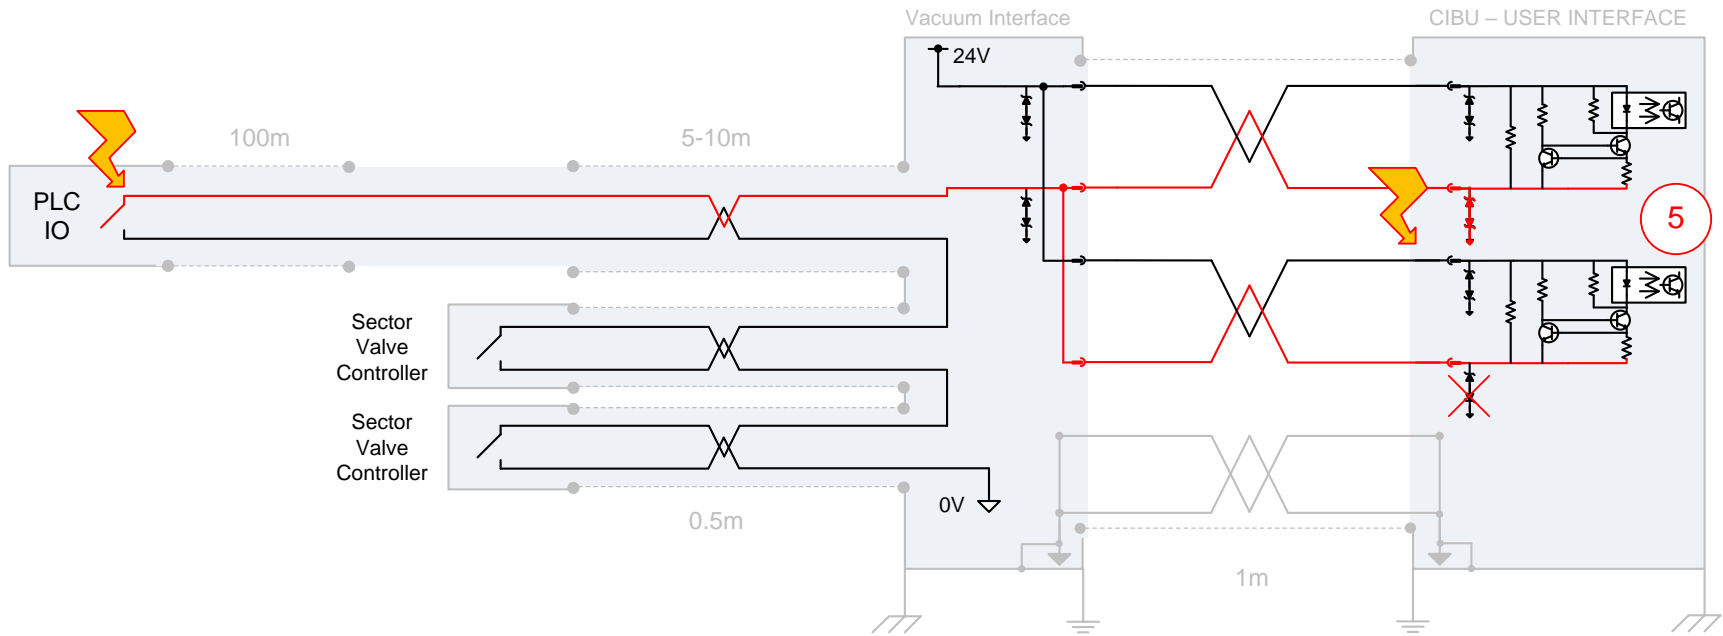
5. 1-2 seconds later this TVS fails short-circuit

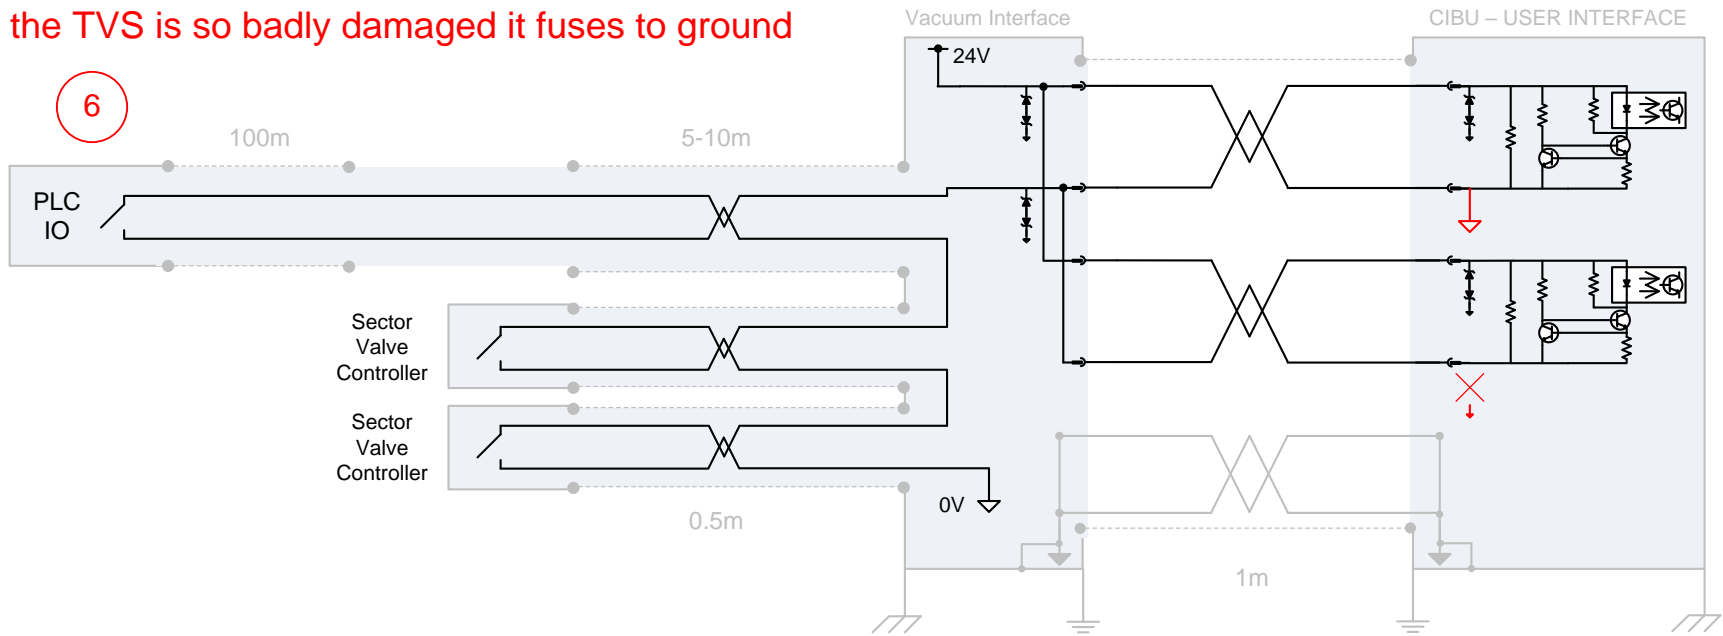
6. The fault is discovered in the ACCESS system and is removed

But the TVS is so badly damaged it fuses to ground

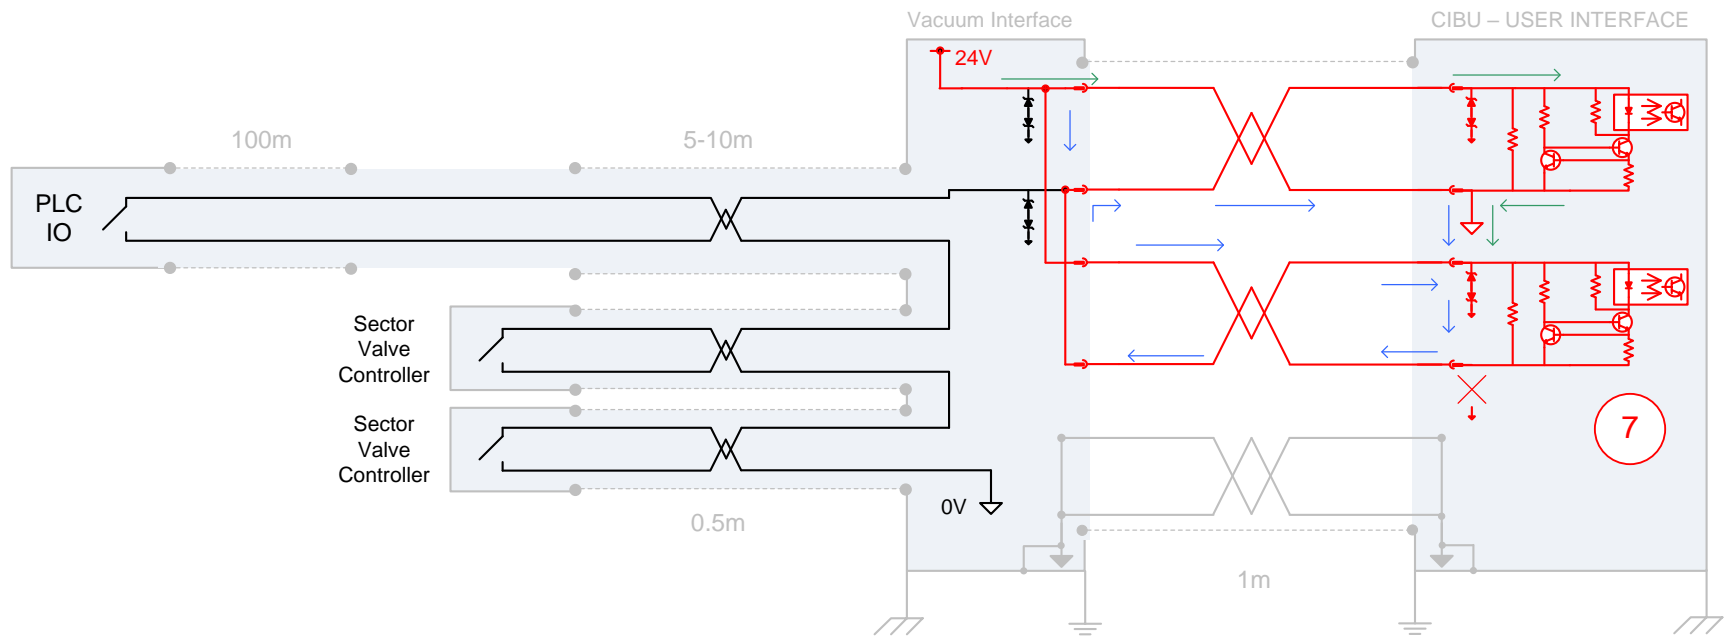
7. At this point both USER PERMIT A and B are stuck TRUE as current flows to ground through A (green) and B (blue) using the damaged TVS

## Several events = complete Blind Failure

1. Two Equipment systems sharing the same channel
2. PLC Voltage against rules
3. TVS Blocked Short-Circuit
4. Inputs were not redundant
5. Not re-commissioned by MI after a significant change

1. Change to use full redundancy
  2. Change so a GND fault doesn't fail blind
  3. Automated Test from User Side  $A \neq B$
- } 2<sup>nd</sup> presentation
- 3<sup>rd</sup> presentation

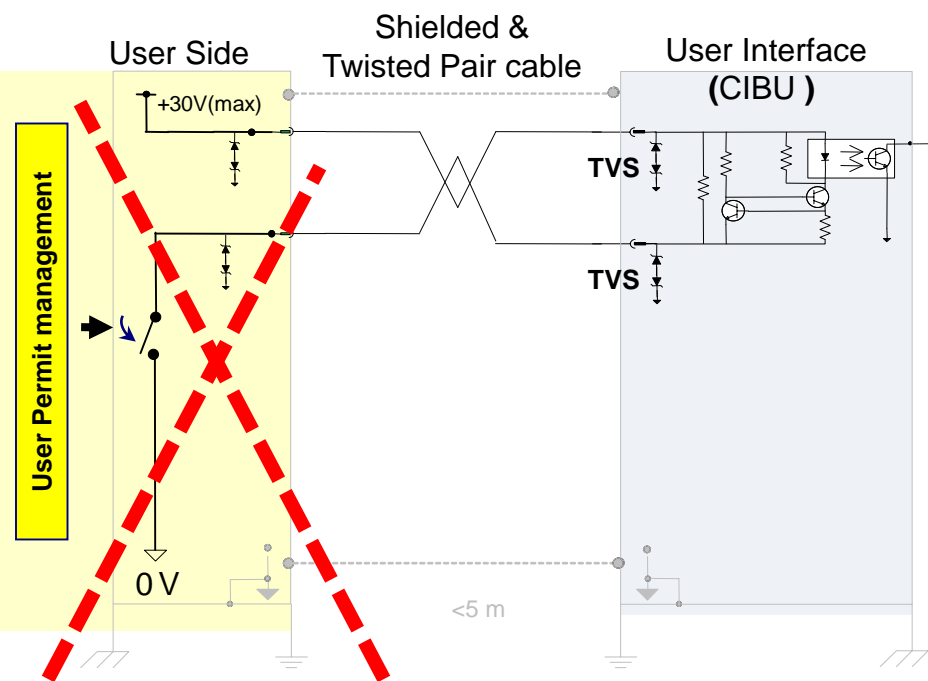
On User side, the connection should be modified in order to avoid a fail blind if GND short (i.e. a damaged TVS fuses to ground)

( Same for Input #B )

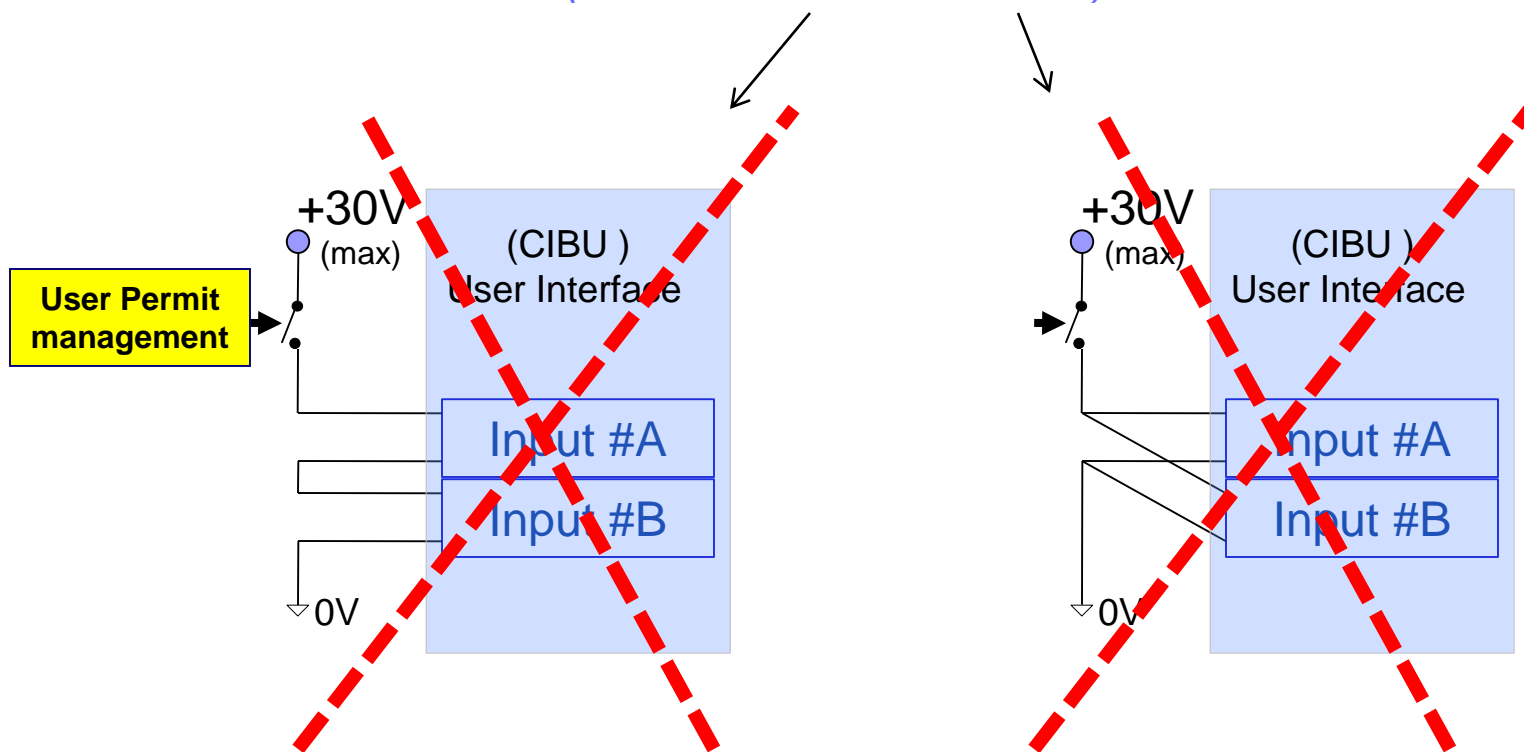
In order to avoid/minimize the single mode failure:  
 the two CIBU inputs should be no longer linked together  
*(neither in series nor in //)*

each User system has to provide two independent signals to the CIBU
