Summary on the LBDS triggering issues

E. Carlier
TE/ABT

MPP – 11/12/2009

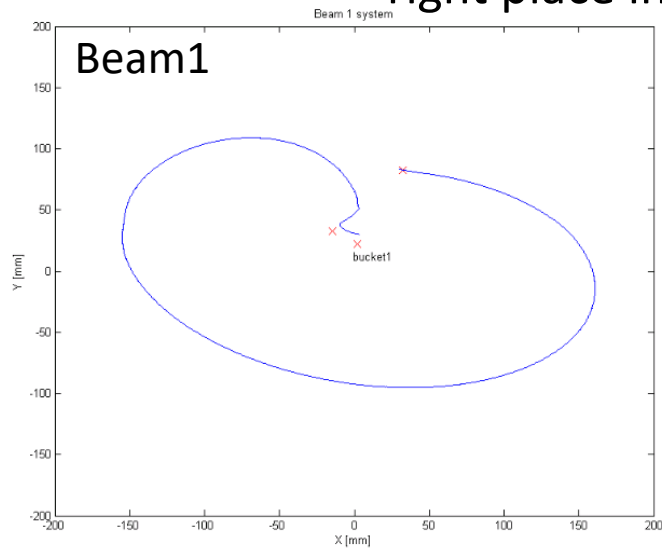
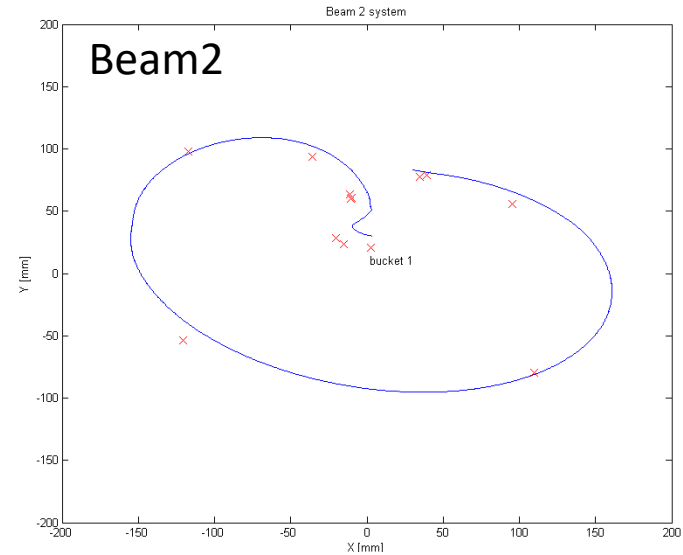
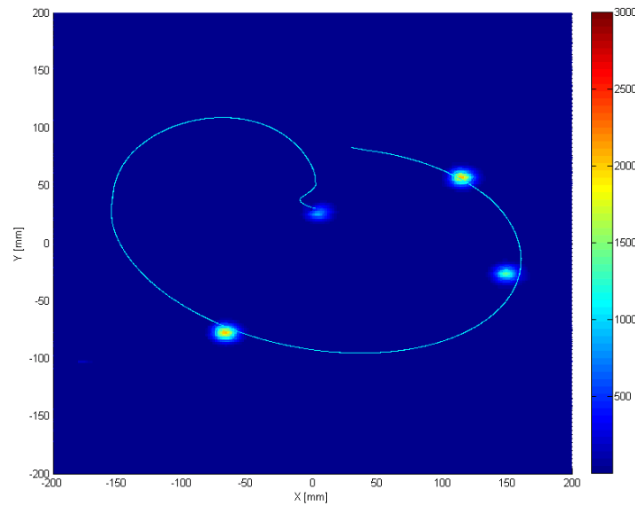
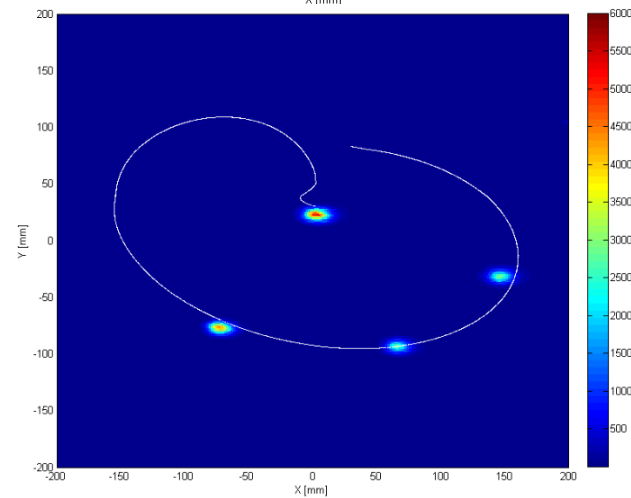
Adjusted, checked, stable and reproducible for B1 and B2 – bucket 1 now at the right place in the extraction sweep

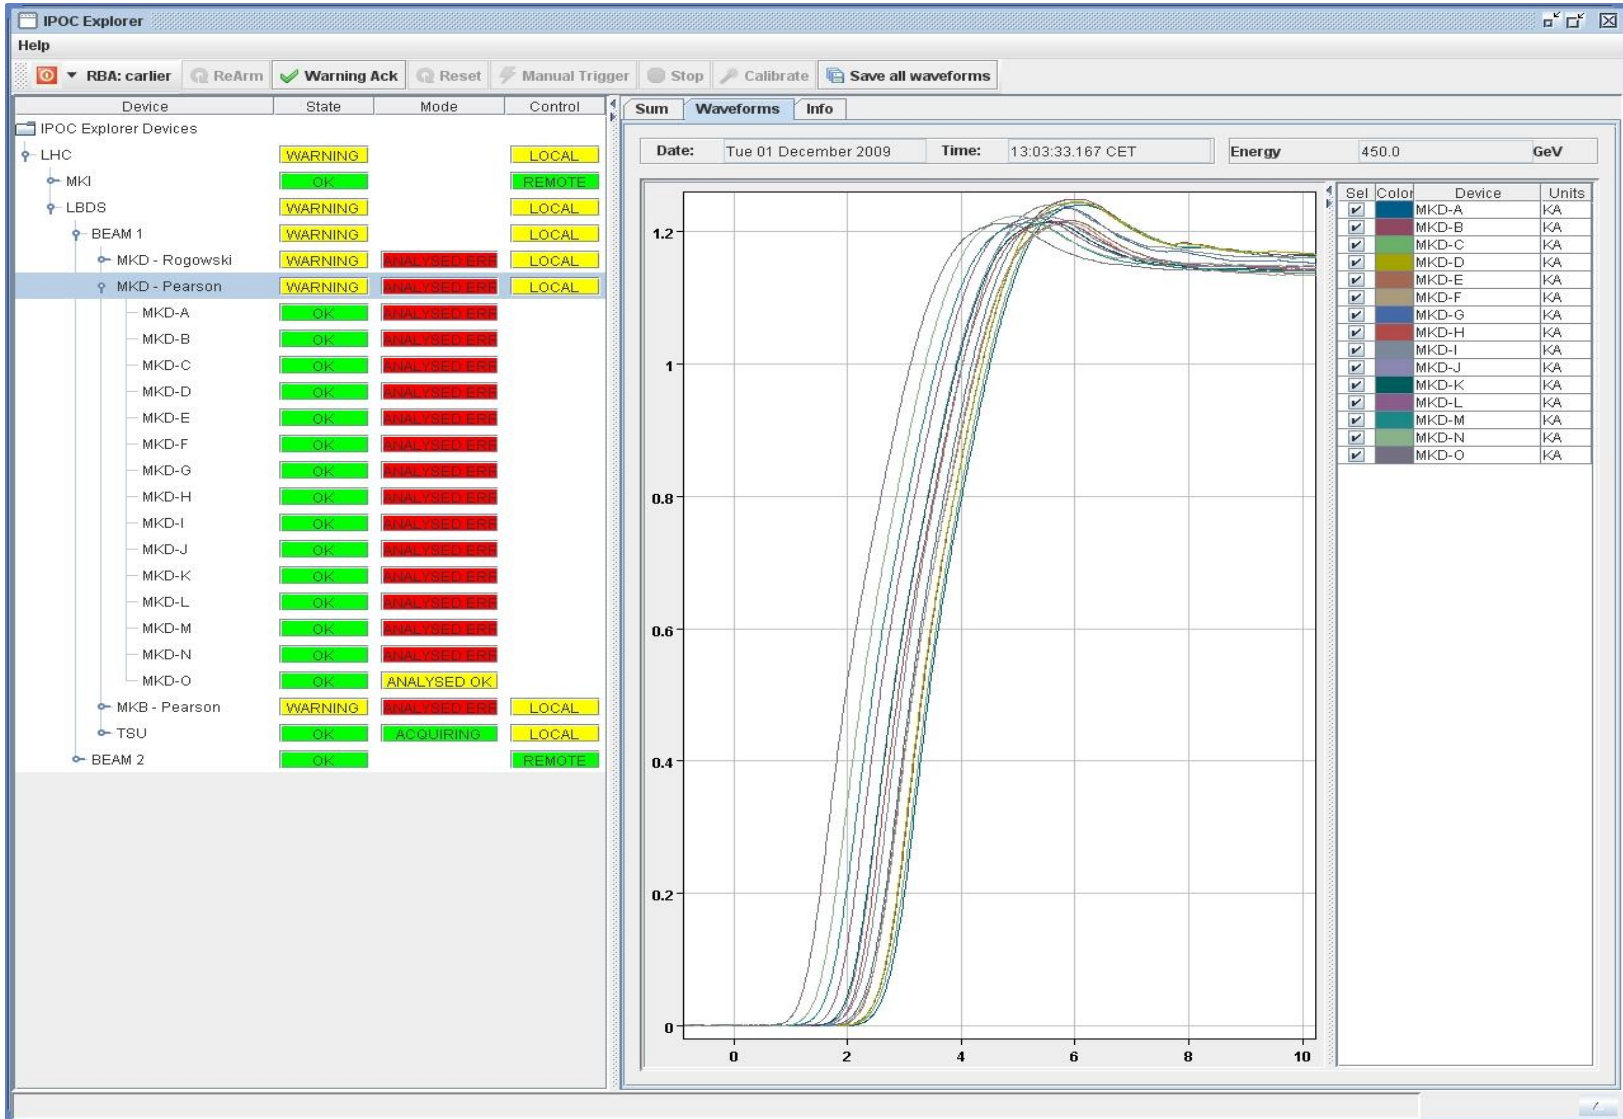
Asynchronous dump IPOC

- 2 events identified
- Only possible during execution of an arming sequence, if
 - All the clients are OK,
 - BIS frequencies properly generated, and
 - BRF is not present or unstable.
- IPOC & XPOC give ERRORS.
 - Expert action required for errors acknowledgement... Should not be necessary as the LBDS was not armed

F_{rev} presence and ADPLL locking now checked in sequencer before starting an arm sequence.

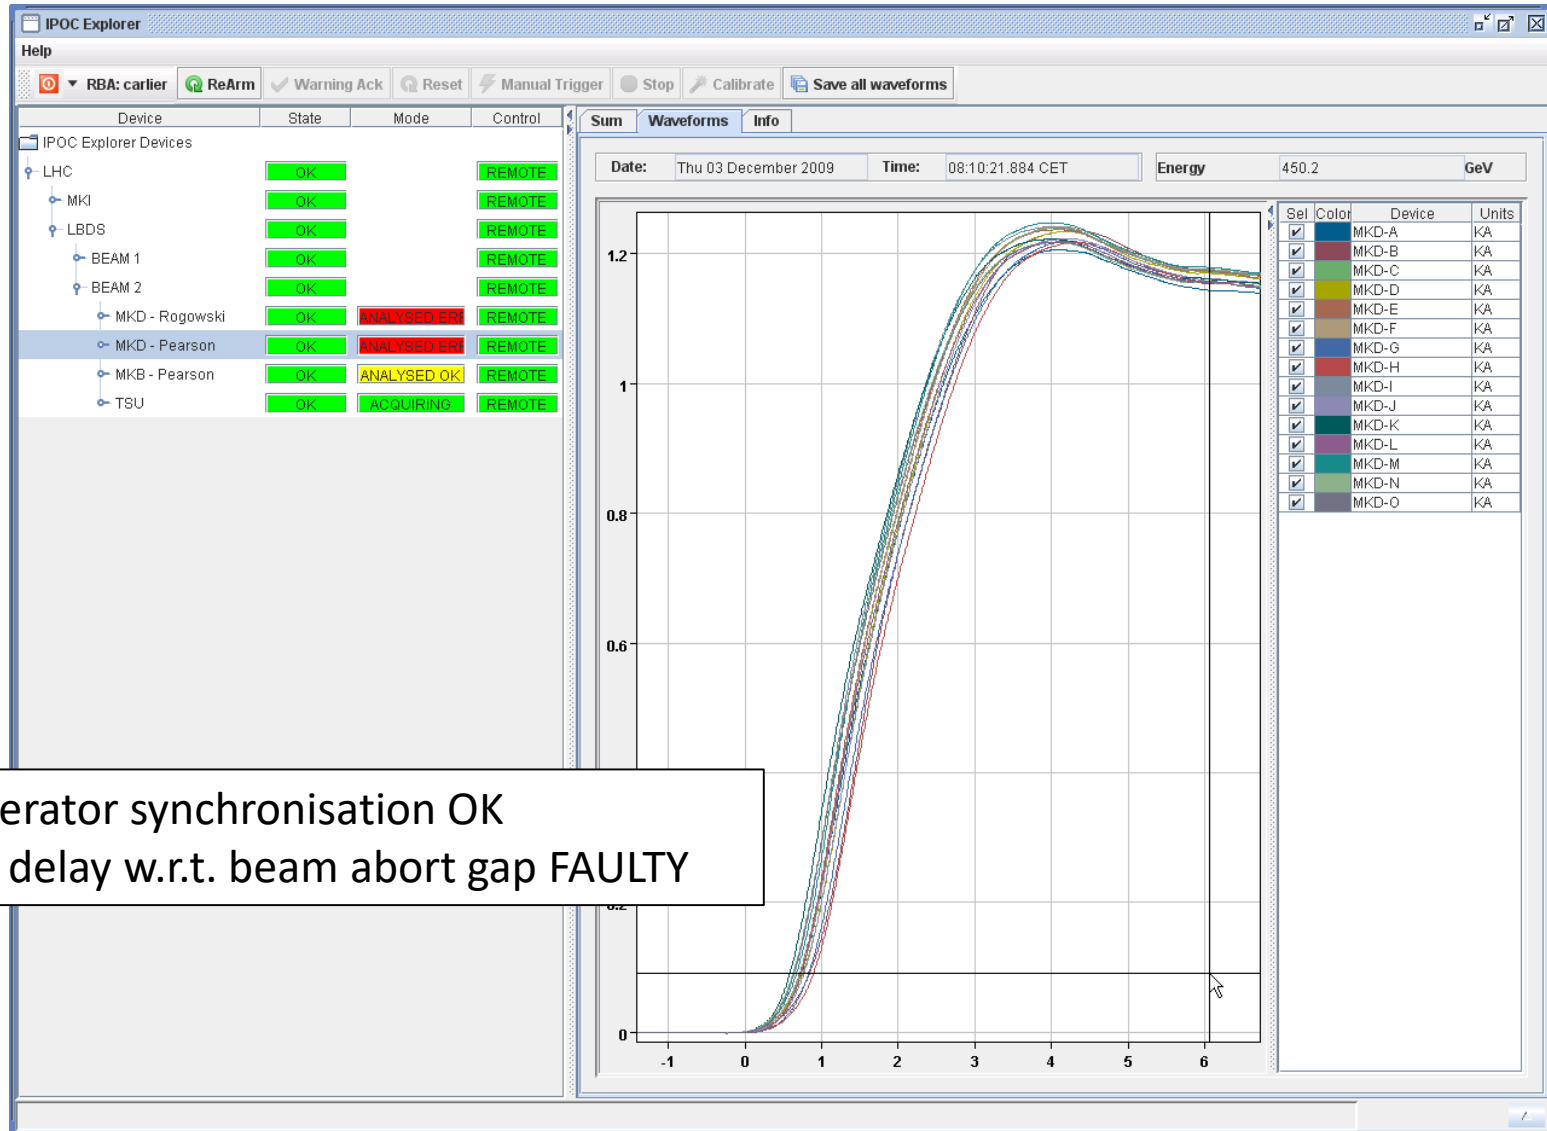
Asynchronous “Synchronised” Dump IPOC

- Dump request received during the $1.5\mu\text{s}$ F_{rev} pulse duration
 - Dump request inhibited for the current turn
 - Dump request executed at the next rising edge of the F_{rev} signal (turn+1)
- Original inhibition mechanism lets a “glitch” going out
 - Synchronous trigger of the 15 kicker generators
 - Asynchronous trigger w.r.t. the circulating beam
- IPOC triggered $\sim 600\text{ns}$ later by the signal coming from the Re-trigger lines
- Synchronisation fault detected by the IPOC and XPOC system
 - Expert action required for errors acknowledgement

- Generator synchronisation OK
- Kick delay w.r.t. beam abort gap FAULTY

TSU firmware upgraded and successfully tested
