Asynchronous dump @ 450GeV 19/11/2010

C.Bracco, E.Carlier, B.Goddard, J.Uythoven

Real Asynchronous dump

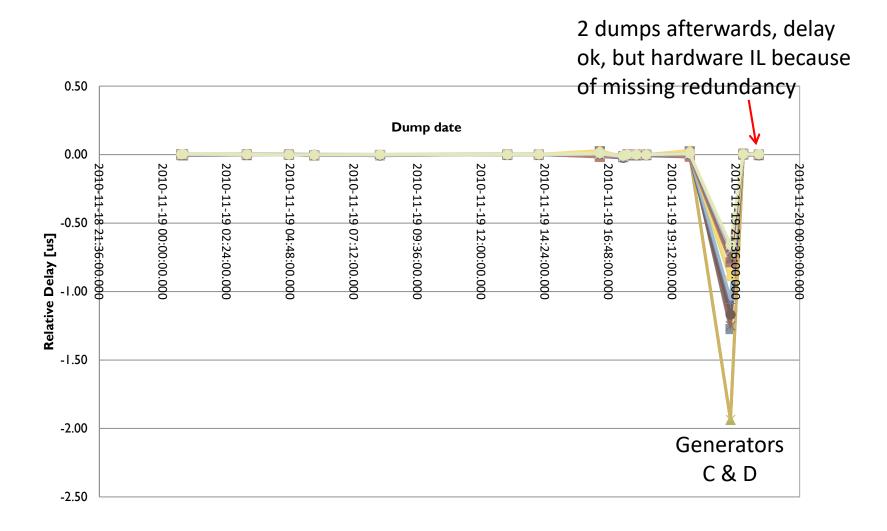
Relative delays of 15 kickers

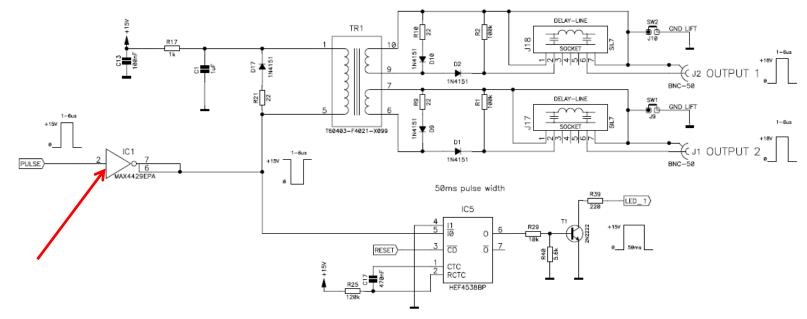
Failure Source

Failure of a MAX4429EPA driver (single power driver) in one TFOT module

- Dual secondary transformer used in TFOT in order to guarantee the triggering of both PTUs of one generator (kick rising edge and synchronization issues)
- MAX4429EPA is oversized for its use in this application (voltage & Current)

- MAX driver breaks... probably initially to short-circuit and finally to open-circuit.
- Power pre-loaded in blocking capacitor discharges in the primary winding of the pulse transformer and generates glitches at the secondary outputs.
- PTU1 of generators C & D triggered on reception of the "trigger" glitches
- Generators C & D pulsed asynchronously with beam on reception of the PTU pulses
- Re-trigger signals sent from the pulsed generators to other generators
- Remaining generators pulsed
- Asynchronous pulse recorded by IPOC
- Asynchronous pulse recorded by XPOC
- Bad trigger signals detected by PTU monitoring system because glitches were smaller than nominal trigger pulse length
- Generators in fault status

- Validation dumps performed after the asynchronous dump where correctly synchronized (no IPOC error)
- Acknowledge still requested due to missing trigger pulses on "PTU1- Trig IN1" for generator C & D (faulty driver circuit)
- 2 options
 - Mask the interlock channels (redundancy exist)
 - Repair the fault (access needed)
- Decided to make an access in UA63 to properly repair the fault
- Trigger signal switched to spare outputs of TFO system (same cabling logic)
- System pulsed in local to validate the intervention
- Faulty TFOT still in the machine
- Procedures for re-commissioning of the system after this type of intervention are missing but the right actions were taken

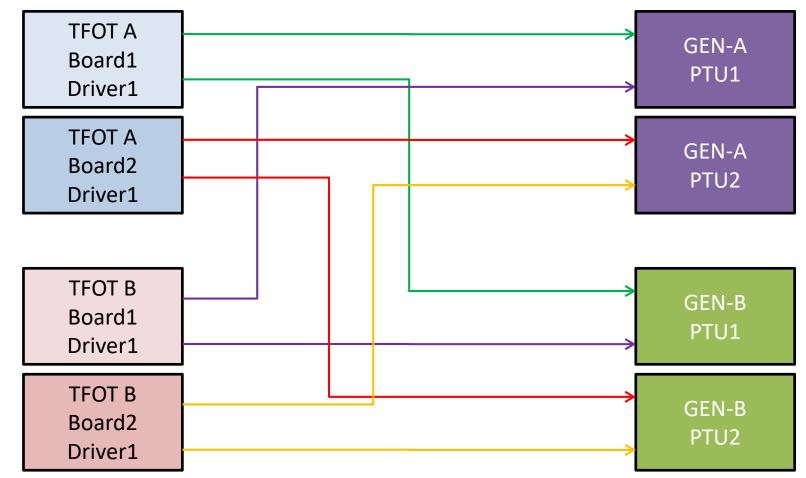
Actual cabling

- 1 out of 4 trigger signal missing in 2 generator in case of failure (missing) of 1 driver circuit
- 2 generators pulsed in case of faulty trigger pulse at driver output

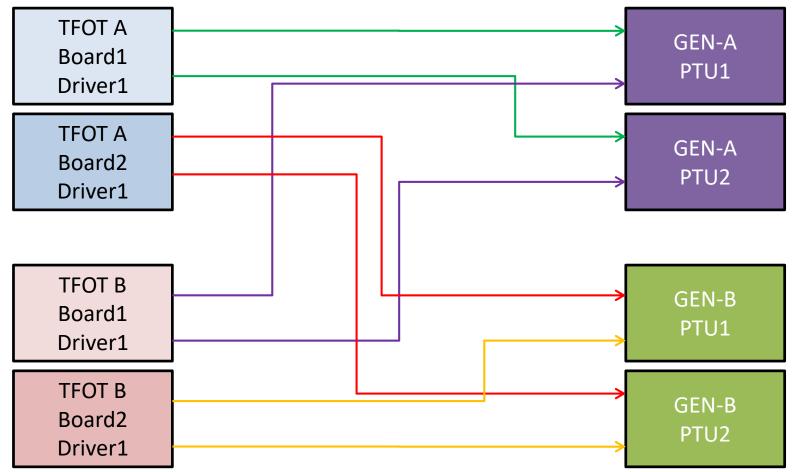
Initial cabling

- 2 out of 4 trigger signals missing in 1 generator in case of failure (missing) of 1 driver circuit
- 1 single generator pulsed in case of faulty trigger pulse at driver output
