# **ALICE BCM & Subdetectors**

## **Observations during kicker failure**

**Mateusz Lechman**

5/8/2011

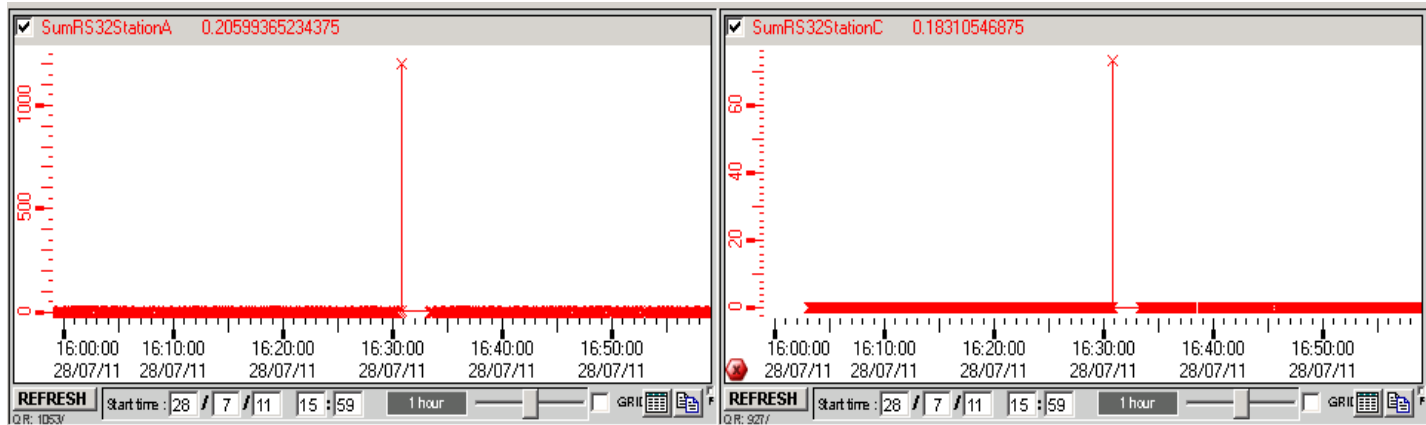
□ 16:30

- ❑ The values of the threshold for the beam background were exceeded:
  - 16:30 - 80 times (the RS1 and RS2 conditions on station A)

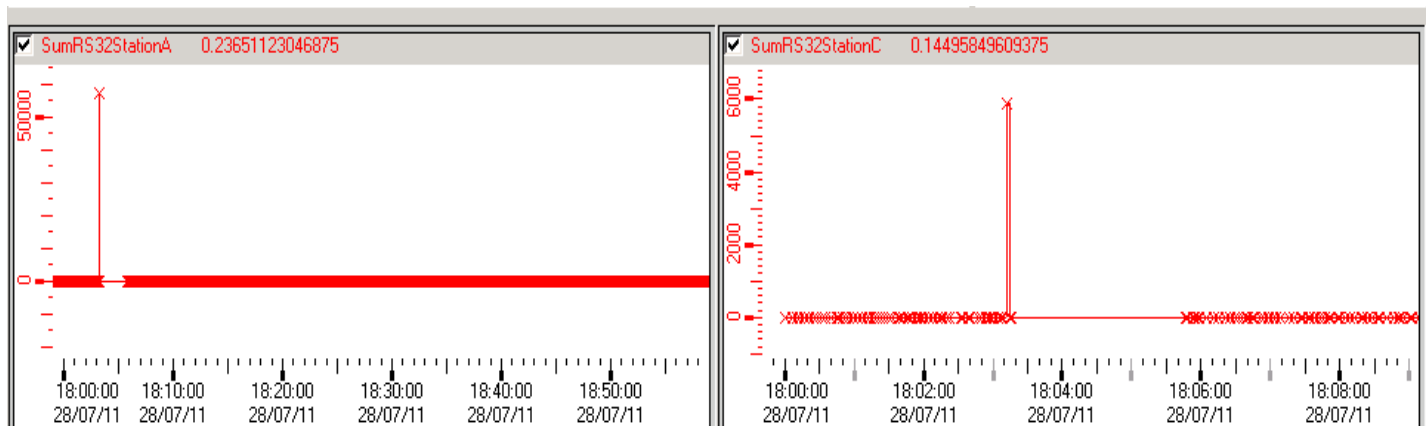
□ 18:03

- 18:03 - 3559 times (the RS32Sum condition on station A)

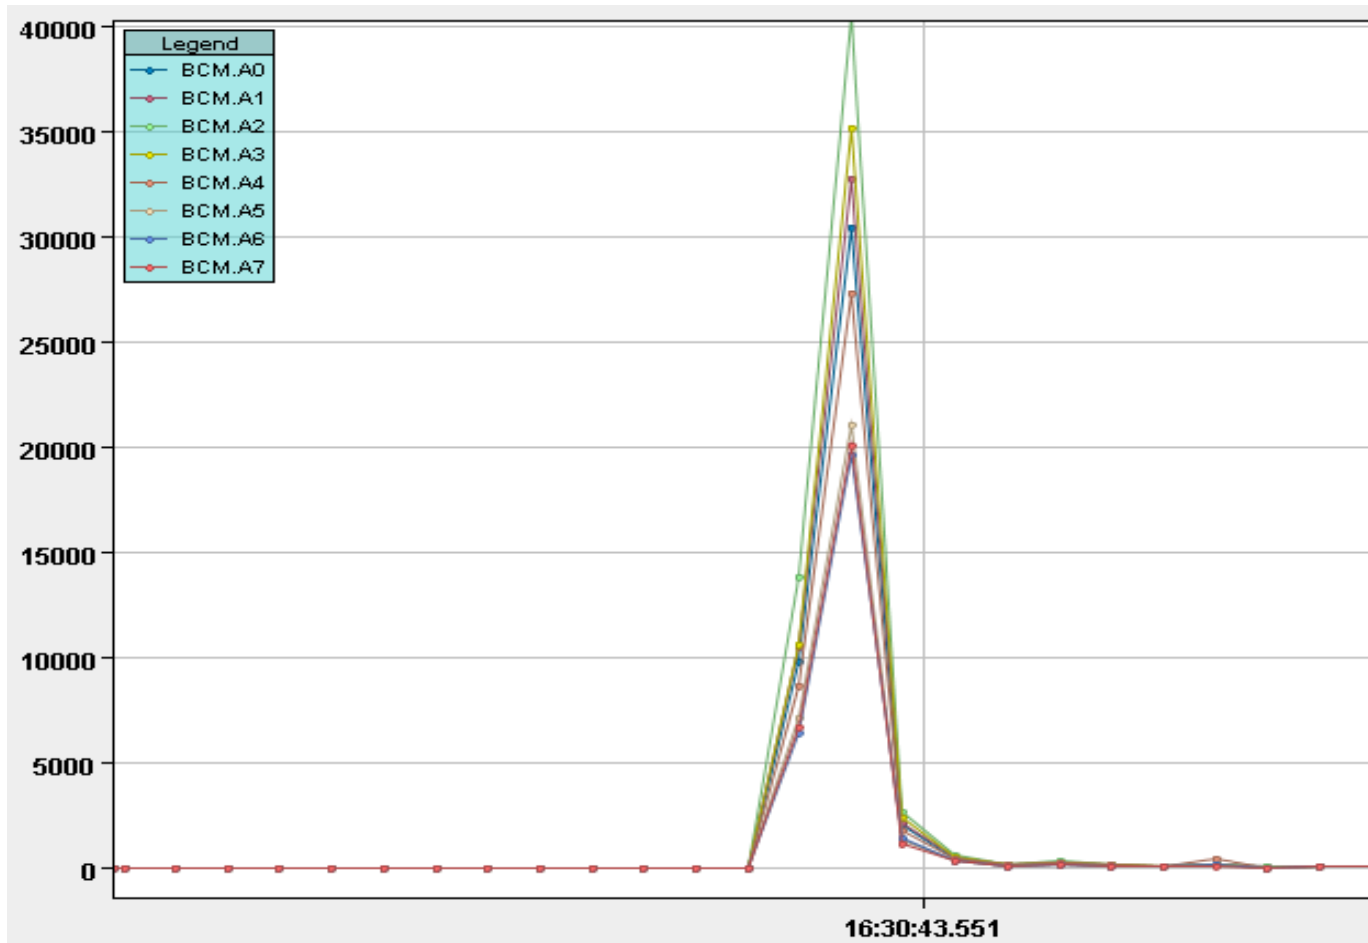
# PM Report - 16:30 – station A

RS1, sampling 40 microseconds
