SEU Risk Analysis of the LHC Collimators low level control rack in UJ14,UJ16,UJ56

A. Masi

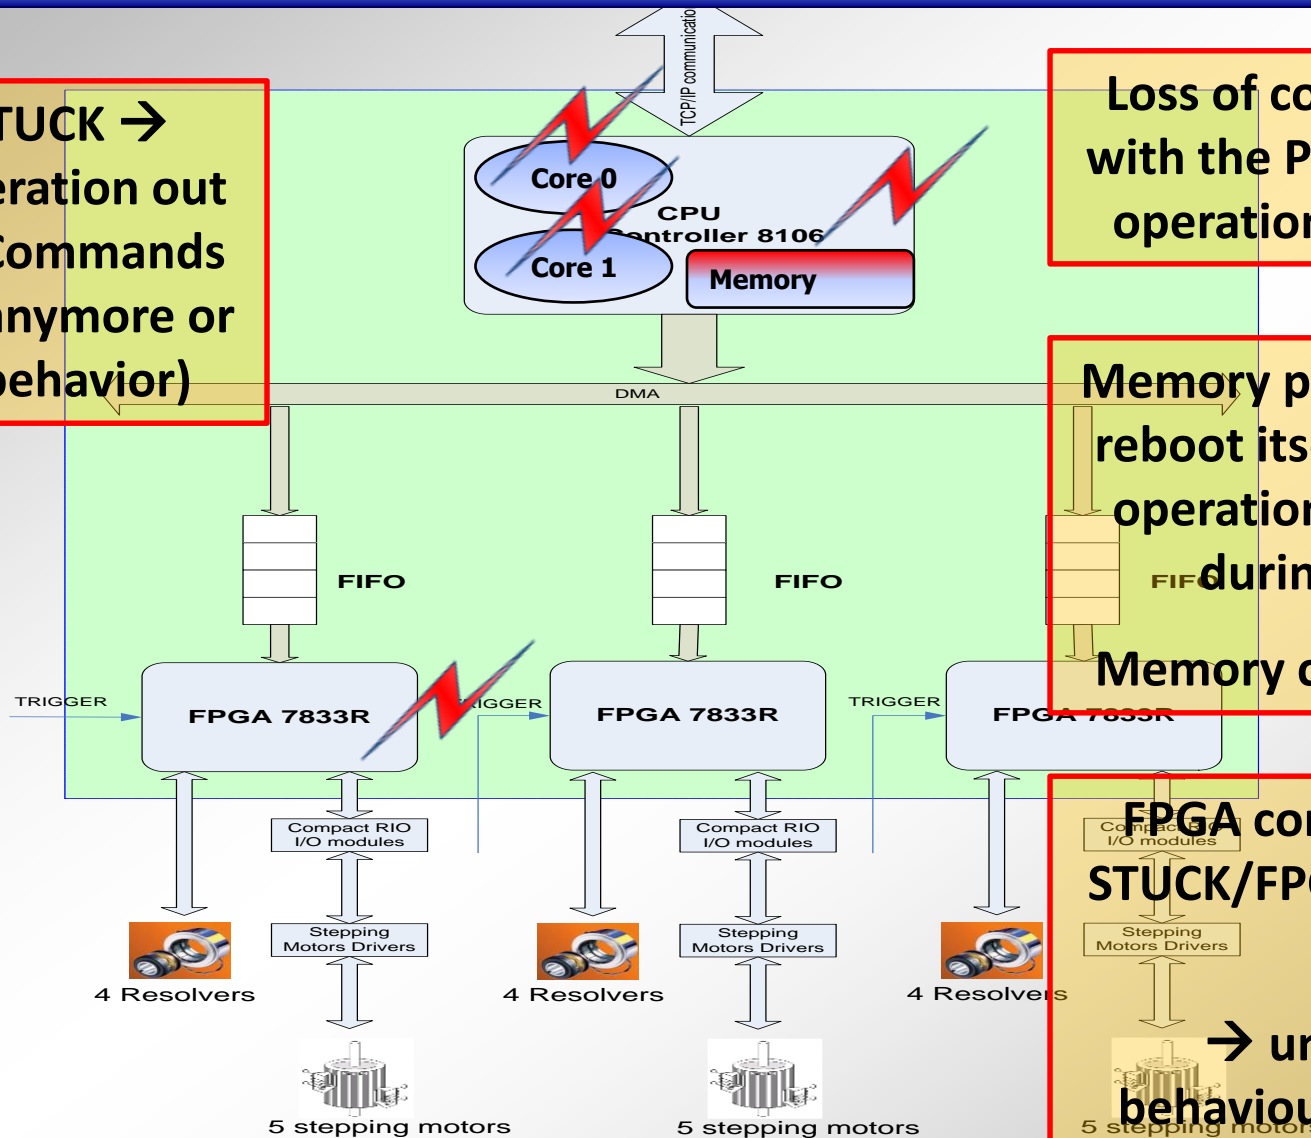
4-SEU effects on the MDC

CPU Core STUCK → collimator operation out of order (i.e. Commands not accepted anymore or anomalous behavior)

Loss of communication with the PXI- Collimators operation out of order

Memory page fault → PXI reboot itself (Collimator operation out of order during reboot)

Memory cells corrupted

FPGA communication STUCK/FPGA bit stuck or flip

→ unexpected behaviour/ collimator operation out of order

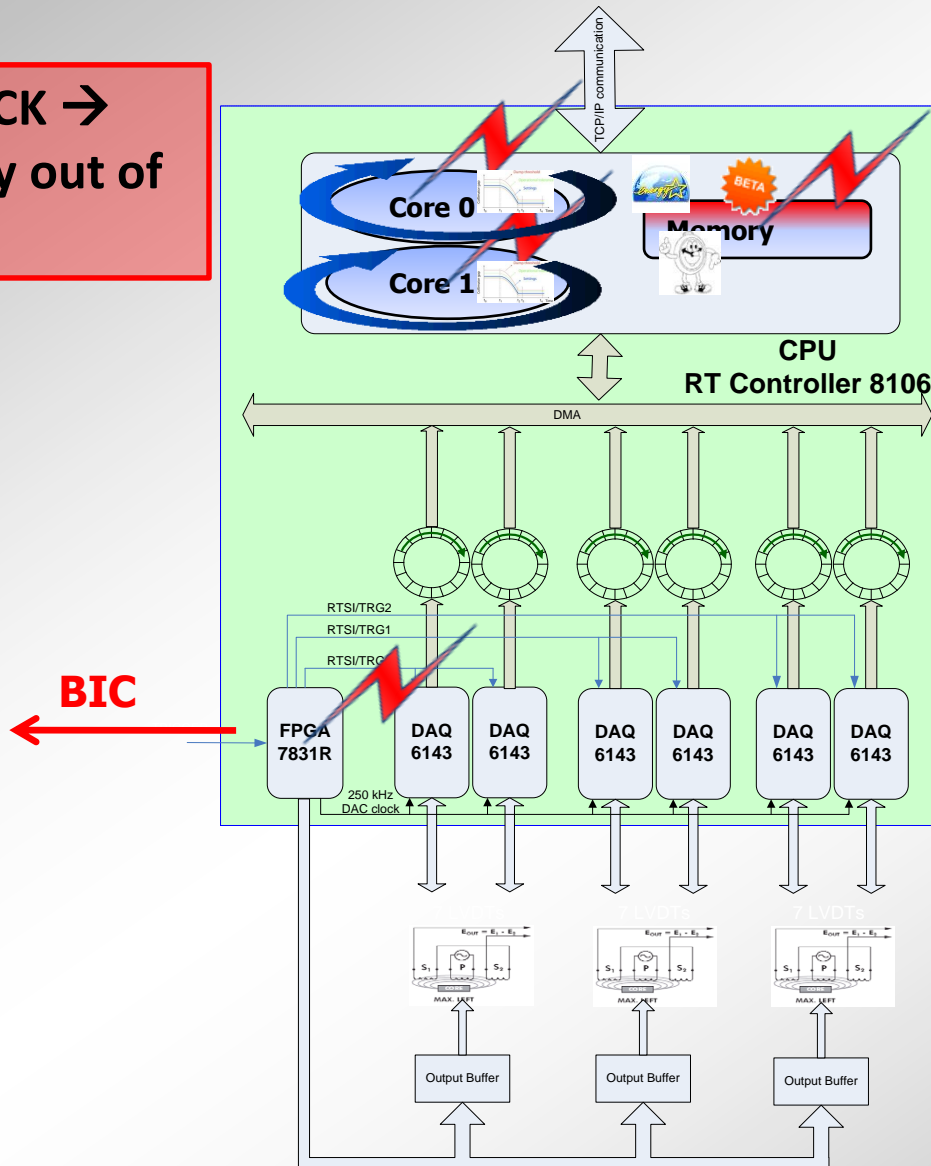
4-The worst case (PRS): SEU Critical effect for the machine safety

CPU Core STUCK →
collimator survey out of
order

Loss of communication
with the PXI → PXI
reboot itself (false dump)
collimator survey still
working

Memory value
corrupted → The limit
values are redundant (6
lvdts, Beta* and energy
limits)

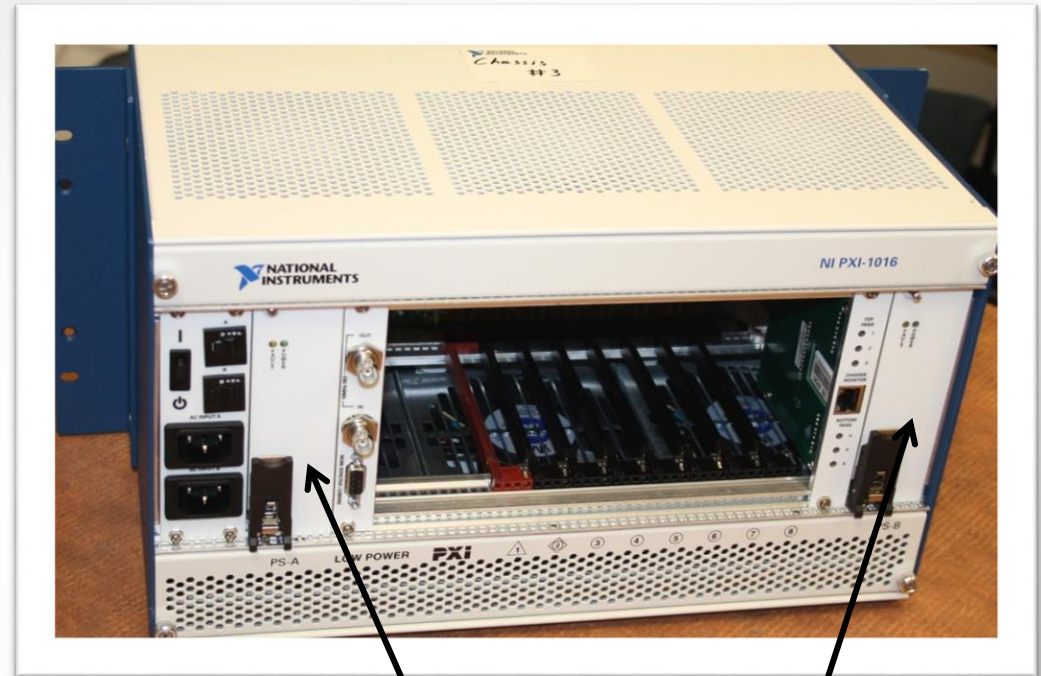
Two prototypes of the new PXI chassis successfully tested in a lab collimator rack

The 12 PXI chassis in the sensitive area will be likely replaced with new High Reliability PXI chassis during next Xmas break

Two redundant hot swappable power supplies and 6 redundant fans

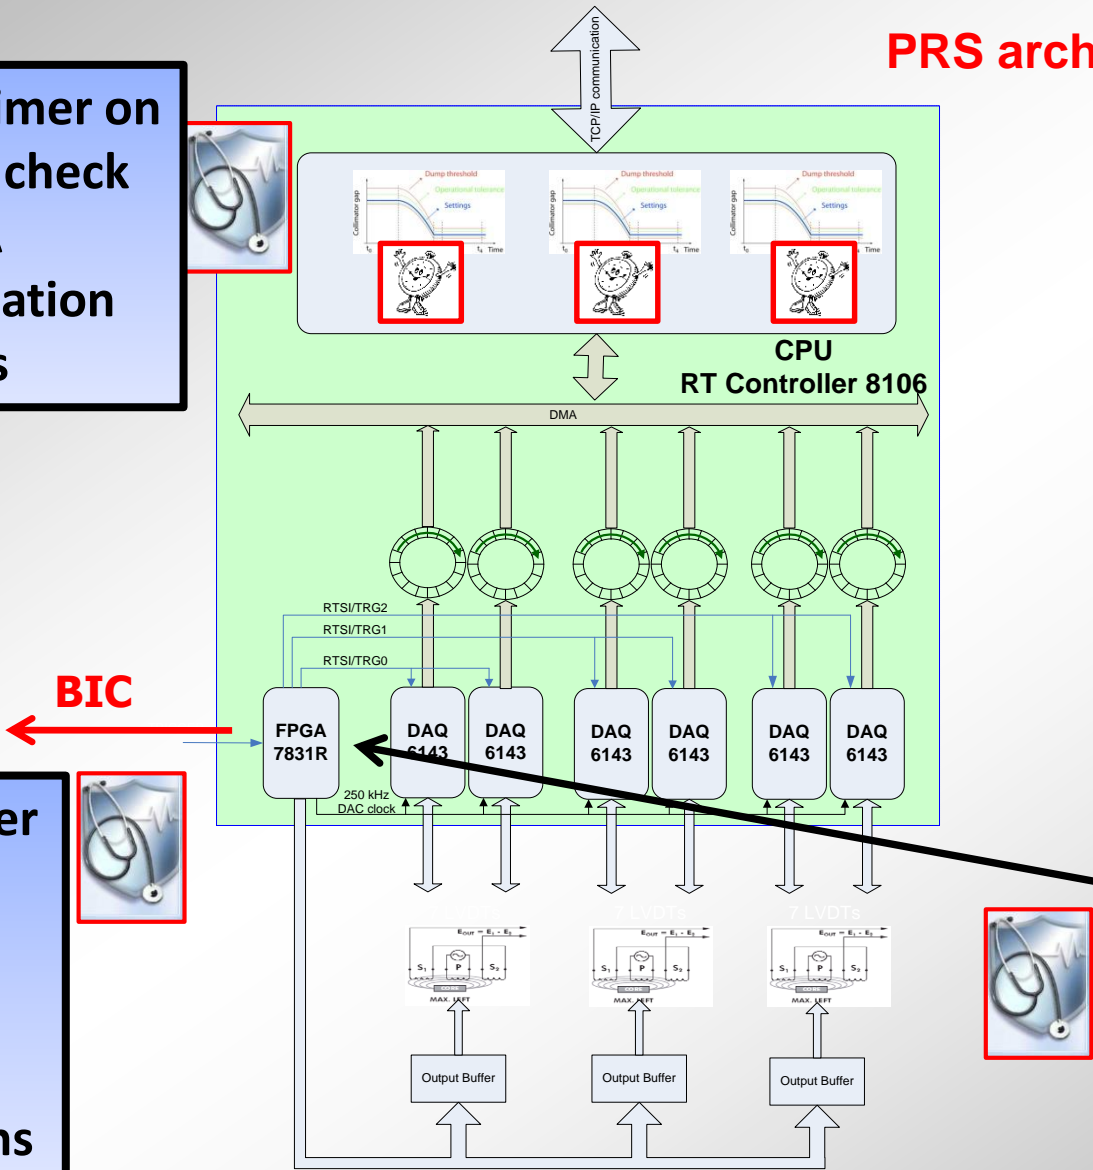
PRS architecture

- ✓ The probability of experiencing on the same system at the same time a CPU and FPGA stuck is negligible....
- ✓ On the PRS system if the CPU is stuck the collimator positions survey is compromised
- ✓ On the PRS system if the FPGA is stuck or affected by errors the beam dump functionality can be compromised

Watch dog timer on the CPU to check FPGA communication status

Watch dog timer on FPGA to verify CPU activity and survey loops stuck conditions

Implementing the TMR (Triple Modular Redundancy) on the interlock logic on the FPGA

- ✓ The CPU watch dog timer on the PRS FPGA should be able to trigger an interlock
- ✓ A Software Interlock can be added at the FESA level on the PRS FPGA stuck error and communication time out

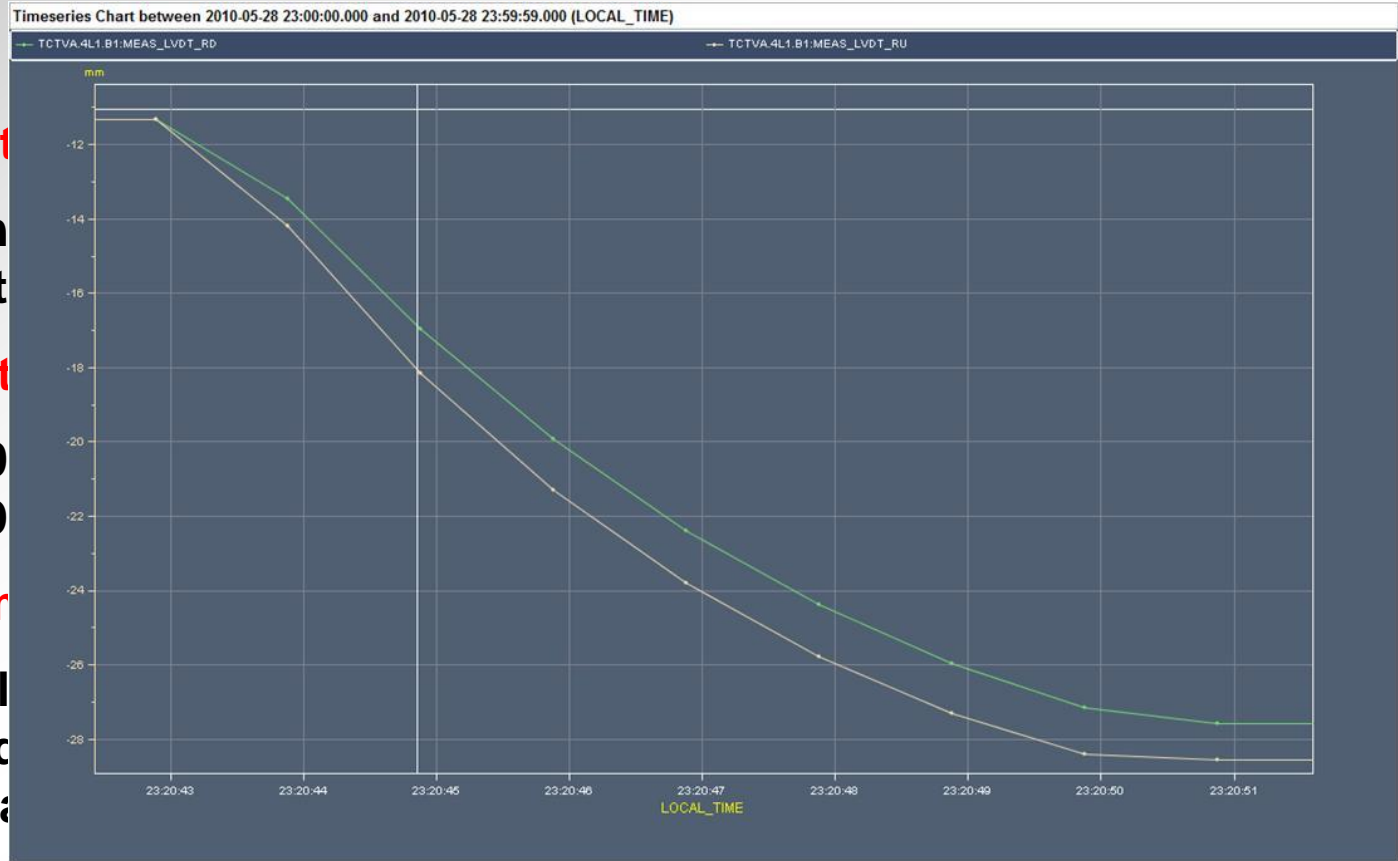
TCTVA.4L1.B1 autoretraction following the power cut on 28-05-2010

$V_{max} = 4 \text{ mm/s}$

$T_{CPU}, T_{svycolli1}, T_{svycolli2}, T_{svycolli3} = 30 \text{ ms}$
