Observations and conclusions
after TDI issue in IP8
Scrubbing Run: TDI, MKI and MKE interlocks

ABT/BTP

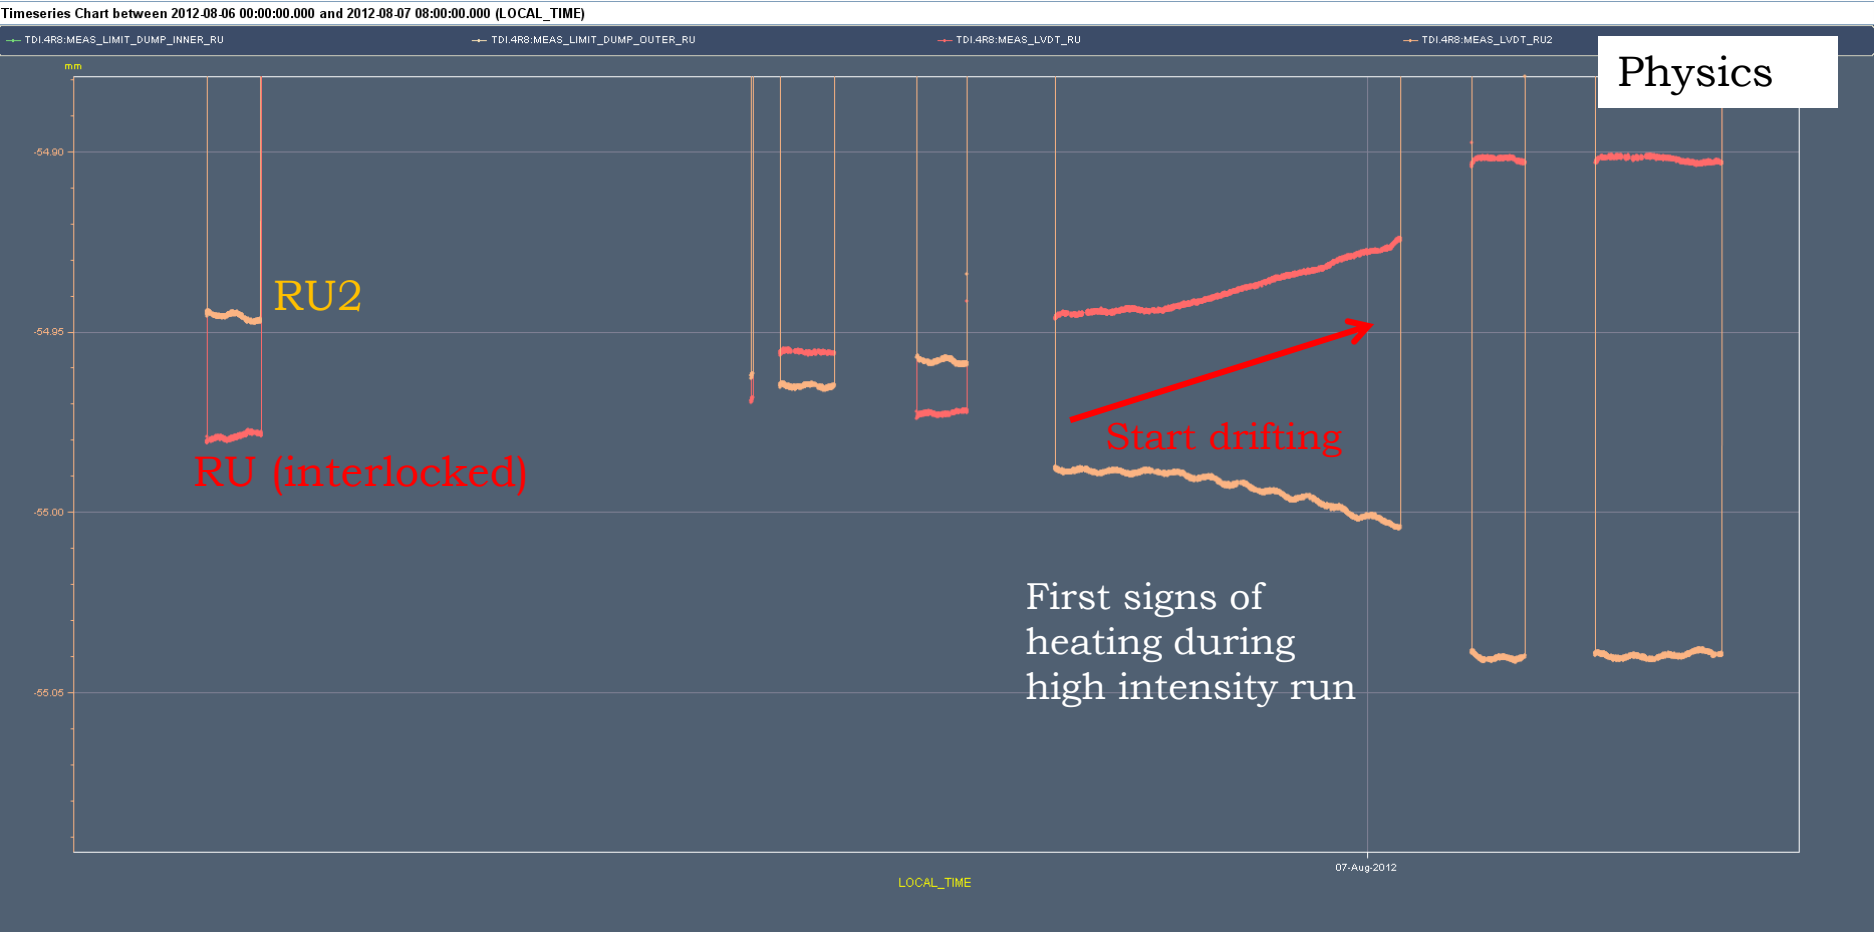
TDI Heating

- ▶ Sign of heating inducing LVDT drifts observed when moving to high bunch intensity → elastic deformation
- ▶ Scrubbing run:
 - ▶ TDI retracted to parking if > 15 minutes without injections

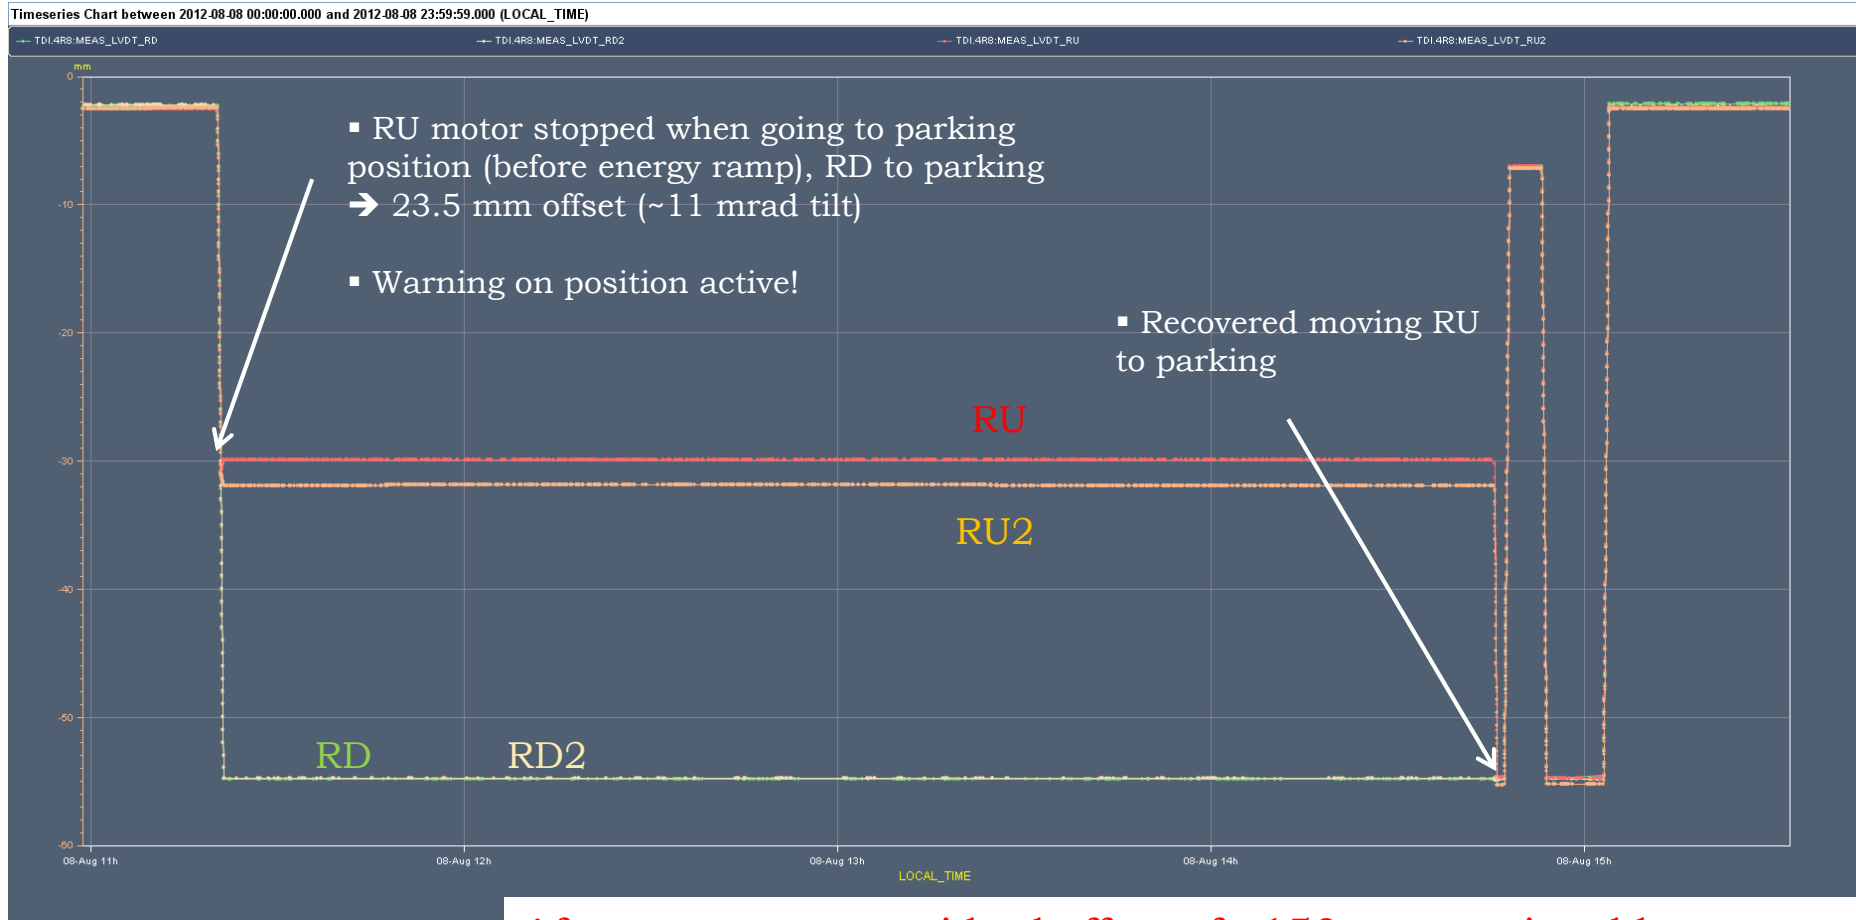
TDI Issue 08/08/2012

After recovery, a residual offset of ~150 μm persisted between **RD LVDT** and **Resolver** at injection position → deformation!

- ▶ **Not found any mechanical problem** → not clear correlation with TDI heating
- ▶ Most likely candidate: **spurious glitch** on the RU end-switch → switch active → motor stopped

- ▶ The **control module** (rack in service tunnel) of the switch was **exchanged** (09/08/2012) → the problem did not appear any more
- ▶ New task in the sequencer: **TDI position check before ramp.**

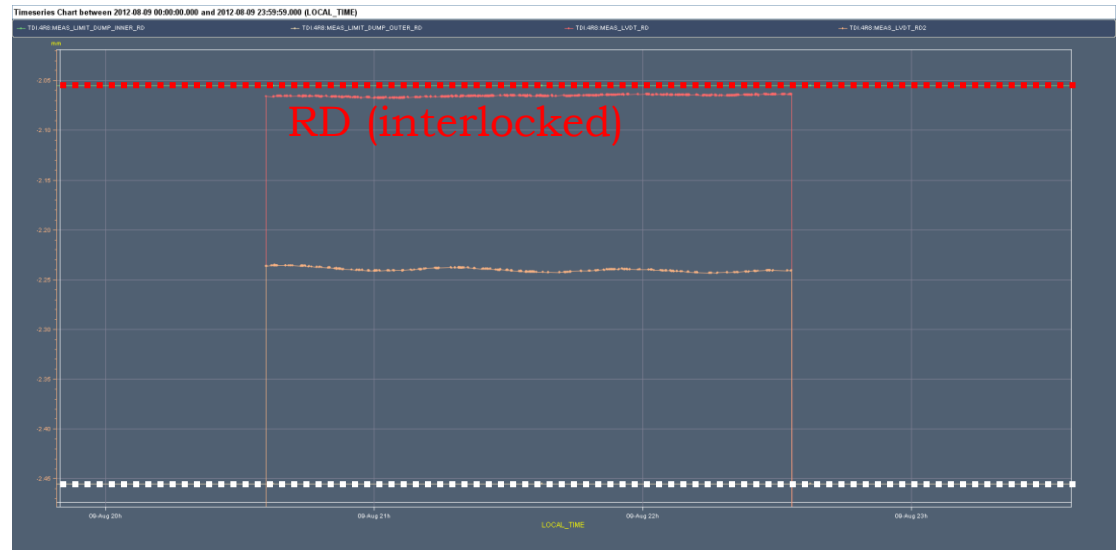
- ▶ After switch exchange the motor counter had to be re-initialised → LVDT used as reference
 - ▶ Parking position used as reference (09/08/2012), moreover 150 μm offset introduced by the deformation → interlocked LVDT too close to inner dump threshold at injection position

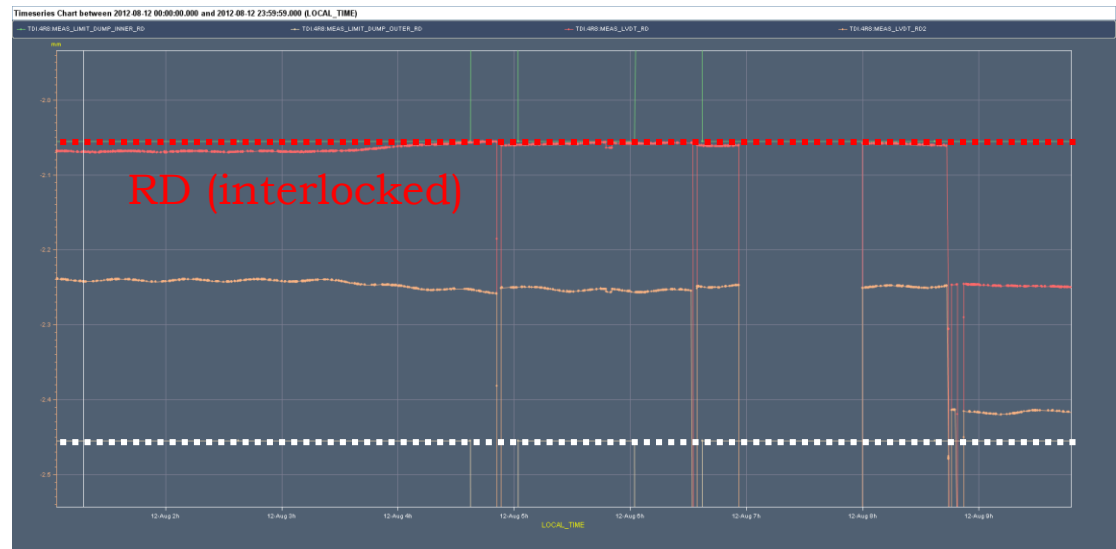
- ▶ After switch exchange the motor counter had to be re-initialised → LVDT used as reference
 - ▶ Parking position used as reference (09/08/2012), moreover 150 μm offset introduced by the deformation → interlocked LVDT too close to inner dump threshold at injection position
 - ▶ Beam dumped during Q20 injection studies because of thermal drift (12/08/2012)

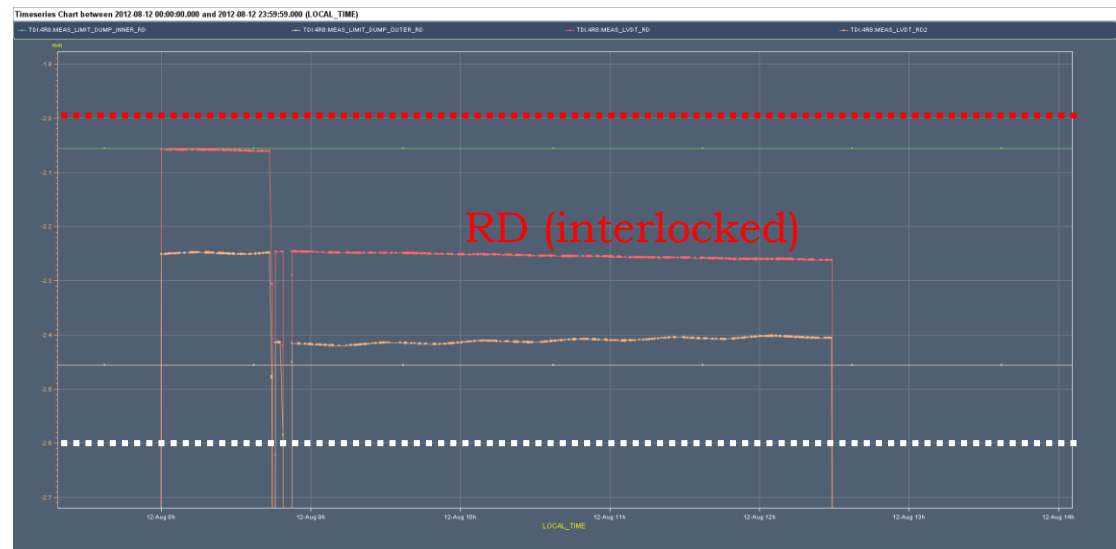
- ▶ After switch exchange the motor counter had to be re-initialised → LVDT used as reference
 - ▶ Parking position used as reference (09/08/2012), moreover 150 μm offset introduced by the deformation → interlocked LVDT too close to inner dump threshold at injection position
 - ▶ Beam dumped during Q20 injection studies because of thermal drift (12/08/2012).
 - ▶ New re-initialisation: offset “removed” using as reference an old LVDT reading at injection position (before 07/08/2012) → centered wrt thresholds **BUT 150 μm deformation hidden by the new re-initialisation! Impact on the jaw?**

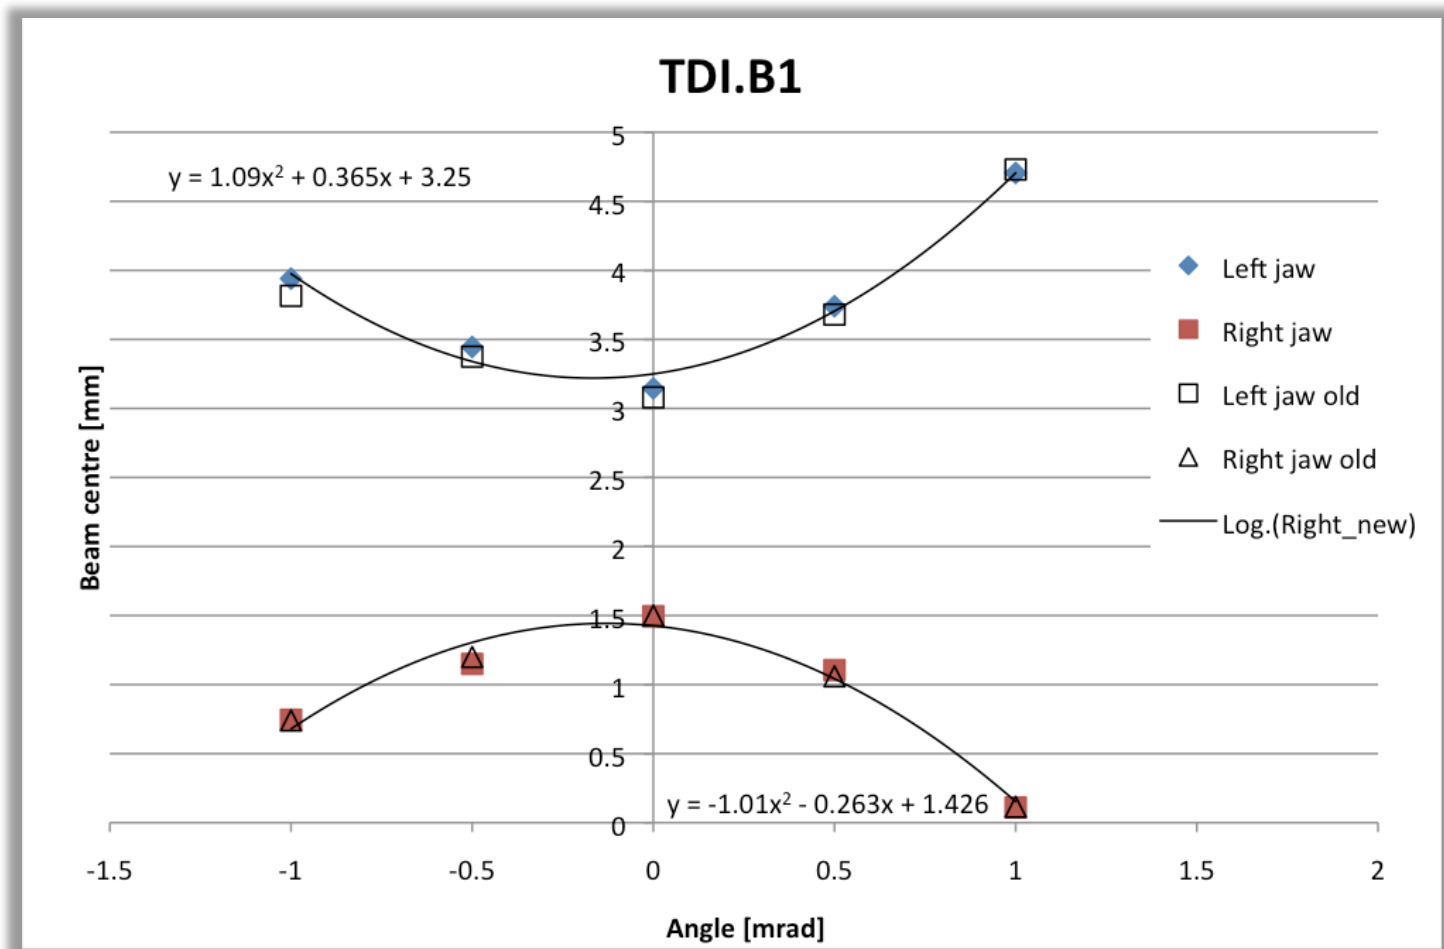
- ▶ Angular scan → no measurable change

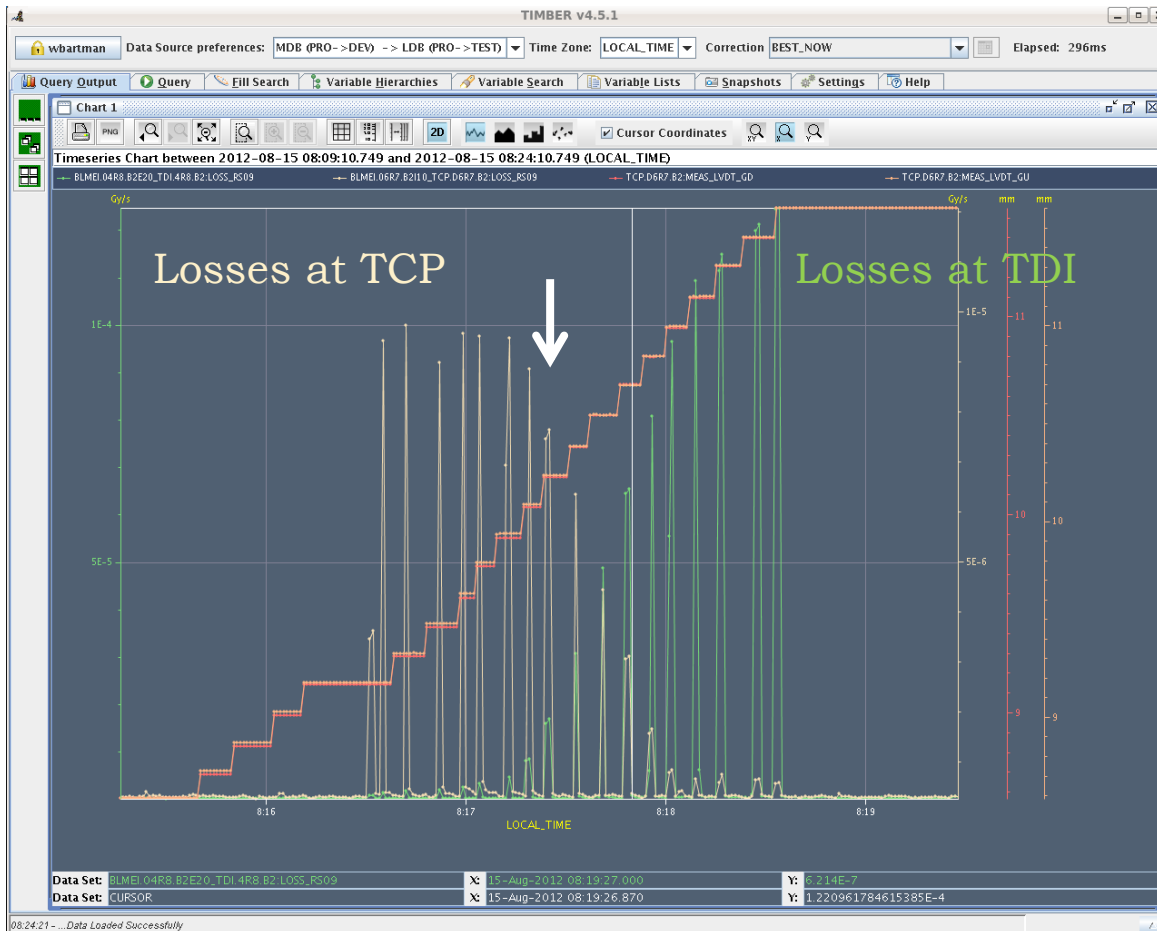
- ▶ Retraction wrt vertical primary collimator: beam blowup with MKQ → retract TCP with 0.1 sigma (76 μm) steps → TDI becomes primary when losses decrease at TCP and increase at TDI → number of TCP steps gives retraction

Measured retraction:
Right jaw = $6.8 \pm 0.1 \sigma$
Left jaw = $6.4 \pm 0.1 \sigma$

Difference within the measurement accuracy.

TDI jaws OK!
