LHC Injection scheme

What happened on
Friday 30 November 2012 ?

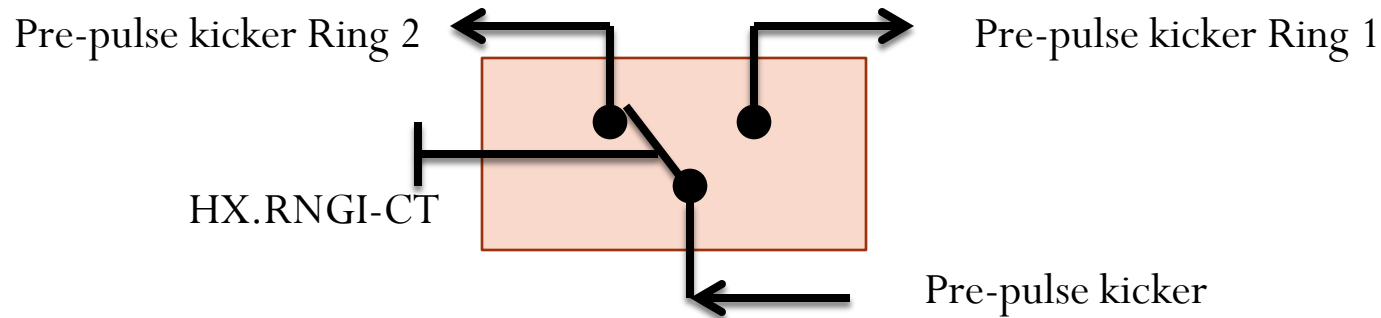
- Cause :
 - The selection of the injected ring is managed by a pre-pulse switch
 - The switch is controlled by the event HX.RNGI-CT witch contains in its payload the LHC destination

- **The event HX.RNGI-CT was not sent because the following constraint has not been respected:**
 - SPS.LHCSEQE.NLHCINJ and SIX.FW1KFO-CT must arrive in the same basic period.
- The switch remained in the position it was when the last HX.RNGI-CT arrived
