Powering interlock changes during LS1

I. Romera
on behalf of TE-MPE-MS...

Beam dump after losing PP_60A

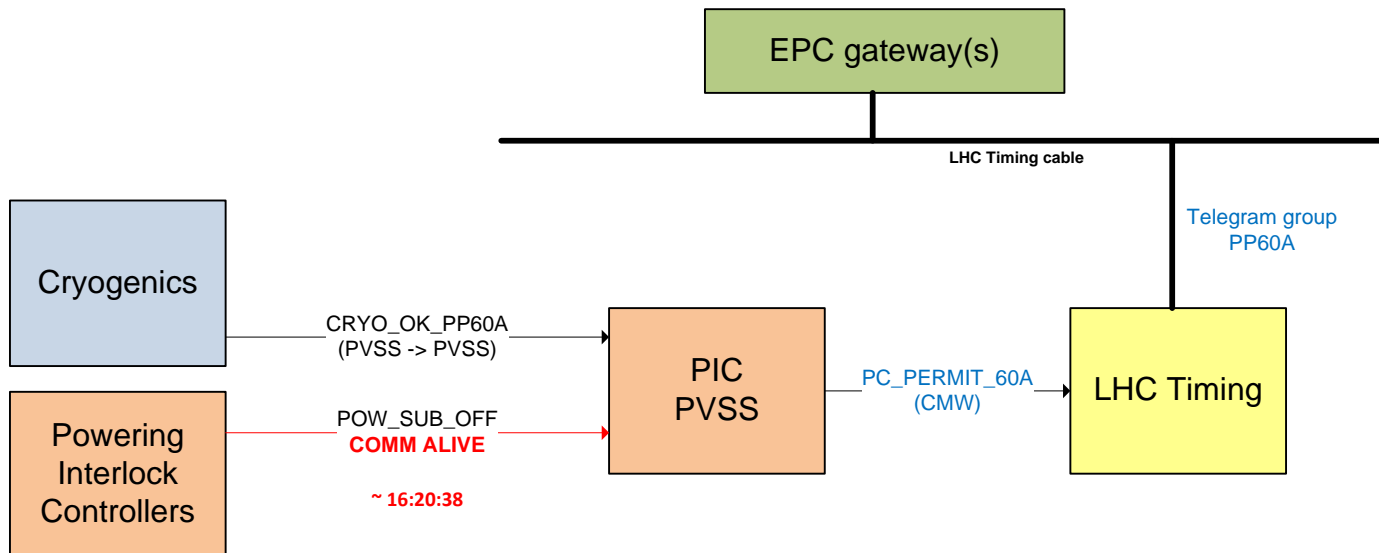
- 25.Oct.2012 16:23:18.685 => Beam dump at stable beams
 - 16:20:38 => Ethernet switch communication problem with PIC in AL6

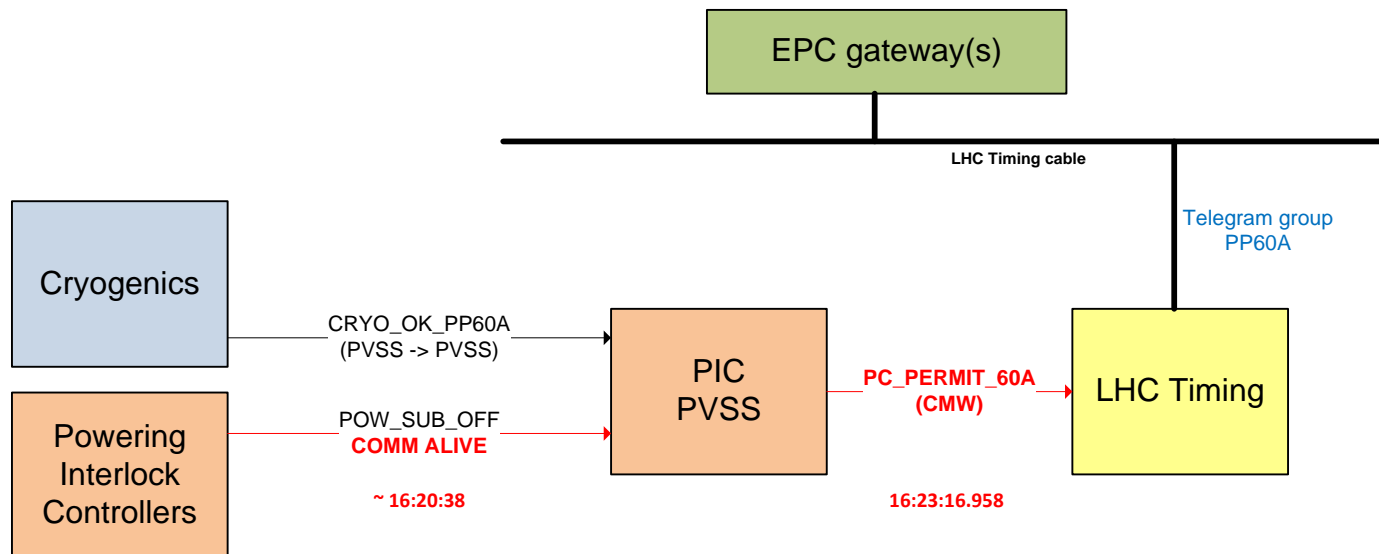
- 25.Oct.2012 16:23:18.685 => Beam dump at stable beams
 - 16:20:38 => Ethernet switch communication problem with PIC in AL6
 - 16:23:16.958 => Loss of the PC_PERMIT_60A in sector 56

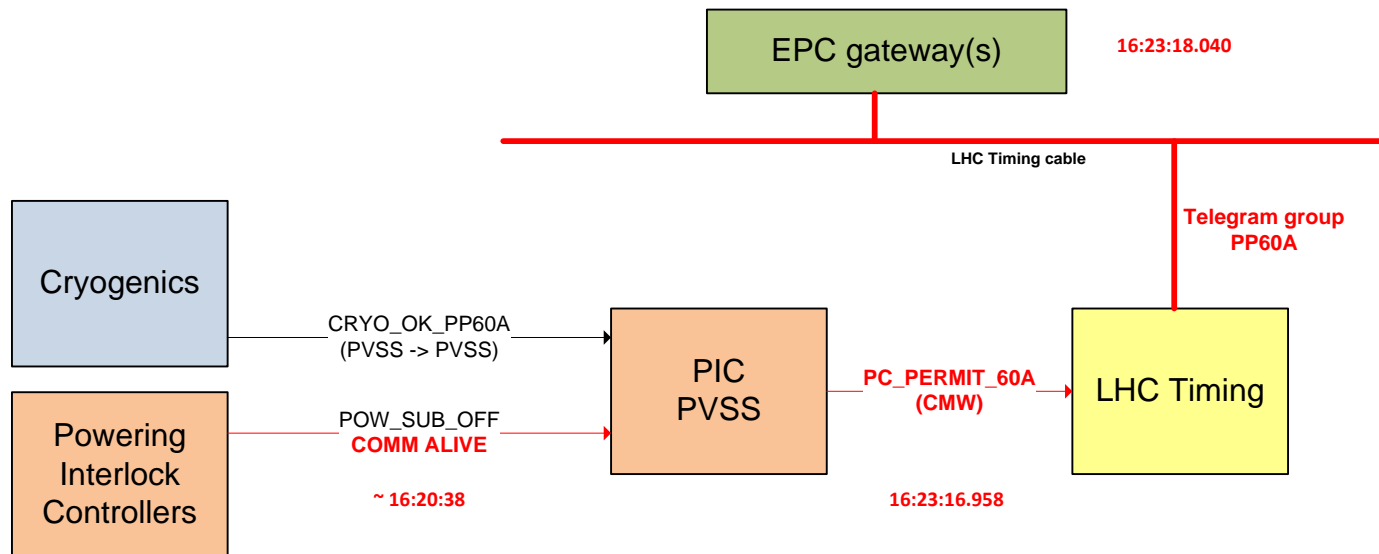
- 25.Oct.2012 16:23:18.685 => Beam dump at stable beams
 - 16:20:38 => Ethernet switch communication problem with PIC in AL6
 - 16:23:16.958 => Loss of the PC_PERMIT_60A in sector 56
 - 16:23:18.040 => Slow power abort received by 60A Power Converters

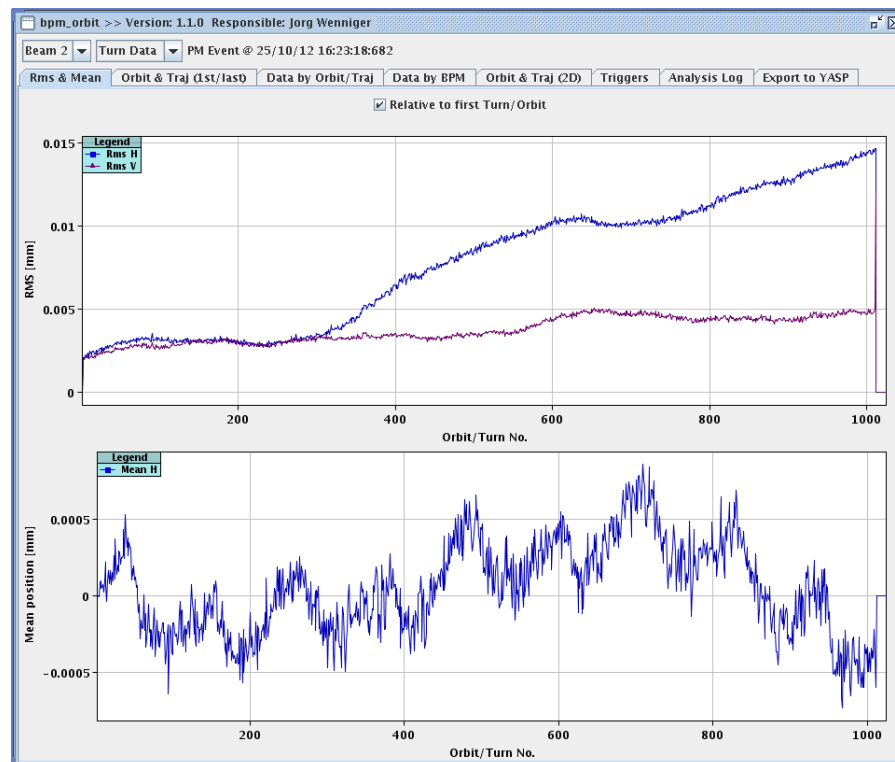
- 25.Oct.2012 16:23:18.685 => Beam dump at stable beams
 - 16:20:38 => Ethernet switch communication problem with PIC in AL6
 - 16:23:16.958 => Loss of the PC_PERMIT_60A in sector 56
 - 16:23:18.040 => Slow power abort received by 60A Power Converters
 - **16:23:18.685 => Beam orbit affected and beams dumped by BLMs in SR7**

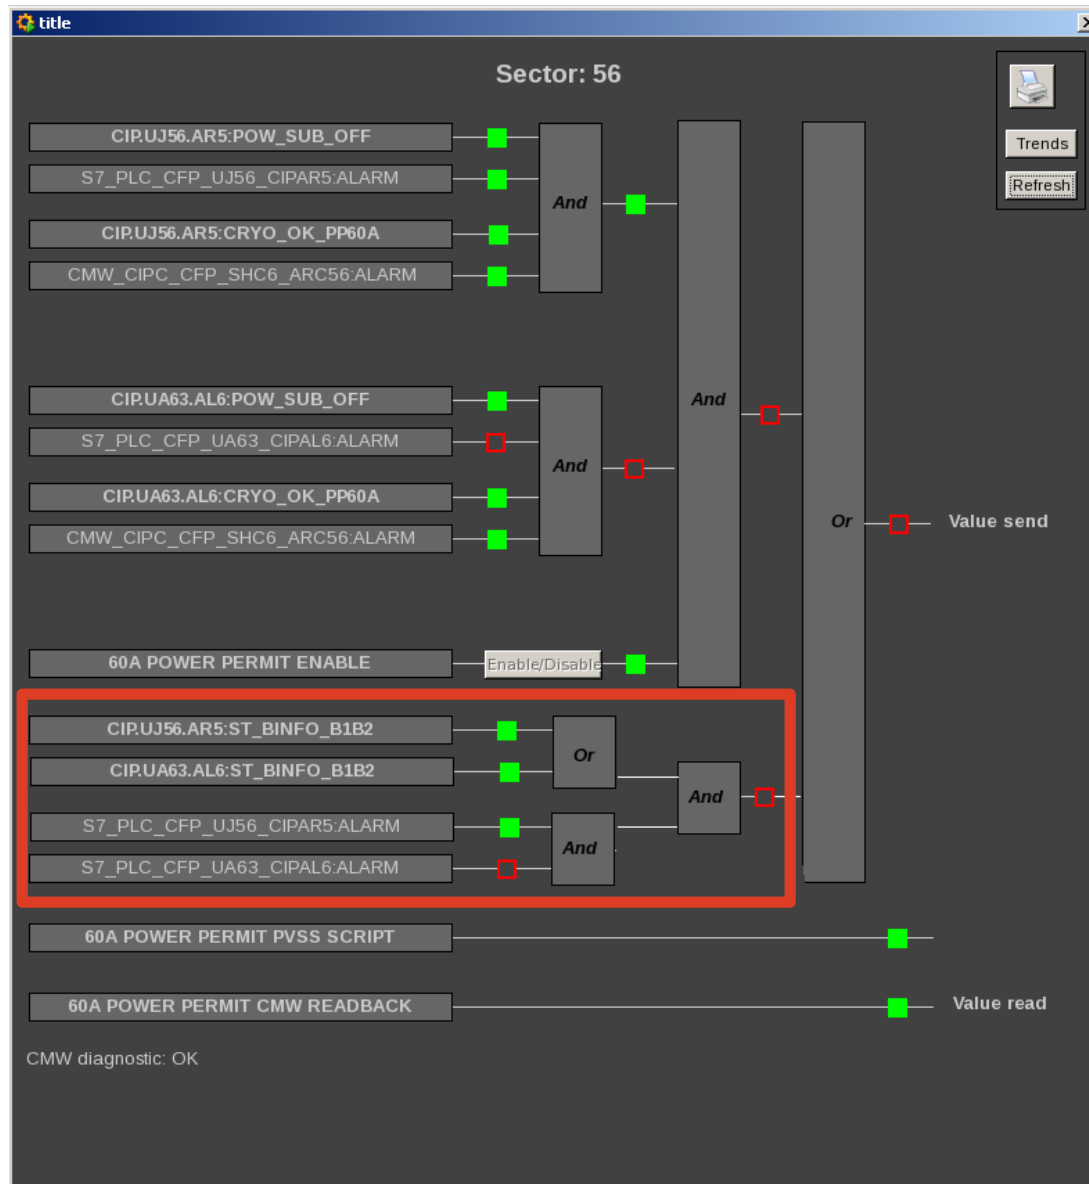
But logic implemented...

- Beams would have **never dumped with correct PVSS logic** due to a communication problem affecting a single PIC!!
- PVSS logic will be **corrected during LS1**

- **2nd proposal:**
 - **PVSS** could also request a **SLOW POWER ABORT to all PICs** in the sector
 - PIC would also trigger a **beam dump before loss detection**
 - Protection features **cannot depend on PVSS availability**

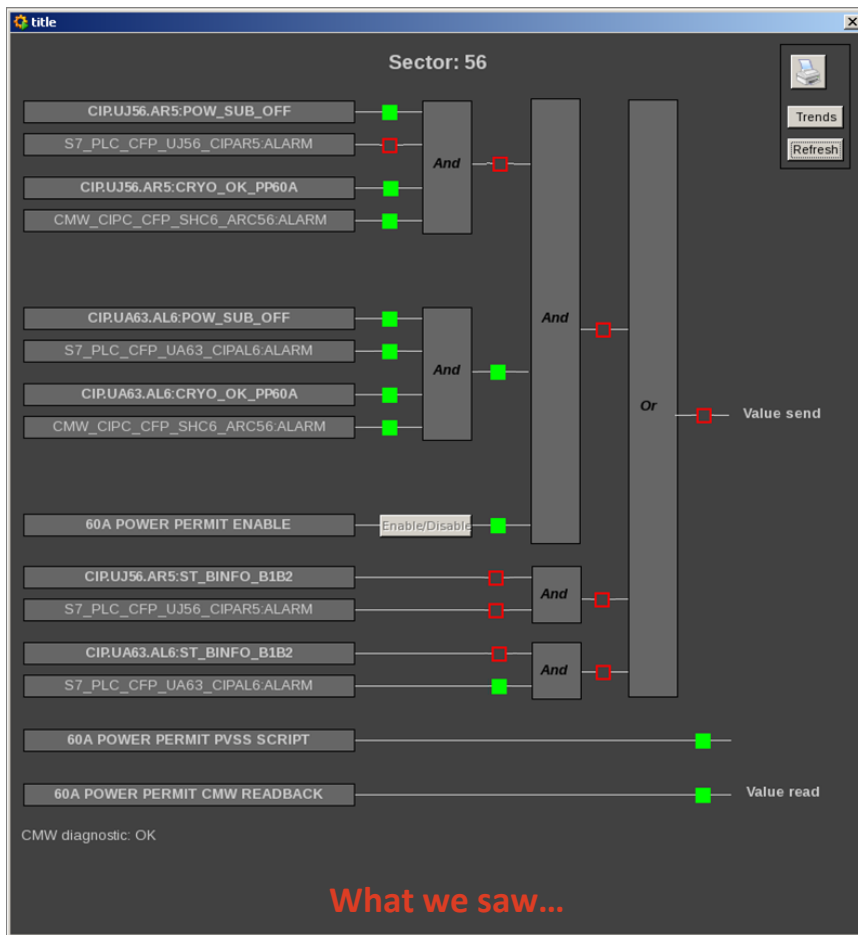
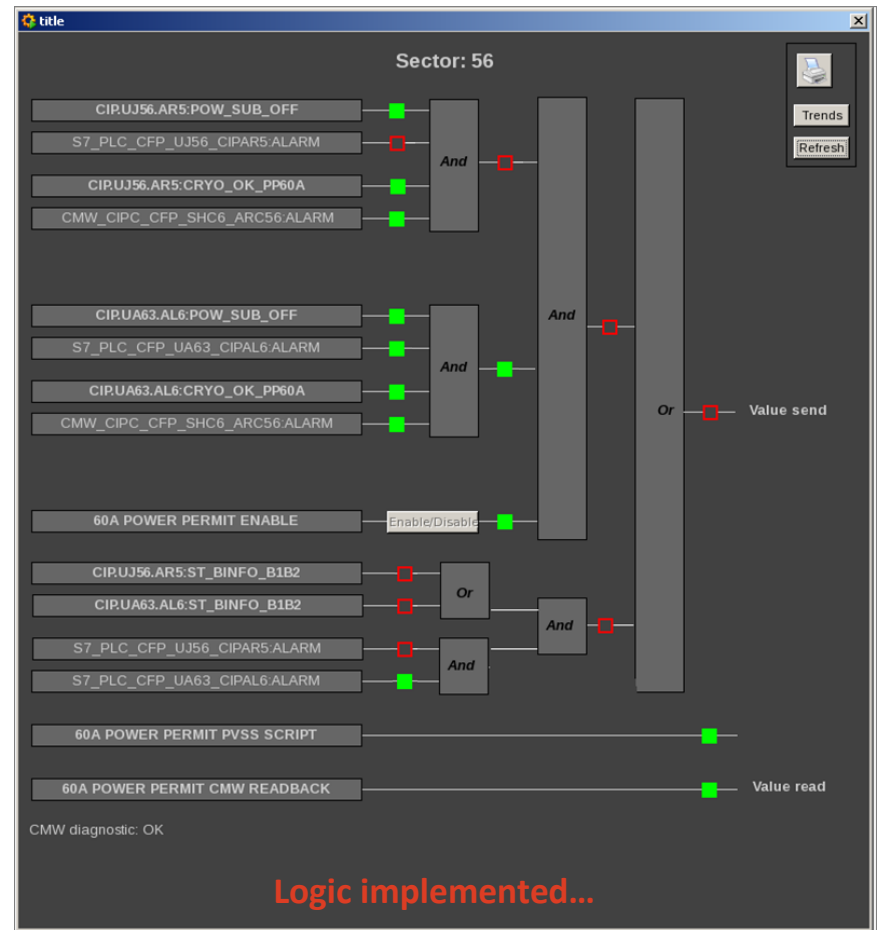
Similar events without beam...

- 9.04.2010 2h25 / 19.06.2010 11h54 (Sector 56)
 - Network communication problem again in S56
 - This time without beam in the machine...
