Irradiation at CHARM of a HL-LHC prototype board for the CMS Muon DT On detector electronics based on the PolarFire FPGA

2 OBDT-v1 boards

C.F. Bedoya, I. Redondo, A. Navarro, J. Sastre, D. Redondo, C. de Lara, J. León, J.M. Cella, C. Carrillo
(CIEMAT)

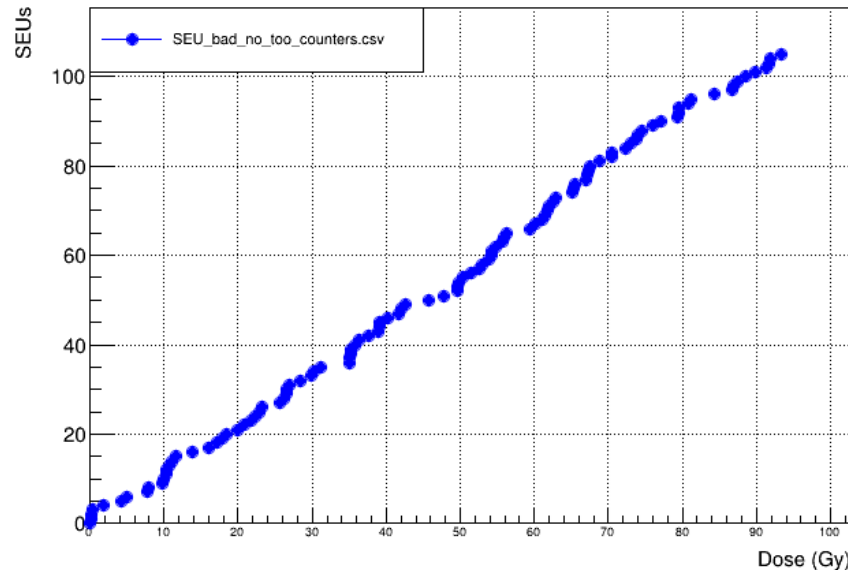
- Missing hit, wrong timing or duplicated hit all considered as failures of SEU type (could be in the OBDT or in the PUFO)
- Typically all of the SEUs affected all of the channels simultaneously, meaning, the SEU was not on the time measurement itself but in the BC0, reset distribution or similar logic.
- If all channels equal errors simultaneously => 1 SEU
- Crosschecked the counters seen from the three different monitoring paths, coherent result.
- Electrical path allowed to identify some burst of errors in the optical path that were not real SEUs (clearly due to link instabilities) (17 events)
- 107 real SEUs counted through all the irradiation campaign The cross section obtained with this number of failures and the amount of logic contained in the Polarfire firmwares is $2.33 \cdot 10^{-15} \text{ cm}^2/\text{bit}$

Caveat: the SEUs from the TX at the Polarfire are not accounted for in this test since optical links were not reliable. The rest of the logic could be considered very similar to the firmware to be used during HL-LHC (including TMR in logic and CRC mechanisms in RAMs).

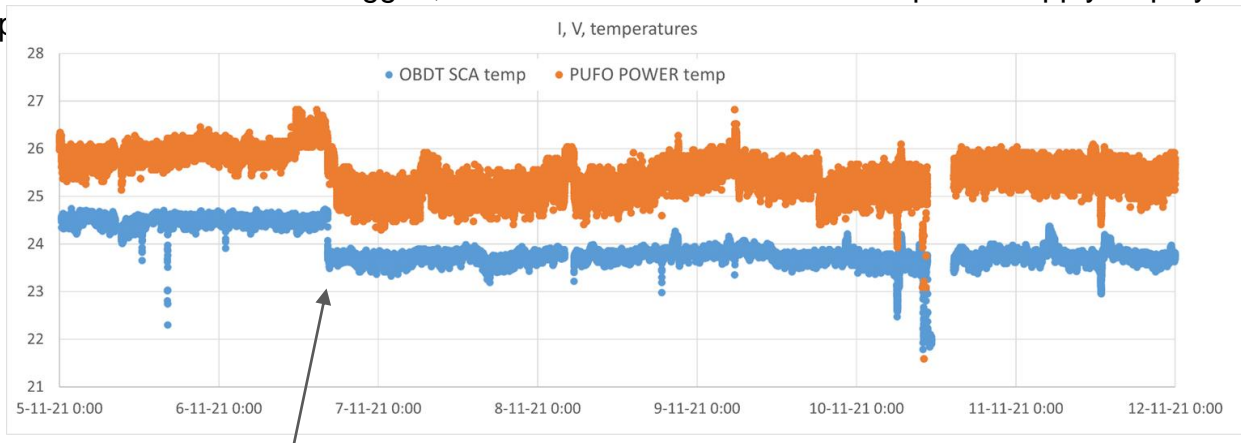
Temperature was relatively stable, no issues of fans not working or degrading observed

Temperature drop due to increasing DC fan from 8 V to 11 V

Both fans worked satisfactorily throughout the test (109.8 Gy) and both remained operational

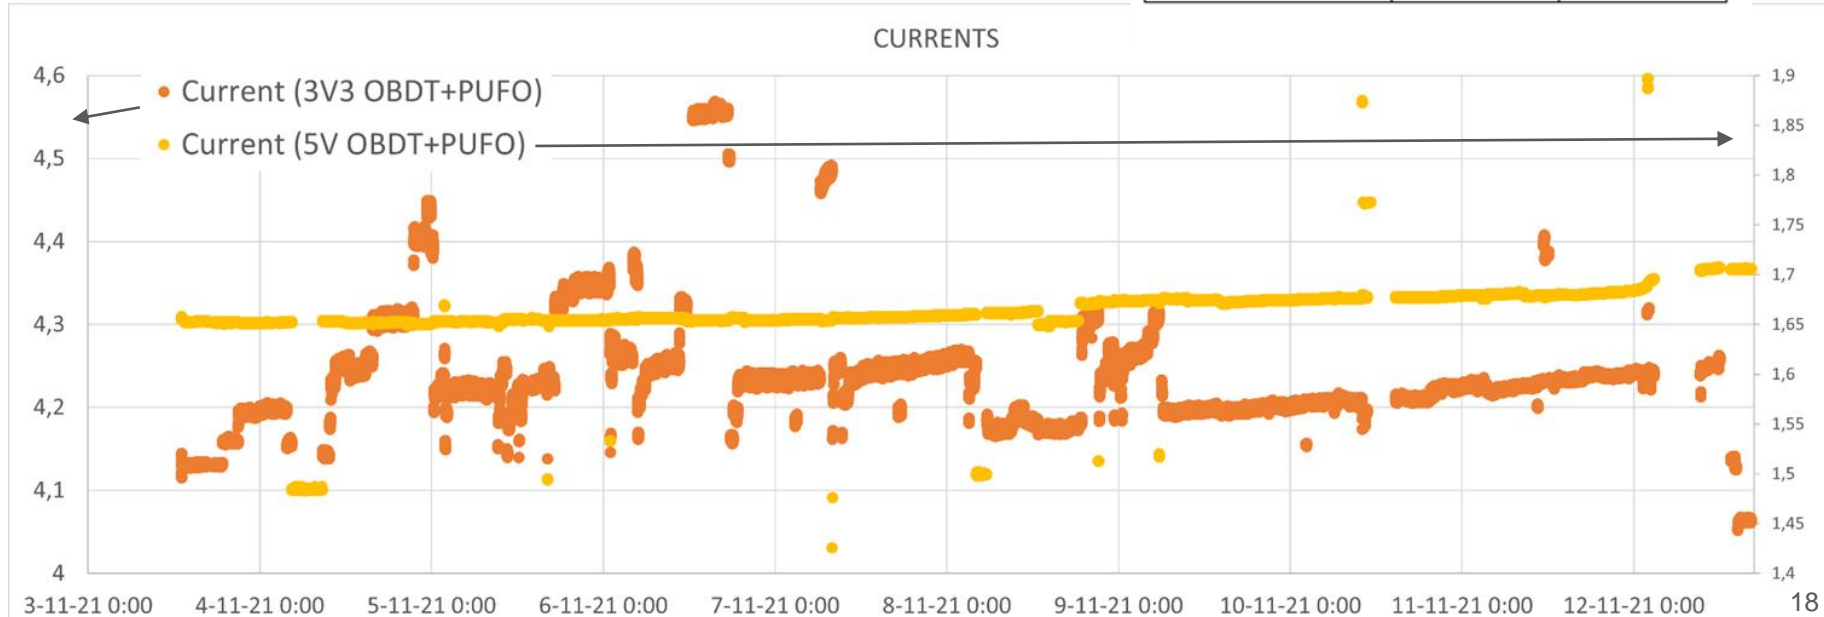
- Besides of the sporadic increases related with malfunctioning of the optical modules, the average current increase in the system has been approximately a 3% in both power rails.
- (Regulators GND current?)

3V3 CURRENT	5V CURRENT
START of the irradiation period CURRENT (AMPS)	4,127	1,653
END of the irradiation period CURRENT (AMPS)	4,256	1,705
TOTAL CURRENT INCREASE (mA)	129	52
% CURRENT INCREASE	3,13	3,15

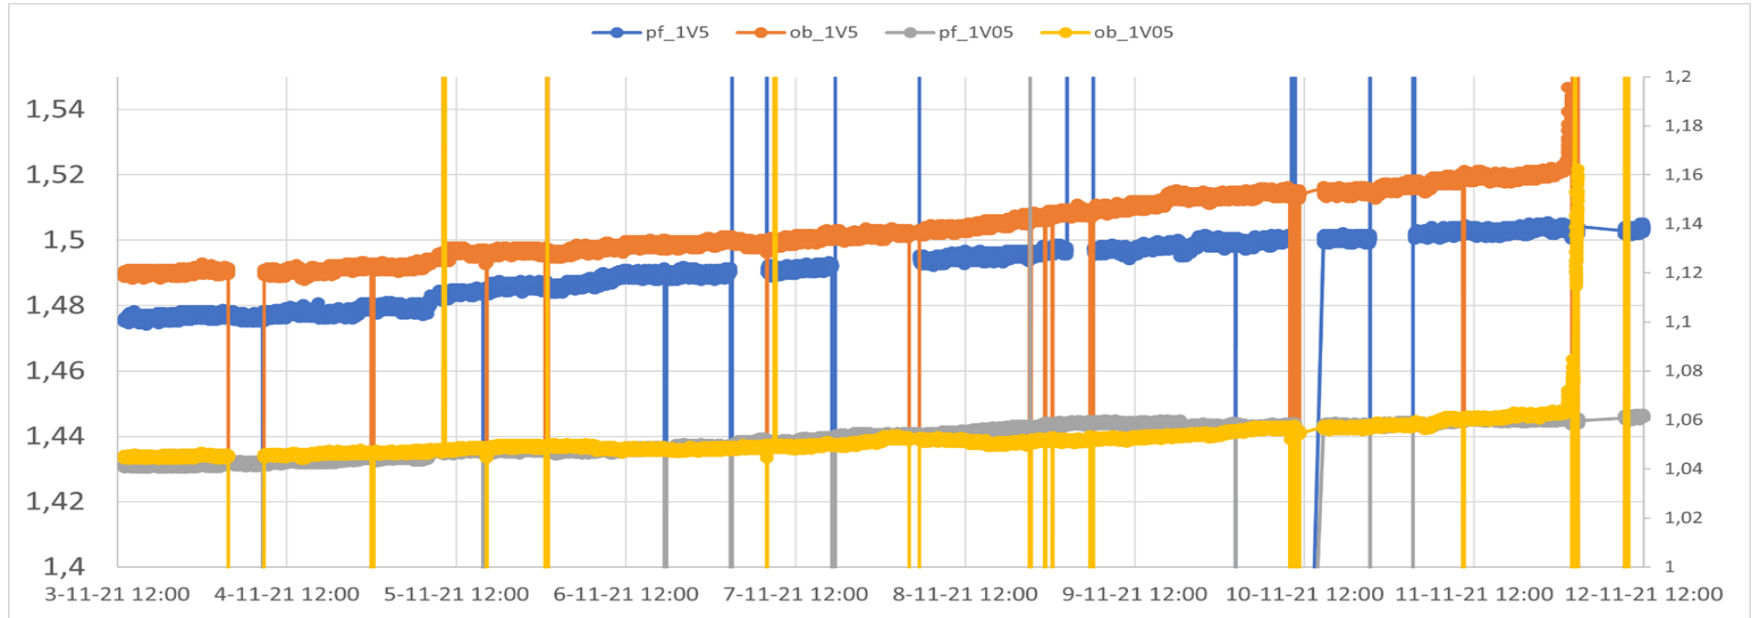
- Voltages at the output of the Micrel MIC69502WR regulator also seen an increase $<1\%$ throughout the radiation period
- Compatible with previous irradiation tests of this technology

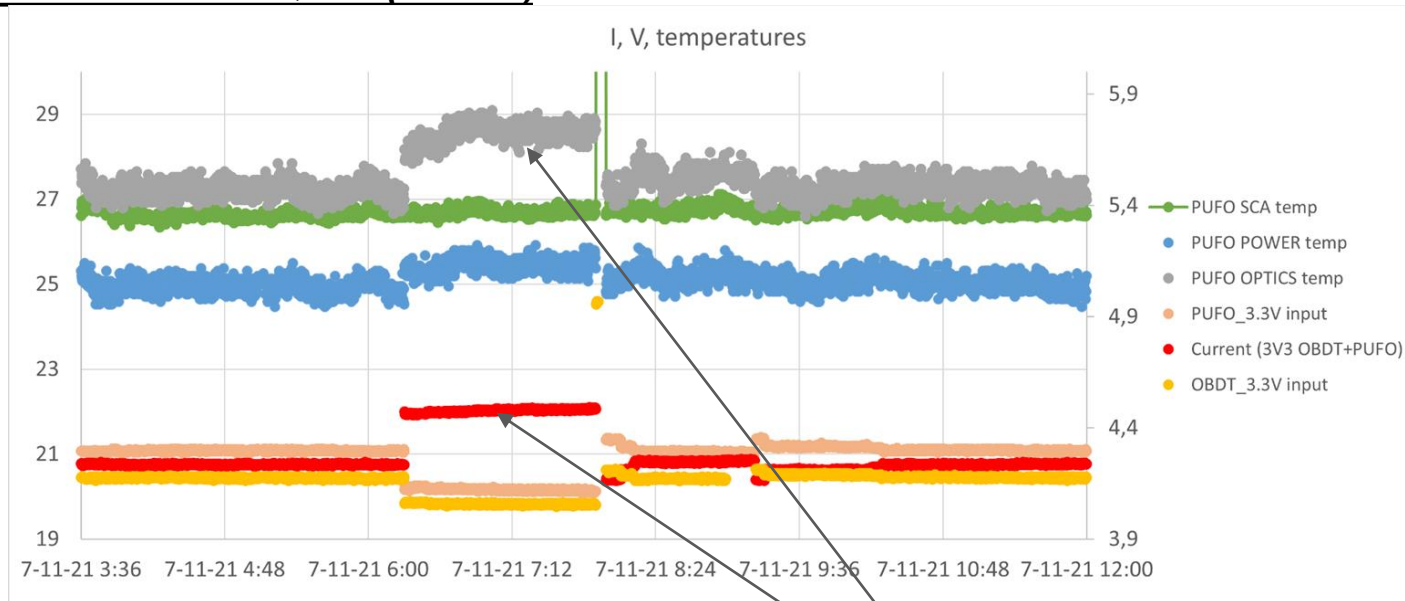
QSFP PUFO: FTL410QD4C (Finisar)

- PUFO optics' temperature in grey (read from a PT1000 which is nearby) has increased significantly following the input currents.
- This temperatures increases are correlated with **increases in the input current** (red) that, among others, serves the QSFP
- Total current is increased by 0.4 A. This increases the voltage drop of the incoming power cables and thus, the voltage seen at the PUFO 3.3V input is lower (though large enough for the board to operate).
- The PUFO SCA temperature is much smoother (green)
- The rest of the test metrics was unaltered during the high current period and SEUs could be measured correctly.
- Currents and temperatures recover after a power cycle

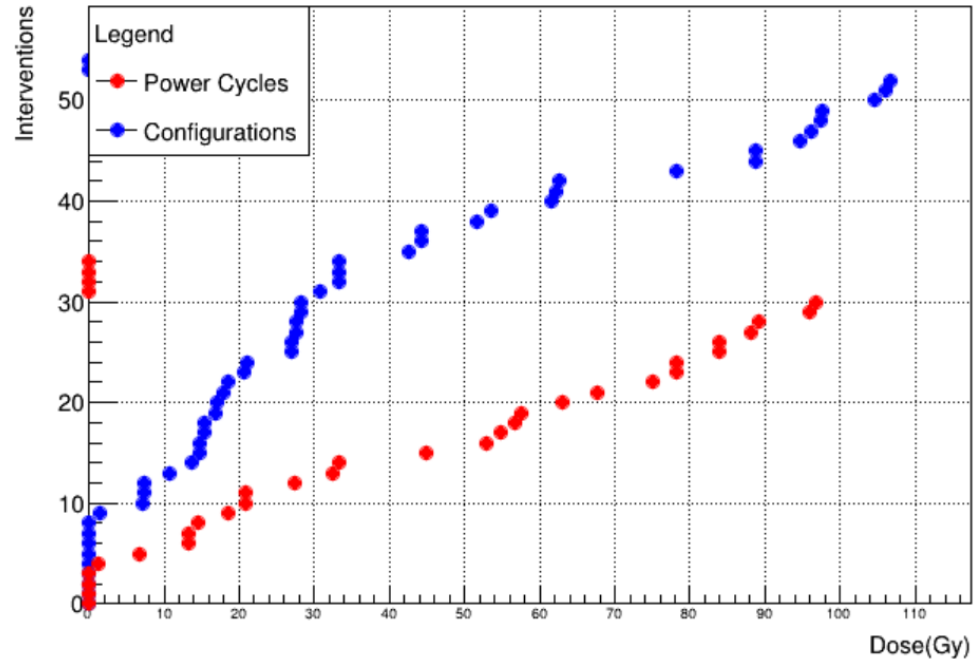
- Power cycles (red)
 - Exclusive configurations (blue)
- All these power cycles belong to two types:
 - Interventions (17) to recover commercial optical transceivers.
 - Shifter actions without system malfunctioning (making verifies, etc)
 - If we were to operate with these optical transceivers: for a total dose of 109,8 Gy it would result in 3,67 power cycles/year. (Using the actual dose expected per chamber)
 - (Note however that the actual BER of this optical transceivers is larger than just these power cycles, so still, we would not recommend to use them)

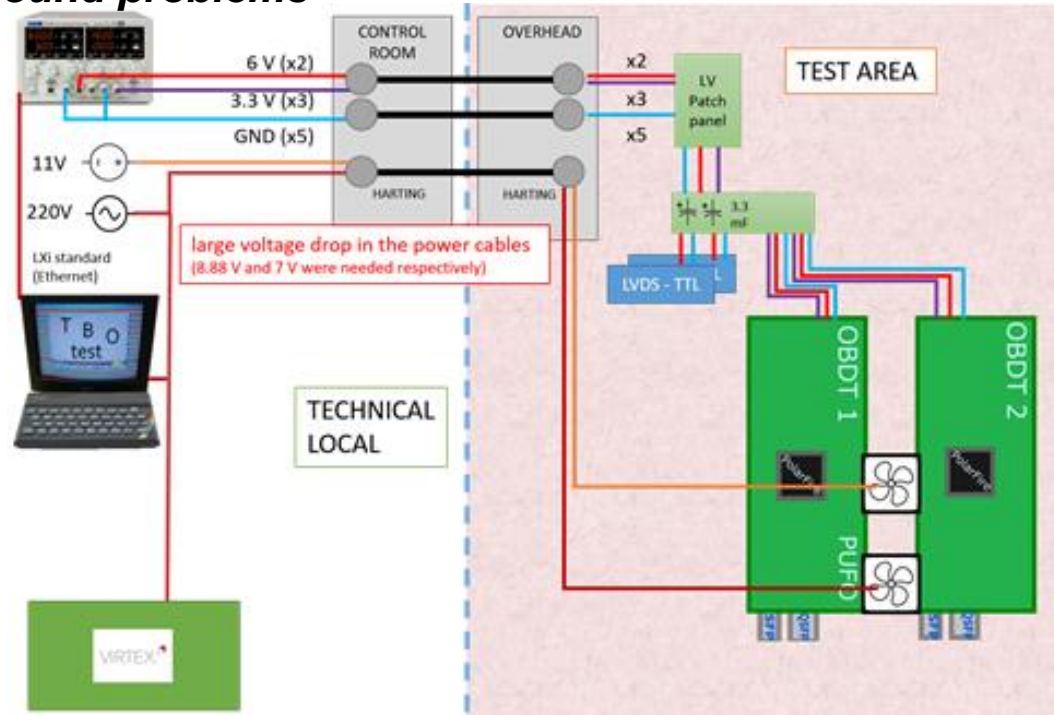
- 35 meters long cables are installed between the power supply and the OBDT boards. The section of the cables was 1.5 mm² and this implied that a significant voltage drop (maximized the number of cables that we could use)
- Voltage drop is dependent on the current and current consumption (configured and locking to the clock). Current between 1 Amp to 2.4 Amps => voltage drop from 1.3 volts to 3.2 volts
- Maximum input voltage is 6 volts for the regulators.
- Problems with the grounding for the secondary link (copper)

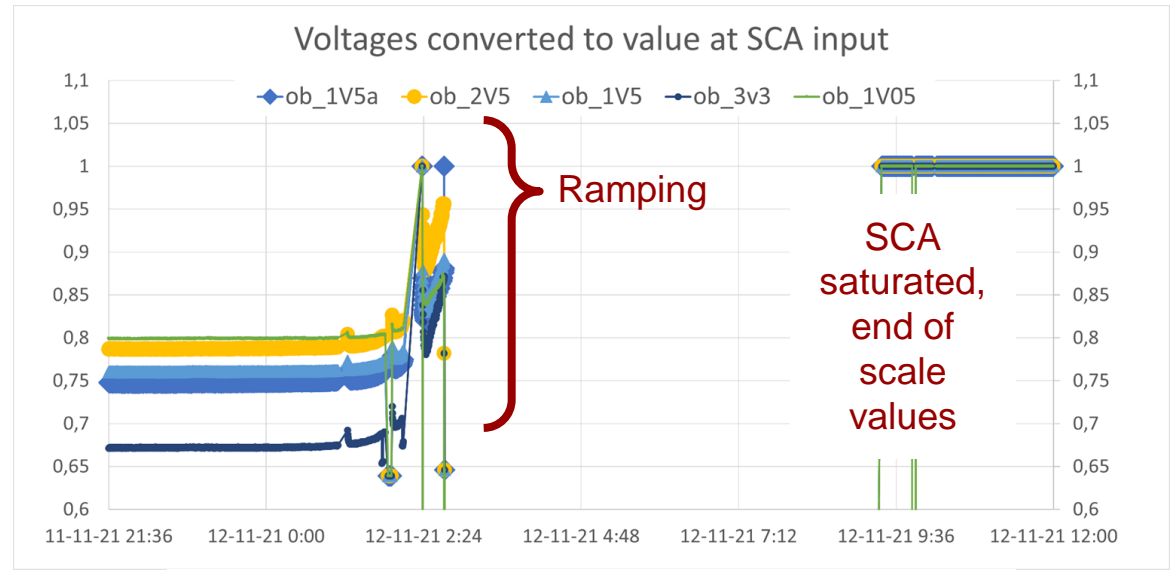
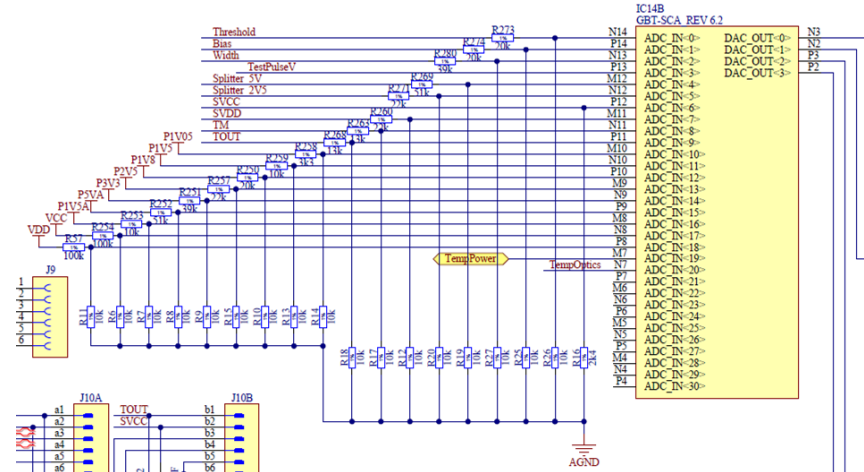
- Last day (November 12th at around 02:46, after 98.77 Gy):
- Temperatures and voltages of the OBDT as measured by the SCA started to increase gradually until they reached saturation point (unphysical temperatures)
- It did not seem a real increase, currents were stable, temperature from the remote sensor was stable, it was an SCA artifact
- ADC values were incorrect but the rest of the SCA functionality was intact
- Similar behaviour as when a high voltage is present at SCA pins input and the ADC saturates.
- Post mortem analysis of the OBDT would be needed to understand why this happened

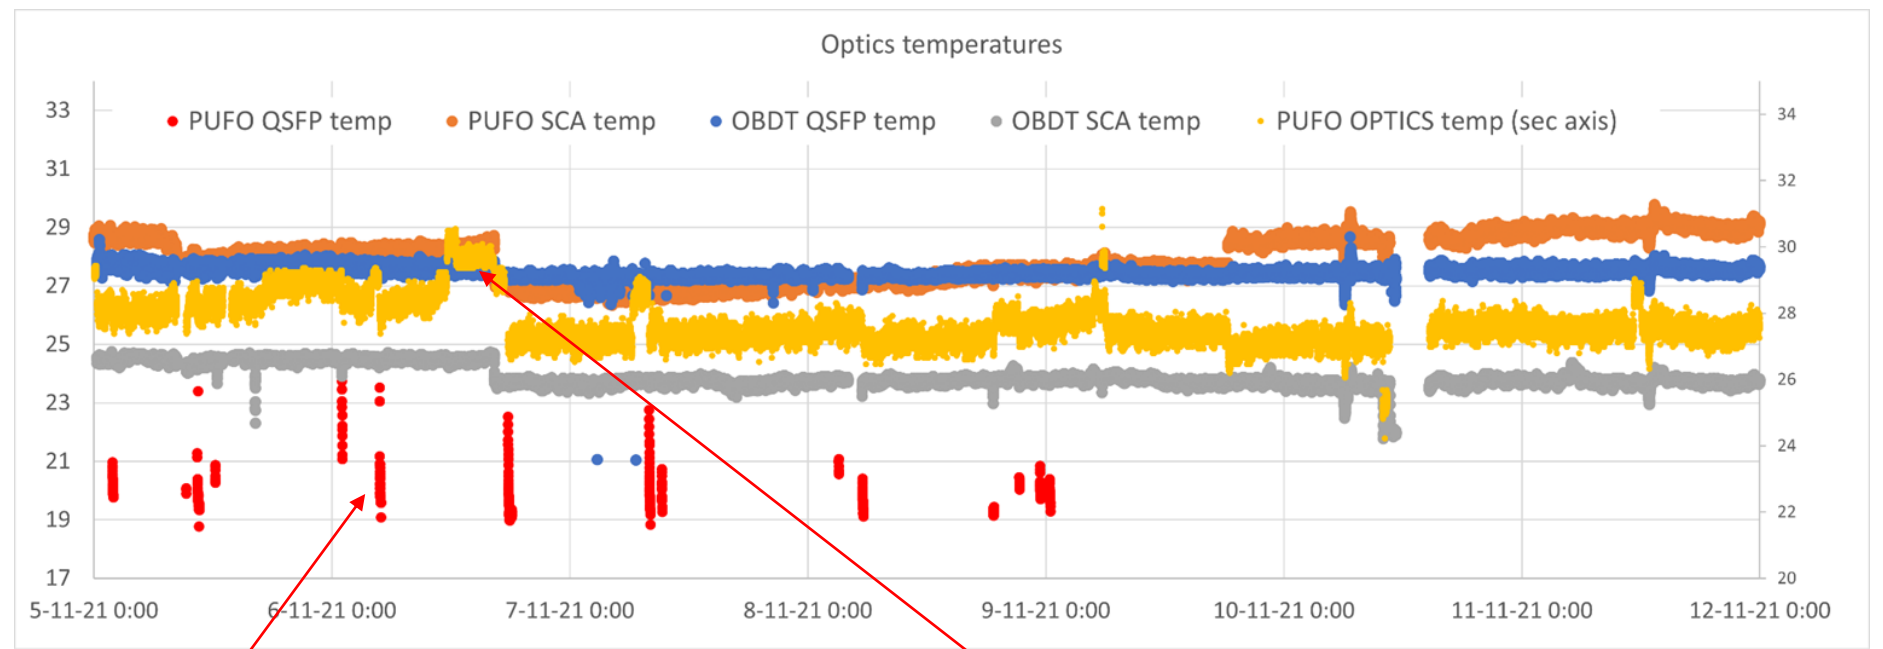
QSFP PUFO: FTL410QD4C (Finisar)

PUFO QSFP temperature reading not working. Recovered briefly just right after power cycles.

Temperature of PUFO optics had sporadic increases which seemed real (and they were correlated with total currents increases). This sensor is a PT1000 read by the SCA which is placed close to the PUFO QSFP (and to the SPF+)

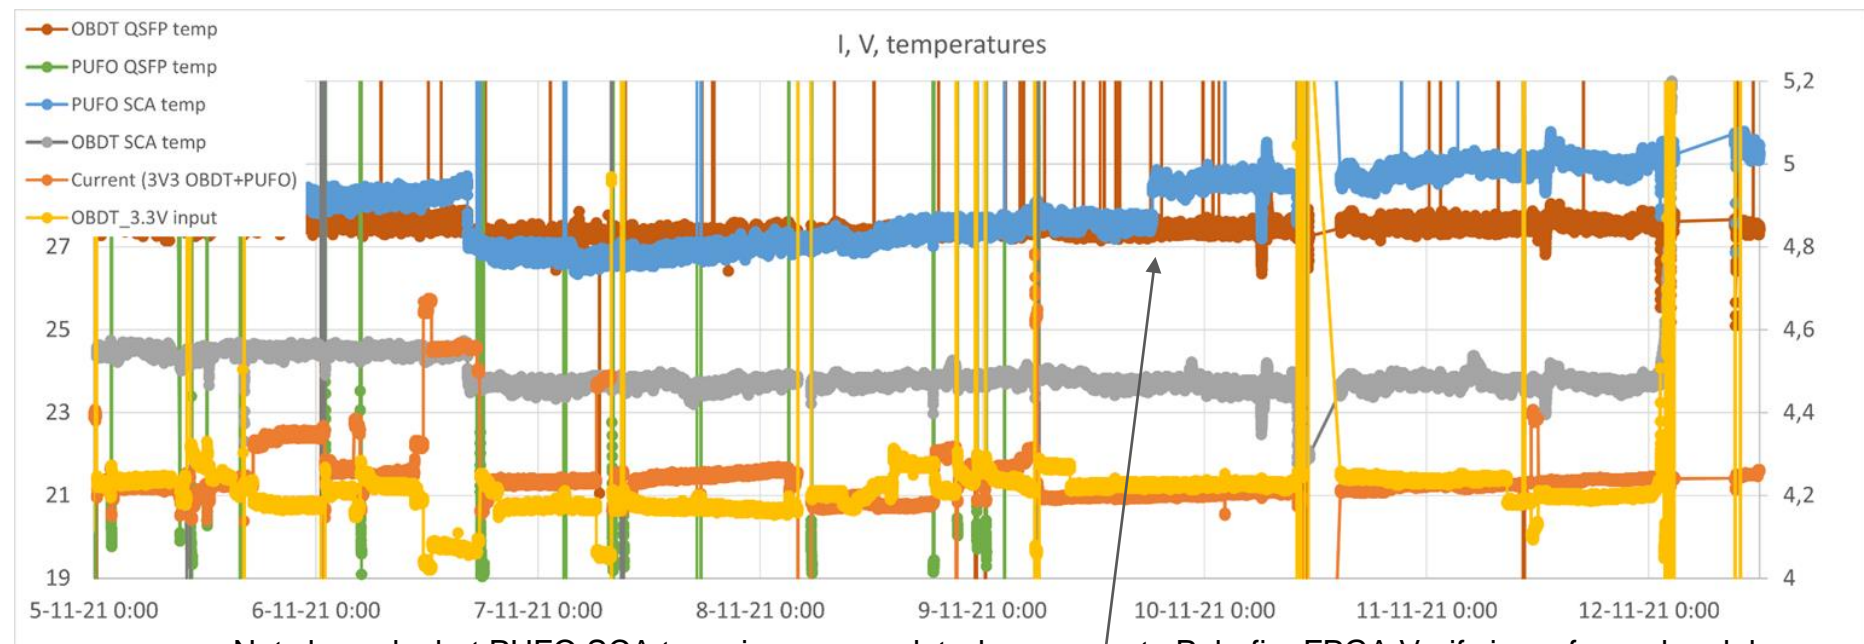
Not clear why but PUFO SCA temp increases a lot when a remote Polarfire FPGA Verify is performed and does not recover afterwards
OBDT SCA temp is not altered and no other symptom is detected

Remote FPGA verify worked fine before the radiation test (bunker zone)
First time it was tried was on Friday Nov. 5th at 13:00, after 15.55 Gy, and it was not working.
IDCODEs were being read properly but the verification was failing at 66% and 45% of the process on each FPGA respectively each time we performed it during the irradiation
However at the end of the irradiation period we were capable of loading the firmware remotely...

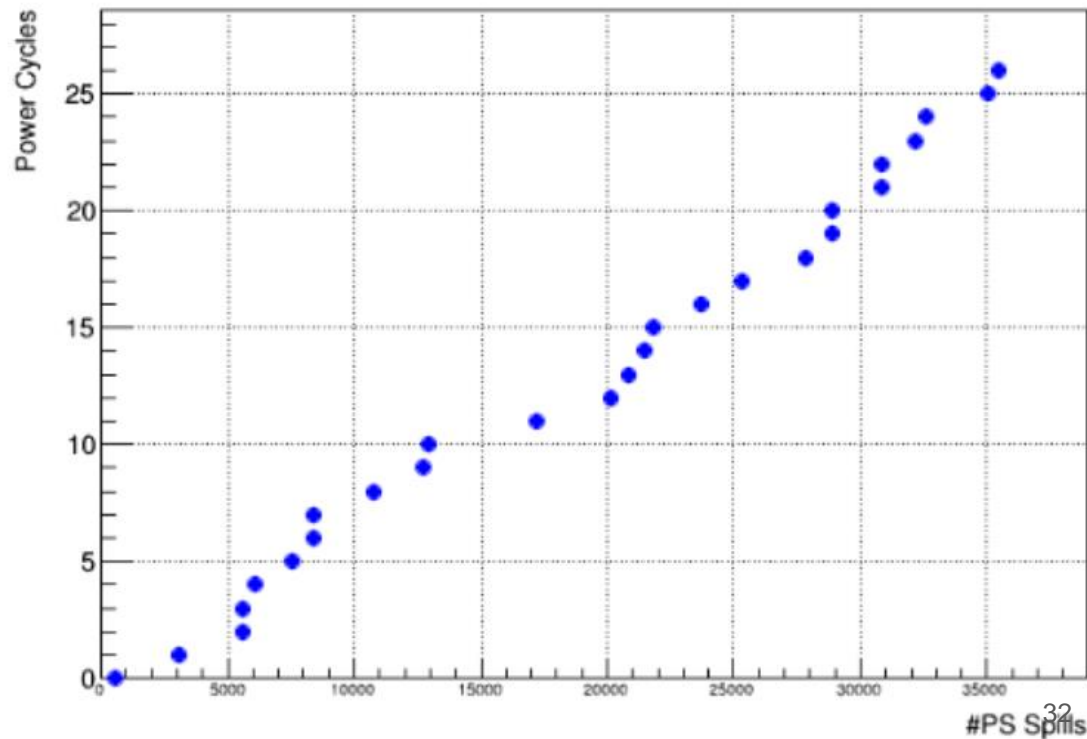
- Most of the interventions (17) to recover commercial optical transceivers.
- Rest due to shifter actions (making verifies, fixing sw, etc)
- If total dose is 200 Gy (tbc) it would result in one power cycle every 4x HL-LHC dose in our hottest area.

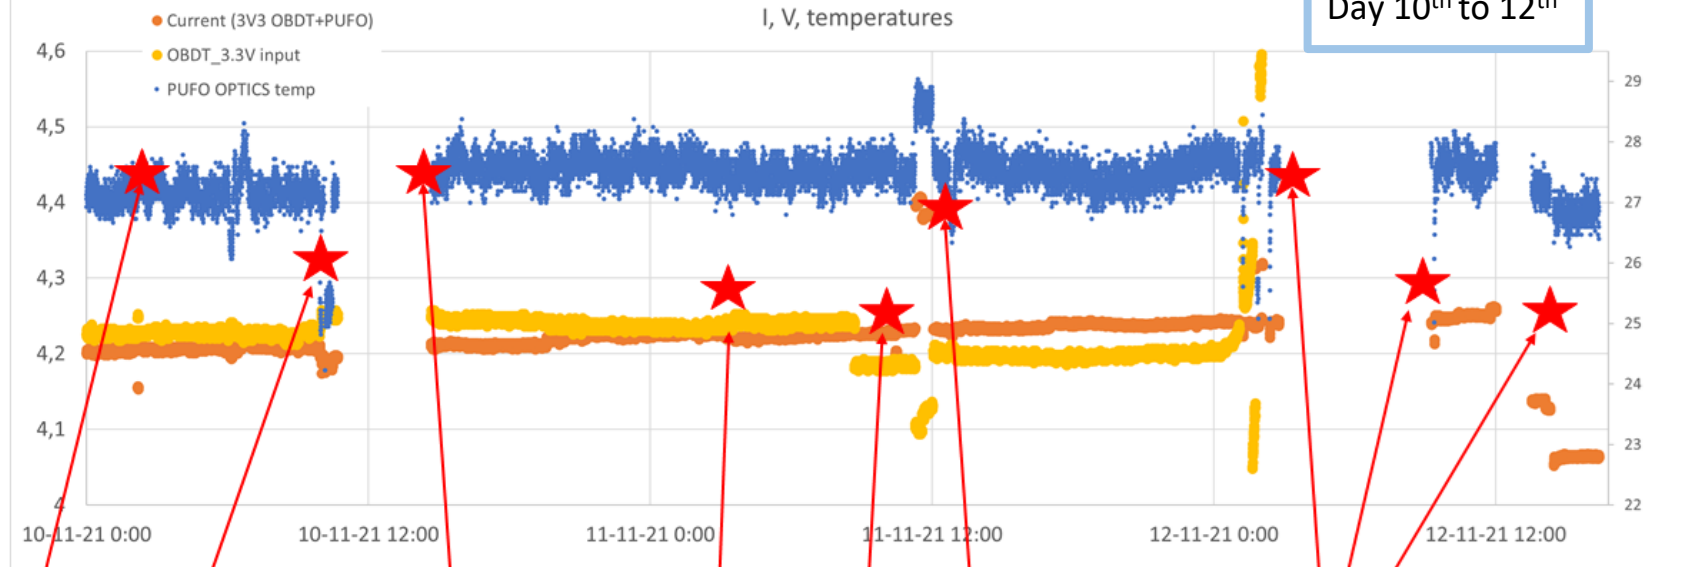
Day 10th to 12th

2:13 link 1
not
working

10:43
FPGA
verify
fresh start
(no beam)

13:18 y
14:39
testing
(no beam)

3:32 links
lost

10:34 Link 2
problems,
wrong
temperature
values

12:02 high currents
(PUFO QSFP?)

00:58 SCA
temperat
ures go
crazy
