# Highlights on status of activities in Hitachi

Tatsushi NAKAMOTO, KEK

On behalf of CERN-KEK Collaboration for  
D1 Construction for HL-LHC

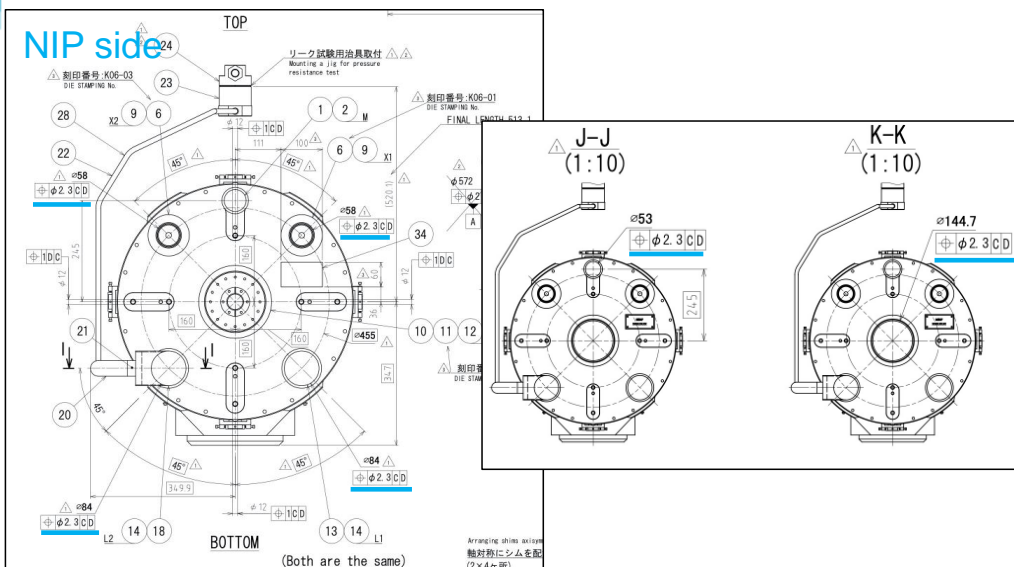
- Determined by the laser tracker system (AT403).
- Thanks to the alignment tooling and performance of the welders at Hitachi, the lateral positions of the extremity pipes were well controlled except 2 NC cases.
  - 2 NC case are also acceptable for the cryostat work at CERN.
- CERN will revise the position tolerances for the series production based on the experience of the prototype.

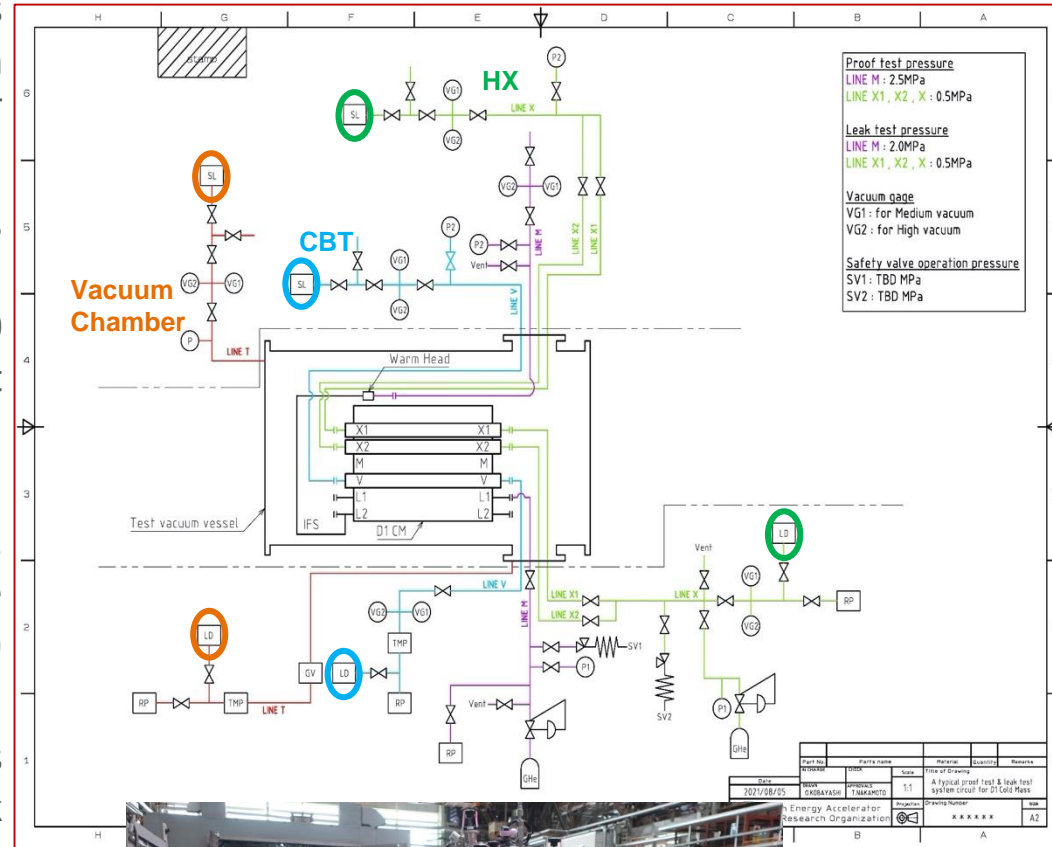
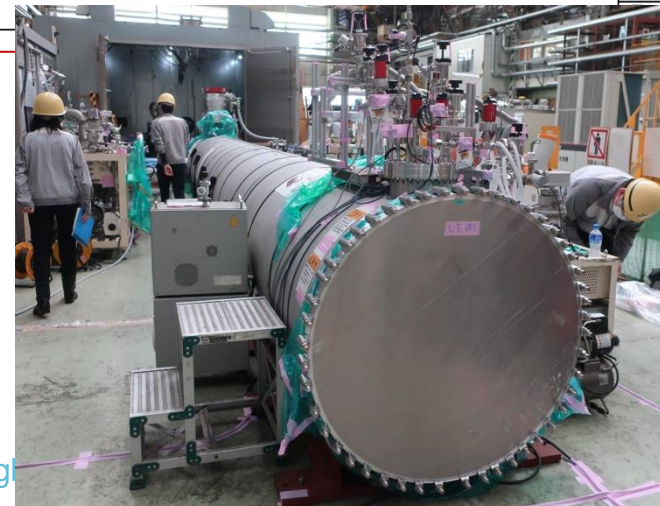
- The leak was found in the 1<sup>st</sup> gas displacement at 1.25 MPa. The leak localization took about 1 month and the leak was eventually localized in the flexible tube.

- The LT of the MBXFP1 was really a good lesson for Hitachi and KEK. Improvement to avoid the leaks along the pressurization lines will be made for the LT of the series production cold masses.

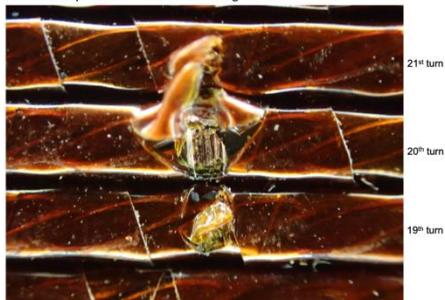
Fig. 3: Macrograph of insulation damage.

An investigation of the root cause is underway. But results of the inspection can be summarized in the following.  
The damage of the 20<sup>th</sup> turn looked severest: the cable insulation was partially peeled off and a scratch on a surface of a strand was clearly confirmed. However, the damage was limited within one strand and current transport capability seemed to be fine because the scratch was not so deep and we could see a glossy copper matrix. Regarding the 19<sup>th</sup> and the 21<sup>st</sup> turns, a level of the damage was obviously lower with respect to the 20<sup>th</sup> turn. The outer layer insulation was damaged but we could not judge if the inner layer insulation was also damaged or not.

The visual inspection was also performed for the protection sheet to judge if the insulation was damaged during the curing process or not. We confirmed that the surface of the corresponding location was still normal and not damaged at all. As mentioned above, the scratch of the copper of the 20<sup>th</sup> turn was glossy (no resin). For these reasons, we concluded that the insulation was not damaged during the curing, but was damaged during the coil handling after the curing.

Further investigation with macrography instrument and deepness instrument devices shown that the scratch is 0.1 mm deep in the deepest part, and 0.6 mm large (Fig. 4).

Considering the damage of the cable and the insulation, the following procedure shall be applied:

- To remove the damaged insulation part very carefully from turns 19, 20 and 21, in order to avoid extra-thickness after repair.
- To adopt the test procedure, using the dedicated tools and inserting polyimide insulation as shown in Fig. 9.

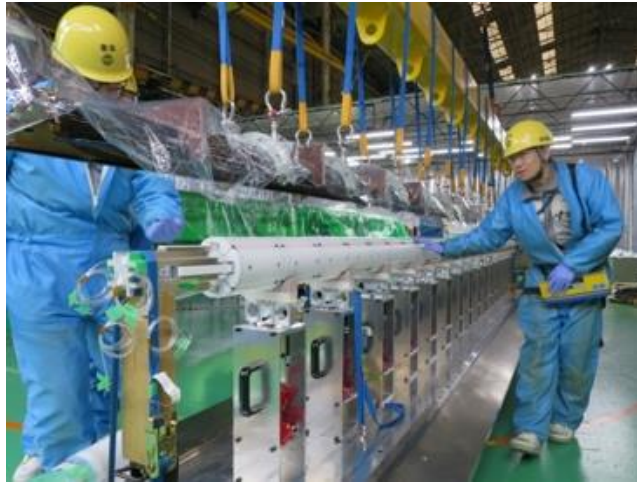
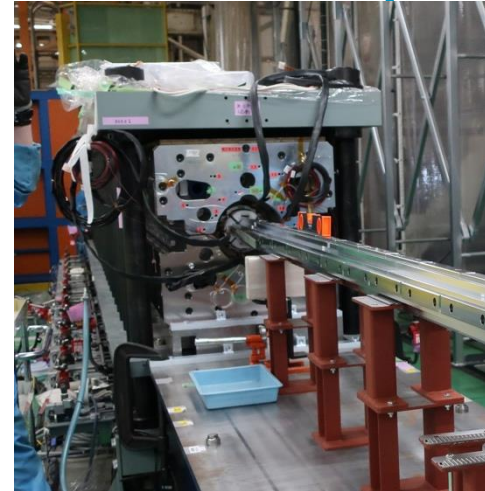
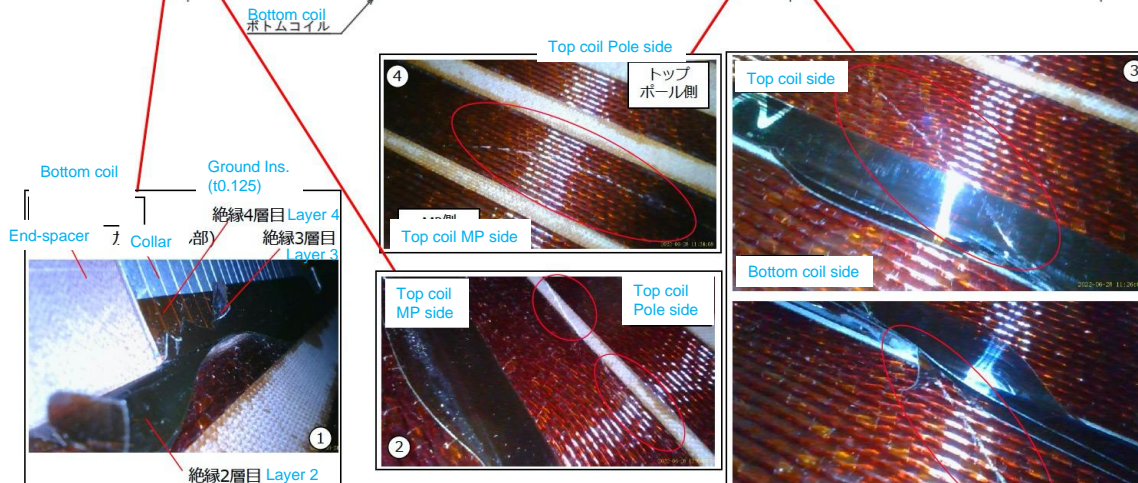
- カラーマンドレル引抜き後のコイル内径面外観検査で傷が確認された。
- ① LE側ボトムコイルポール端部：絶縁2層目・3層目の折り込み部に損傷
  - ② LE側から700mm位置：ウェッジ、トップコイルケーブル表面に傷
  - ③ RE側から2000mm位置：トップコイル・ボトムコイルケーブル表面に傷、MP部絶縁損傷
  - ④ RE側から2100mm位置：トップコイルケーブル表面に傷

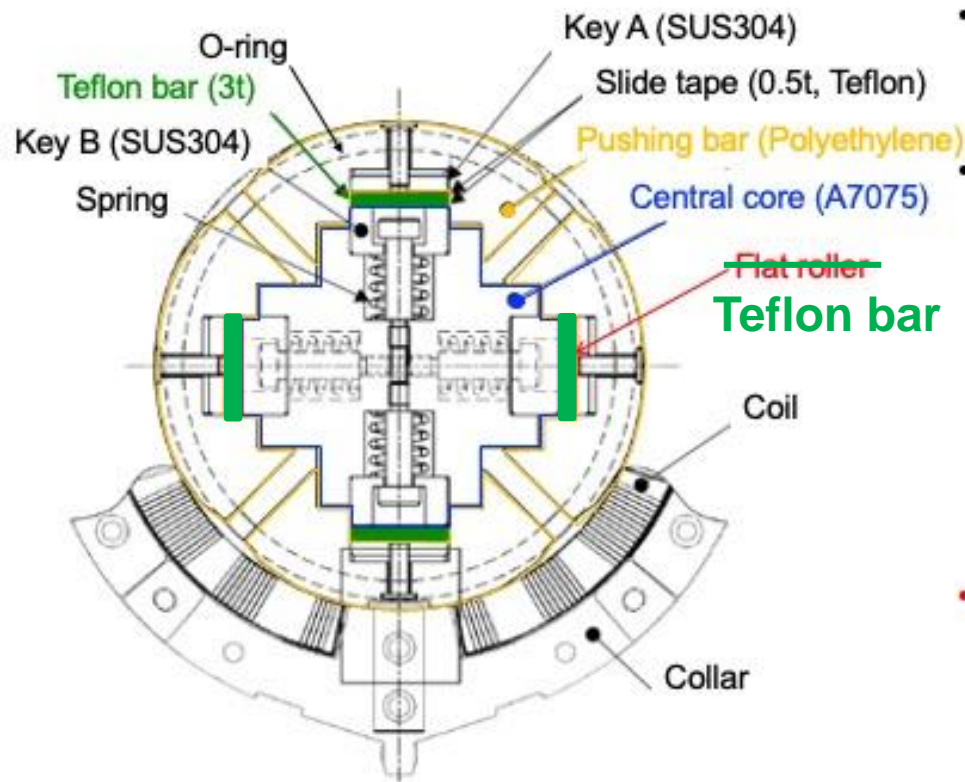
- **Collaring-mandrel for 2 m model magnets (KEK)**  
Flat rollers were used to smoothly pull out the collaring mandrel. Successfully worked.
- **Collaring-mandrel for MBXFP1 (Hitachi)**  
Instead of flat rollers, Teflon bars were used for both vertical and horizontal pushing bars. The central core could be pulled out, but the pulling load was higher than our expectation (~20 kN). In particular, friction at horizontal pushing bars were relatively high. A gap opened at joint part of the central core, suggesting that mechanical strength of central core was not enough.
- **Collaring-mandrel for MBXF5 (Hitachi)**  
In order to reduce the friction, flat rollers were introduced instead of Teflon bars only for the horizontal pushing bars, while Teflon bars were still used for the vertical pushing bars.

- Instead of flat rollers, teflon bars will be revived in the same way of MBXFP1.
- New collaring mandrel will be adopted for MBXF1.
