# RFD Prototype: Assembly lessons learned

12th HL-LHC Collaboration Meeting

21/09/2022

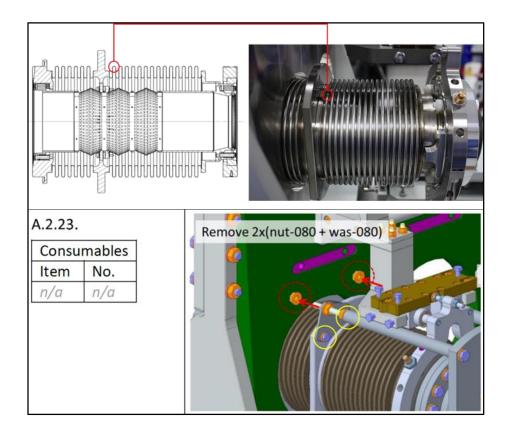
RFD Short CW Transition LHCVBMCC0033 Dent | LHC-ACFVW-QN-0001

- Error during assembly led to a dent on the secondary line CWT,
- Highlighted the need to follow assembly procedures carefully,
- Non-conformance is to be closed once secondary line vacuum

integrity has been demonstrated, (coming weeks)

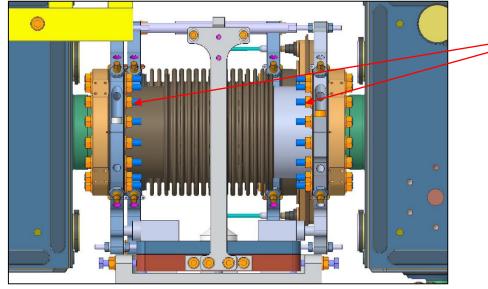
- Studs are longer and 68mm
- Studs are longer than clearance behind flange
  - Studs need to be pre-placed into PIMS before joint is made

• Therefore, studs cannot be replaced once joint operation begins

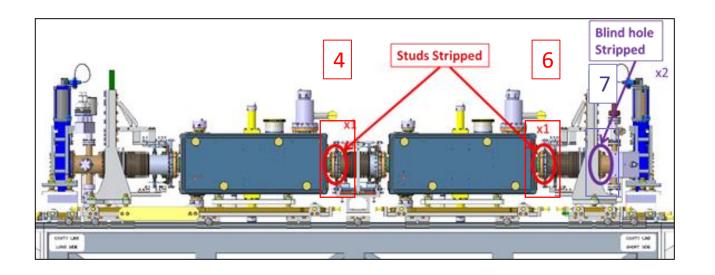
Threads Stripped on String Joints (STEP 1) |LHC-ACF\_A-QN-0001

Cause: combination of poor thread form on fasteners & difficulty of joint arrangement to gauge force/feel feedback during torque setting.

- Joints 4, 6, 7 experience thread failures

Remedy: blind holes and stud threads re-tapped in-situ in cleanroom, vacuum integrity check passed.

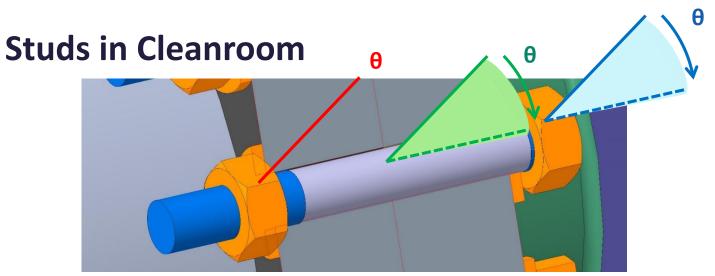
- When torque is applied to the Nut on the stud, there is no way to monitor if the stud is rotating/stationary
- Silver coating of nut means thread form is inconsistent
- Therefore, difficult to monitor force feedback and stud position during torque application
- Remedy for the series will to ensure the Studs used have a slot or equivalent to prevent rotation
