MQXFA magnet assembly: lessons learnt from MQXFA07/08

P. Ferracin

12th HL-LHC Collaboration Meeting
Uppsala, Sweden
September 19-22. 2022

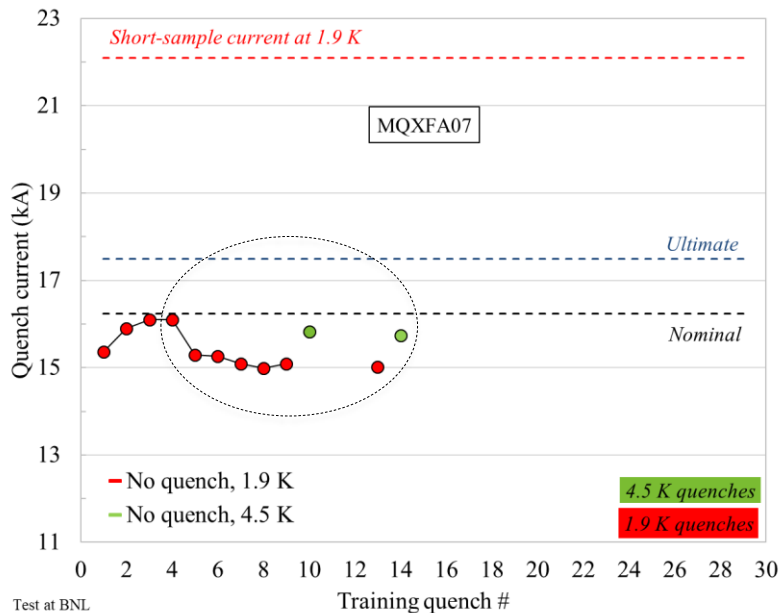
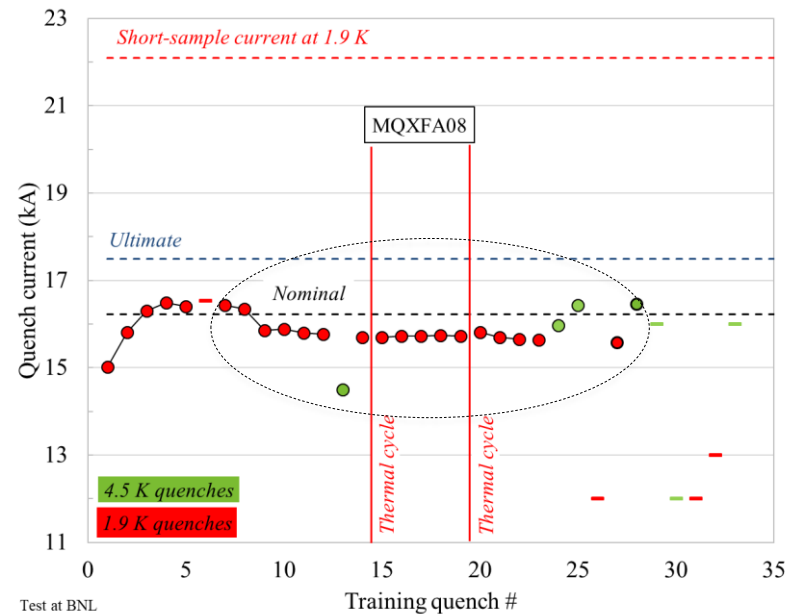
MQXFA07 and A08 test results

- Both magnets with **detraining** after few quenches
 - Reverse temperature and ramp-rate dependence
 - Both magnets limited by **segment a3-a4**
 - Coil 214 in A07 and coil 213 in A08

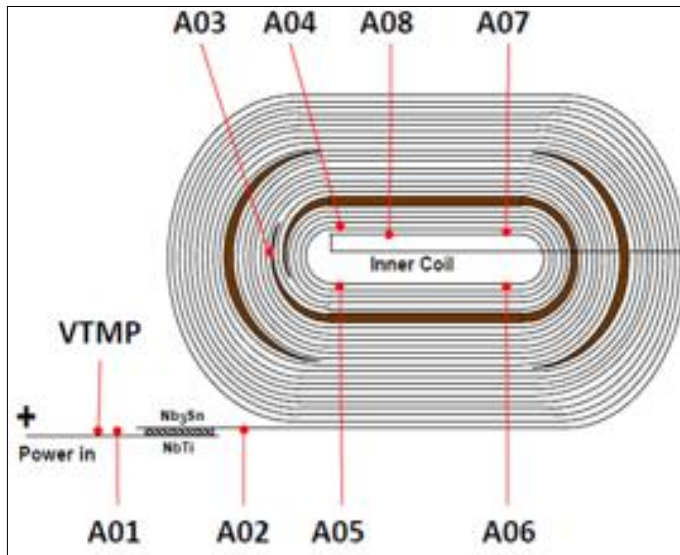
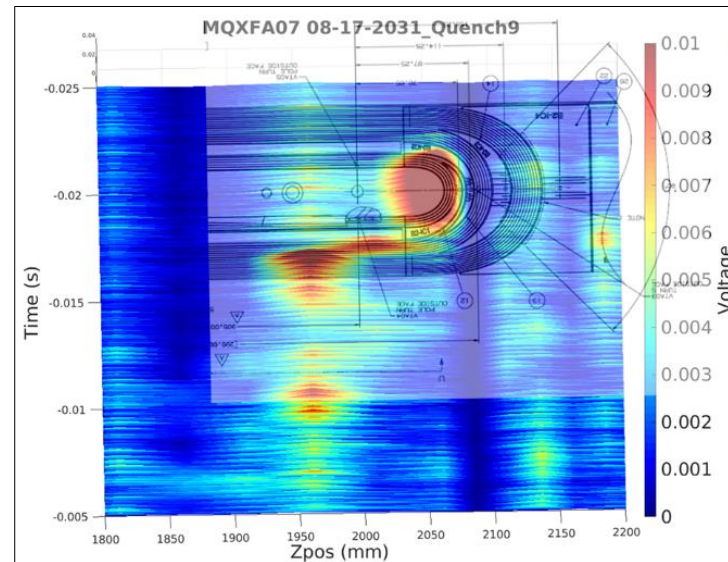
Back to MQXFA07 and A08 test results

- Quench location
 - a3a4: multi-turn segment including turns 2 to 6
 - Turns 2-5 are included in the pole-block multiturn
 - Turn 6 is the first turn outside the wedge
 - Quench antenna signals (50 mm long circuits) point out **LE**, where **pole block turns** go around the pole tip

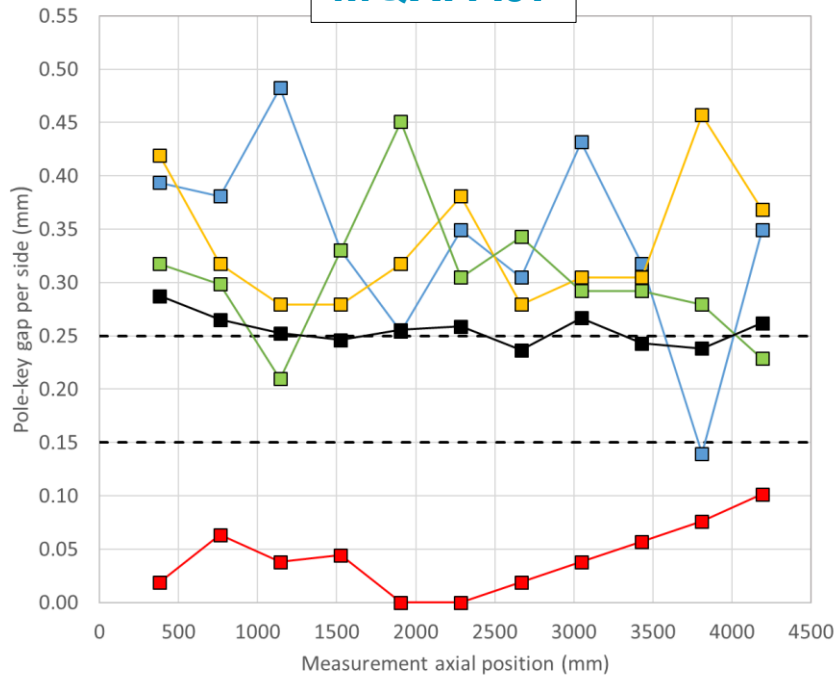
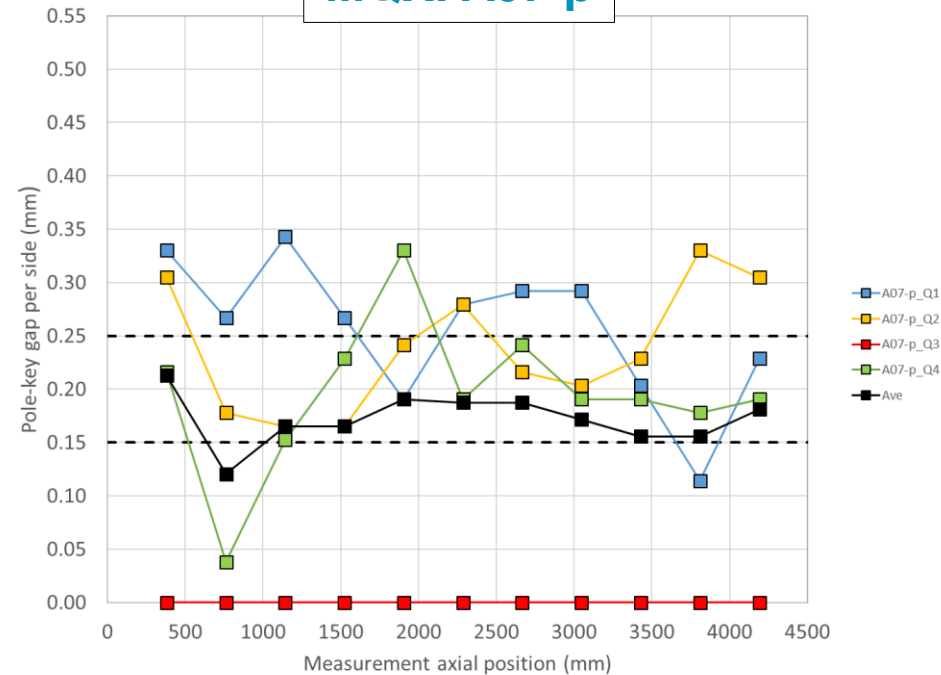
- Spec. pole key gap (local ave. on cross-section)
 - 0.200 ± 0.050 mm
- Before to after the test
 - Q3 with an **very low** gap both before and after the test
 - Average decreased by about 0.100 mm
 - **Same profiles** after pre-load and test

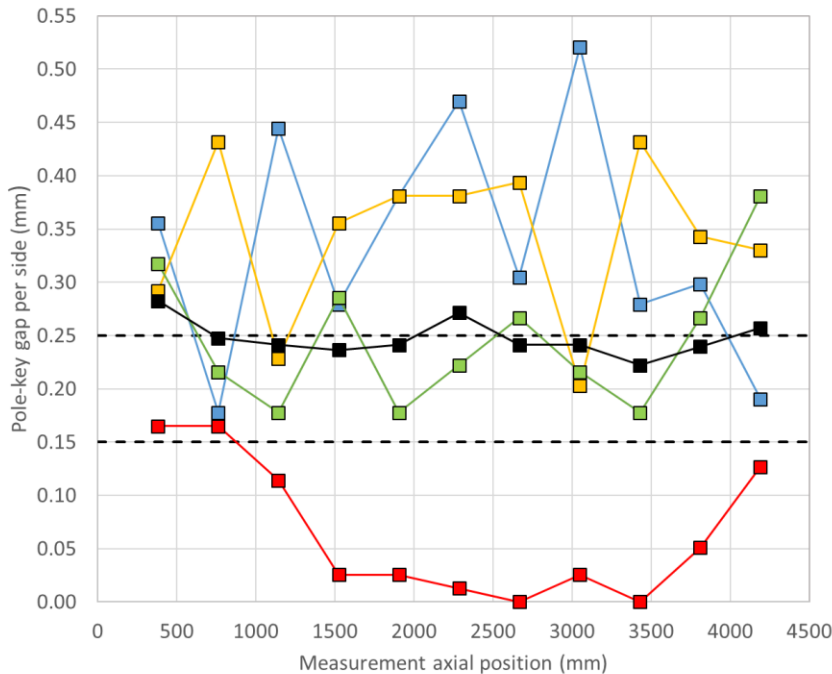
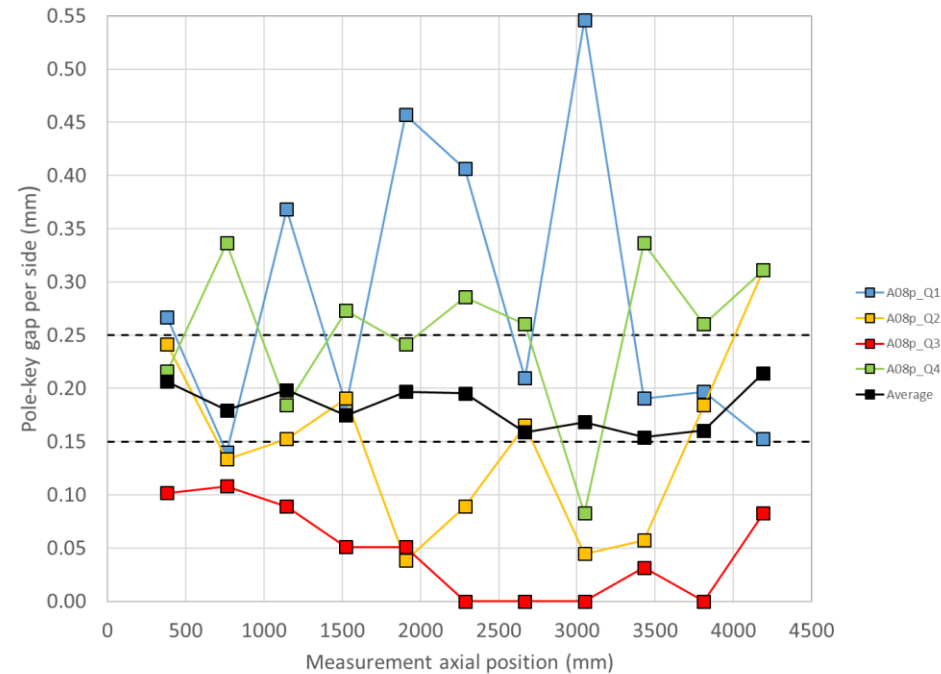
- Similar results on MQXFA08
 - But not as dramatic as in A07-p

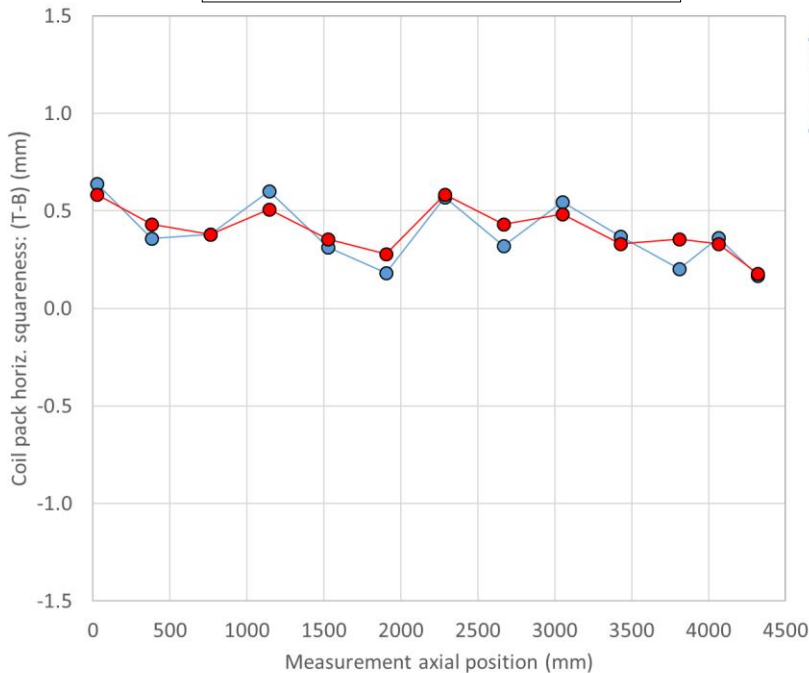
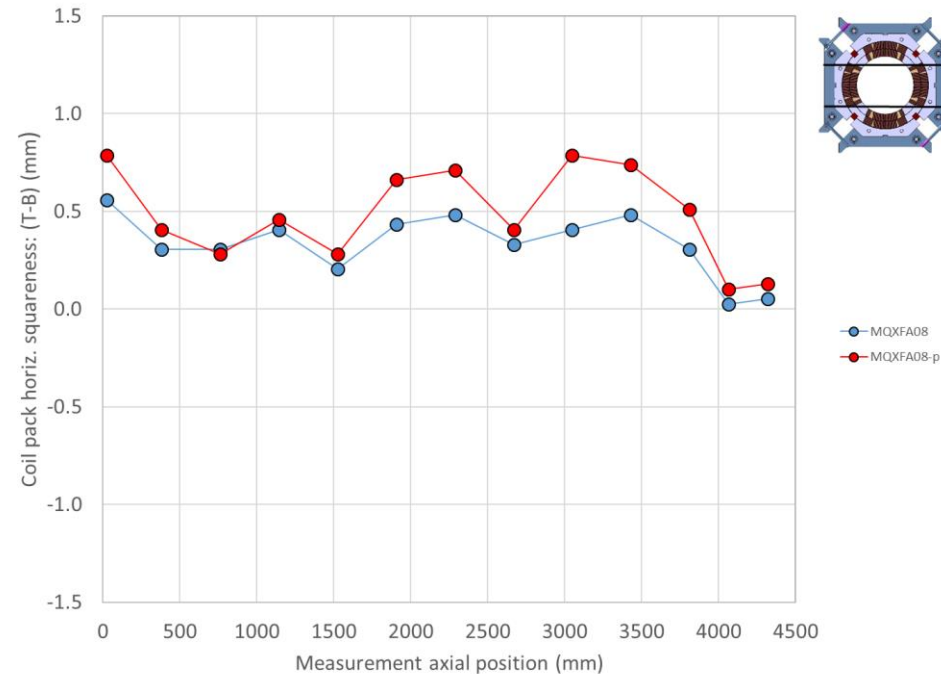
- The same conclusion could be drawn looking at the coil pack dimensions
 - Significant trapezoidal shape
 - No change from before to after test

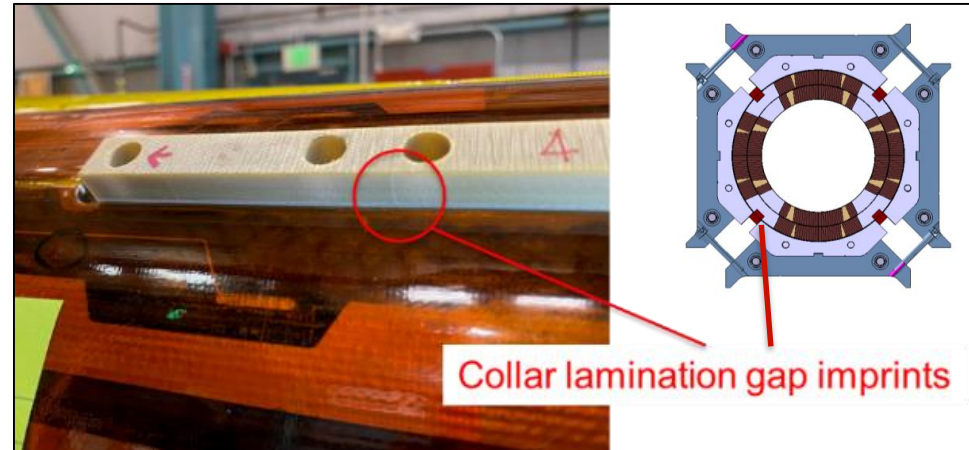
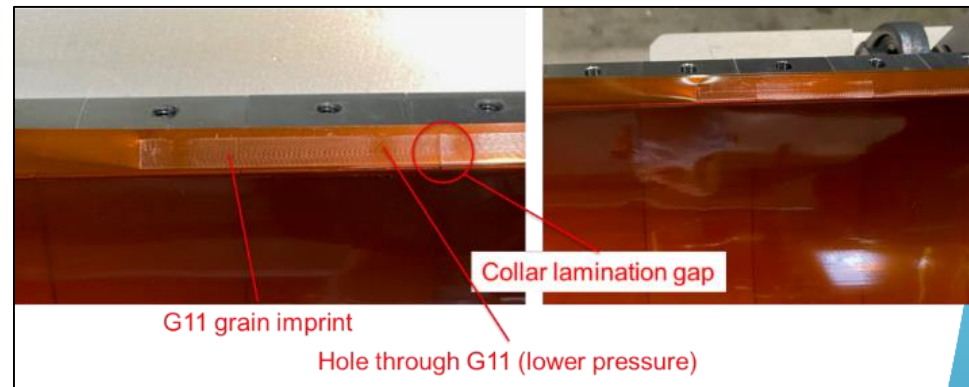
Coil visual inspection

- In Q3, **deep imprints** in the Kapton indicating collar lamination lines, G11 grain, and “lower pressure” spots at every hole
 - These imprints, all indicative of a **higher pressure**, not seen in the other quadrants.
- The **G11 keys** in Q3 also showed high pressure imprints of collar lamination gaps
 - **Not observed** in the other quadrants.

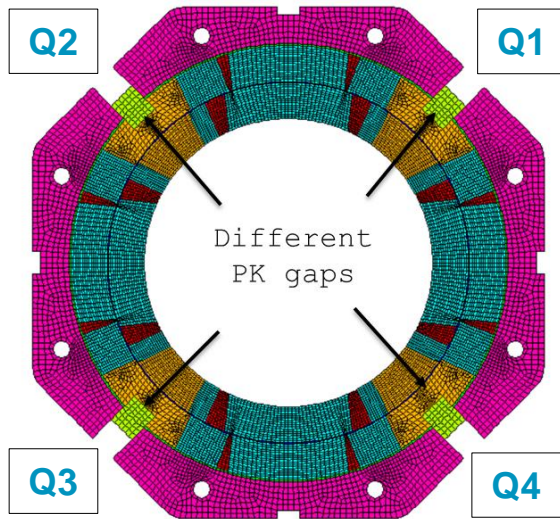
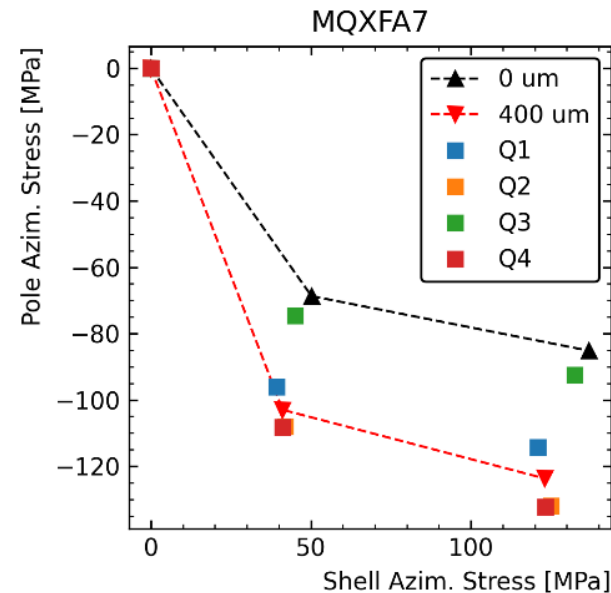
360-degrees, full cross-section 2D model

- With a **close pole key gap** in Q3, the azimuthal pre-stress is
 - **Significantly lower** (~30 MPa reduction) in the Q3
 - ‘Medium’ on the opposite side (Q1),
 - “Maximum” on the two remaining quadrants
- This effect is not measured by the **strain gauges**
 - However, measurement on a single axial location in RE

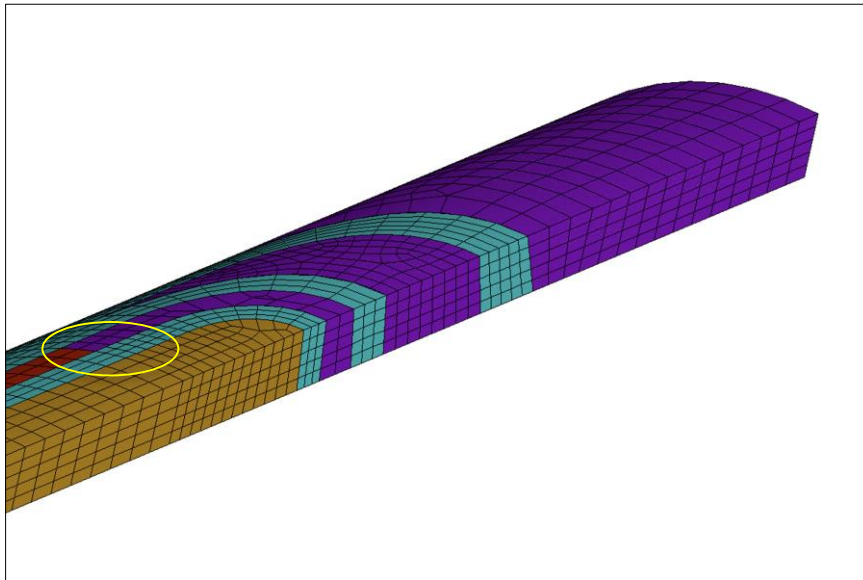
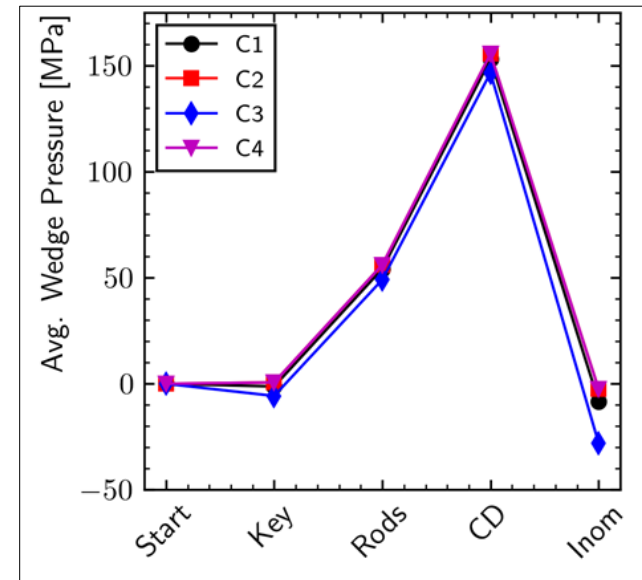
360-degrees, full cross-section 3D model

- “a3a4 LE area”
 - Contact between **wedge** and **end spacer** in L1
 - Considering **bonded** conditions
 - **Tension** occurs in Q3 during excitation

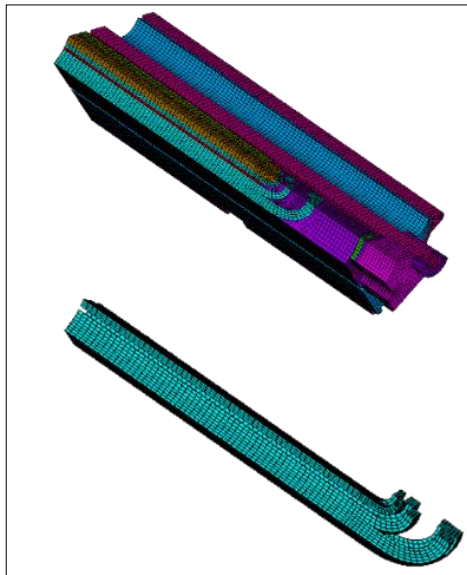
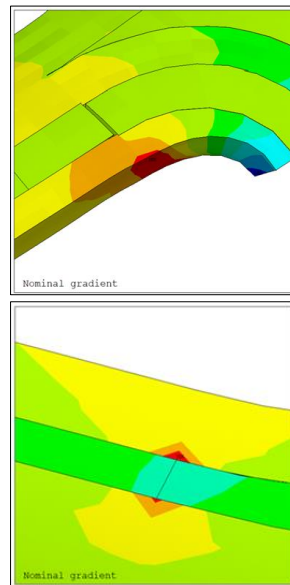
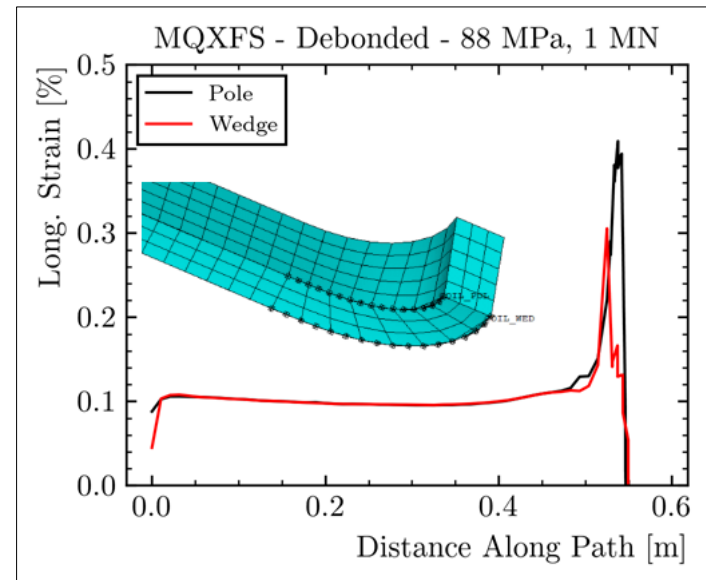
45-degrees, octant 3D model

- More detailed analysis with refined meshed
 - Not bonded, so as if **epoxy cracking** has occurred
 - The gap between wedge and end-spacer, induces a **spike in axial strain** in the coil, which can reach the 0.4% level
 - larger increase in the turn towards the pole.

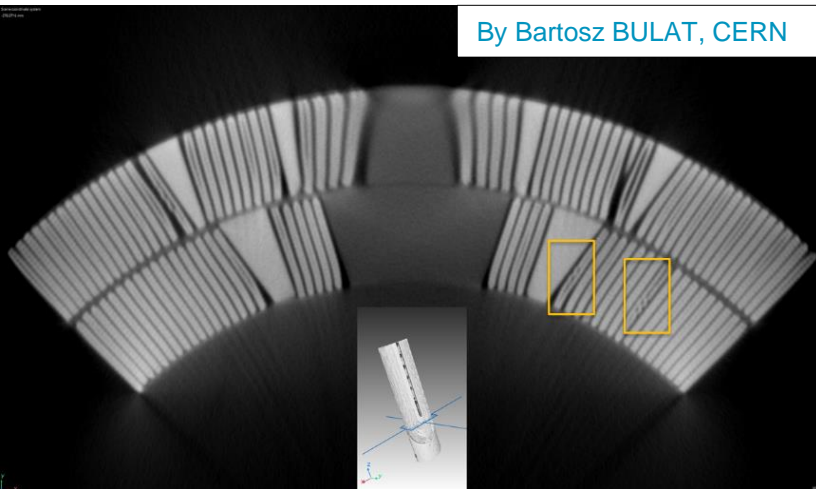
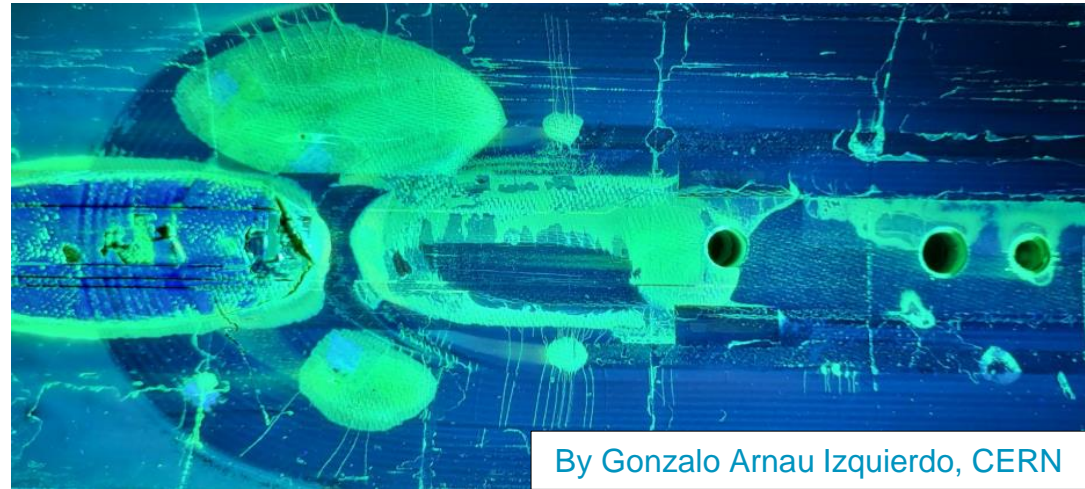
CT scan and die penetrant test

- In total 12 **popped strands** between LE and RE
 - But only one in the a3a4 segment, LE
- Bubbles/blisters also in the **wedge - end-spacer interface**
 - Horizontal cracks seen by **die-penetrant test** at CERN

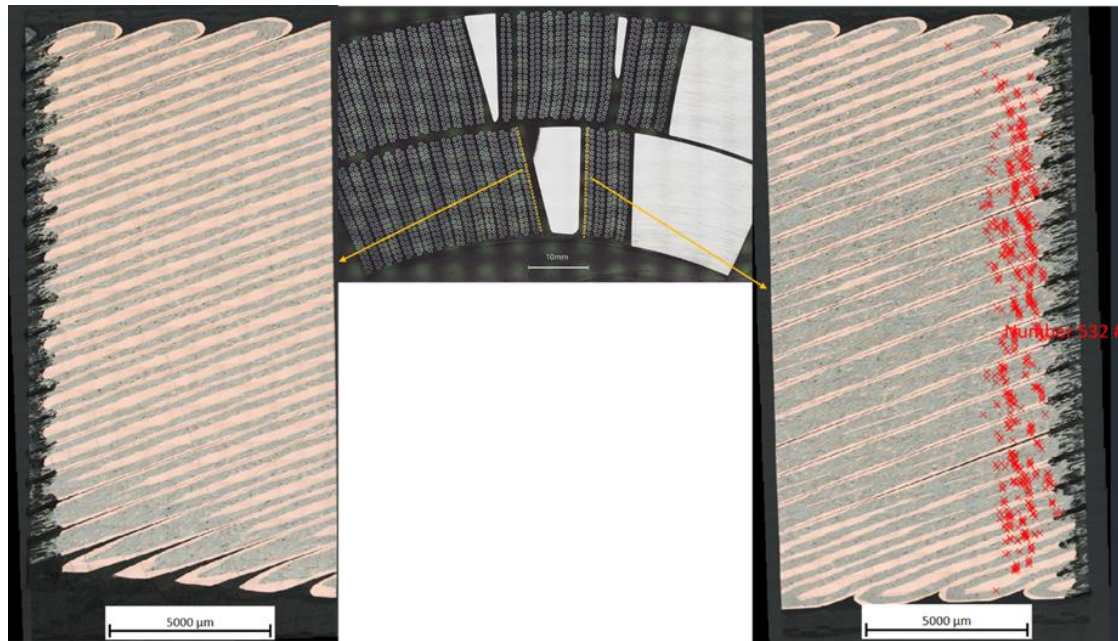
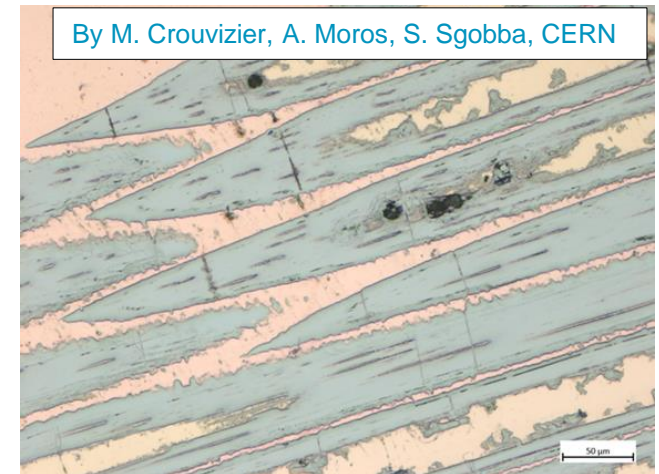
Metallurgical inspection

- Longitudinal cuts of first row of Rutherford cables adjacent to the end spacer/copper wedge transition
 - Localized field of **cracked filaments**, especially at pole block, between resin and copper wedge

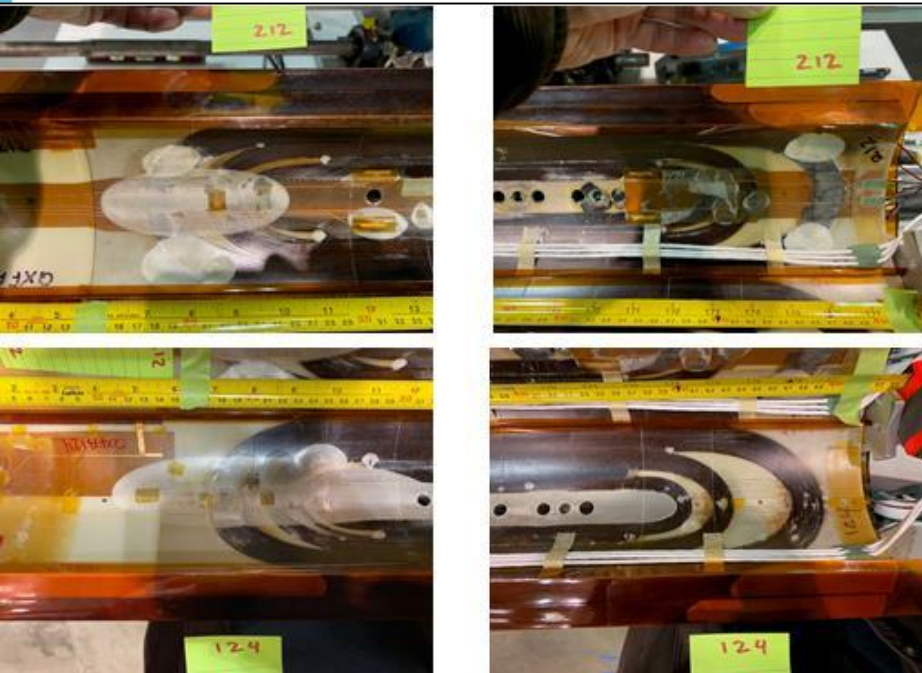
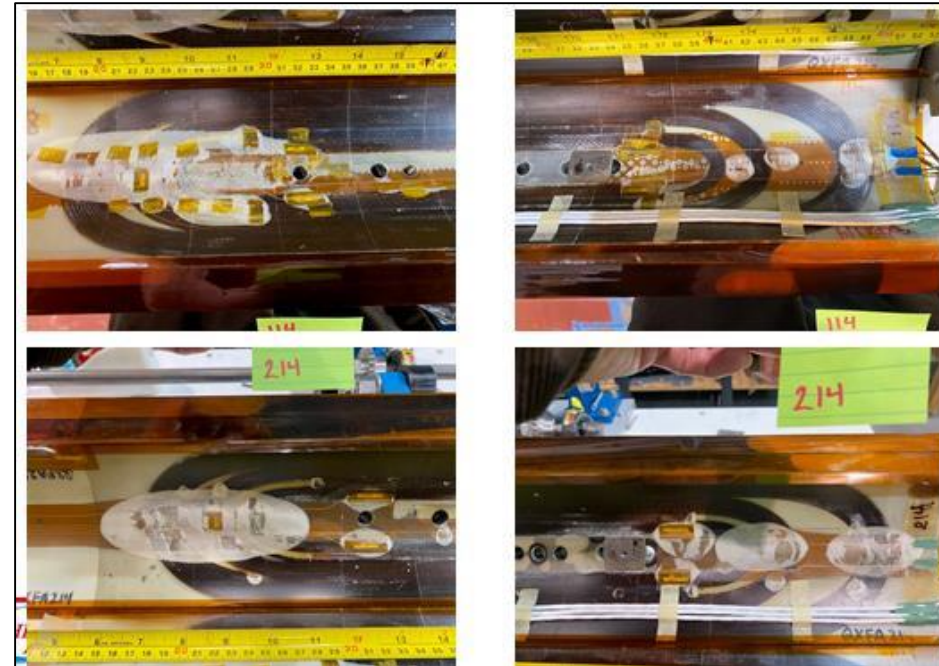
Coil visual inspection (II)

- The coil inner surface was characterized by many **bubbles/blisters**, predominantly on the LE
 - Also in the wedge/end-spacer interface

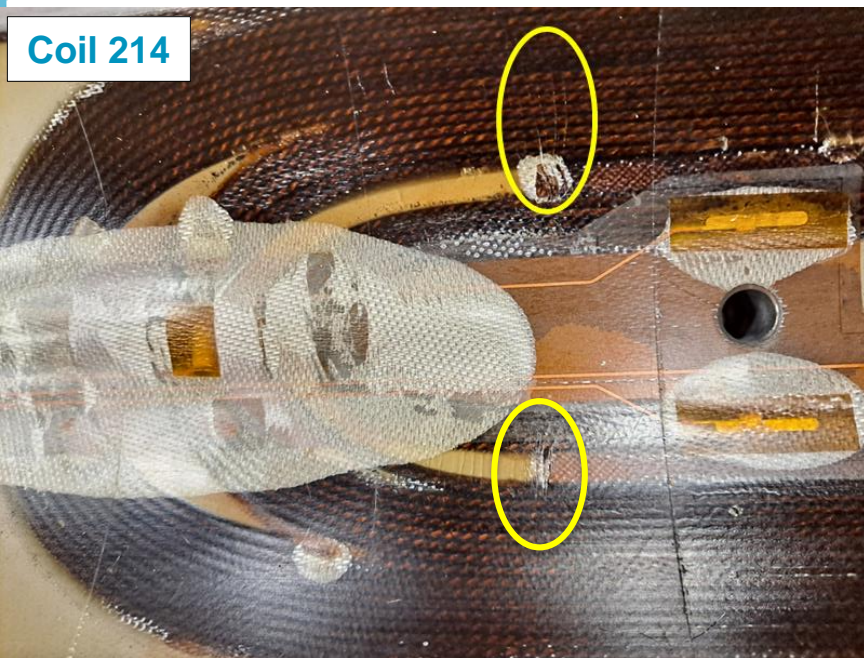
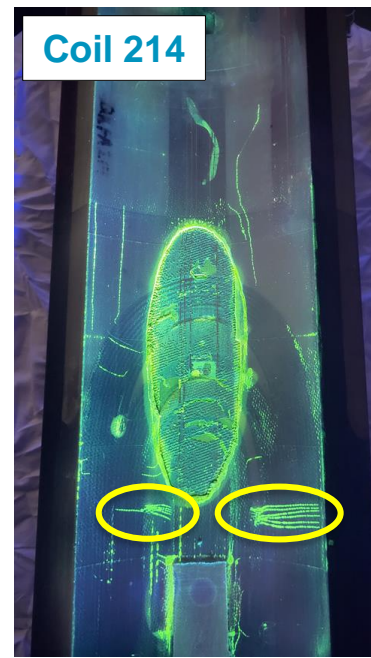
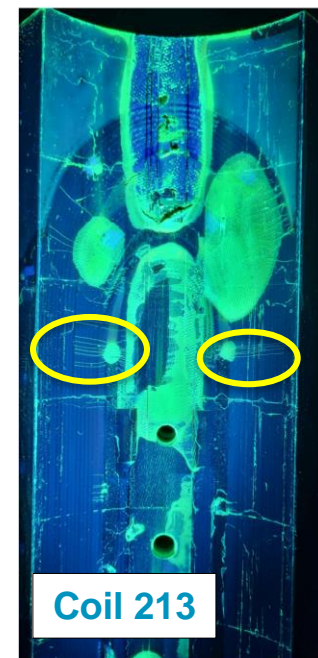
Die penetrant test

- Within the “critical zone” (a2a3...quench antenna...)
 - Bubbles/blisters also in the wedge - end-spacer interface
 - Observed in all coils
 - Horizontal cracks seen by die-penetrant test at CERN

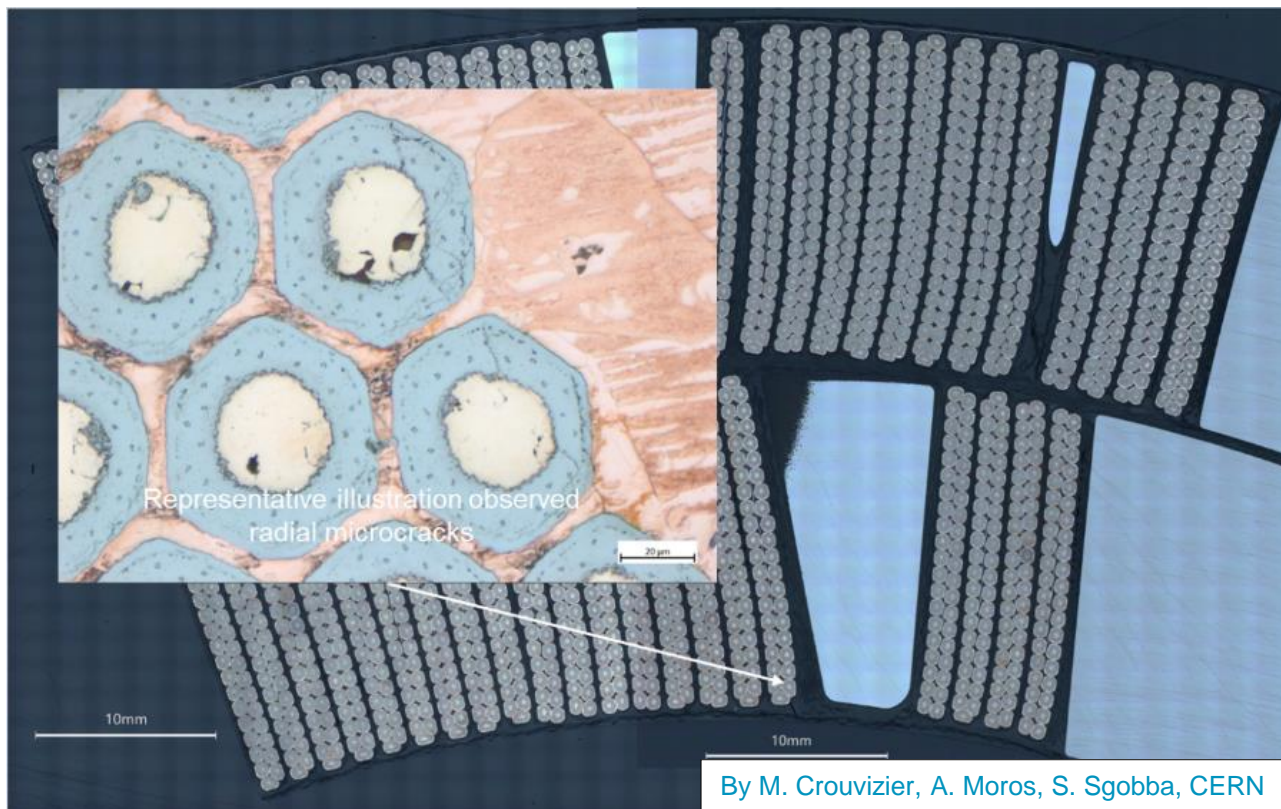
Metallurgical inspection

- Inspection of SC filaments did **not** reveal any **major events**.
 - Some radial “closed” microcracks can be observed
 - No collapsed filaments
